MINES BRANCH INVESTIGATION REPORT IR 65-6

EXAMINATION OF THREE ROCK DRILL PISTONS FOR USE IN THE INGERSOLL-RAND JR 300A ROCK DRILL (T.I.S. 58,733)

FEBRUARY 3, 1965

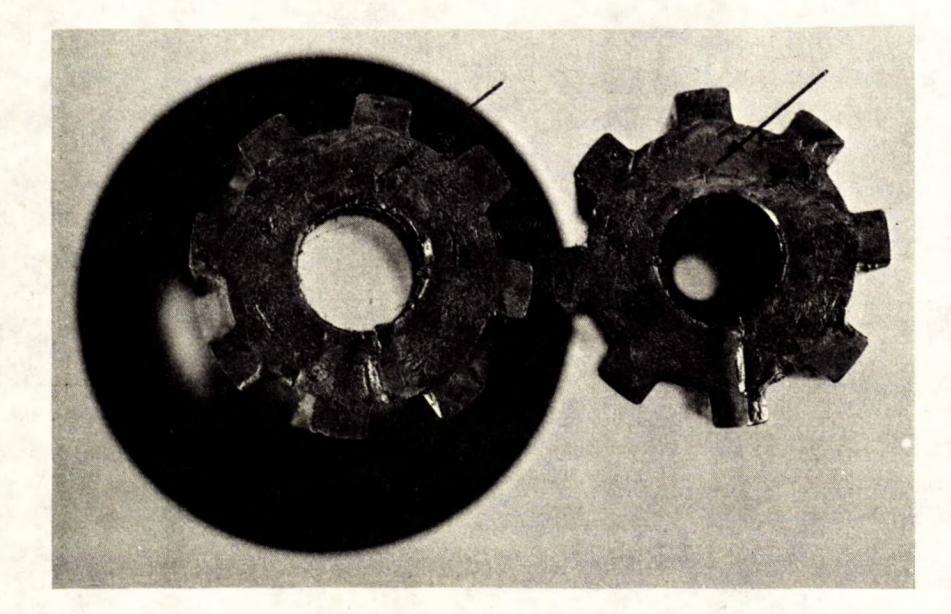
approximate actual size

Figure 2. Piston No. 2. View of transverse fracture at midpoint of piston shaft. The apparent origin of the fatigue fracture and the intersection with a steel defect (see also Figures 4 and 13)are marked (arrows). The third sample was supplied as a longitudinal half section, but had been surface ground and deep-etched prior to receipt. This unit, like that shown in Figure 1, had failed by battering of the work surface and by development of a transverse crack adjacent to the compression (driving) end, (arrow Figure 3).

- 2. Examination of the fracture on sample 2 suggested that this piston had failed after brief service. The origin of the fracture appeared to coincide with a longitudinal defect present in the bar stock. The crack surface was coated with bronze, indicating that the crack had progressed from the outside inwards rather than from the borehole. The ridge pattern, present on the end surface of the piston shaft, if due to service, suggests that this end, as it rotated, was contacting a rough drill rod or tappet surface. Wear had occurred since the ridges were formed as illustrated in Figure 6.

- 1. Purchase steel to highest standard of cleanness with respect to inclusion stringers (directionality) or consider use of forged blanks. The finished pistons should receive a magnetic particle inspection to reveal any quench cracks, grinding cracks, undercuts, or unacceptable inclusions prior to service.

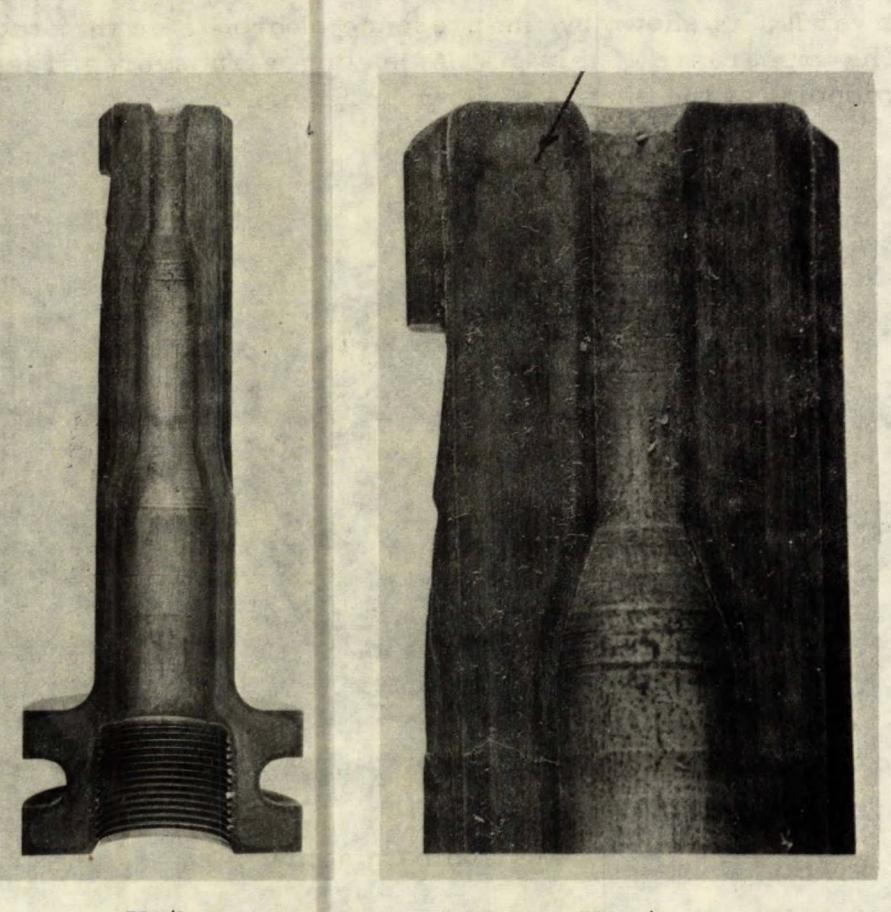
Figure 3. Piston No. 3, half section as-received - etched. This piston, like piston No. 1, had failed by battering of the end, spalling of the splines and by development of a transverse crack (arrow) 1/4 in. from the impact (compression end).

> The core metal has a hardness of R_c 38; the surfacehardened metal is visible as a dark line following the external and bore contours. The surface hardness is R_c 59 to 61. Transition from R_c 59/61 to R_c 38 occurs within the darkened etch-zone.
