This document was produced
by scanning the original publication.

Ce document est le produit d'une
numérisation par balayage
de la publication originale.

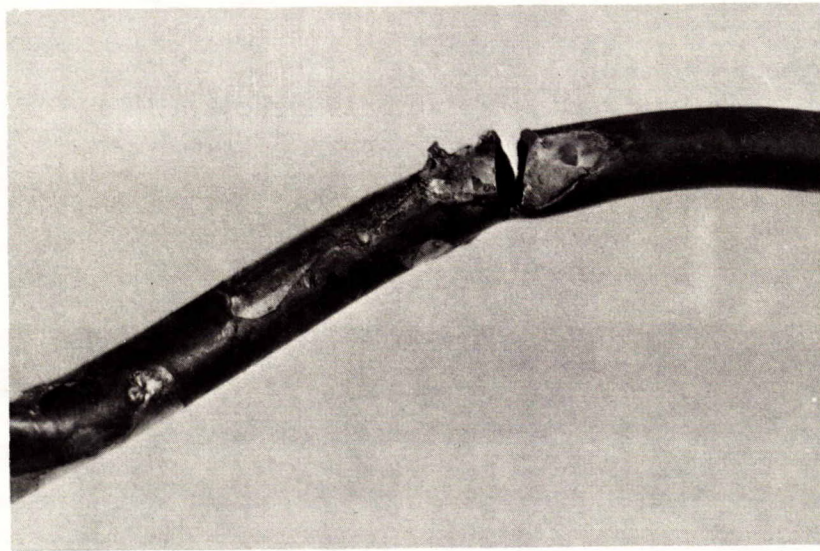
Figure 1. As-received broken pipe.

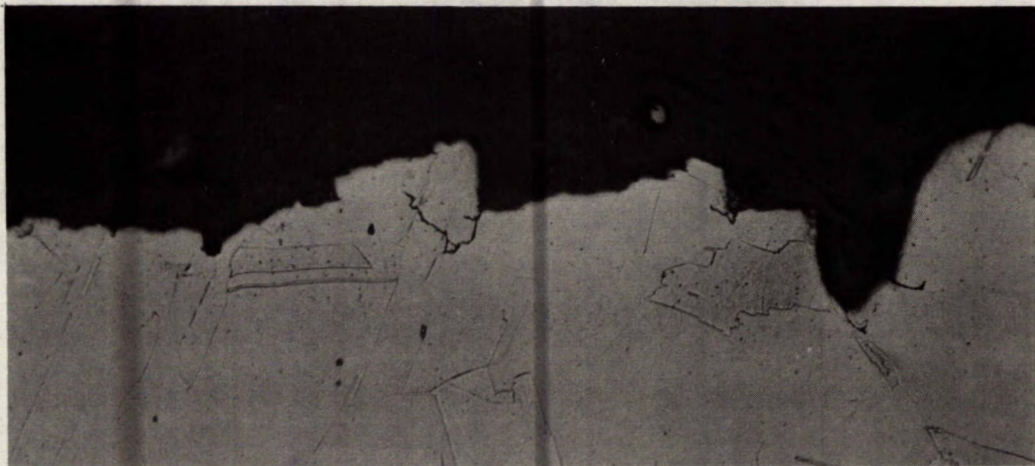
Figure 2. Fatigue failure, mainly transcrystalline
Etched in alcoholic ferric chloride.

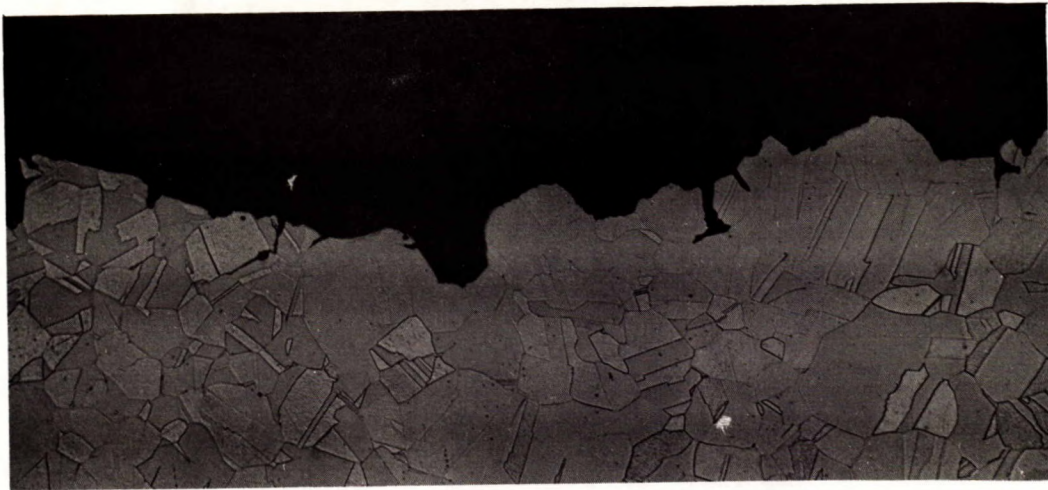
Figure 3. Fatigue failure, mainly transcrystalline and
crack damage in adjacent material.
Etched in alcoholic ferric chloride.

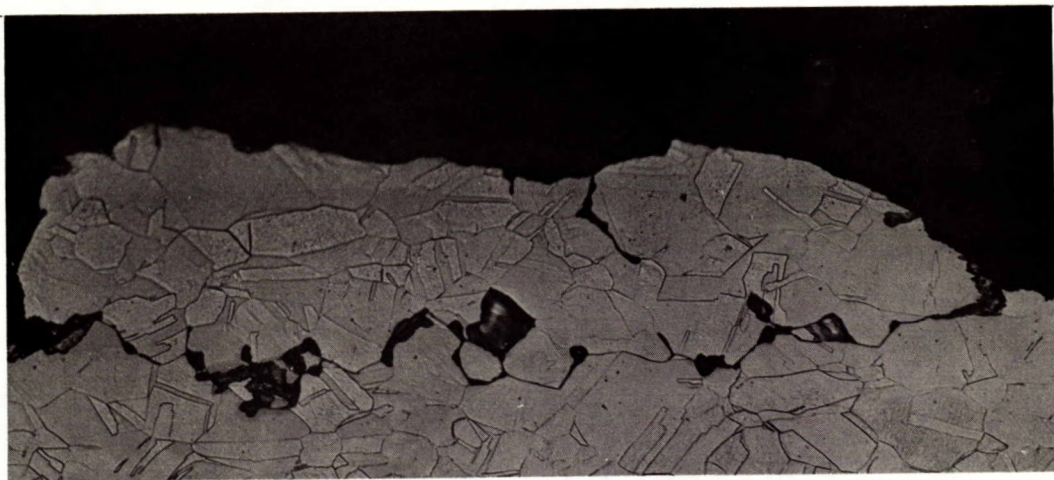
Figure 4. Fracture in last tube is mainly intercrystalline with transcrystalline components. Etched in alcoholic ferric chloride.

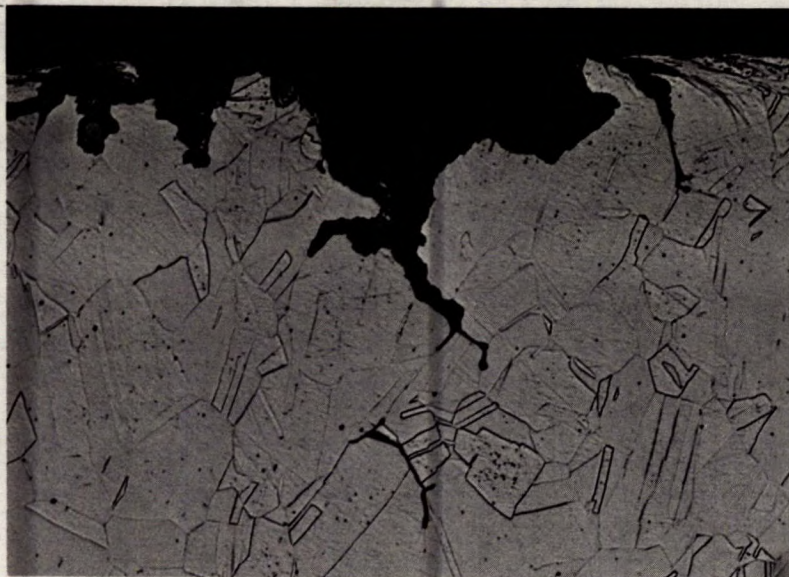
Figure 5. Intercrystalline crack running approximately parallel to main fracture in last tube. Etched in alcoholic ferric chloride.

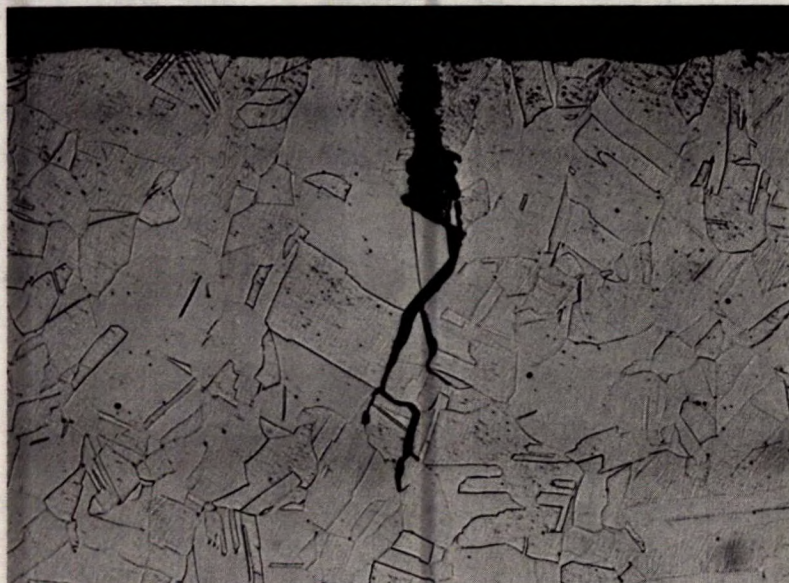
Figure 6. Fracture area - main fracture parallel to top of picture. Note intergranular voids. Etched in alcoholic ferric chloride.
