MINES BRANCH INVESTIGATION REPORT IR 66-1

EXAMINATION OF SAMPLES FROM DIPPER STICK OF A BUCYRUS-ERIE 280-D SHOVEL

D. R. BELL & D. A. MUNRO

FEBRUARY 1, 1966

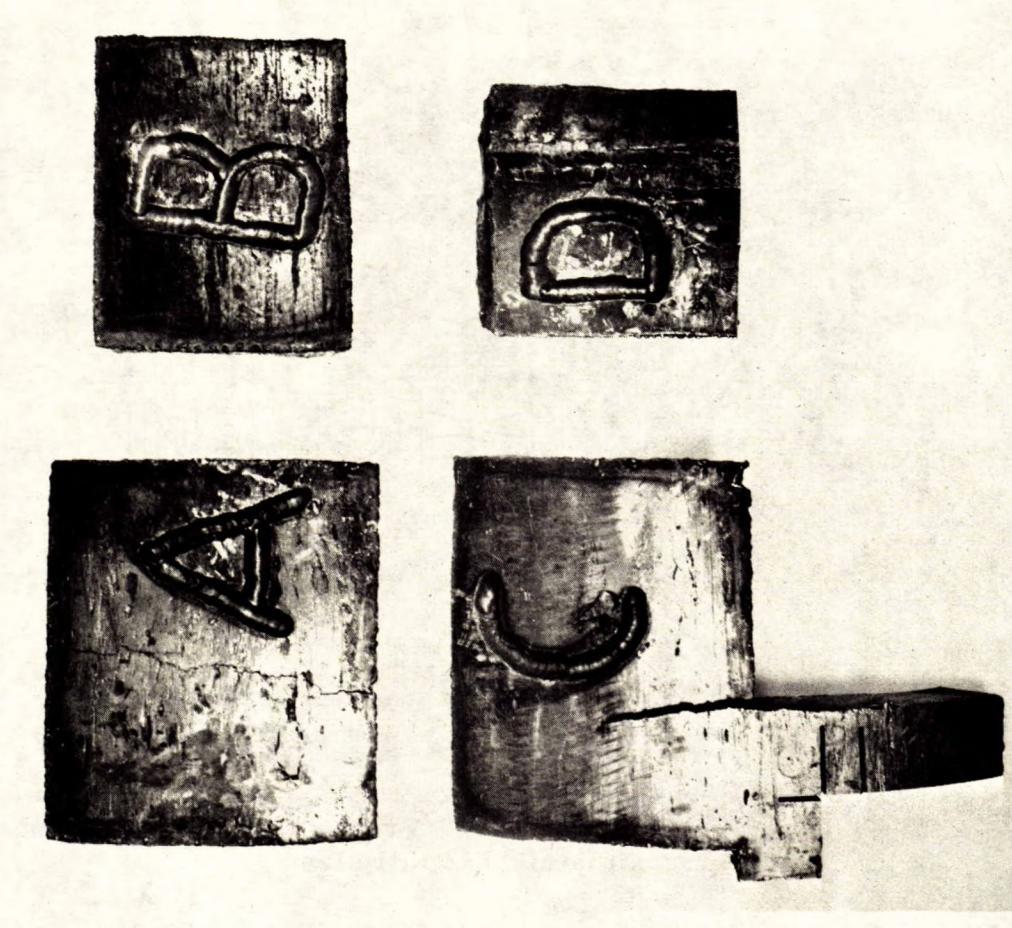
The samples are shown in Figure 1. The identification letters were torch-burned into the surface to a depth of about 1/4 inch. Total thickness of the material was 1-7/8 inches. The size of the letters and the extent of heat affected zone rendered much of the material unsuitable for determining the original properties. Samples B and D showed no evidence of fracturing or cracking. Sample A showed a branched crack along the full width of the external surface parallel to the direction of curvature (circumferentially). A similar crack showed on the interior surface, Figure 2. When stressed as a beam in a press, the sample broke readily into two pieces. As can be seen in Figure 3, there were three fatigue fractures in this sample. The only reason it had not separated when first cut free from the dipper stick was the fact that the fractures were not quite in the same transverse plane. The mechanical strength of the section across the cracks was virtually zero. As can be seen in Figure 4, the fracture in sample C originated as a fatigue crack. It is apparent that the fatigue crack penetrated the full wall thickness (as did those in sample A) before the occurrence of rapid fracture. Although not visible in the illustrations, there was a distinct lateral contraction at the end of the crack. Such contraction is typical of that which occurs at the arrest point of a brittle fracture. There was a longitudinal surface tear at the fracture origin, Figure 4(b).

Figure 1. Samples as received, except for portion removed from lower right corner of sample C.

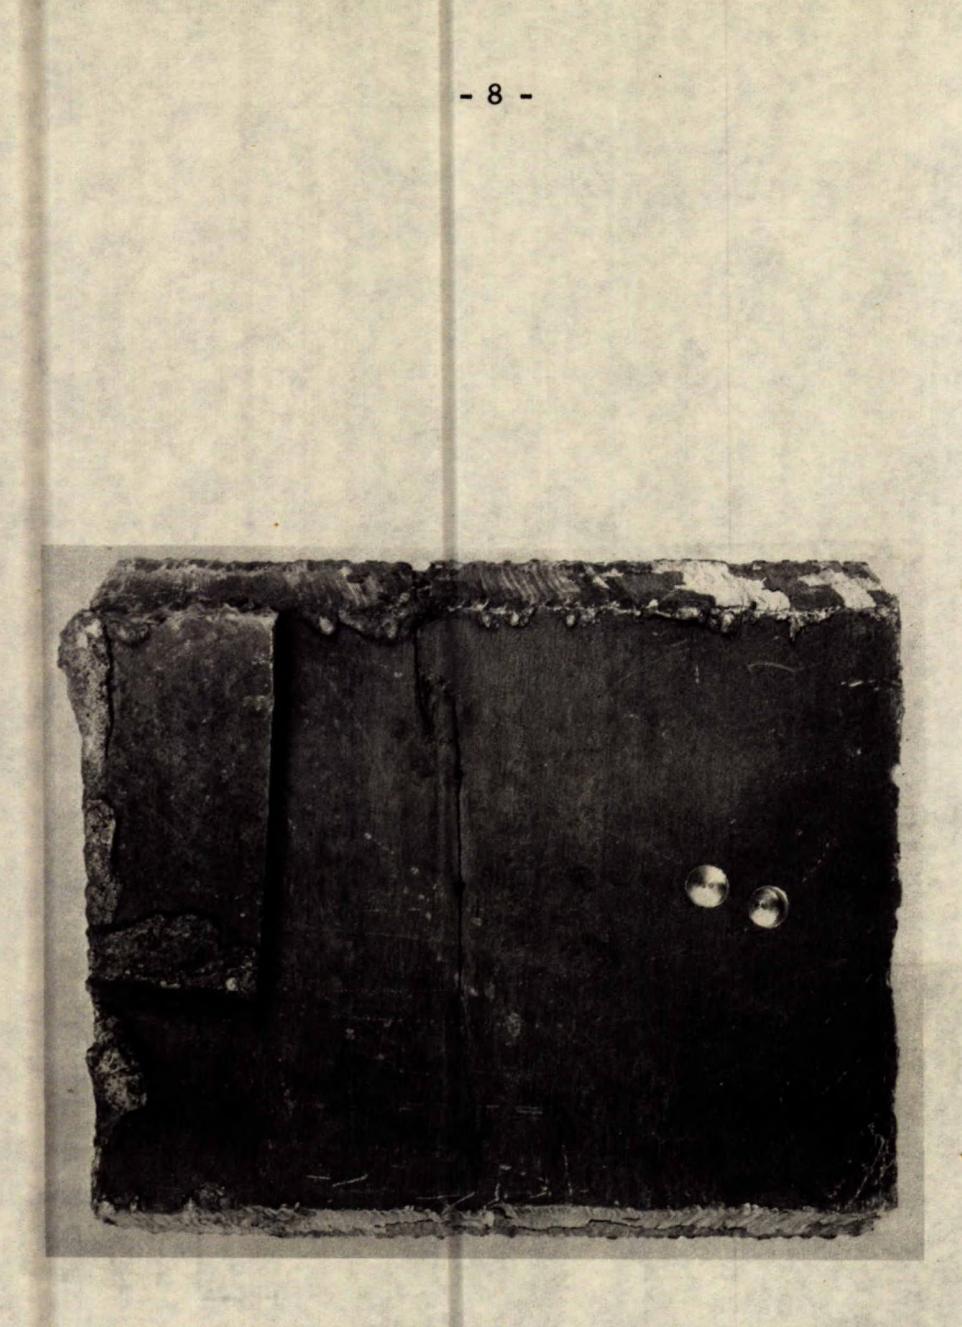
Figure 2. Interior surface of sample A, illustrating through-the-section penetration of crack shown on the opposite surface in Figure 1.

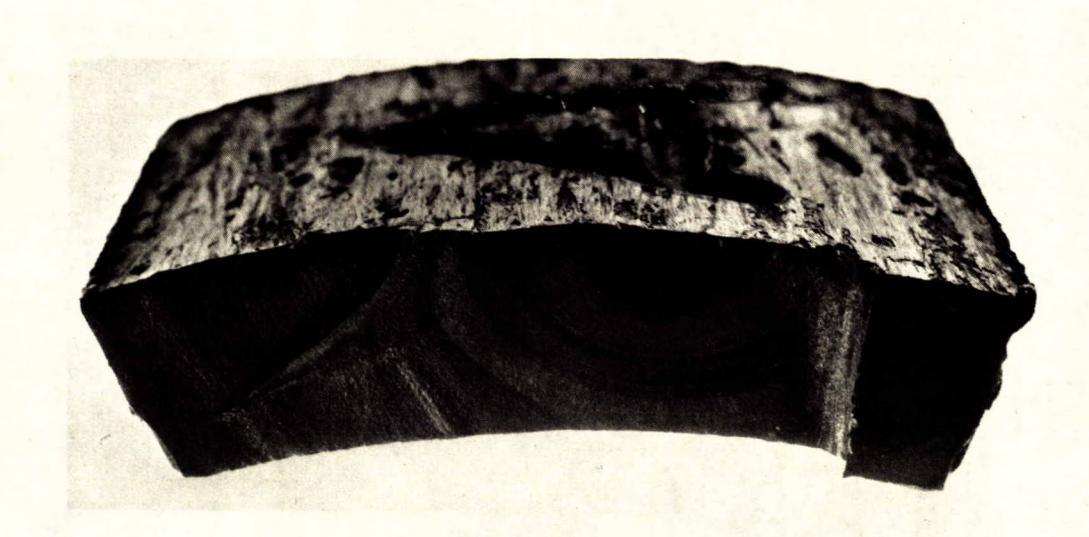
Figure 3. Sample A after it was broken open, illustrating 3 fatigue fractures in this short length.

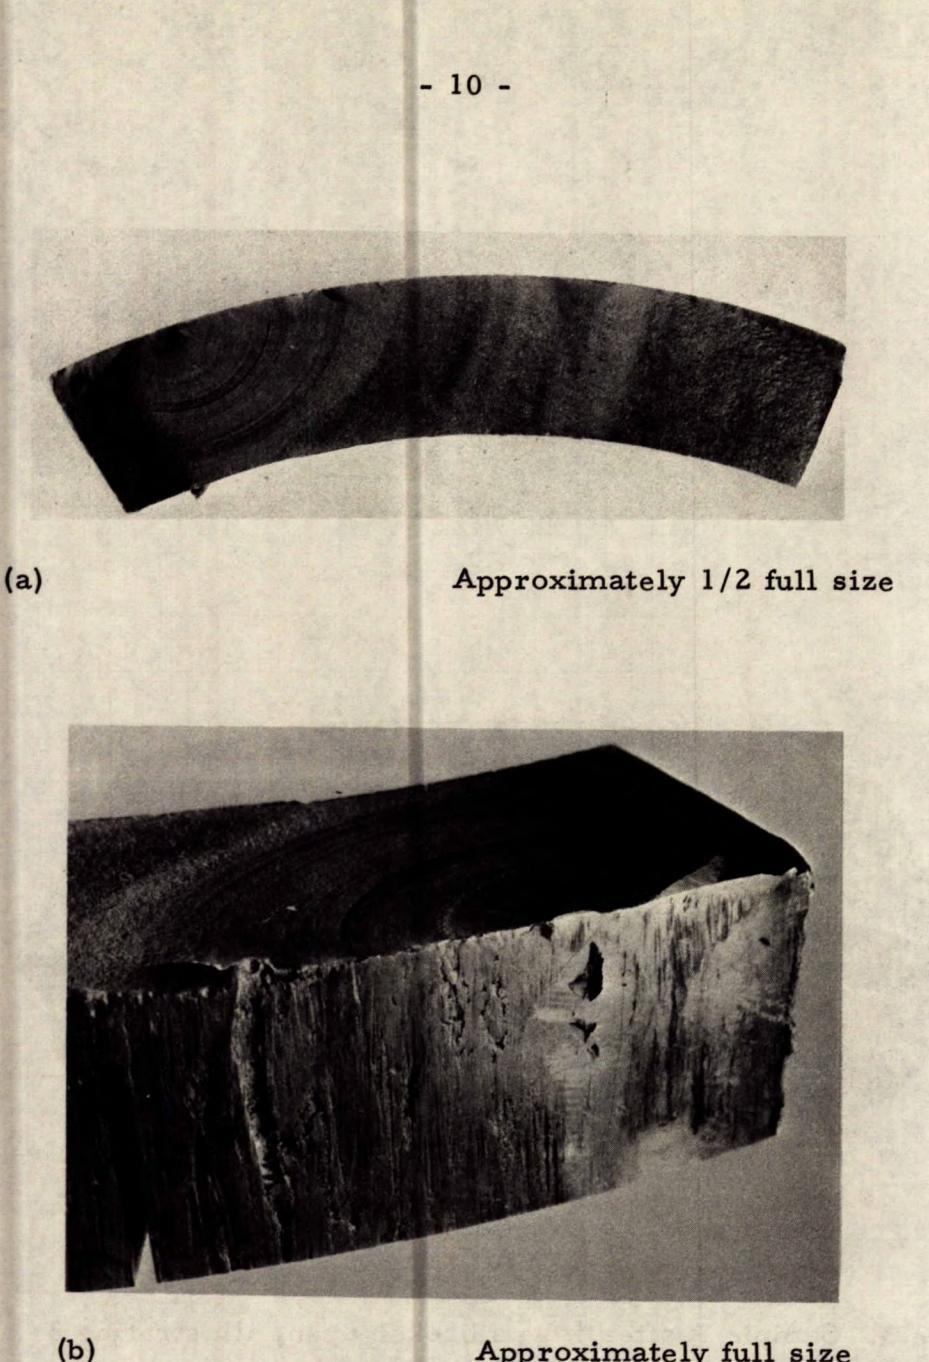
Figure 4. Sample C.

- Illustrating classic fatigue "beach" marks on fracture (a) surface. Crack arrest occurred just beyond this portion to the right and the developing ductile "shear lip" can be seen at the upper right.
- (b) Oblique view of fracture origin showing hollow formed when surface metal sheared due to galling following lubrication failure.

- 1. Lubrication should be improved to eliminate galling.
- 2. Accidental arc strikes should be avoided. If one occurs, the area should be repaired with a weld utilizing all the welding precautions relevant to the material and circumstances.
- 3. It is suggested the same material be used and the situation be reassessed following corrective action as per 1 and 2 above.

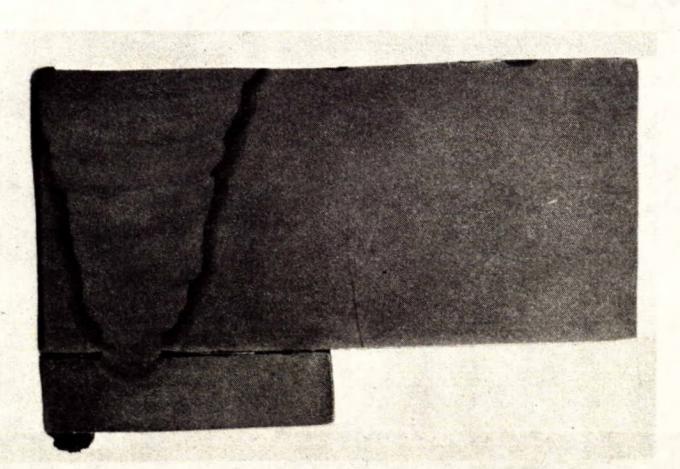
Longitudinal sections were taken through two fracture origins in sample A and the single origin in sample C. Figure 5 shows a full section of sample A. It is notable that the fatigue fracture, right-hand edge of section, was not associated with the weld, although a small crack was found in the base of the weld adjacent to the interior surface of the tube. Three dark etching patches can be seen at the surface (top of the section) between the weld and the fracture. The right-hand patch is due to an arc strike, Figure 6(a), which resulted in the formation of at least six cracks. The other two patches were due to galling damage. One patch is shown in Figure 6(b). Figure 7 shows a portion of the section through two fracture origins in sample A. In both cases, fracture originated in cracks in brittle martensite which was formed as a consequence of high temperature generated in unlubricated sliding friction followed by self-quenching when motion ceased.

Figure 5. Full section through a fatigue fracture origin of sample A. The fracture, right edge, is not associated with the weld at the left. Note the three dark spots on the section at the upper edge between the weld and the fracture. The right hand one is an arc strike, Figure 6(a), while the other two are due to galling, Figure 6(b).

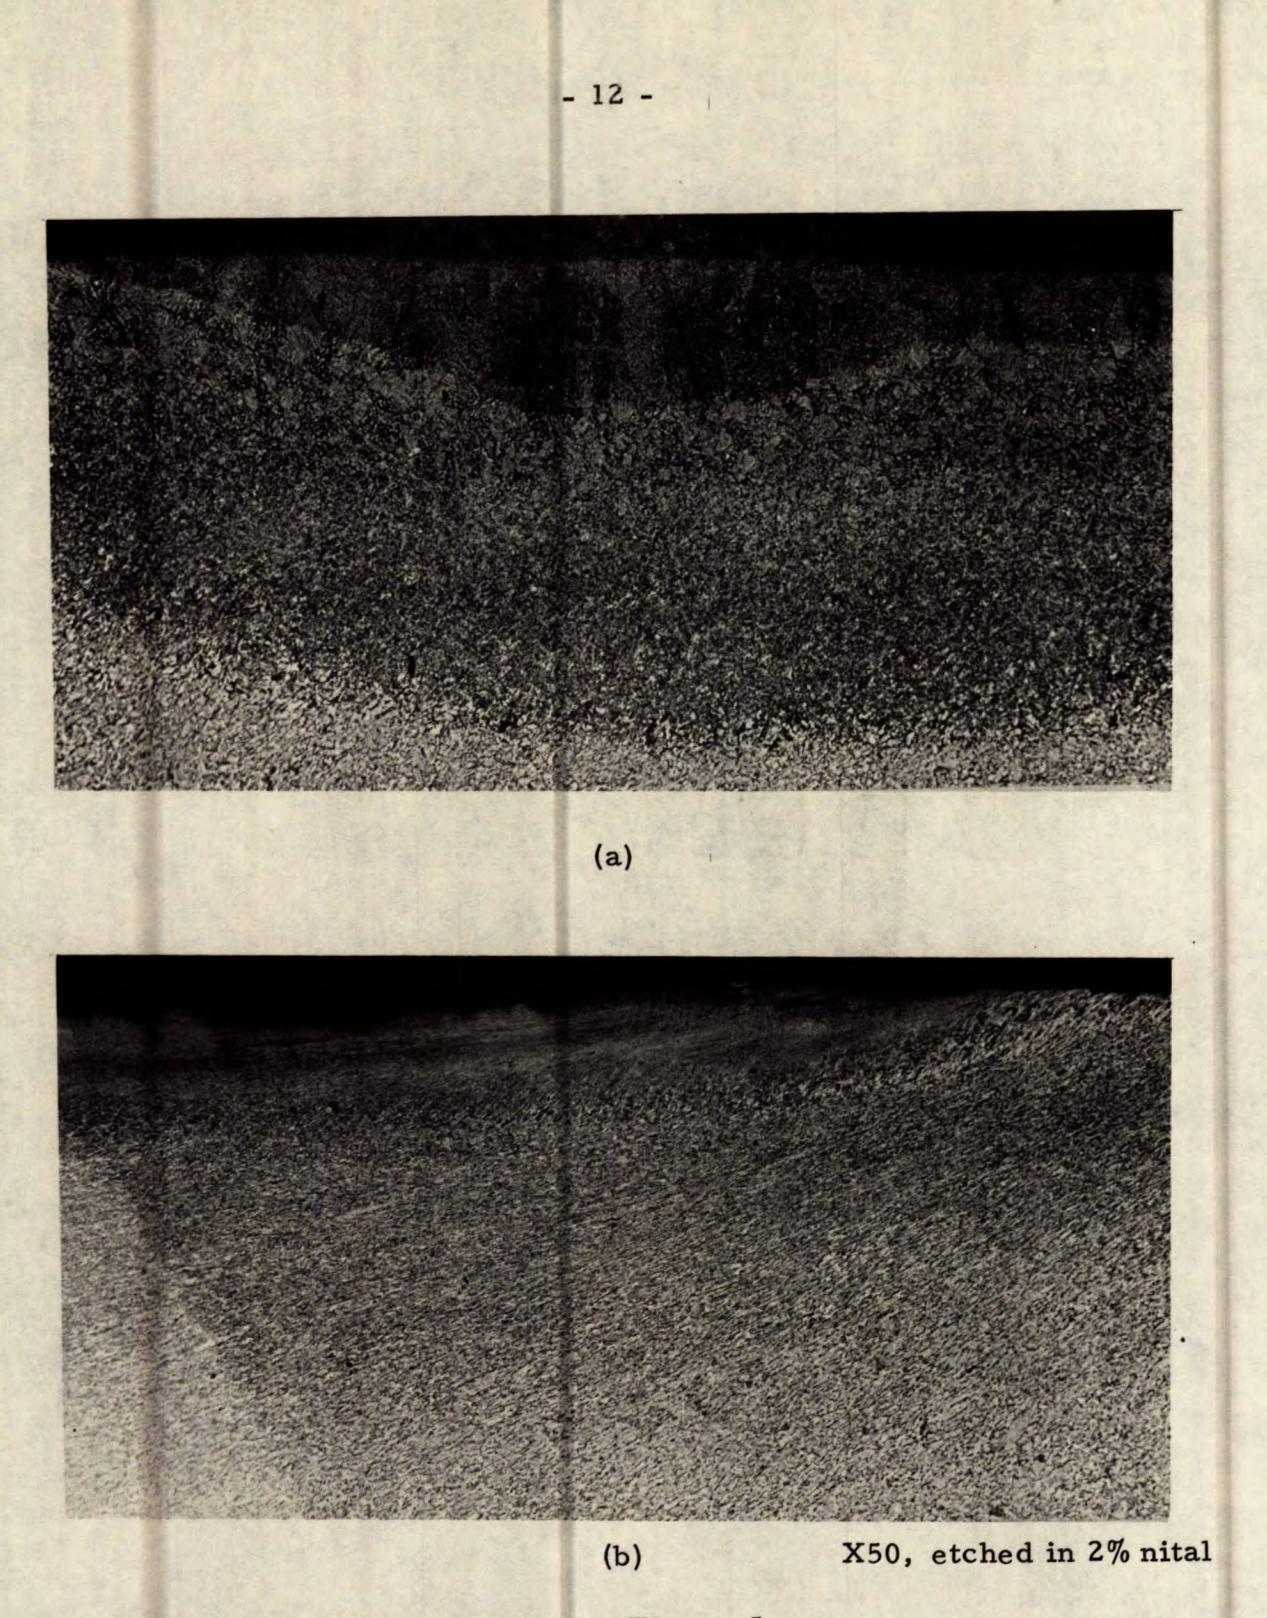
Figure 6. Both same section as Figure 5.

No fractures were found to be associated with the welds. Even the arc-strike cracks had not nucleated a fracture. This may well have been because of low surface stress in the particular area due to an adjacent pre-existing fatigue crack. In any event, it can safely be predicted that such arc-strike damage would cause failure in new dipper sticks where improved lubrication has eliminated galling damage.

- (a) Illustrating arc strike containing at least 6 cracks.
- (b) Illustrating plastic flow and martensite generated at the surface due to lubrication failure.

Both structures are potential crack starters.

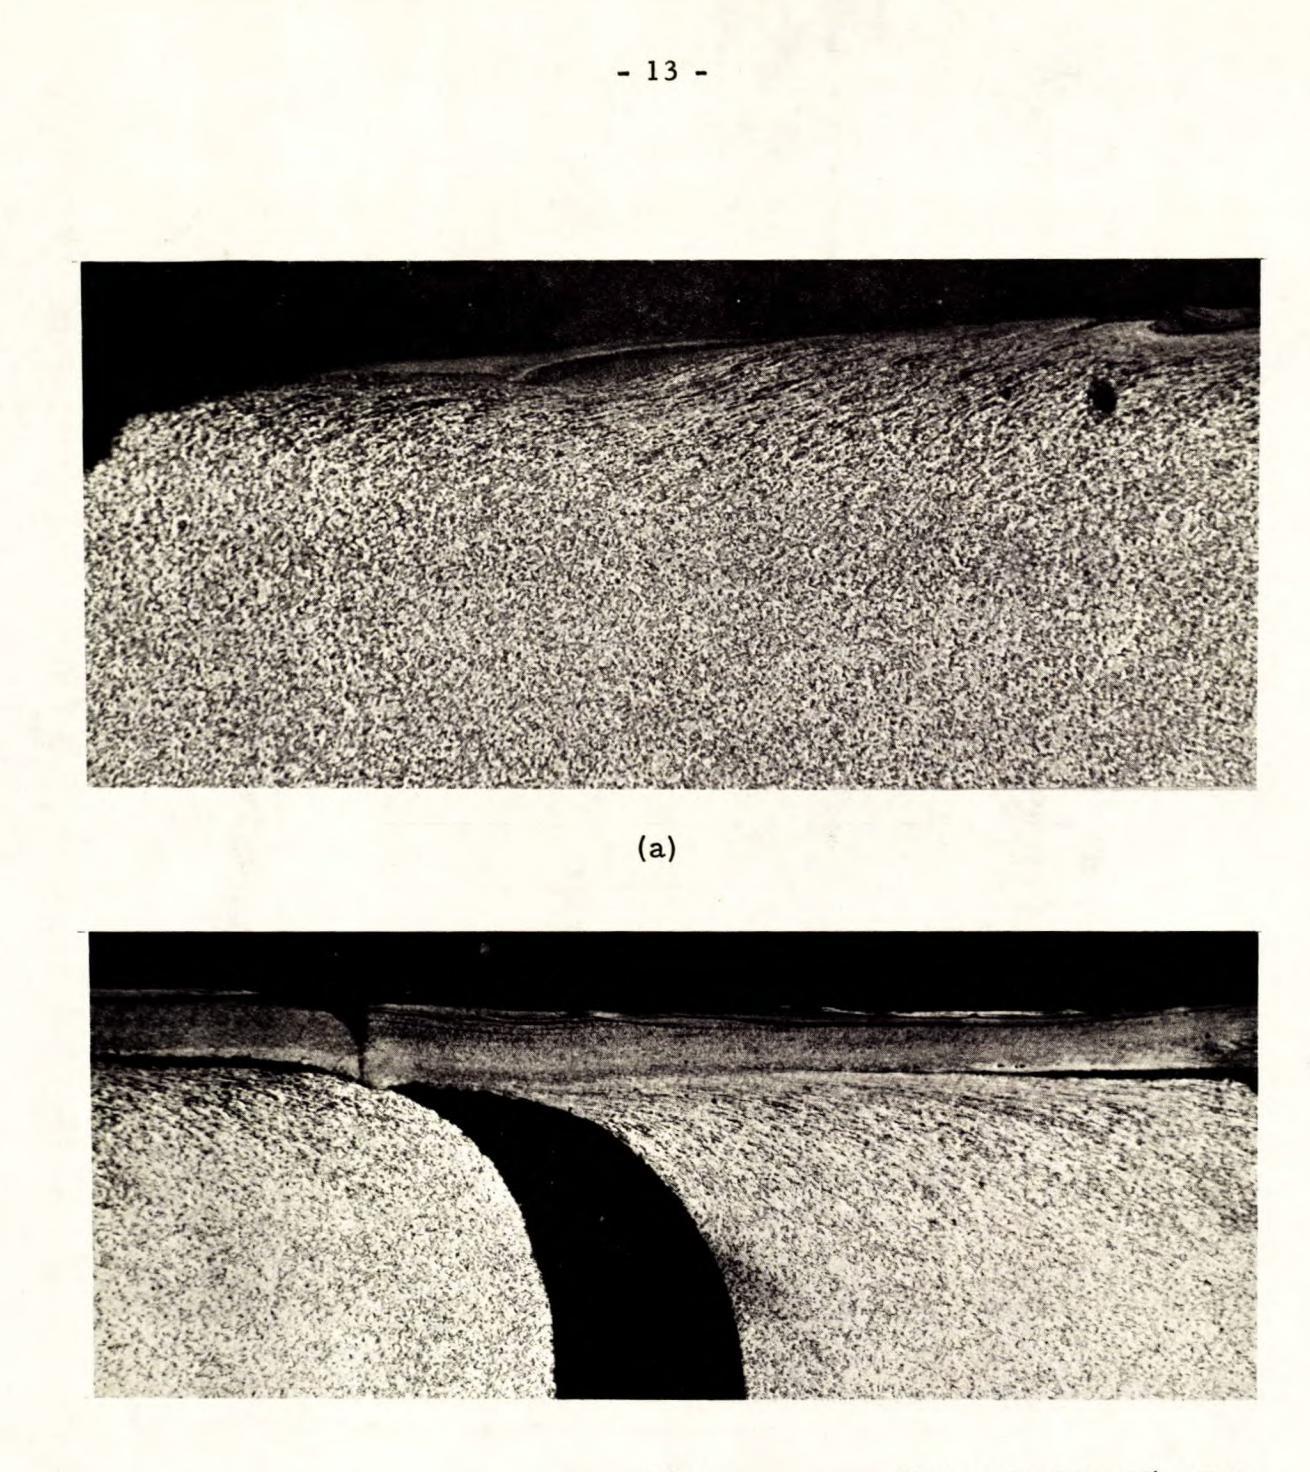
Figure 7. Sections through fatigue crack origins in sample A. In each case galling has generated brittle martensite, which has cracked, thus serving as a fatigue crack nucleus.

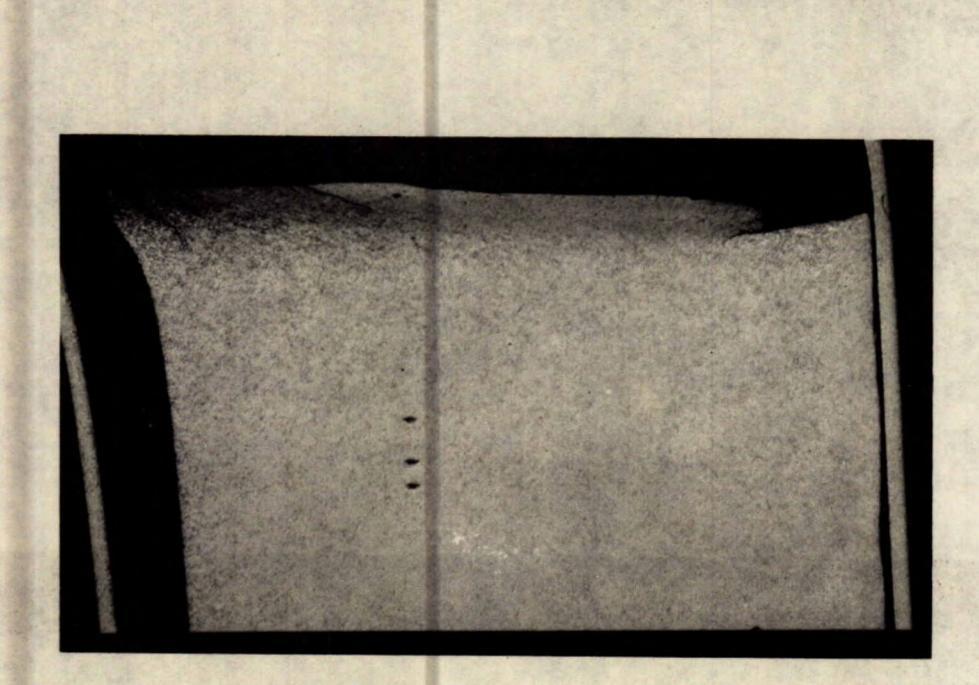
Figure 8 shows the fracture origin in sample C. In this case, no martensite was formed but the severity of shearing cold work, Figure 10, due to galling exhausted the ductility of the parent material and resulted in the formation of several surface cracks, one of which nucleated the fatigue crack.

Figure 8. Section through fracture origin of sample C. Top surface is exterior surface and left edge is fatigue fracture, illustrating the other form of damage consequent to lubrication failure. In this case, galling has sheared the surface metal to a degree that exhausted all the ductility of the parent metal leading to surface cracking, which nucleated a fatigue failure.

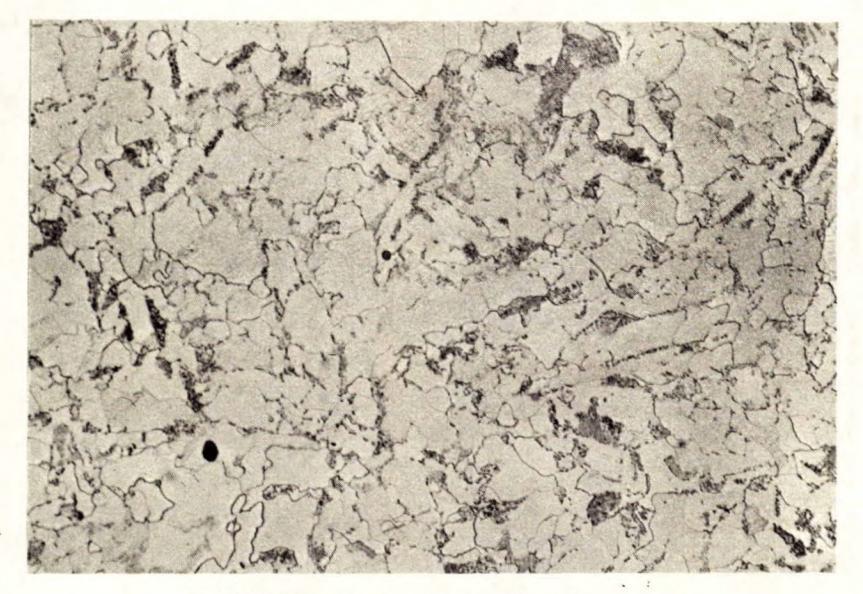
The microstructure of the parent metal consisted of ferrite and semi-spheroidized pearlite, Figure 9. The structure is typical of that expected for such material in the normalized and tempered condition. The non-metallic inclusion content and distribution was deemed normal for standard commercial product. There is no evidence of metallurgical quality deficiencies in the original tube.

Figure 9. Interior of sample C, same section as Figure 8. Typical original microstructure. Hardness - Knoop 198 (approx. Rockwell B 89).

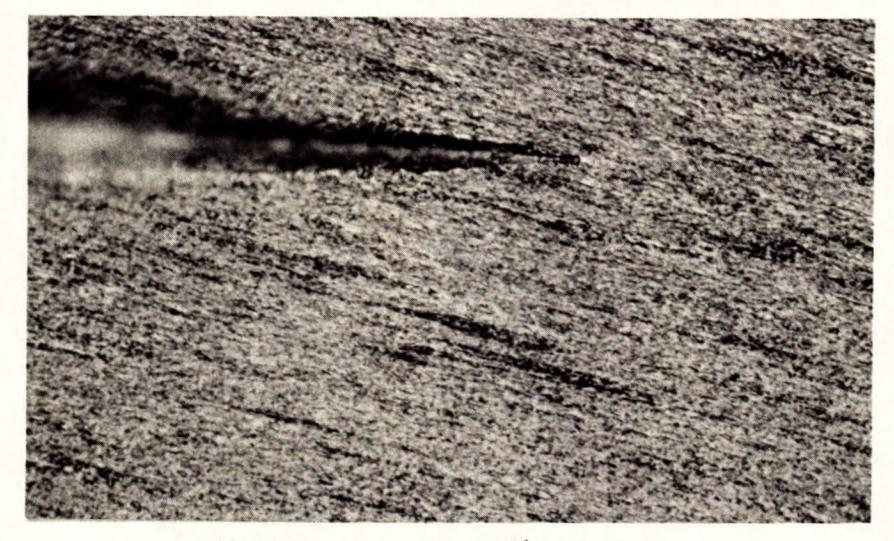
Figure 10. Sheared surface of sample C, same section as Figure 8, illustrating the extreme cold work due to galling. The black pointed area in the upper left portion is part of a microhardness impression. Hardness - Knoop 430 (Rockwell C 42).
