**THE BURSTING OF A SNOW DAM, TINGMISUT LAKE,
MELVILLE ISLAND, NORTHWEST TERRITORIES**

Project 770037

J.A. Heginbottom
Terrain Sciences Division

Heginbottom, J.A., The bursting of a snow dam, Tingmisut Lake, Melville Island, Northwest Territories; in Current Research, Part B, Geological Survey of Canada, Paper 84-1B, p. 187-192, 1984.

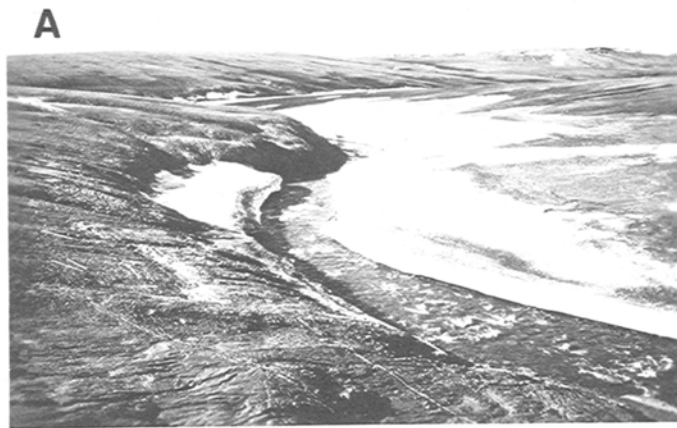
Figure 20.4. The remains of the snow dam on the morning of 23 July 1979.

On the morning of July 23, the stream was still flowing across ice in the area of the upper part of the main snow dam. In the lower part of this dam, the stream had cut down to the boulders and bedrock of its normal bed (Fig. 20.4A). The increased flow of water in this section led to the sides of the "snow gorge" being undercut, by as much as 2 m in places. Periodically large blocks of snow would break away, falling into the stream (Fig. 20.4B). Farther downstream, the second dam had become a snow bridge (Fig. 20.5A). At about 1115 h this bridge collapsed, partially damming the stream again (Fig. 20.5B) and forming a "snow-jam", as discussed above. As the water level behind it rose the blocks floated, the jam failed, and some water escaped. The jam then reformed and blocked the stream again. The result was a period of pulsed flow farther downstream.

A. 0800 h: channel across main snow dam cut down to natural, rocky stream bed (compare with Fig. 20.3A and 20.3E). (GSC 203553-U)

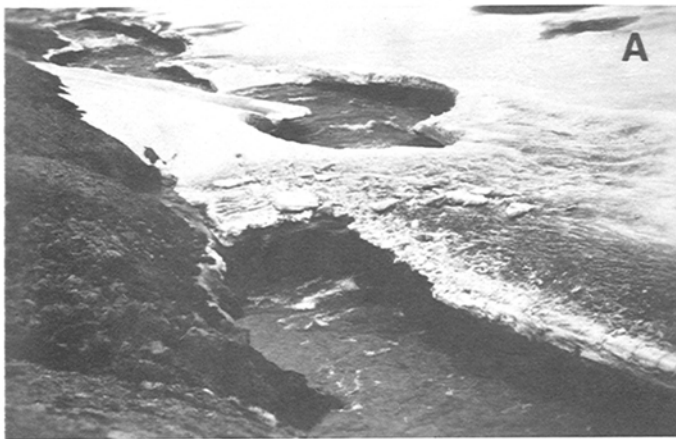
Figure 20.5. Formation of the snow jam at the site of the lower snow dam on the morning of 23 July 1979.

A. 1100 h: snow bridge at site of the lower snow dam. (GSC 203554-D)
