Destructive Mass Movements in High Mountains: Hazard and Management

Geological Survey of Canada
Paper 84-16

G.H. Eisbacher and J.J. Clague

1984

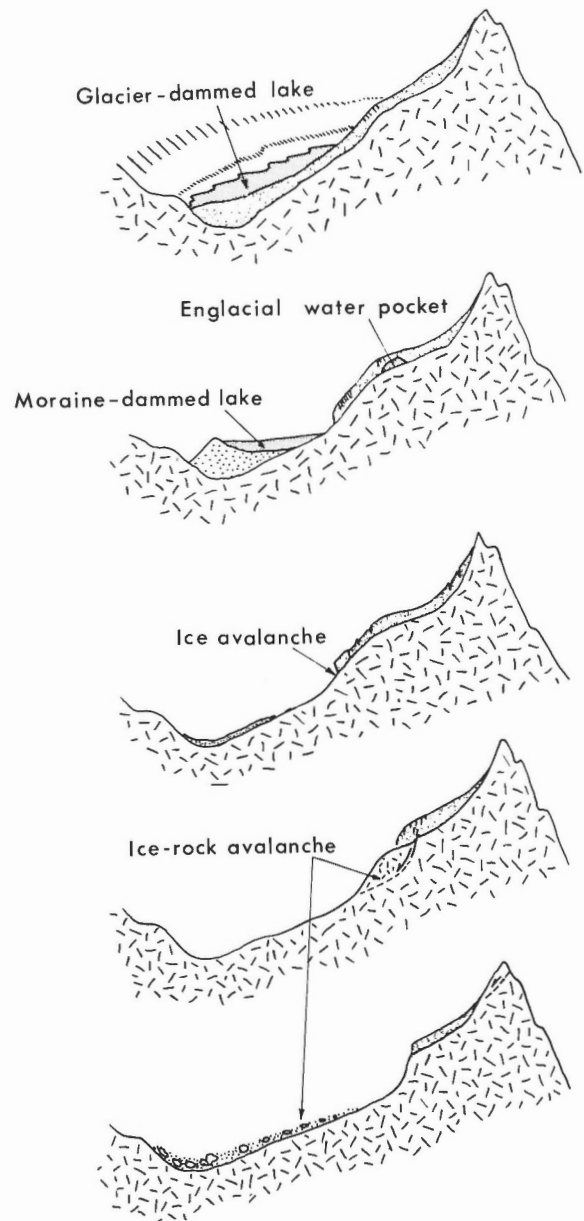
Figure 33: The principal situations in which glacier-related mass movements occur (see text for explanation).

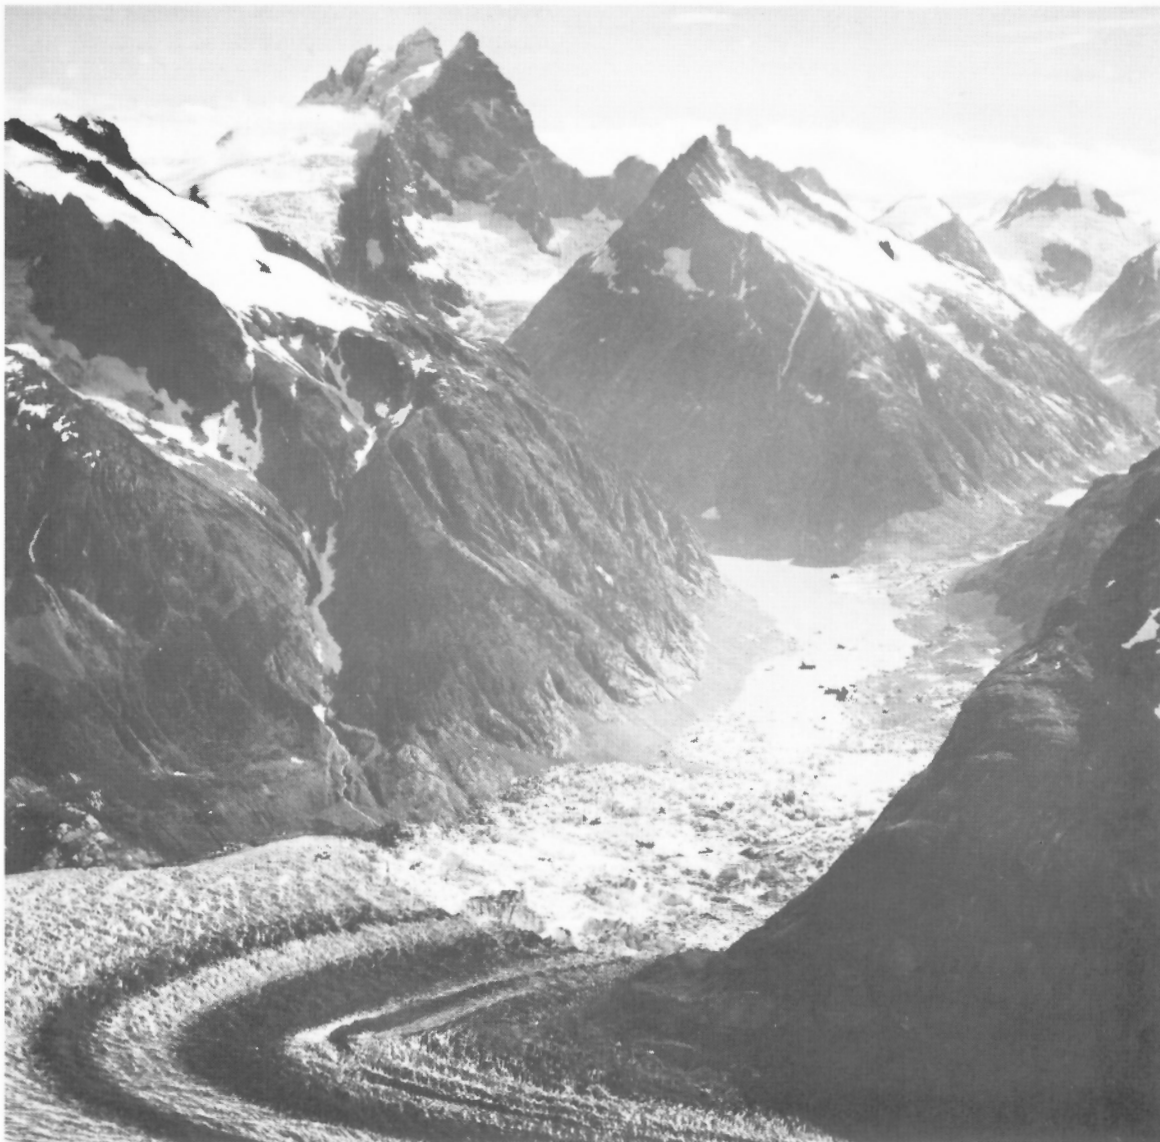
Figure 34: Lake Tulsequah in the northern Coast Mountains of British Columbia shortly after it emptied during a jökulhlaup. The lake is dammed by a lobe of Tulsequah Glacier (foreground). Photo by Austin Post.

See Fig. 34, page 45 for description

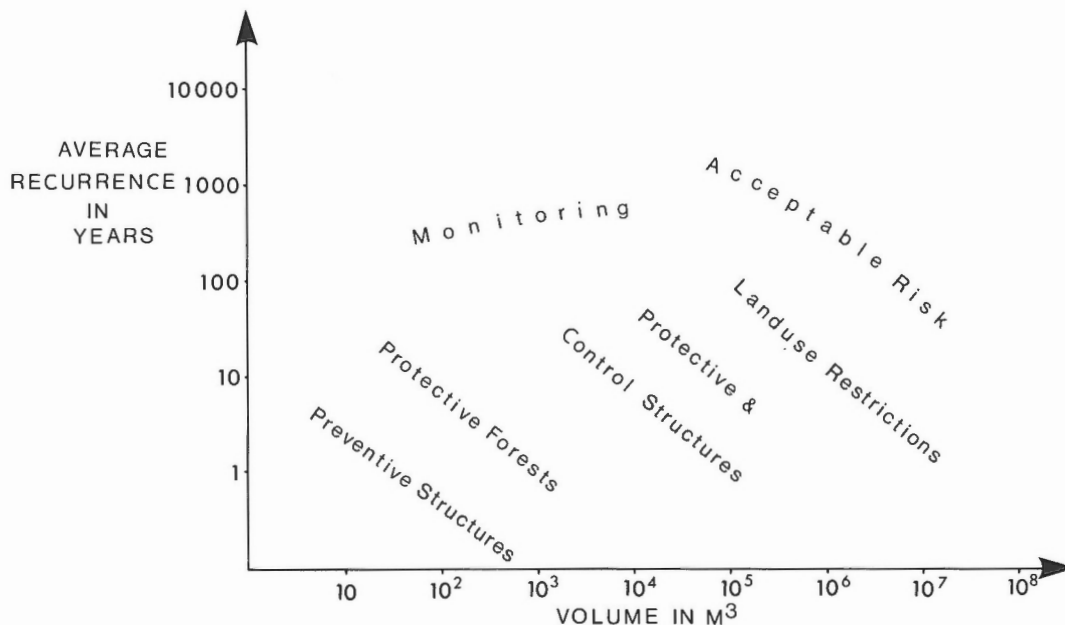
Figure 39: Summary diagram derived from numerous case histories illustrating the most effective use of passive and active measures in reducing the impact of destructive mass movements in developed mountain regions depending on their volume and projected recurrence. Most of the measures shown can be applied in combination with each other and their position in the diagram depends greatly on the social-economic context of a specific situation.

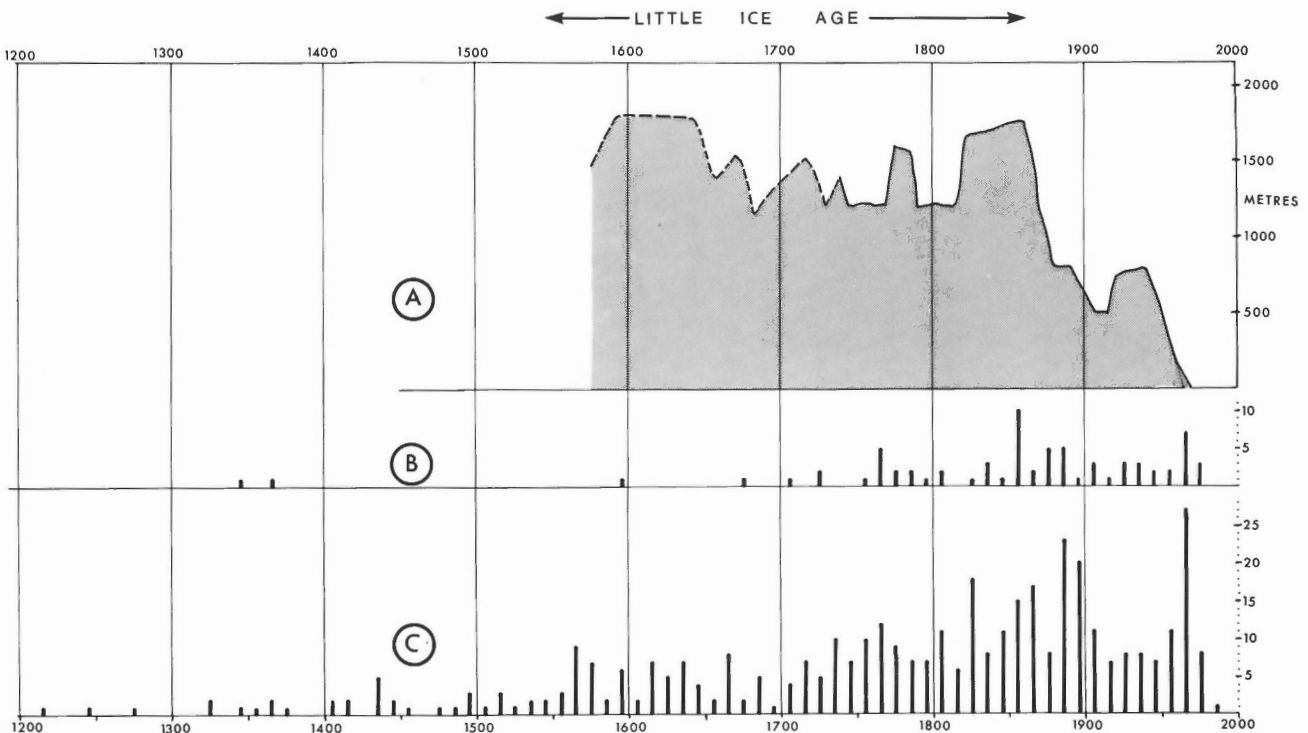
Figure 45: A: Historical fluctuations of the snout of the Grindelwald Glacier relative to its position in 1970, measured in metres along the glacier bed (from Messerli et al., 1975). B: Number of historical destructive mass movements in the Ötz Valley, western Austria, grouped in ten-year intervals (data from Leys, 1977). C: Number of destructive mass movements presented in this Appendix, grouped in ten-year intervals.

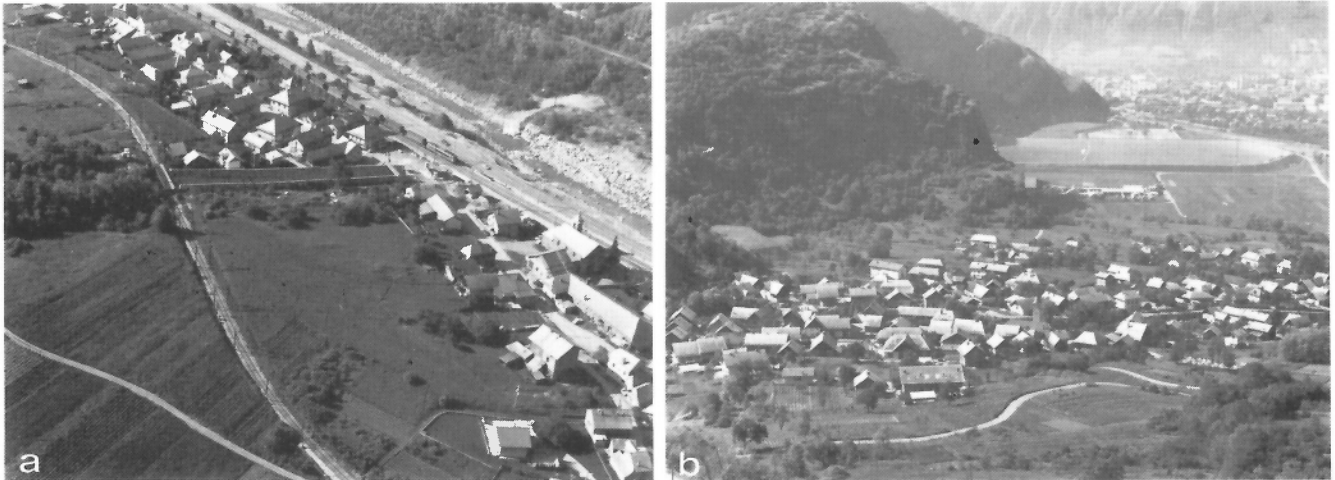
Figure 82: a) Walled channel of the Ravoire Torrent at Pontamafrey along the banks of the Arc River (centre of photo) (GSC 204166-D). b) View southward from above the apex of the Hermillon fan towards St. Jean-de-Maurienne; note flood retention basin in the background; the channel of the Hermillon Torrent is in the built-over area in the foreground (GSC 204166-E).

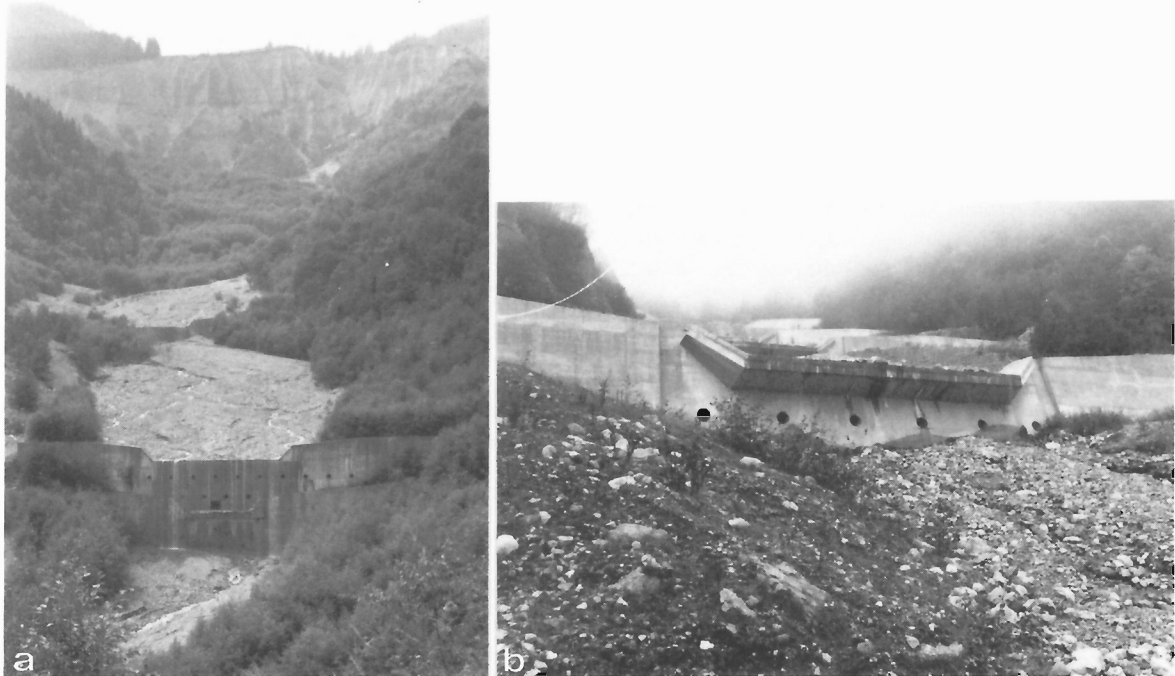
Figure 174: Two views of the large check dams along the Schesa Torrent below the erosional bowl of the Schesatobel: a) check dams confining the braided channel of the Schesa Torrent to the centre of the valley thus preventing lateral scour (GSC 204167-Y); b) steel-concrete check dam with an armoured carapace which minimizes damage to the structure from minor debris flows (GSC 204167-Z).

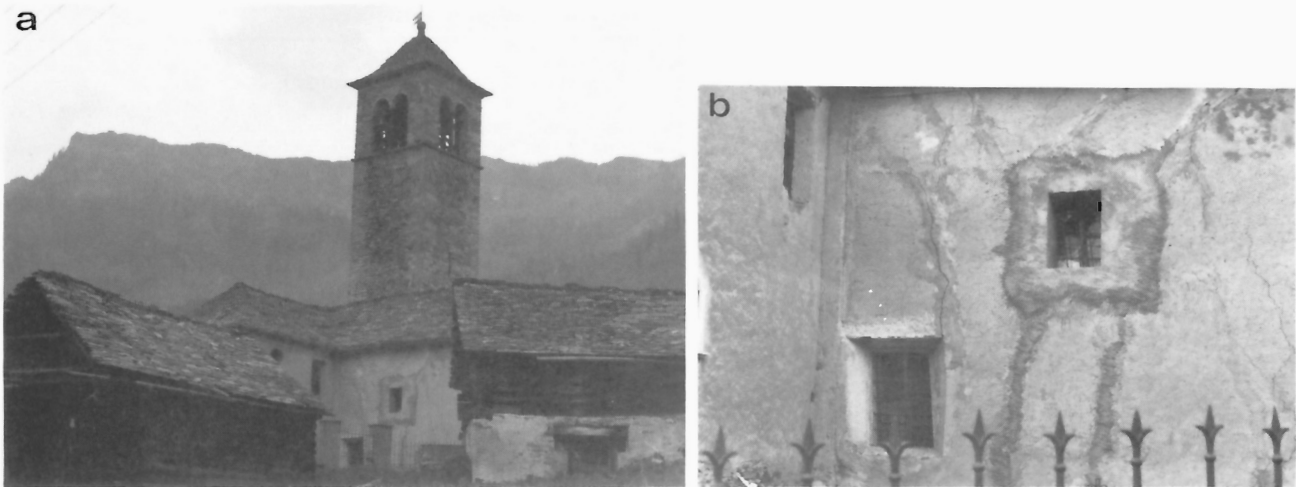
Figure 213: a) The old church of Campo which during the last century has shifted at least 15 m horizontally (GSC 204168-V). b) Close-up view of the cracked and distorted church wall (GSC 204168-W).

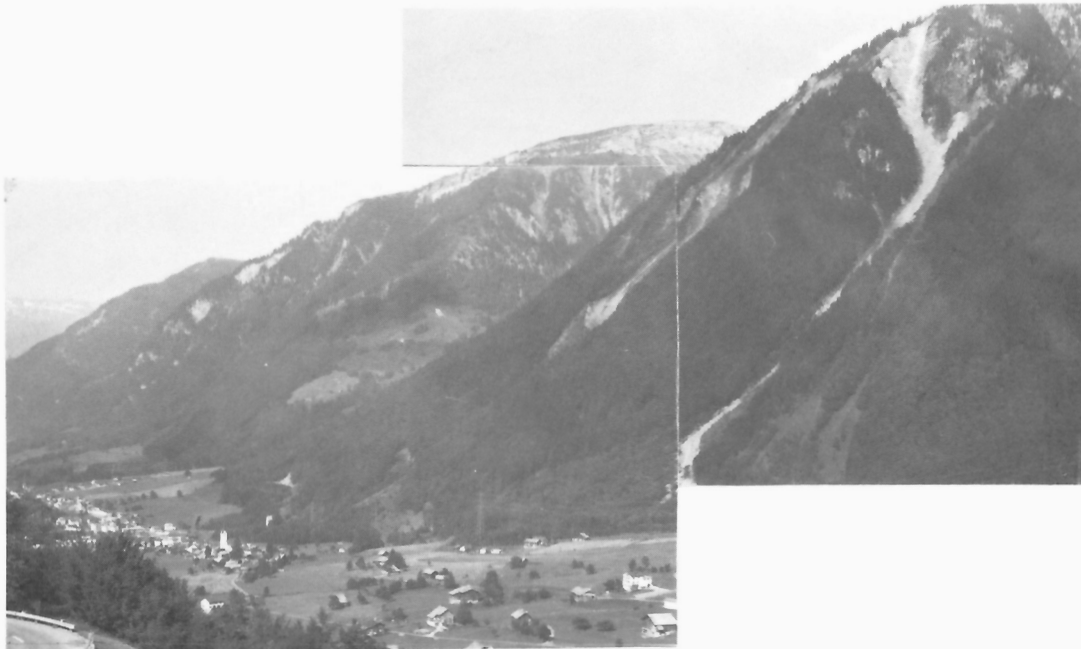
Figure 246: View of the Kilchenstock slope southeast of Linthal; note the two active rockfall chutes flanking the main unstable rock promontory. (GSC 204169-J)

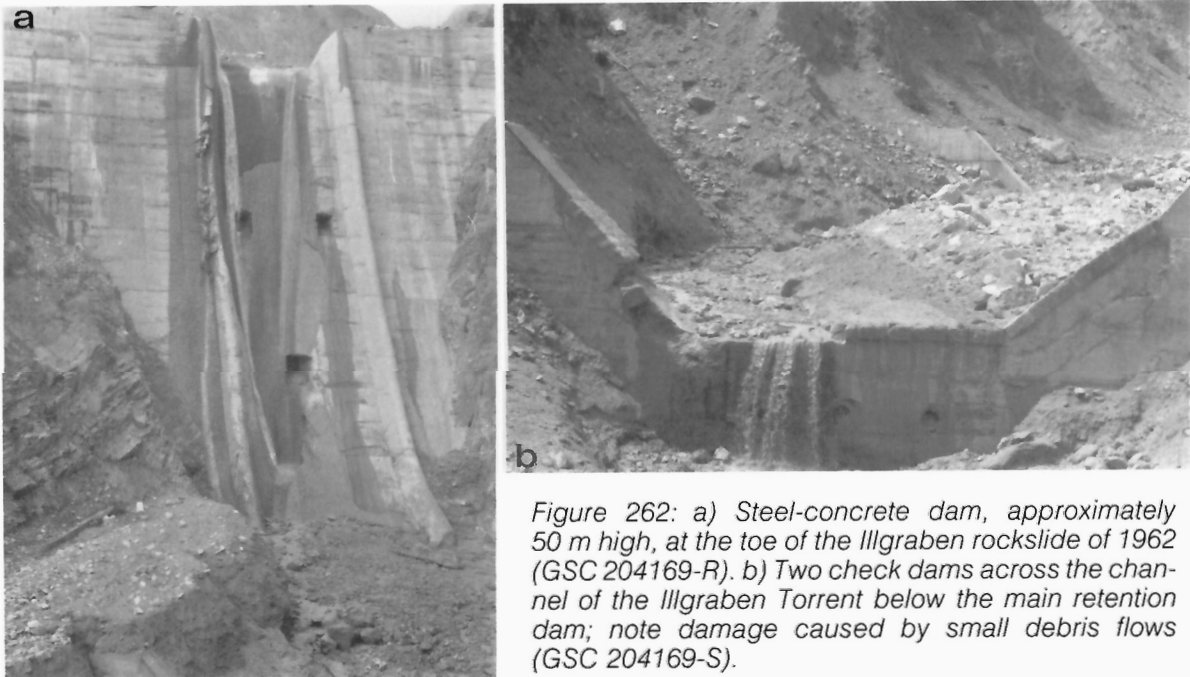
Figure 262: a) Steel-concrete dam, approximately 50 m high, at the toe of the Illgraben rockslide of 1962 (GSC 204169-R). b) Two check dams across the channel of the Illgraben Torrent below the main retention dam; note damage caused by small debris flows (GSC 204169-S).
