**A STUDY OF THE  
OCCURRENCE OF STRUDEL SCOURS  
IN THE CANADIAN BEAUFORT SEA**

**Department of Supply and Services**

**Pilkington and Associates  
4500 - 5 Street N.E.,  
CALGARY, Alberta  
T2E 3Z6**

GEOLOGICAL SURVEY OF CANADA, OPEN FILE NO. 2272

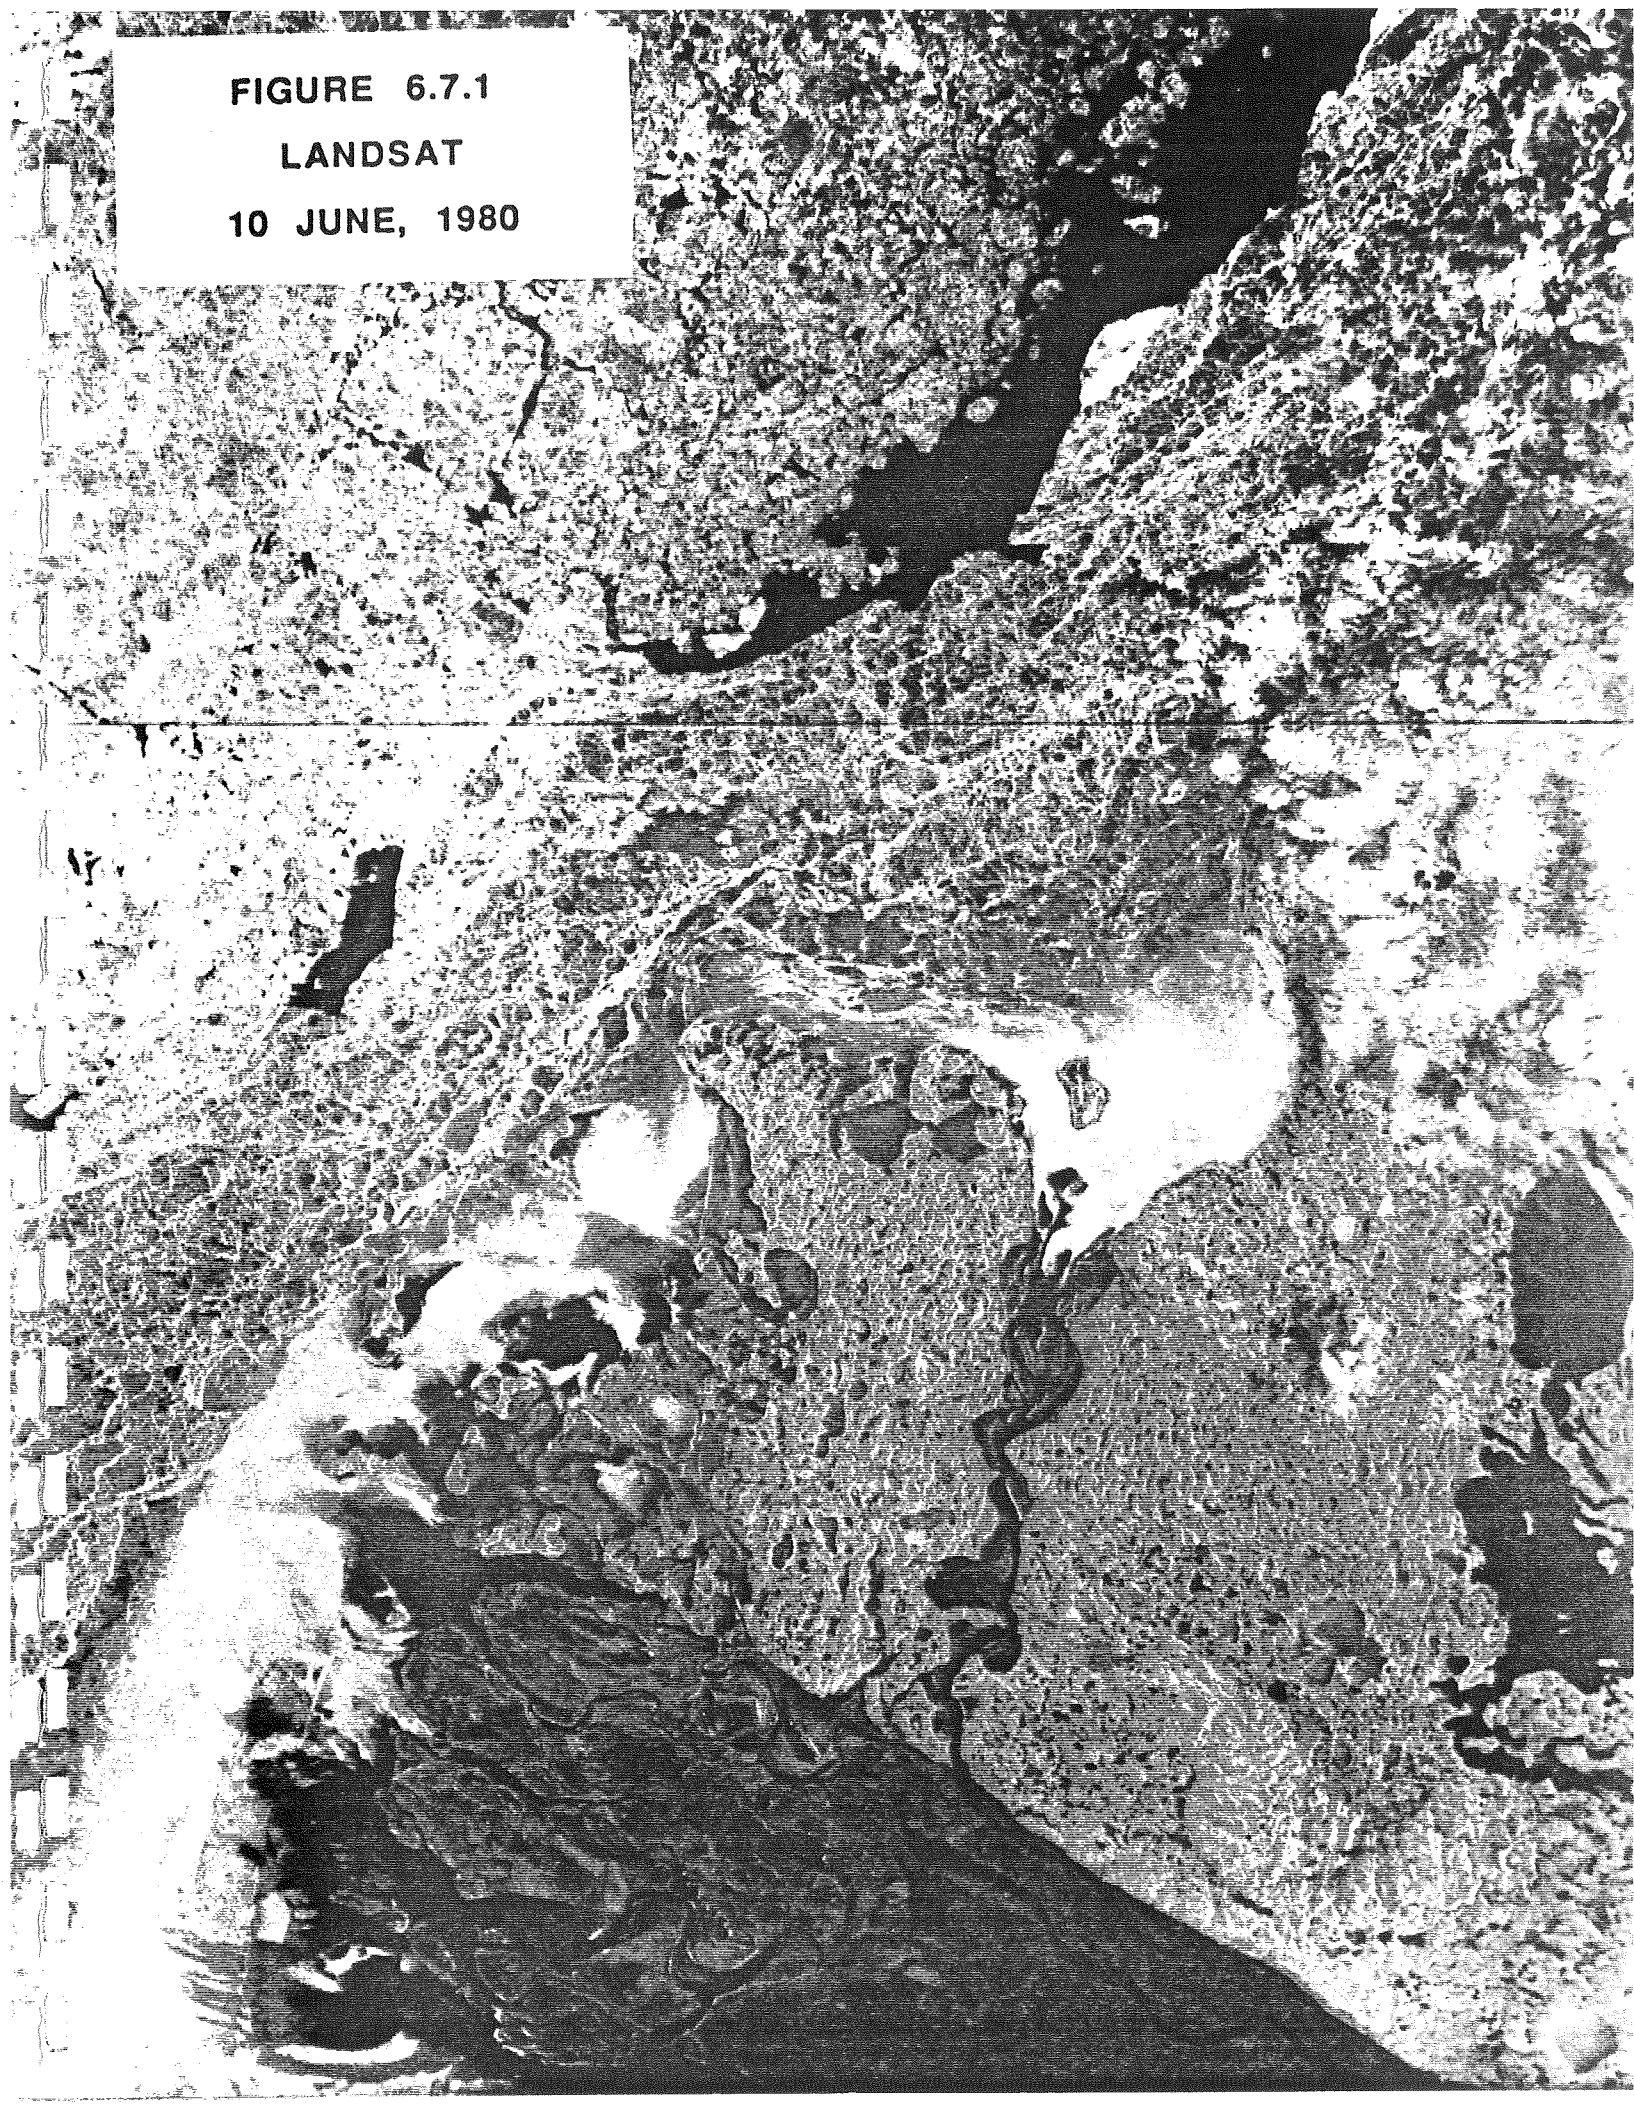
FIGURE 6.7.1  
LANDSAT  
10 JUNE, 1980

No early May data are available. By 10 June there was extensive open water along the shore of Richards Island as indicated in the LANDSAT data. This photo also shows regions of grey ice seaward of the open water areas which are interpreted as regions of flooded ice. Looking carefully at the grey (flooded) region in Shallow Bay to the west of Olivier Islands, one notes that flooding occurs in fingers that extend seaward. In some regions flooding stops at a distinct line on the ice at about the 1.6 m water depth, which is presumably the tidal crack. The flood fingers extend out beyond 6 km past the tidal crack into water depths of 6 metres or more.

It is noted that some of the shallow lakes and the coastal areas in Beluga Bay are quite grey in contrast to the fast ice further offshore; this is presumably indication of very rotten, water covered ice.

Figure 6.11.10 shows areas that are clearly flooded, as irregularities in the ice surface show above the flooding. In this image there is no evidence of the tidal crack limiting the extent of flooding, as was seen in Fig. 6.7.1 and mentioned frequently by Spedding (Refs. 7 to 13). However, the flooding here (and in most of the other examples shown) does appear to be limited to water depths of about 1.6 to 1.2 m which is where the tidal crack would be expected to be.

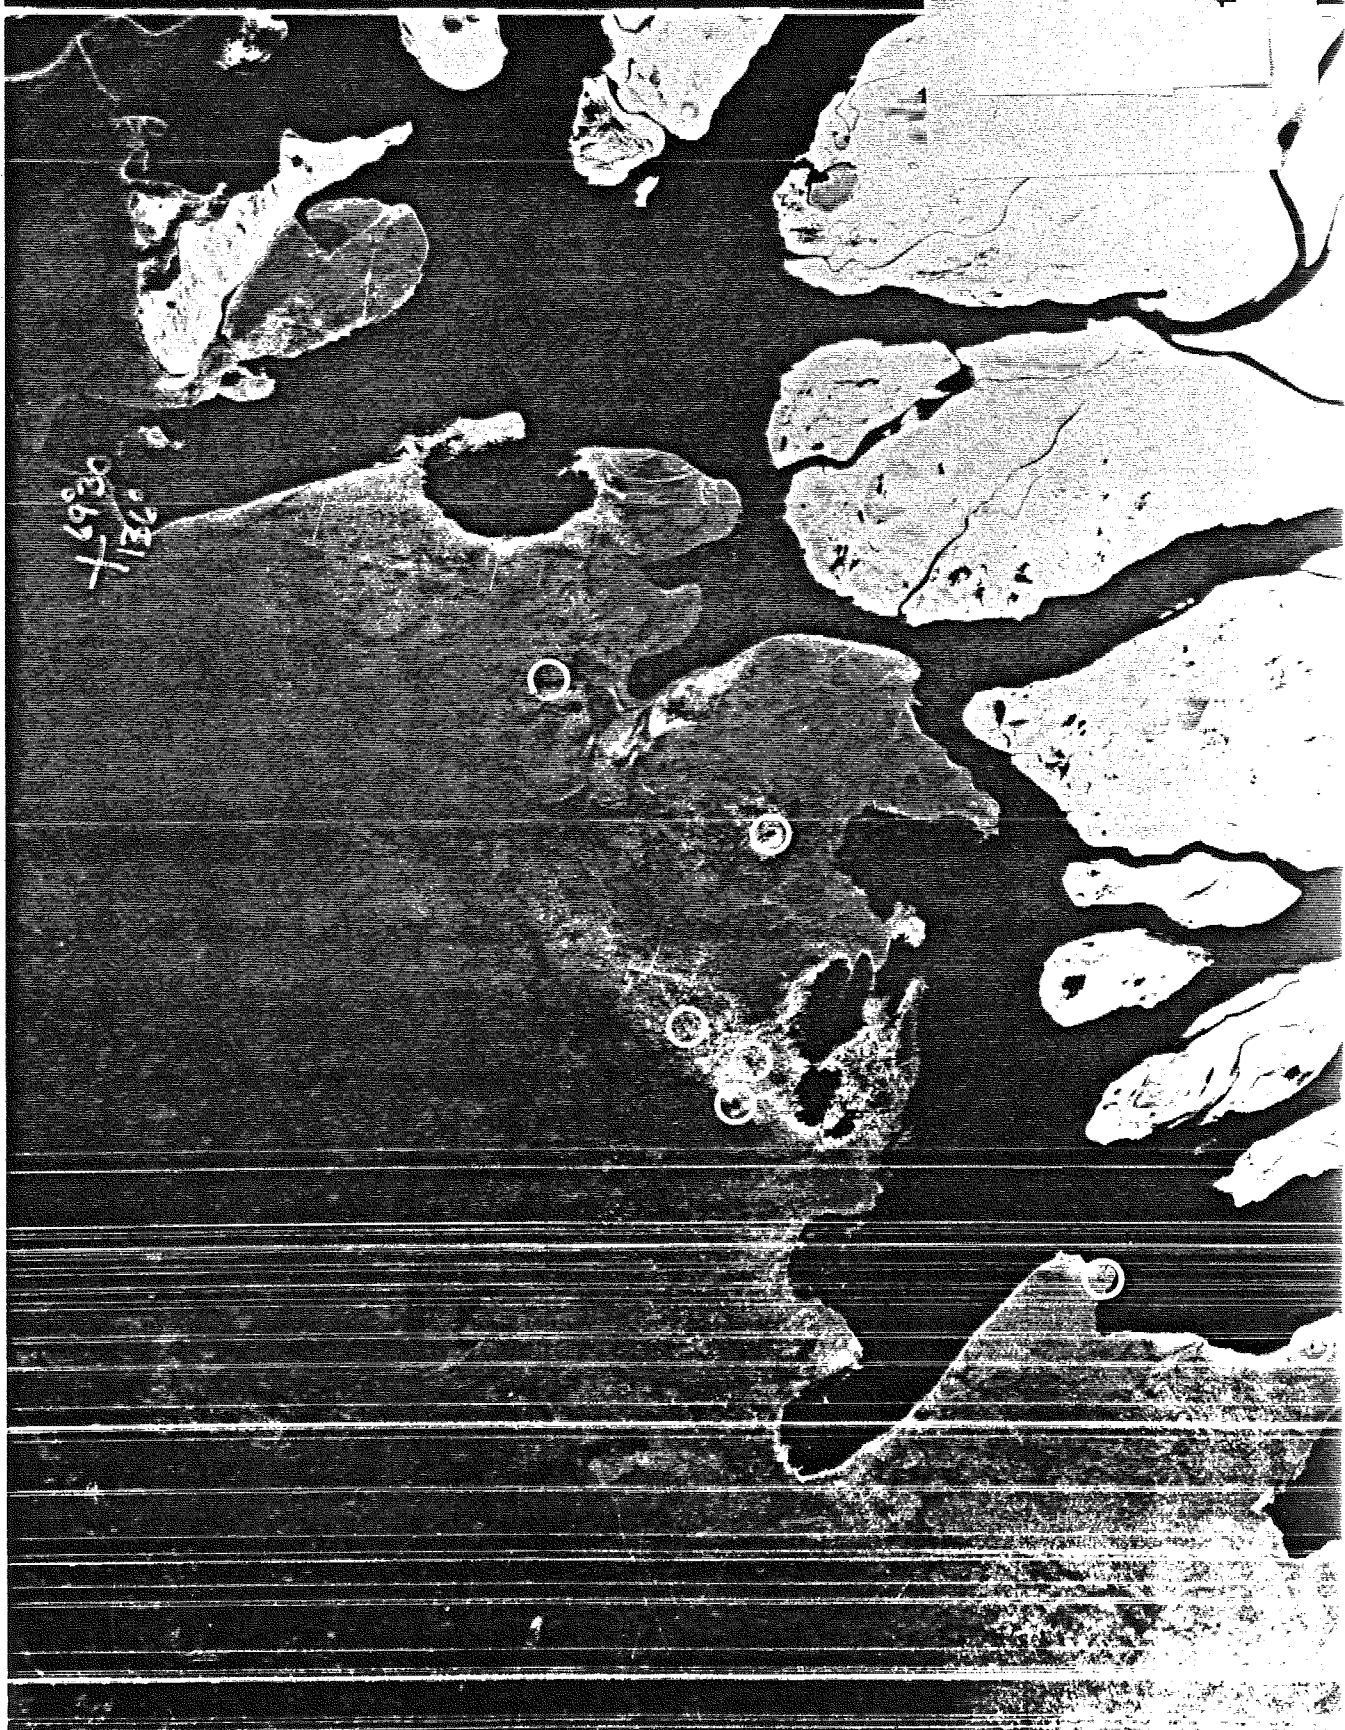
FIGURE 7.1

Figure 7.1 shows a section of Gulf/Dome STAR 001 data for the area between Olivier Islands and Beluga Bay. There is extensive open water along the coastline of Richards Island, particularly adjacent to the various river channels. Of particular interest are the black dots which may be strudel holes on the ice, although at this late date they could be surface melt holes from the melting ice and snow. A similar example was found for Phillips Bay for June 8, 1984, and Fig. 6.14.3 shows flooding and possible strudel holes by Anderson River in Liverpool Bay.

Of all the data examined, these were the only examples found showing "black dots" - possible strudels - on the ice cover; the SLAR data had marginal resolution for this project. Unfortunately one cannot say categorically that the black dots are indeed strudel holes.
