BEACH OBSERVATIONS ALONG THE EAST COAST
OF CAPE BRETON HIGHLANDS NATIONAL PARK,
NOVA SCOTIA

R.B. Taylor and B.J. Kelly
Atlantic Geoscience Centre
Dartmouth, Nova Scotia

Geological Survey of Canada

Open File 1119

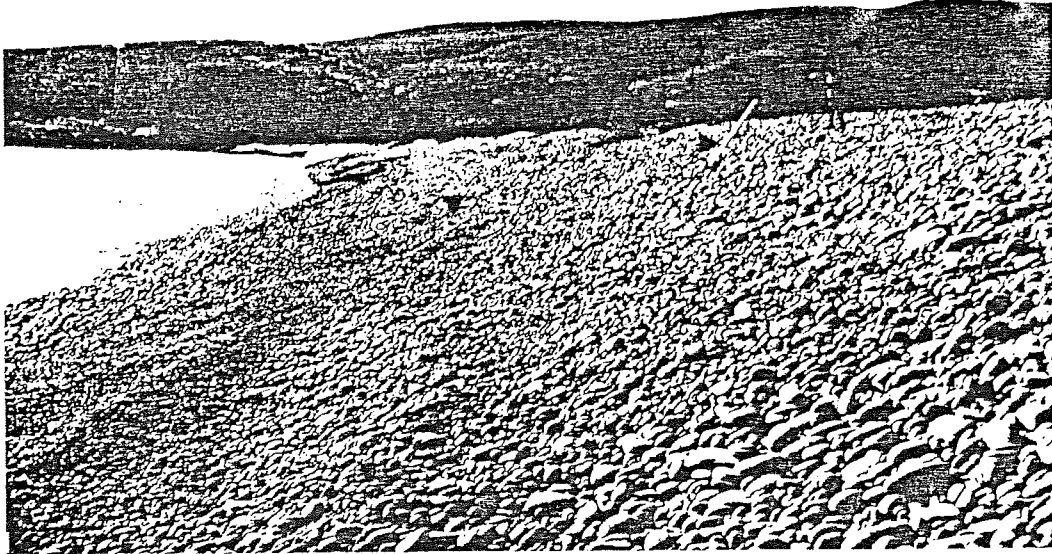
Figure 6. View of the steep foreshore slope produced at profile 1, Ingonish Beach during the October 25, 1983 storm; Note 1.5 m graduated staffs for scale (arrows). The largest cobbles are found at the base and near the crest of the beach.

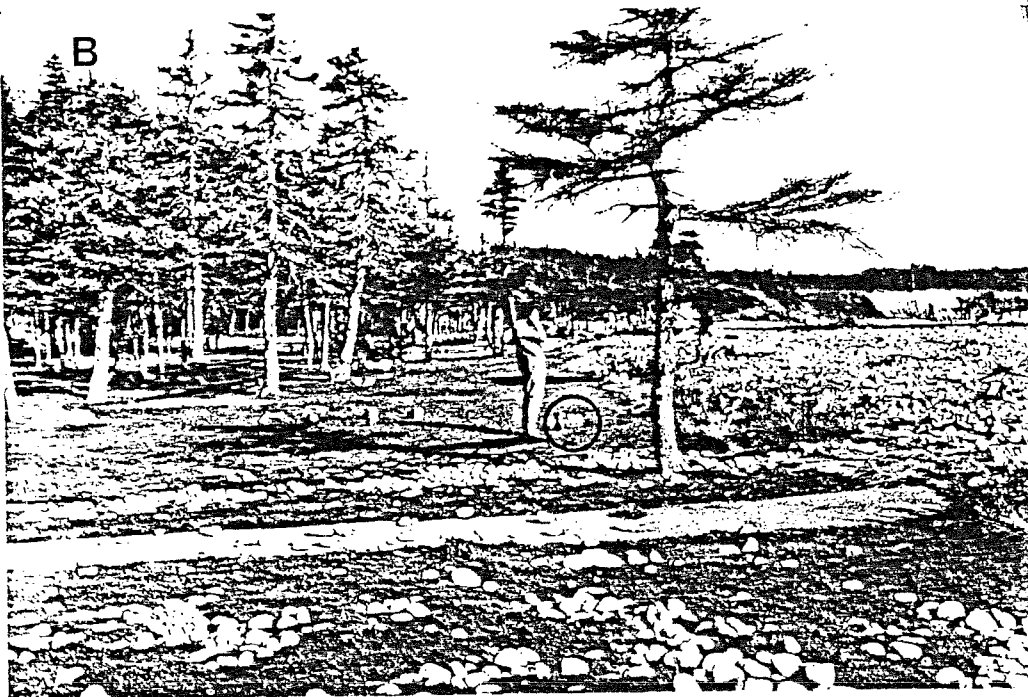
Figure 12(a). View of the backshore at profile 1 Ingonish Beach. The bench marks consist of the tree and two rock cairns (arrow) seaward of the tree. (b). View of the backshore at profile 2 Ingonish Beach. The bench mark is the tree stump (circled).
