WIRE PROTECTION PROGRAM  
BROOKE OCEAN TECHNOLOGY LTD.  
UNDER CONTRACT TO:  
THE ATLANTIC GEOSCIENCE CENTRE  
PROGRAM SUPPORT SUBDIVISION  
BEDFORD INSTITUTE OF OCEANOGRAPHY  
DARTMOUTH, N.S.  
JULY 1985

## ABSTRACT

CRITERIA FOR LUBRICANT SELECTION

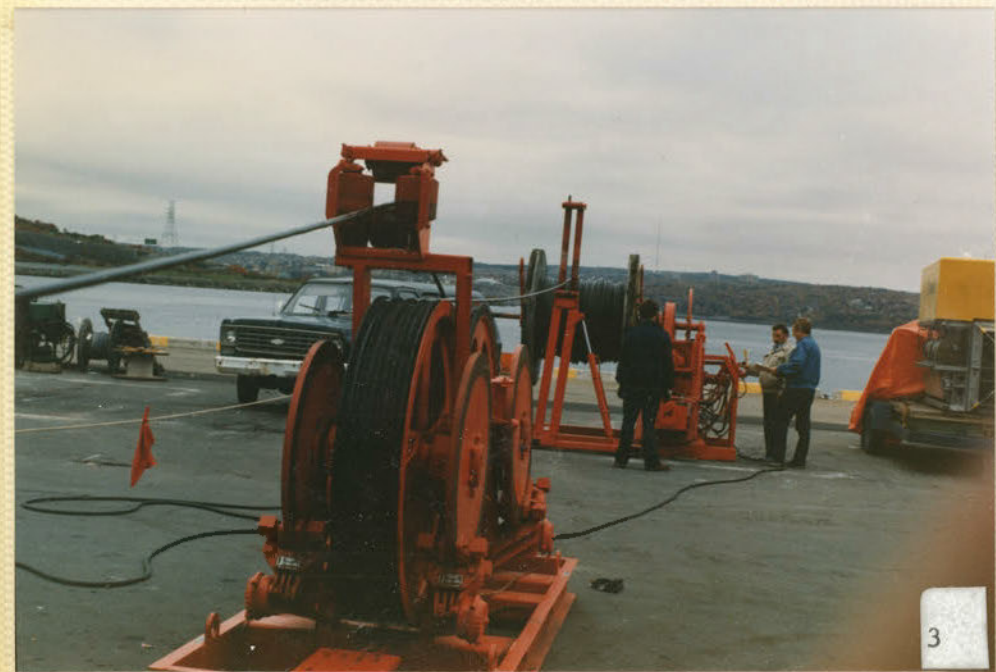
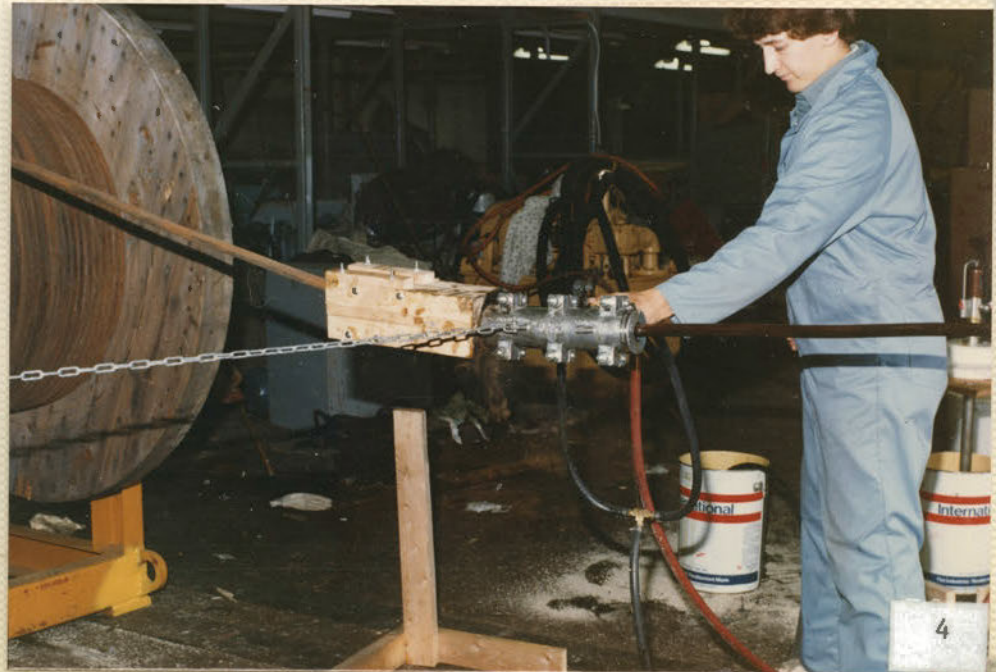
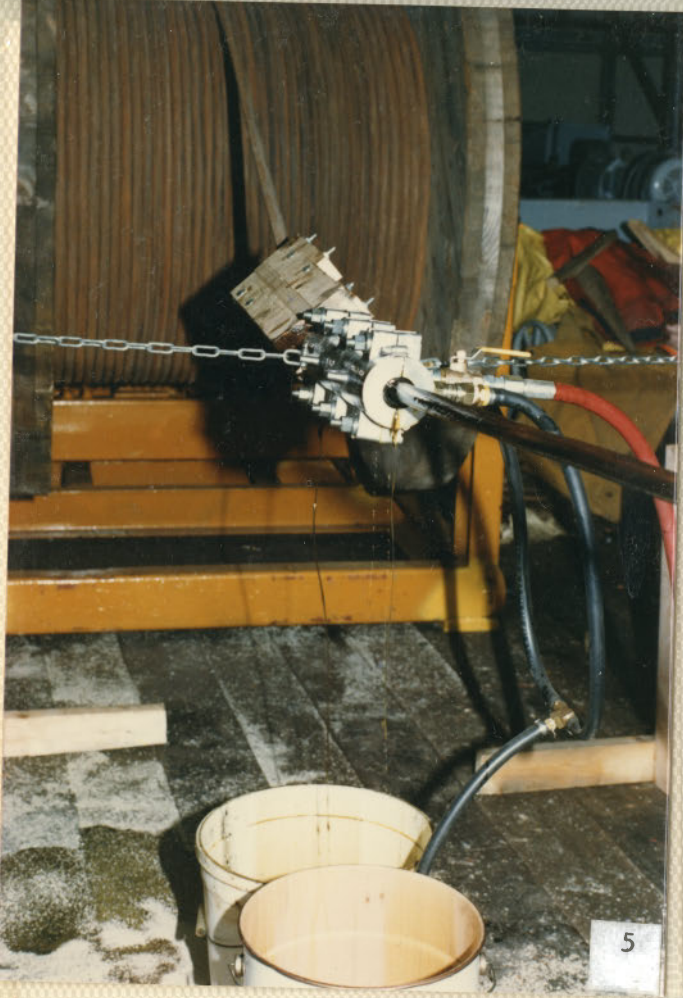
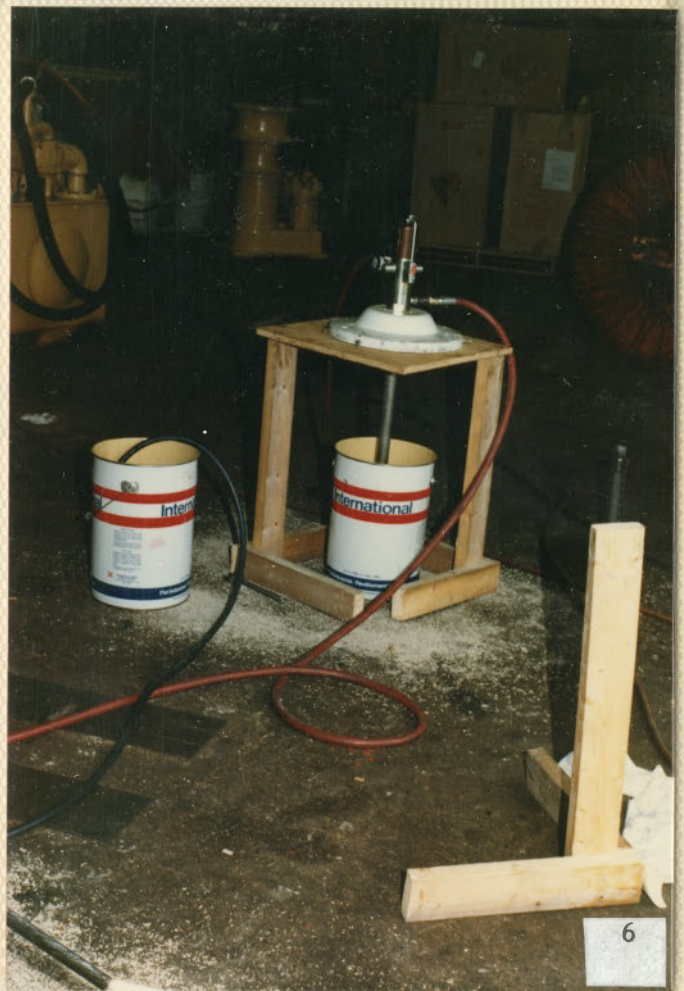
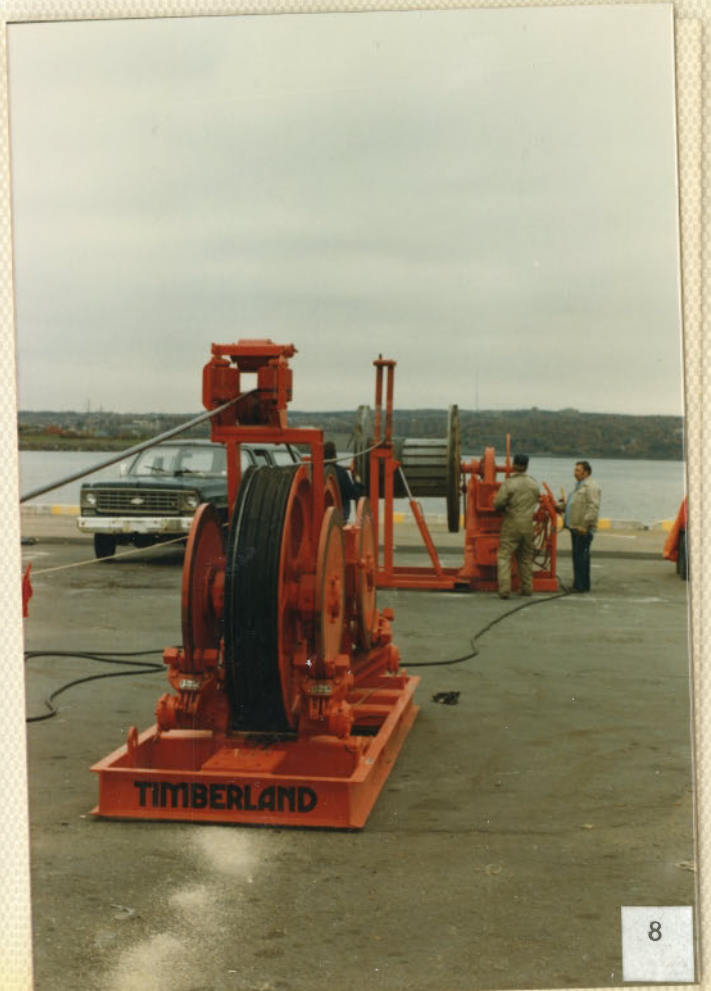
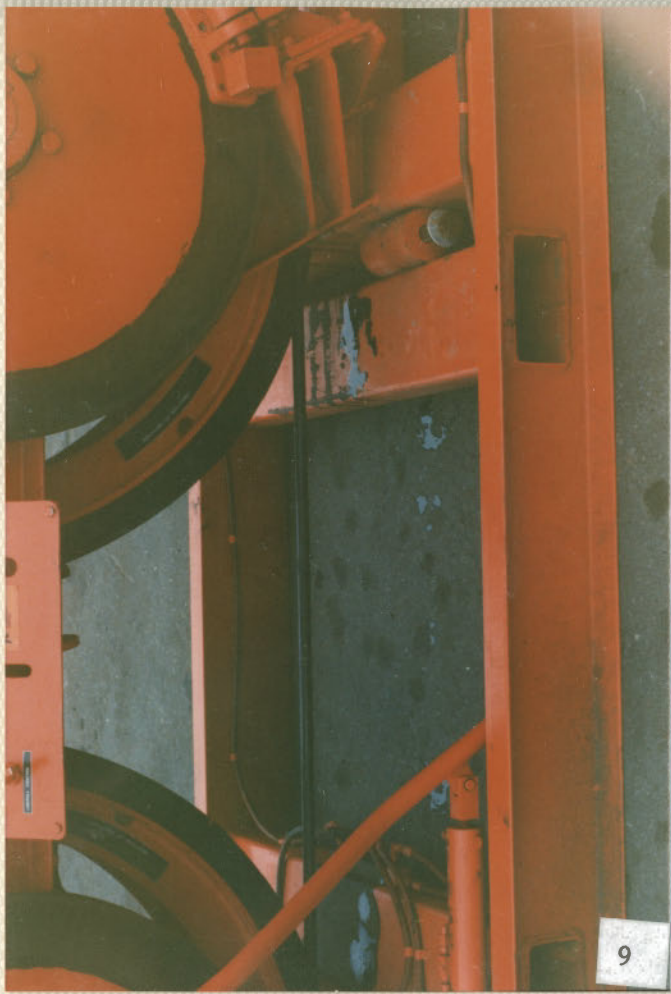
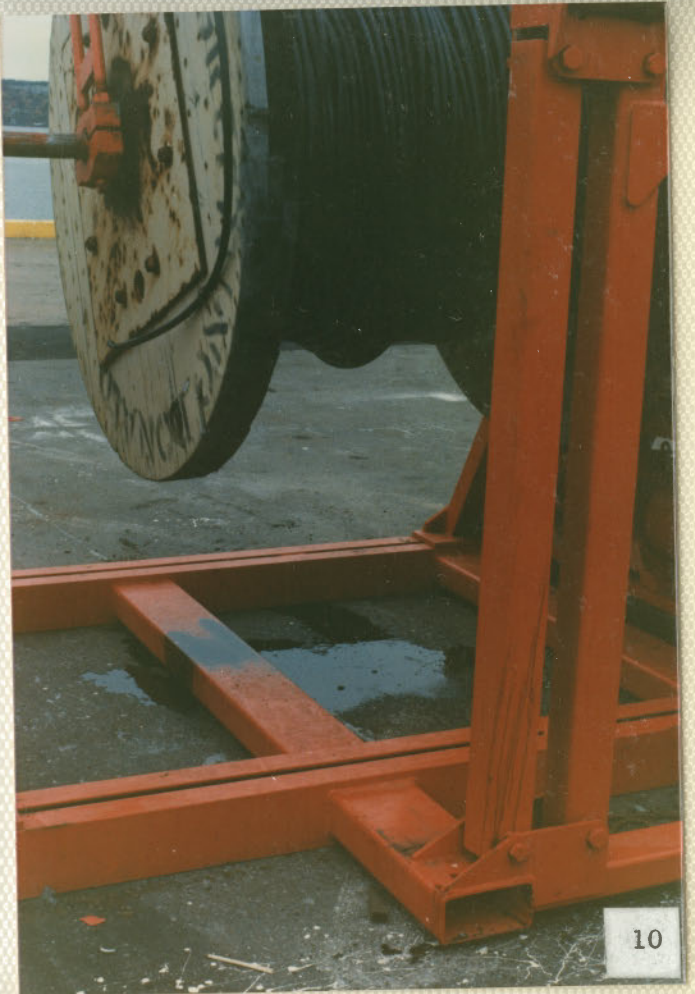
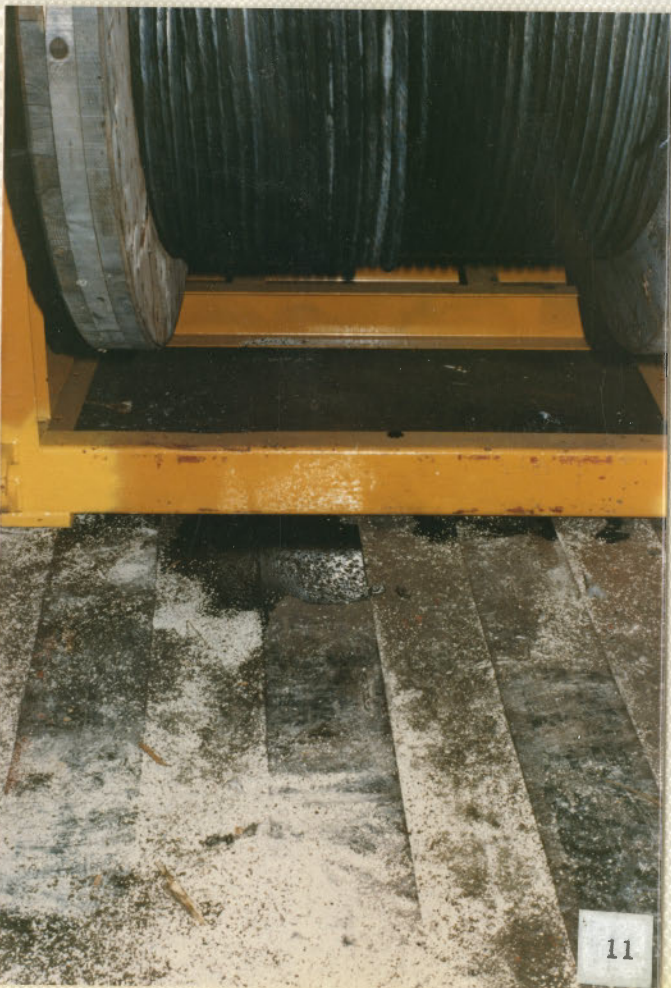
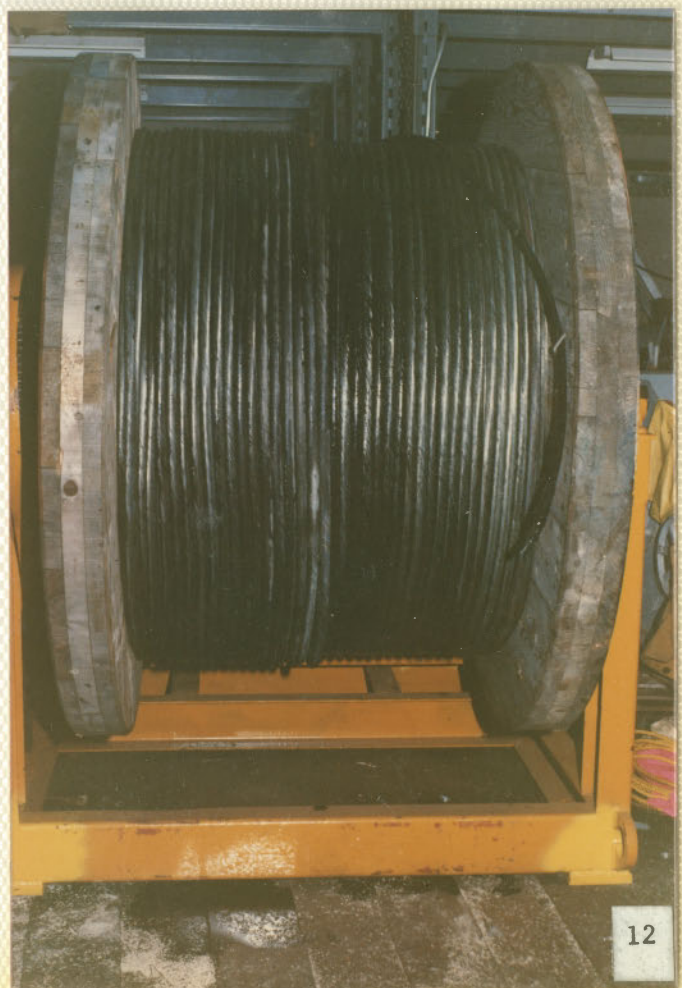
## LIST OF PHOTOGRAPHS

1. STATIC TEST SHOWING CAPILLARY ACTION
2. MASTO AND ROPE CLEANER- NOTE DIRT REMOVED AND LEAKAGE
3. TIMBERLAND REELER AND MEASURING DEVICE
4. MASTO AND ROPE CLEANER IN OPERATION
5. MASTO AND ROPE CLEANER- NOTE LEAKAGE
6. PUMP AND RETURN LINE
7. MASTO SHOWING BROKEN LUGS
8. TIMBERLAND REELER AND MEASURING DEVICE AT START OF OPERATION
9. LUBRICANT DRIPPAGE AT MEASURING DEVICE
10. DRIPPAGE AT TAKE UP DRUM
11. DRIPPAGE AFTER 24 HOURS
12. DRIPPAGE AFTER 24 HOURS

Another problem was the failure of the unit's tightening lugs (see photo 7). The literature states that the nuts should be tightened securely and at no point specifies a torque limit. Several jubilee clamps were used to continue with the tests.

The long term weepage gradually decreases over a period of one month. Photos 11 and 12 show the leakage 24 hours after lubrication. Table 2 lists observations made during periodic inspections of the cable.
