**GEOLOGICAL SURVEY OF CANADA
OPEN FILE 2011**

**DEEP-SEATED SLOPE MOVEMENTS IN THE
BEAVER RIVER VALLEY,
GLACIER NATIONAL PARK, B.C.**

M.A. Pritchard, K.W. Savigny, S.G. Evans

Project 830016

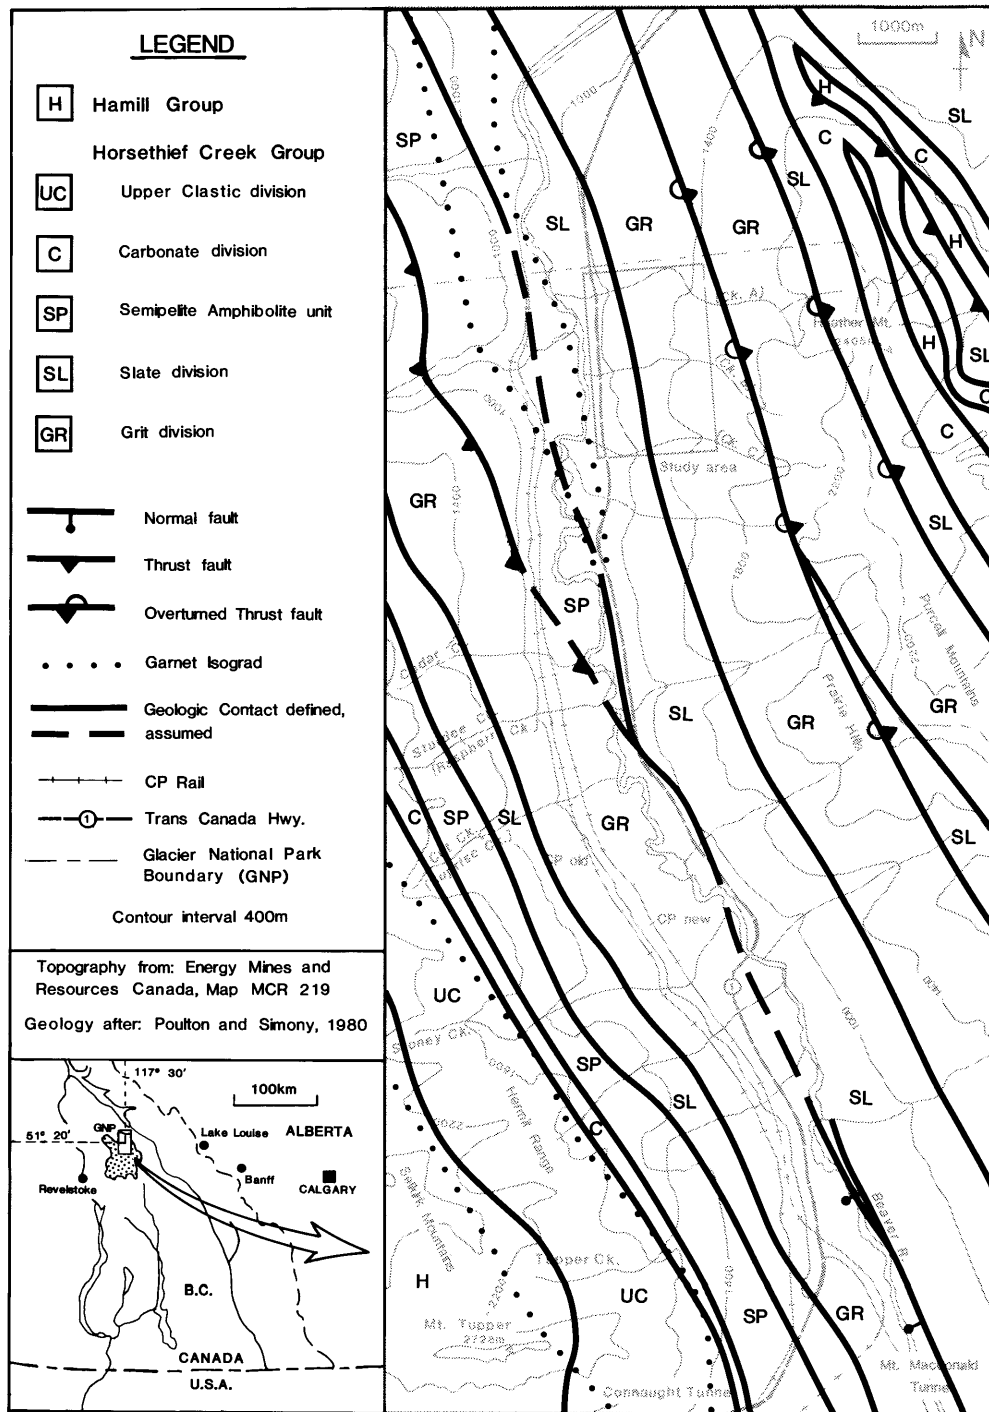
Figure 1: Location map and Regional Geology map of the Beaver Valley (After Poulton and Simony, 1980)

The Beaver River valley is situated between Golden and Revelstoke, British Columbia (Fig. 1). It forms the eastern part of a narrow transportation corridor which traverses the rugged Purcell and Selkirk Mountains. The route was first discovered and utilized by the Canadian Pacific Railway (now CP Rail) in the late 19th century. The Trans Canada Highway was constructed along the corridor in the early 1960's and a second CP Rail line is scheduled for completion in 1988. Both C.P. Rail alignments enter the northern end of the Beaver Valley along the valley bottom and climb the western slopes. The highway also enters from the north, but high on the eastern slope. It then descends to the valley floor, crosses the Beaver River, and climbs again along the western slope (Fig. 1).

The regional geology is shown in Figure 1. The valley is formed in rocks of two groups: the Hadrynian (Late Precambrian) Horsethief Creek Group, and the Lower Cambrian Hamill Group (Wheeler, 1963; Simony and Wind, 1970). The Horsethief Creek Group includes a lower grit division successively overlain by a slate division, a carbonate division, and an upper clastic division. The slate division is further divided into a semipelite amphibolite unit in the Beaver Valley. The Hamill Group consists of Upper, Middle and Lower Members of which only the dominantly quartzite Lower Member is present in the Beaver Valley (Simony and Wind, 1970).

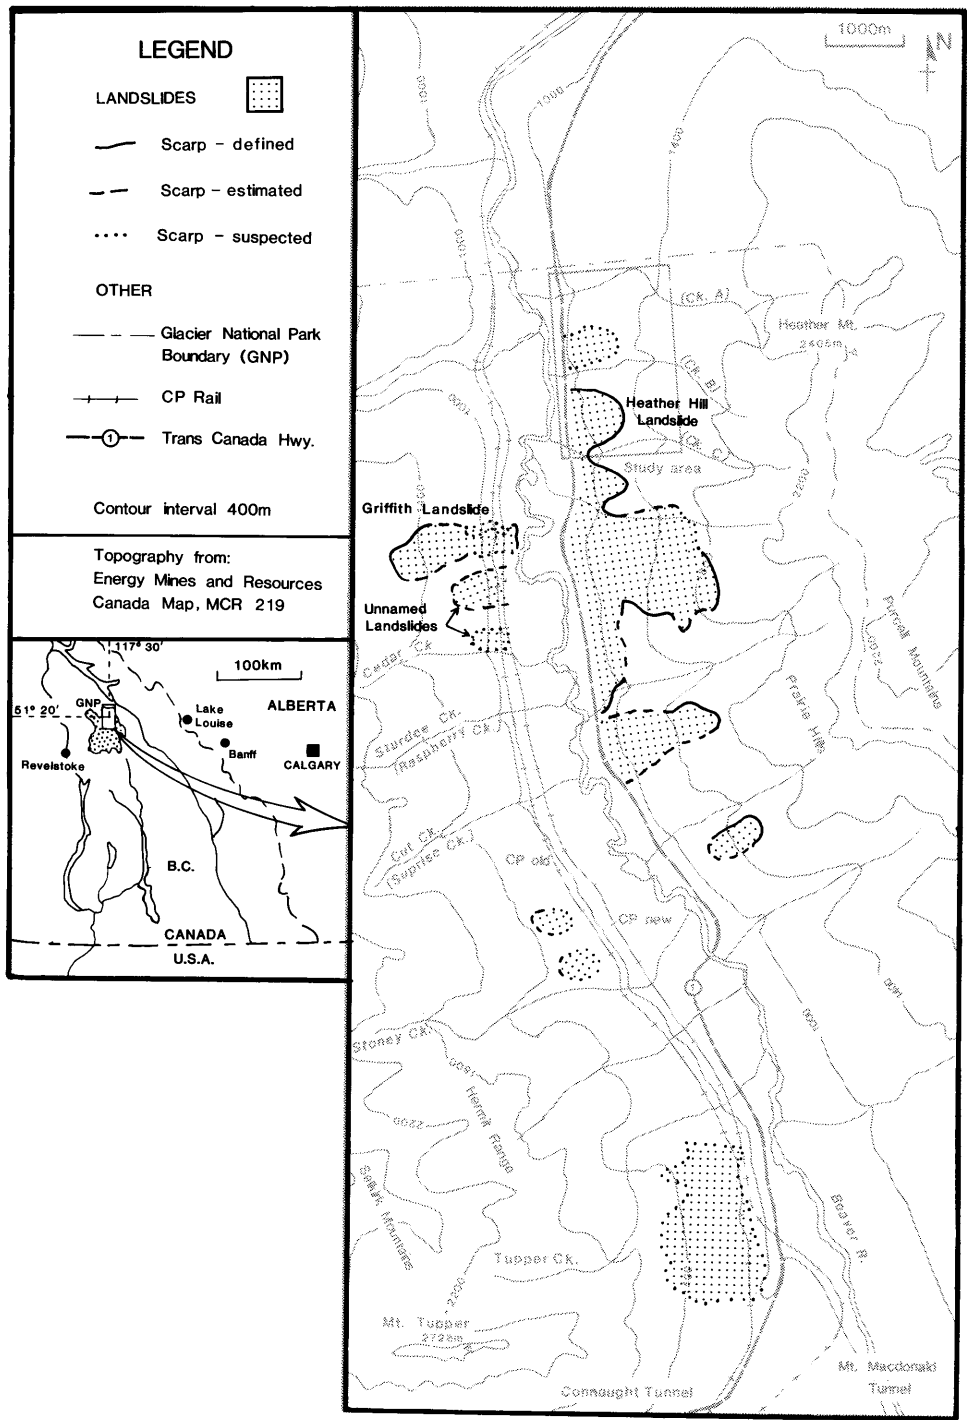
Figure 2: Topographic map of the Beaver Valley showing location of deep-seated landslides.

The large landslides shown in Figure 2 occur in the grit and slate divisions of the Horsethief Creek Group. The lower grit division consists mainly of coarse and fine-grained gritty, feldspathic and micaceous sandstone with slate interbeds (Simony and Wind, 1970); planar bedding and graded beds on the scale of outcrop are common (Poulton and Simony, 1980). The slate division consists of pelitic rocks, with minor coarser clastic and carbonate interbeds transitional with adjacent units.

Figure 2 shows the extent of deep-seated slope movements in the Beaver Valley. All of the movements are located on the lower valley slopes and are seated in the Horsethief Creek Group rocks. The exact age of the failures is unknown. However, it is believed that the initial Griffith slide (Fig. 2) predates the last glaciation (Thurber Consultants 1979), and that all show evidence of post glacial movement.

Progressive deformations have been measured at the Griffith slide (Fig. 2) where continuous movement of the debris has caused displacement of the current CP Rail line throughout its life, necessitating detailed geotechnical studies and stabilization works. Monitoring of slope indicators shows deformations of up to approximately 30 mm over a one month monitoring period (Thurber Consultants Ltd., 1979). Whether or not other deep seated mass movements are moving, and their rate of movement are not yet known.
