**FINAL REPORT**  
**DOCUMENTATION OF SUMMER**  
**NOGAP ACTIVITIES**

**July 22 - August 25, 1990**

Prepared for: Geological Survey of Canada  
Atlantic Geoscience Centre  
P.O. Box 1006  
Dartmouth, N.S.  
B2Y 4A2

HGR Project No.: 90-6

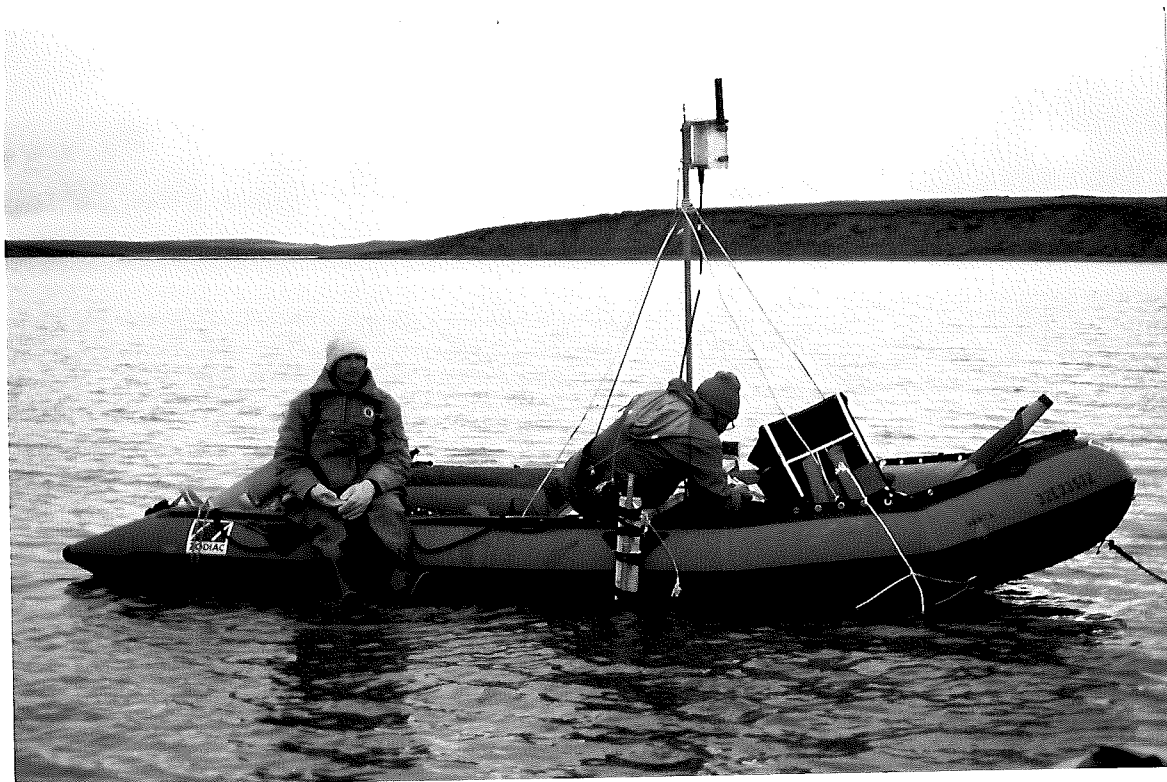
**Figure 4.** Photo of sounding Zodiac.

The miniranger receiver was mounted on a mast, secured by guy lines to the Zodiac (Fig. 4). Underway positioning was maintained by noting ranges from the digital read-out on the Miniranger console and marking the sounder and sidescan records simultaneously. As the sidescan recorder was located in a second Zodiac (Fig.3), the fix was announced by the navigator using a walkie-talkie system. The Miniranger system worked well throughout the program although the batteries at each transmitter had to be changed every 4-5 days. Because the receiver

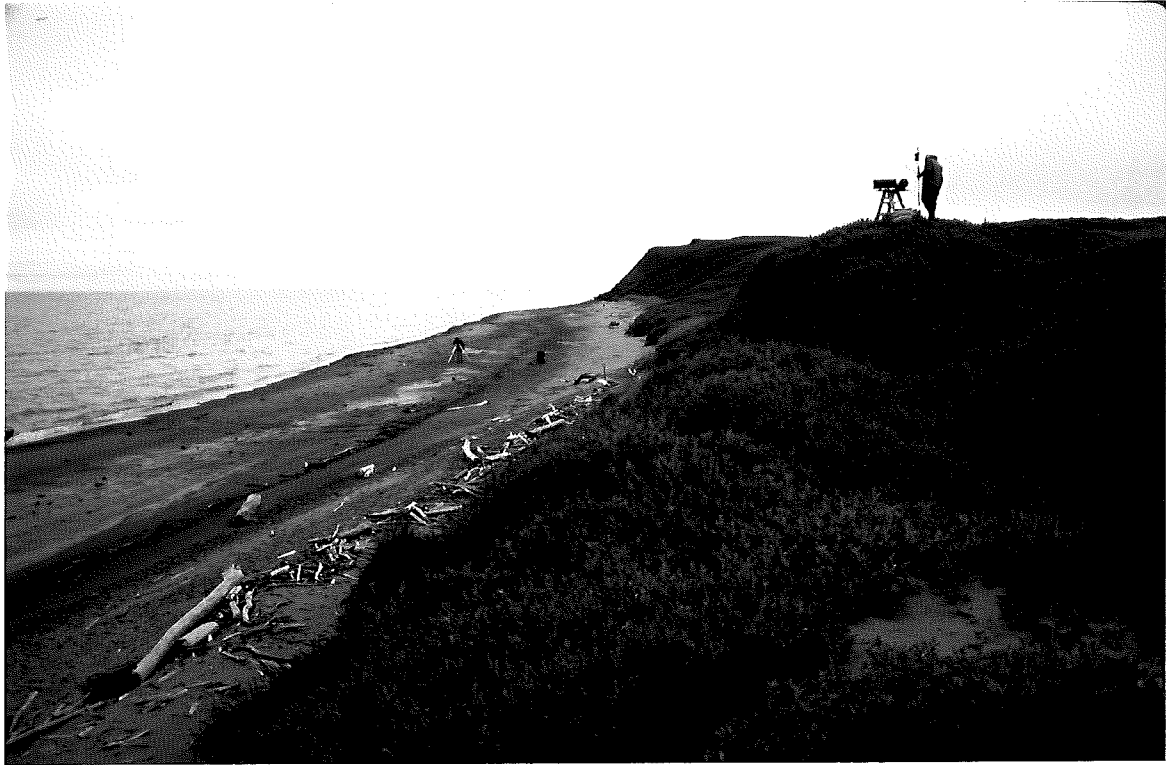
**Figure 5.** Photo of site 90-2 showing location of video cameras on knoll overlooking the beach.

A video camera system was supplied by U. Lobsiger for monitoring a beach site. This consisted of two portable camcorders and an electronic timer, mounted in a weather proof case. The selected site was on the western end of Reindeer Island near MR2 (Fig. 2). The cameras were attached to an aluminium ladder and positioned on top of a small frost-heave mound, approximately 5 metres above sea-level (Fig. 5). The RCA camera was oriented offshore at a bearing of 328° (magnetic), and the Minolta camera pointed alongshore at a bearing of 039° (magnetic). A 2-metre long plastic pipe, painted with 0.5 metre intervals was positioned on the beach in the RCA camera's field of view. Because of its length, the pole had to be placed in a 0.5 metre-deep hole, before it could be driven deeper into the sand. Consequently, attempts to position this marker in the breaker zone (for estimation of wave height) proved to be impossible.

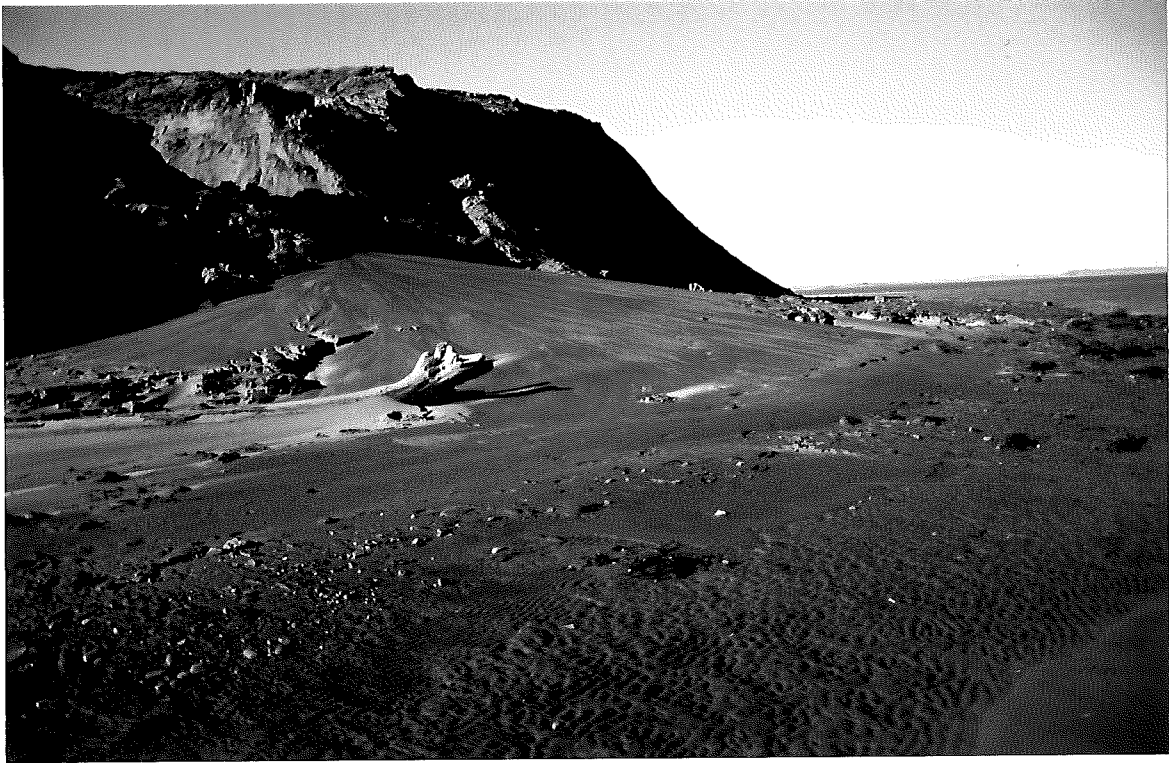
**Figure 6.** Flow slide near Site 90-2.

Retrogressive thaw flow slides are common in the Kittigazuit Formation cliffs. Several old and inactive slides and one active slide were observed in the study area. The active slide occurred on Reindeer Island, just west of site 90-2 (Fig. 2). Typically the slides were narrow, but deeply incised into the cliff face, forming a steep-walled gorge. The flow formed a steep fan that covered the beach and extended below the water line (Fig. 6). A small scarp had been cut at the water line and the sediment deposited by the flow slide was noticeably soft and high in water content compared to the surrounding beach sand.

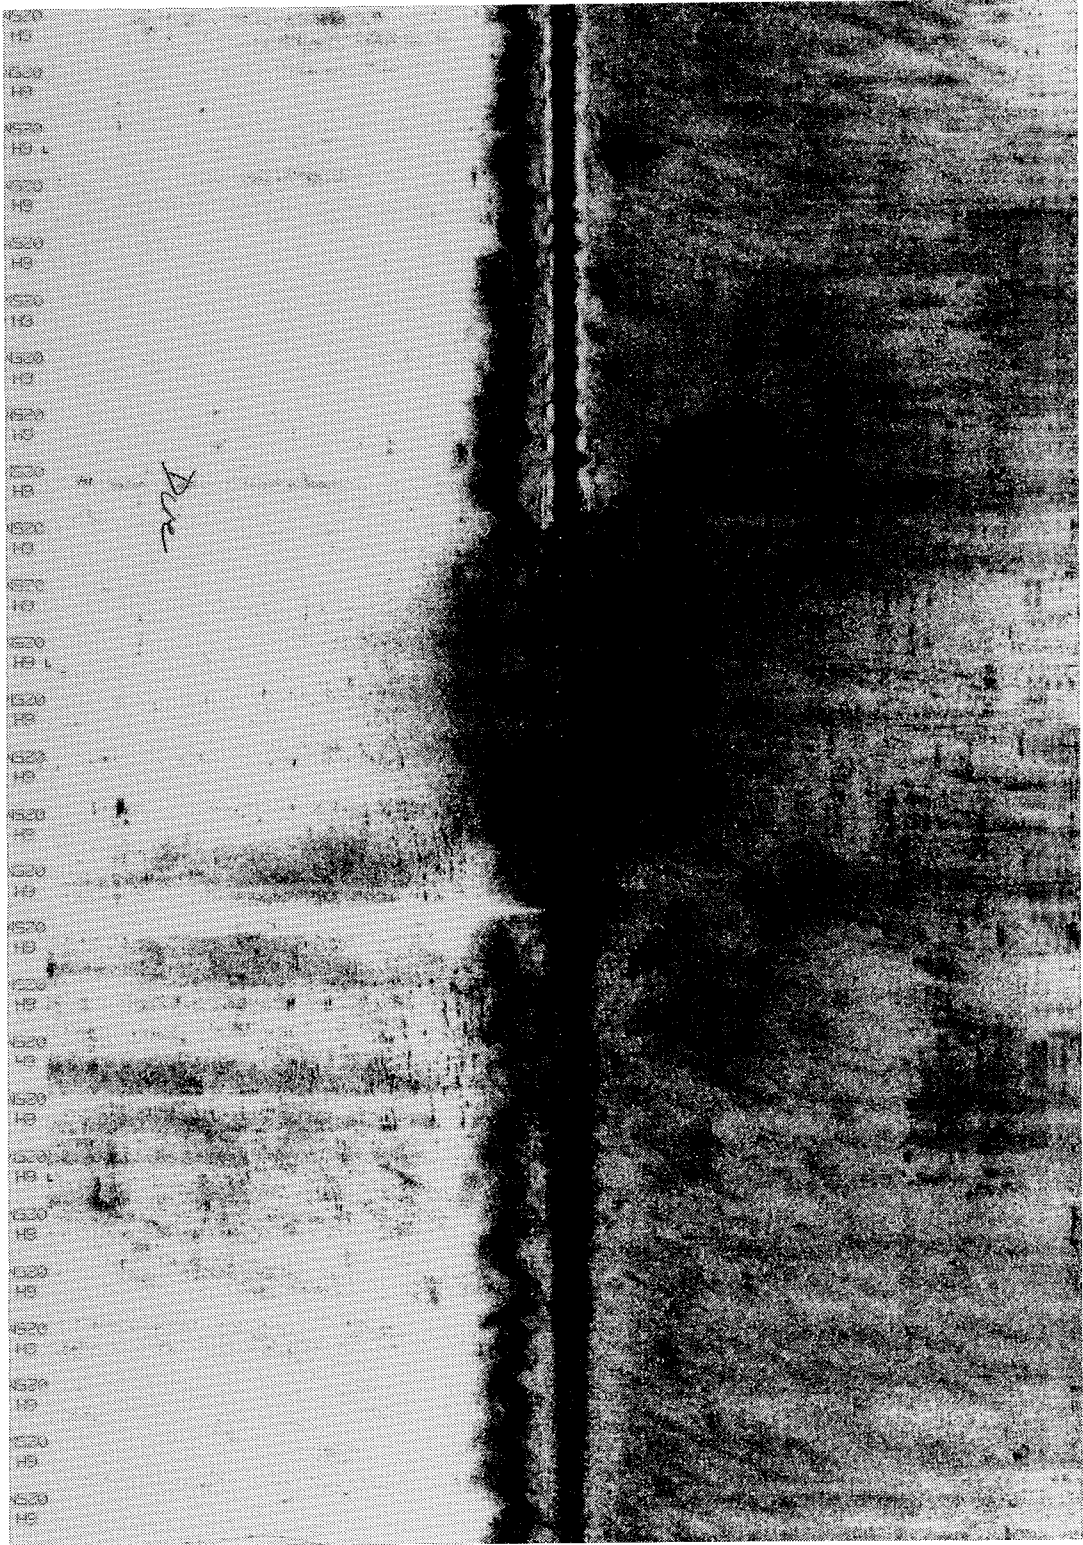
**Figure 32.** (Following page) Possible thaw flow slide deposit off MR2 island.
