GEOLOGICAL SURVEY OF CANADA
PAPER 90-18

EVOLUTION OF SURPRISE RAPIDS LANDSLIDE, YUKON TERRITORY

Brent C. Ward, Lionel E. Jackson, Jr., and K.Wayne Savigny

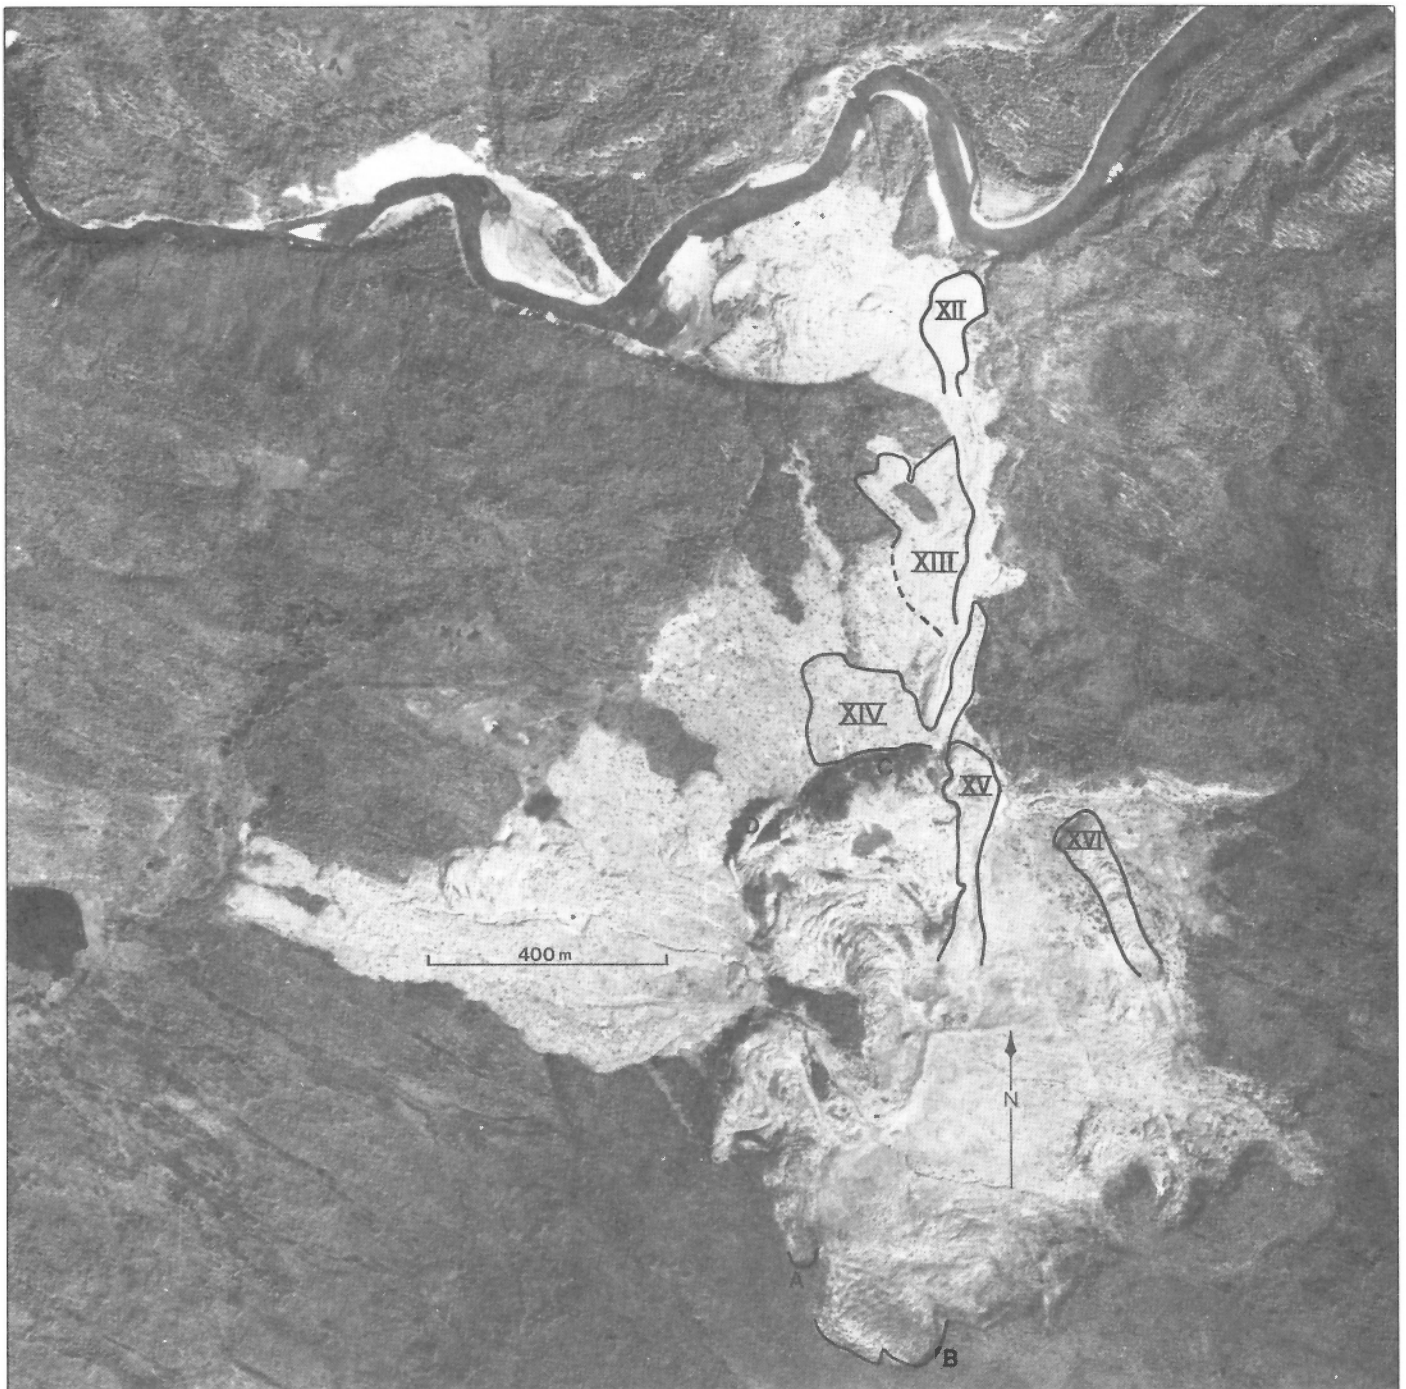
Figure 5. Enlargement of a 1968 airphoto of Surprise Rapids Landslide showing geomorphic elements, flows (Roman numerals), and flow source areas (capital letters), which are discussed in the text. NAPL A20695-100

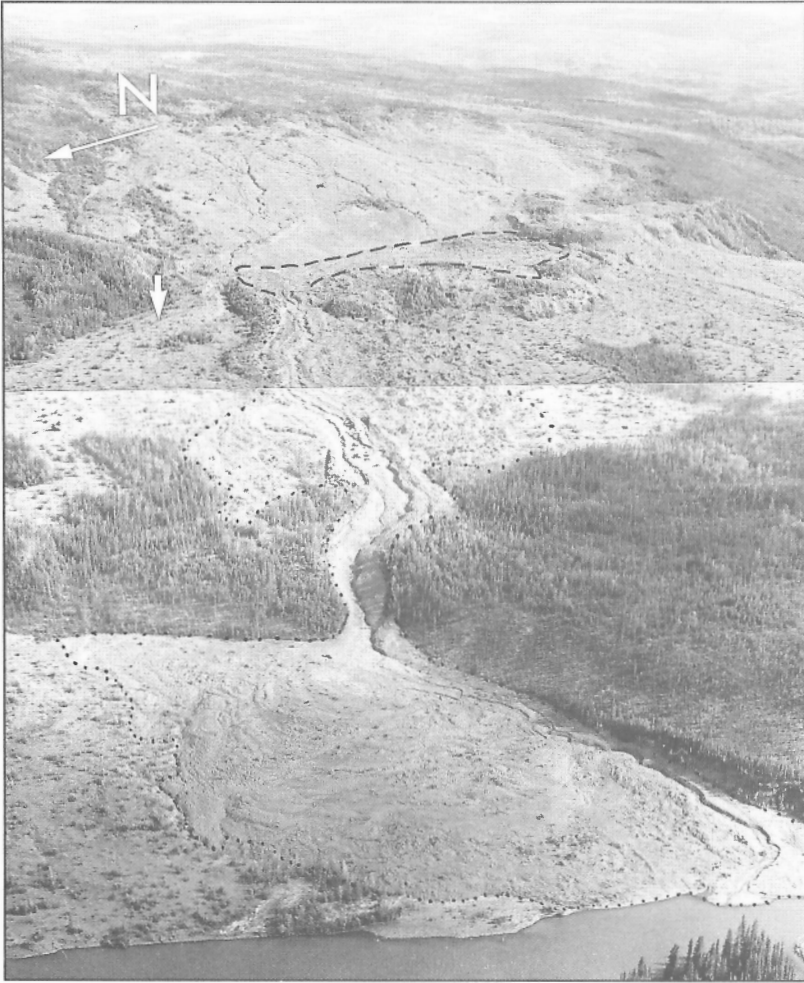
Figure 6. Low-level oblique photo of Surprise Rapids landslide taken in 1988 showing geomorphic element 6 (dotted line) and geomorphic element 7 (dashed line). Nested levee of element 4 indicated by small arrow. GSC 1991-114

Geomorphic element 6 (Fig. 2 and 6) is the most recent major failure. Its outline on Figure 2 is approximate, based upon low-level oblique photos and tape and compass traverses. Element 6 formed in three stages with each stage having different surficial morphologies. The first stage involved the catastrophic failure of geomorphic element 1 and earthflows ponded behind it (C of Fig. 3). This failure resulted in an

The causes of the catastrophic failure of element 1 and the creation of elements 6 and 7 are not clear. The morphology of element 6 indicates that two modes of failure occurred concurrently during its formation. The upper 3 to 5 m or more of the mass was brittle and failed by fracture and foundering, whereas the base had extremely low strength and probably flowed like a viscous fluid, as evidenced by the low gradient of slope over which the failure occurred. The brittle upper part of the flow progressively foundered into the low strength base as the flow advanced and thinned (Fig. 15, 17, 18, 19). A third mode followed, characterized by mobile earthflow and debris flow that lacked a brittle crust (Fig. 6 and 12).

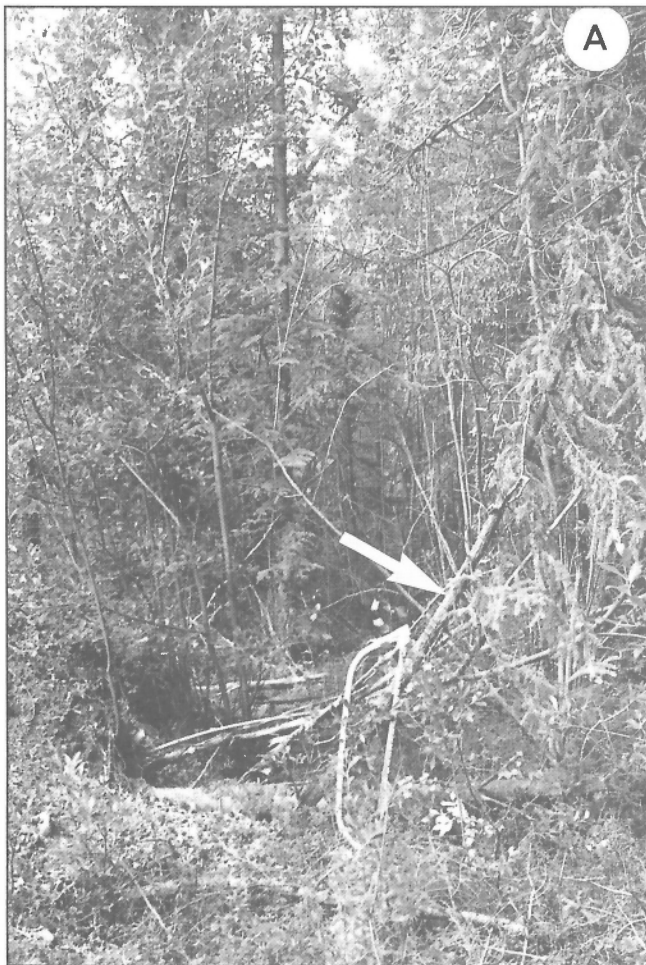
Figure 9. The tree X-11 (A) The tree inclined by the impact of another tree, which had been impacted by landslide activity to the left of the photograph. (B) A section from tree X-11. The impact resulted in minor scarring as well as reaction wood (eccentric dark ring growth) on the opposite side of the tree. Reaction growth started in 1977, which was the time of formation of element 6. Also of interest are the many false rings associated with the reaction wood. Annual rings are denoted by dots. GSC 1991-113

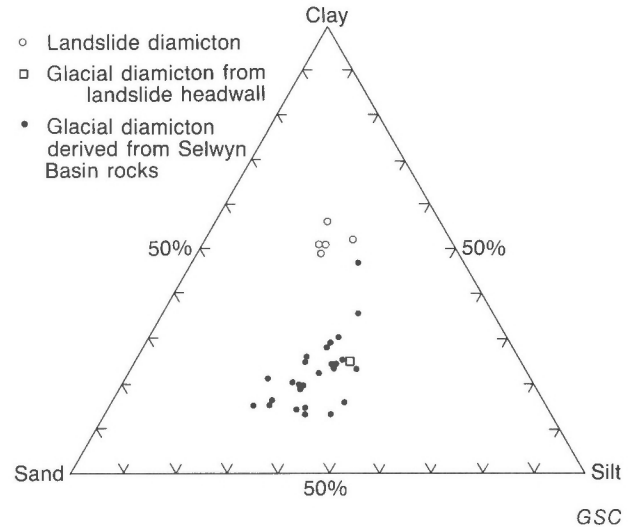
Figure 10. Ternary diagram of landslide diamicton, glacial diamicton sample texture from the headwall of element 5, and the glacial diamicton samples overlying Selwyn Basin (Gabrielse, 1967) sedimentary rocks.

The landslide colluvium is dark grey. Clay content of the <2 mm fraction of four samples taken from widely spaced areas of the landslide range from 49 to 56 weight % (Fig. 10). These values are anomalously clay rich relative to the clay contents of glacial diamictons derived from Selwyn Basin bedrock elsewhere in the region and now exposed in the headscarp of the landslide (Fig. 10). The local bedrock has been inferred to be Earn Group clastics of Devonian-Mississippian age. The Earn Group is not highly argillaceous (S.P. Gordey, personal communication, 1987) so the ultimate source of the high clay content of the colluvium composing the landslide is unknown. A likely explanation for this anomalously high clay content is that a significant part of the landslide was derived from lacustrine or glaciolacustrine sediments rather than glacial diamicton. Further evidence to support this hypothesis is discussed later.

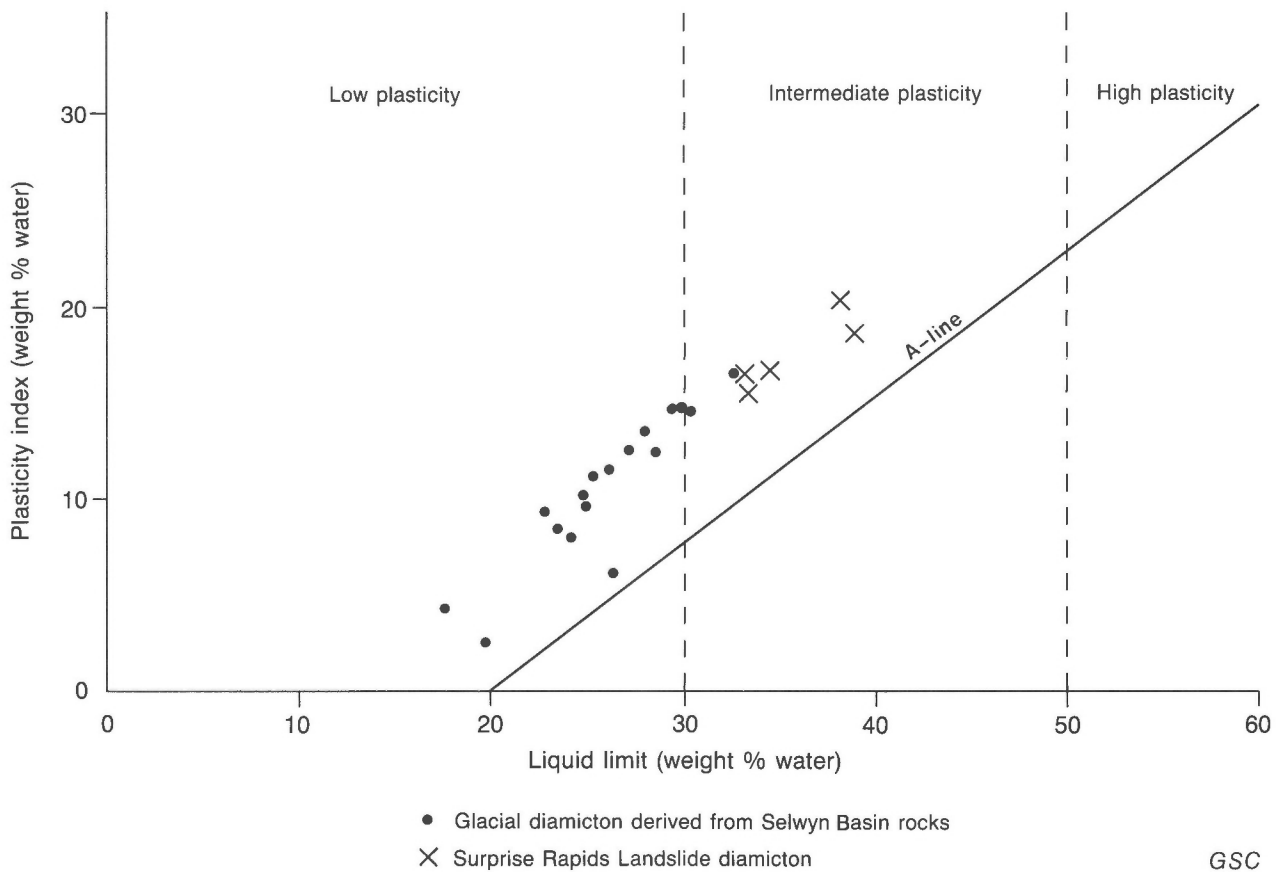
Figure 11. Plot of liquid limit versus plasticity index for landslide diamicton samples and glacial diamicton samples derived from Selwyn Basin sedimentary rocks.

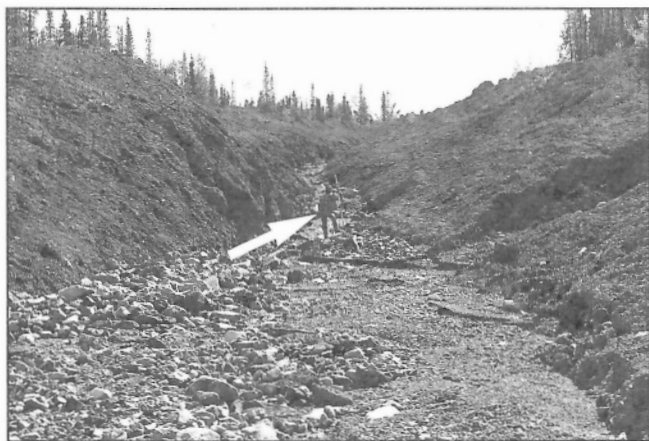
Figure 12. Looking up the large levee system associated with the second stage of formation of element 6. (The arrow indicates a man 1.8 m tall for scale). GSC 1991-117

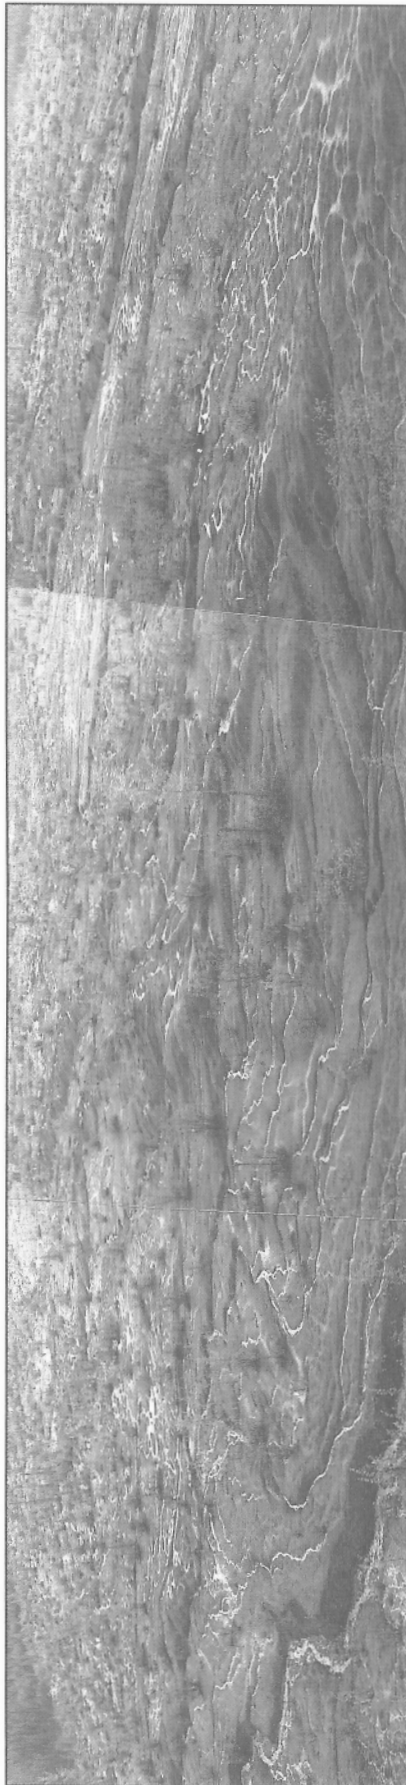
Figure 14. Panoramic view of element 2 from a promontory atop element 1 looking west to northwest, immediately after a rainstorm. Note the low gentle relief, the relative lack of vegetation, and the well developed drainage pattern. The largest streams follow the edges of lobes. The extensive amount of water on element 2 reflects the high clay content and poor drainage properties of the diamicton composing the landslide. GSC 1991-110

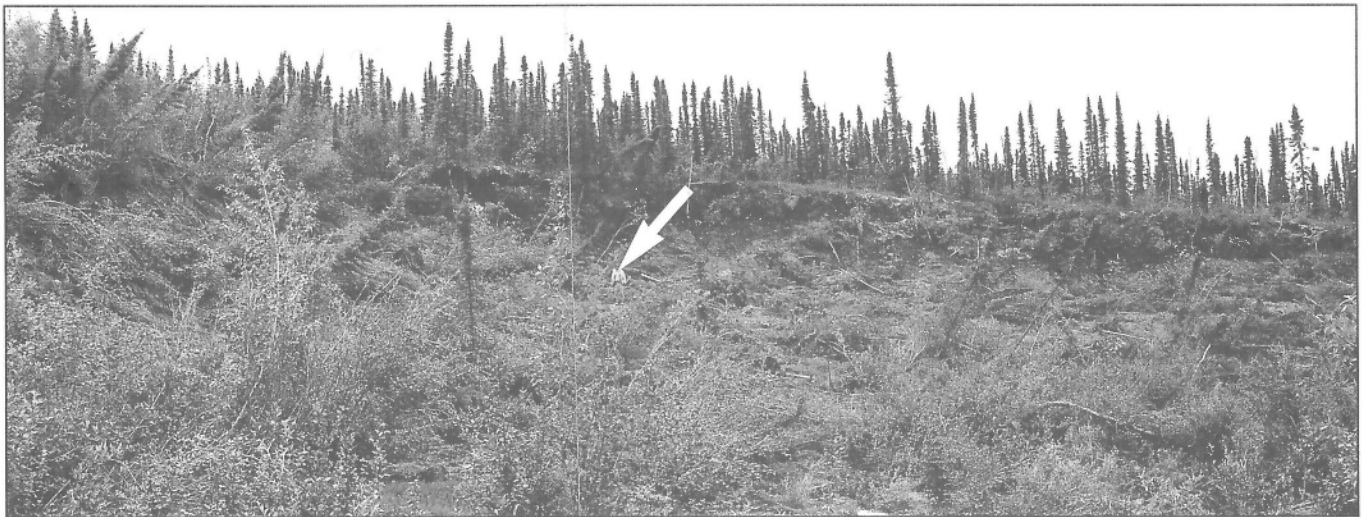
Figure 16. Active failure in the western part of element 3, June 1988. (The arrow indicates a man 1.7 m tall for scale.) GSC 1991-112

is now expanding south into the adjacent upland along its southwestern margin (Fig. 16). The active area of element 3 is characterized by the surface vegetation mat draping over scarp faces (Fig. 16), trees tilting, and blocks of colluvium and pedologic soil material rotating or toppling as they progressively become transformed into earthflows. The total volume of slope material removed from elements 3 and 5, which together make up the headscarp of the landslide, is between 0.8×10^5 and 1.6×10^6 m³ assuming the average thickness of slope removed to be between 1 and 2 m.

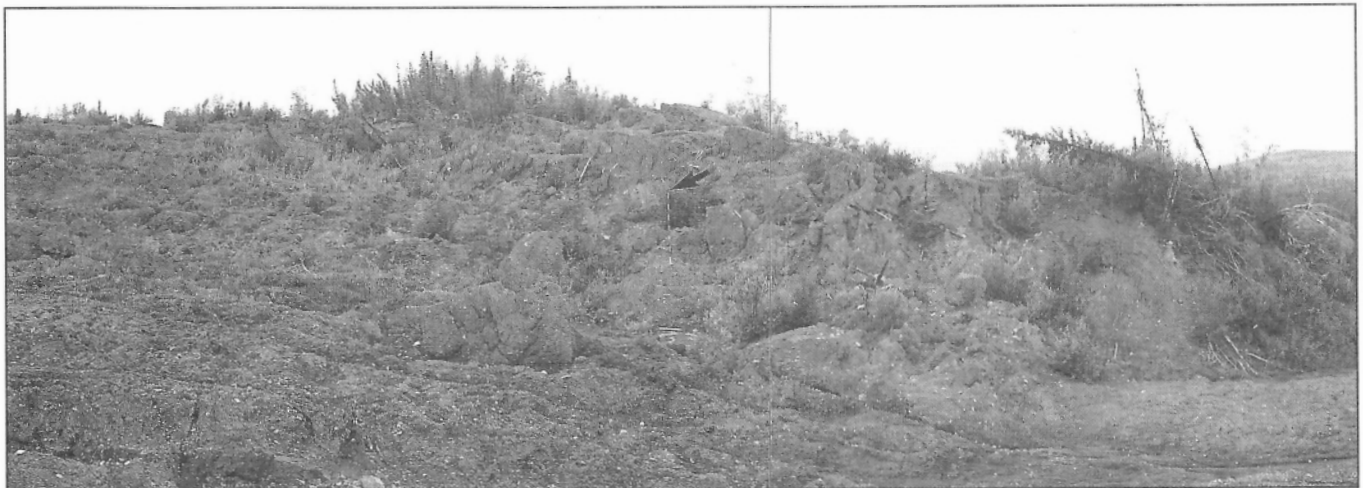
Figure 19. View looking southwest to west from the eastern side of the major failure of element 1 (C of Fig. 6). Landslide material is failing from the back (upslope side) of element 1 into the newly formed depression of element 7. (A 3.7 m ranging pole for scale indicated by the arrow.) GSC 1991-078B, 1991-078C

of) element 1. Figure 19 shows unsupported material along the back (upslope) margin of element 1 breaking away and moving towards the central depression. A panoramic view from the middle of the depression looking southwest to west (Fig. 20) clearly shows active failure over a slope of $<5^\circ$.

Geomorphic element 7 was created simultaneously with element 6 and is currently failing actively (Fig. 19 and 20). Failure here will likely continue until debris flow and earthflow sediments accumulated behind element 1 have flowed out through the breach created during the formation of element 6.

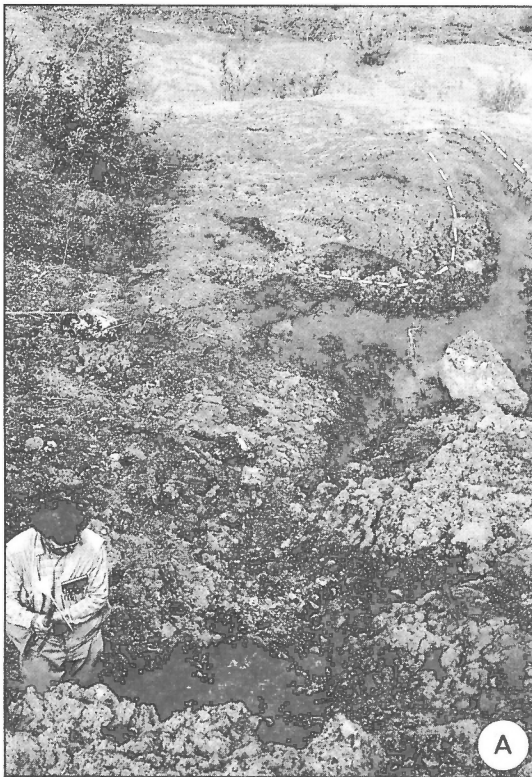
Figure 23. Headward sapping by springs along element 1. (A) View down from rim of element 1 of the area of transition from brittle slumped sediment to debris flow; dashed lines mark debris flow levees. (B) Looking toward the face of element 1; fresh slumping, directly behind the senior author has occurred as a result of undermining by spring activity visible beneath his feet. GSC 1991-111

- b) Progressive weakening of element 1 as a result of localized instability affecting the steep toe. This process is currently underway (B to C of Fig. 3 and 23) and may be analogous to the processes leading to the failure of element 1 and the formation of element 6. In this area, groundwater discharges at midslope and causes shallow sloughing. The groundwater may originate from ponds in numerous closed depressions upslope and pass either through deep flow or paths through an active layer; the groundwater may alternatively indicate thermal degradation of ground ice. The colluvium is progressively remolded into debris flows that flow down the face of element 1. The face of element 1 is thus undermined causing the slope face to retreat along an amphitheatre-like margin about 15 m across. This process systematically reduces the lateral strength of element 1 and, in the extreme, will breach it. Both circumstances could result in the catastrophic failure of fluid landslide colluvium behind element 1.

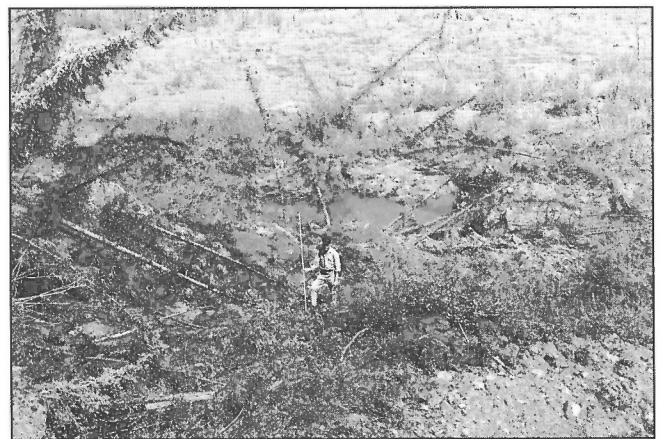
Figure 25. Standing water of element 7. GSC 1991-116
