GEOLOGICAL SURVEY OF CANADA

OPEN FILE 2541

Investigation of geological constraints on granular resource extraction in the Tuktoyaktuk Coastlands area, Northwest Territories Source 160/161

1992

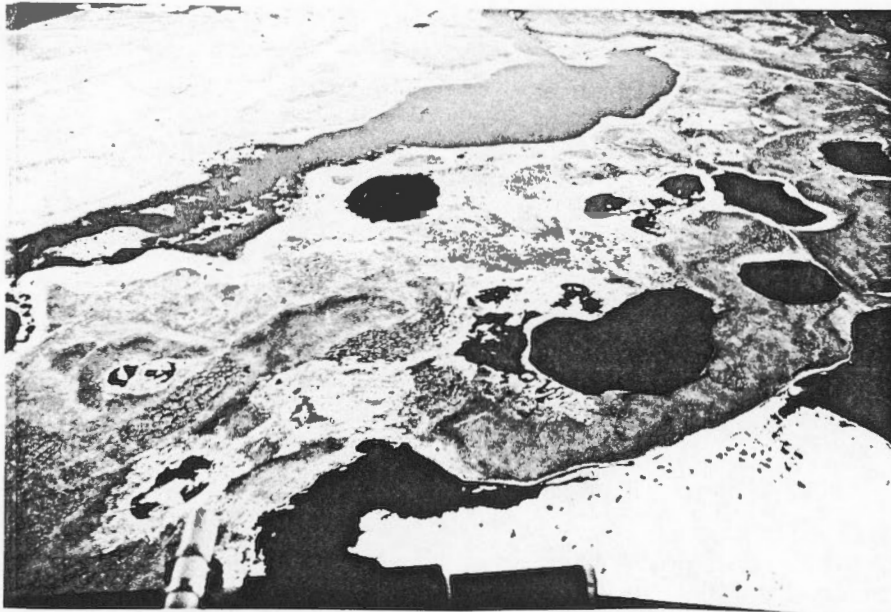
Photograph 1. Aerial view of borrow pits 160/161 C, E, F and G looking west, June, 1991. Kudluk Lake is in the near foreground.

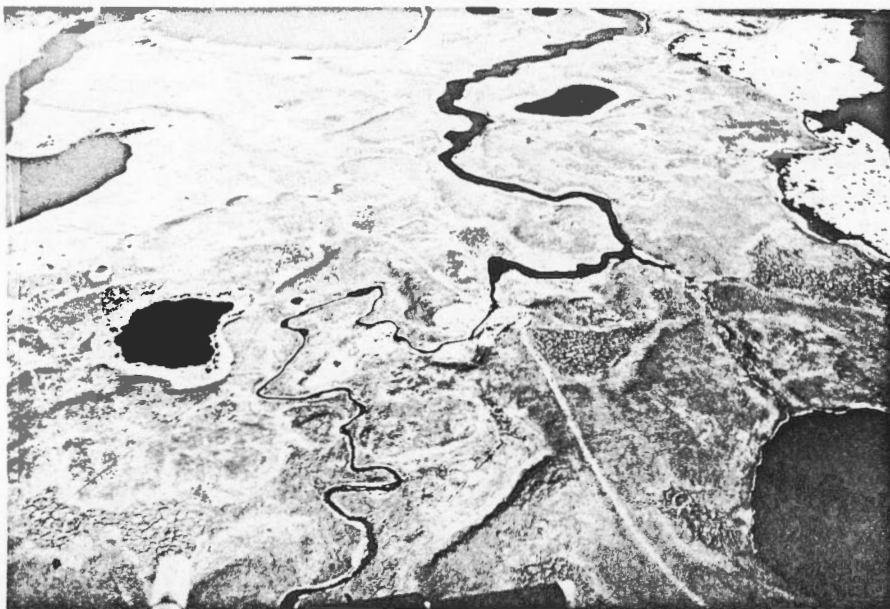
Photograph 2. Aerial view of Fresh Water Creek and borrow pit at 160/161 West, looking northwest, June, 1991.

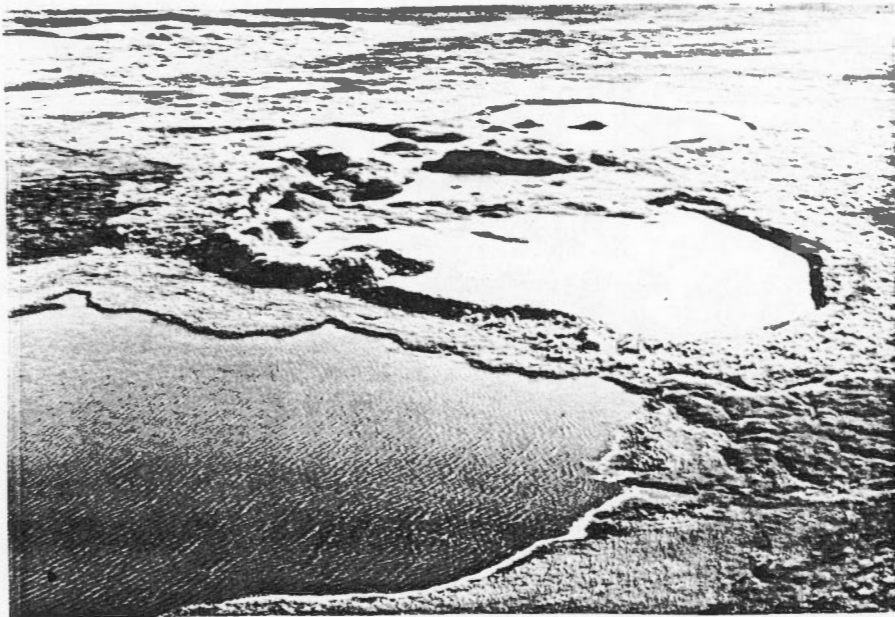
On the east side of the thermokarst pond that occupies the southwest part of Source C. The pond is substantially more extensive than it was in 1985 and appears to be expanding rapidly. There are fresh tension cracks and collapse structures on this side of the pond. There is at least one metre of gravel exposed in a good section just above the pond. There is a small plateau of undisturbed material to the east of this but it dips off into a low wet area and potential to extract more material is limited.

Photograph 3. Aerial view of borrow pit 160/161C, looking south, September, 1991. The thermokarst ponds, the ridge between the pond and Lake C the ridge in the centre of the pit and the hill on the east side of the pit area shown. Lake C is in the foreground.

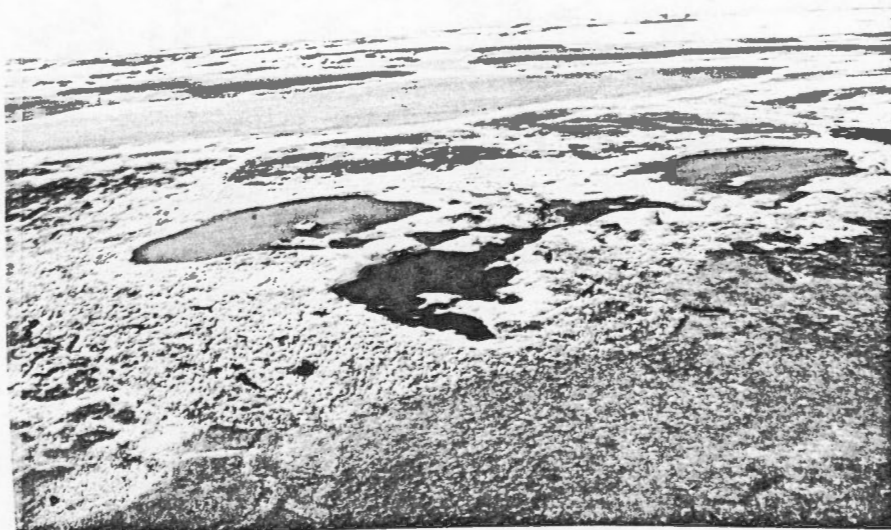
Photograph 4. Aerial view of borrow pit 160/161C, looking west, September, 1991. The new vegetation growth on the disturbed organic fringe is visible by its lighter tone.

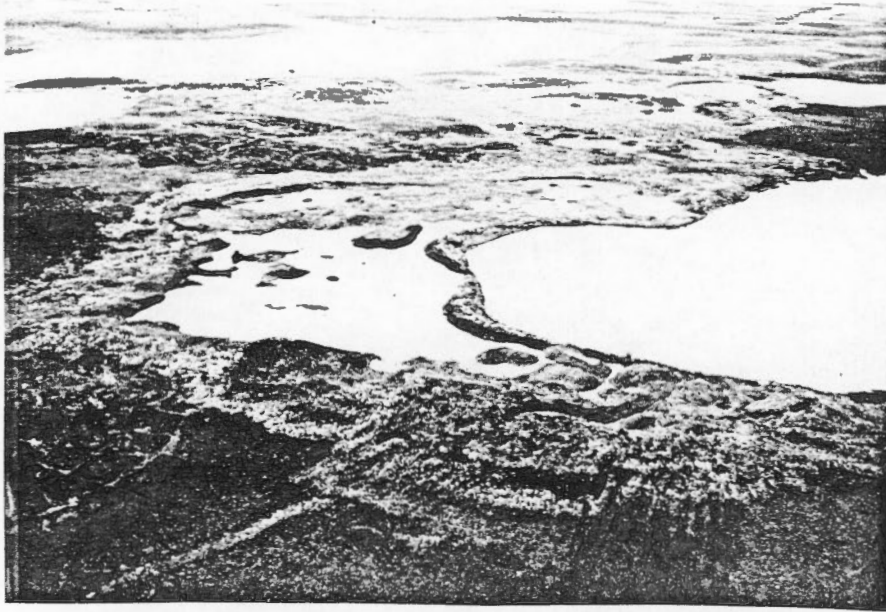
Photograph 5. Aerial view of borrow pit 160/161E, looking west, September, 1991. The narrow ridge between the thermokarst pond and Lake E is shown in the centre of the photograph. Lake E is to the right in the photograph.

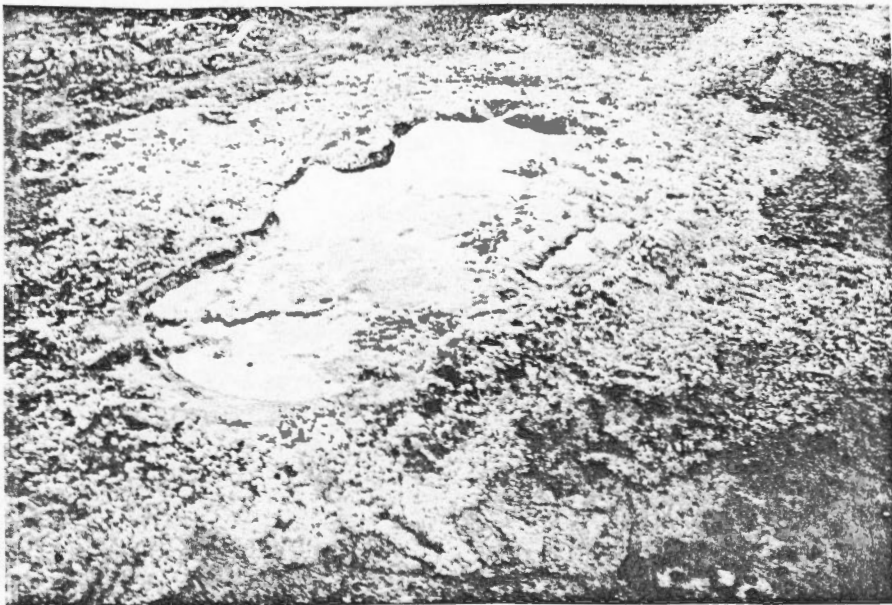
In the south pit there are 3 small water filled depressions. These ponds were not probed but appeared to be shallow, likely less than one metre. Total depth of these depressions, including the depth of water, was less than 3 metres. The extent of the ponds in 1991 is similar to that observed in the 1985 airphoto. There are a few tension cracks in the south pit which reflect some continued settlement but the depressions do not appear to be expanding rapidly. In the north pit the surface is irregular, suggestive of some differential settlement which may reflect melt of buried ice.

Photograph 6. Aerial view of the southern borrow pit at 160/161F, looking north, September, 1991.. Note the thermokarst ponds and the new vegetation growth on the disturbed organic fringe is shown.

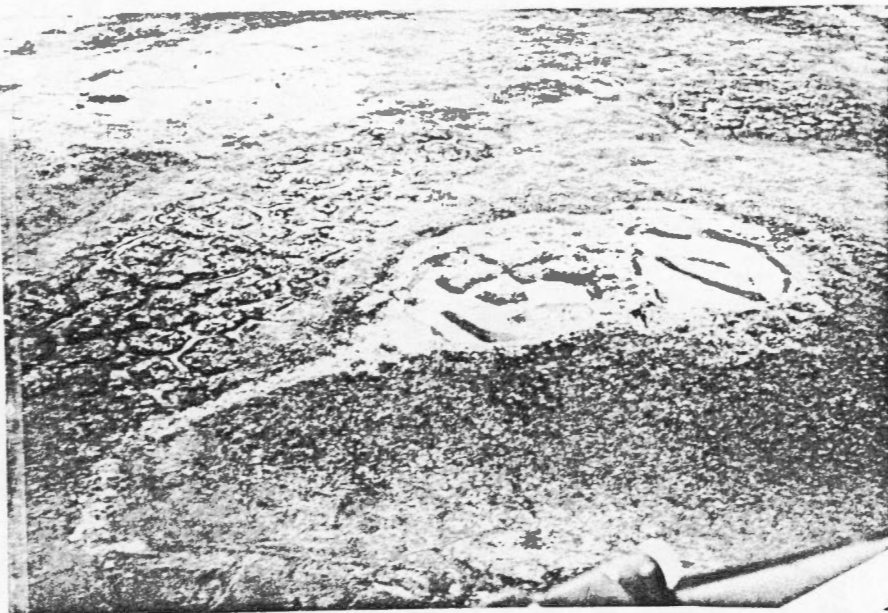
Photograph 8. Aerial view of the borrow pit at 160/161G, looking east, September, 1991. The southern borrow pit at 160/161F is visible in the background.

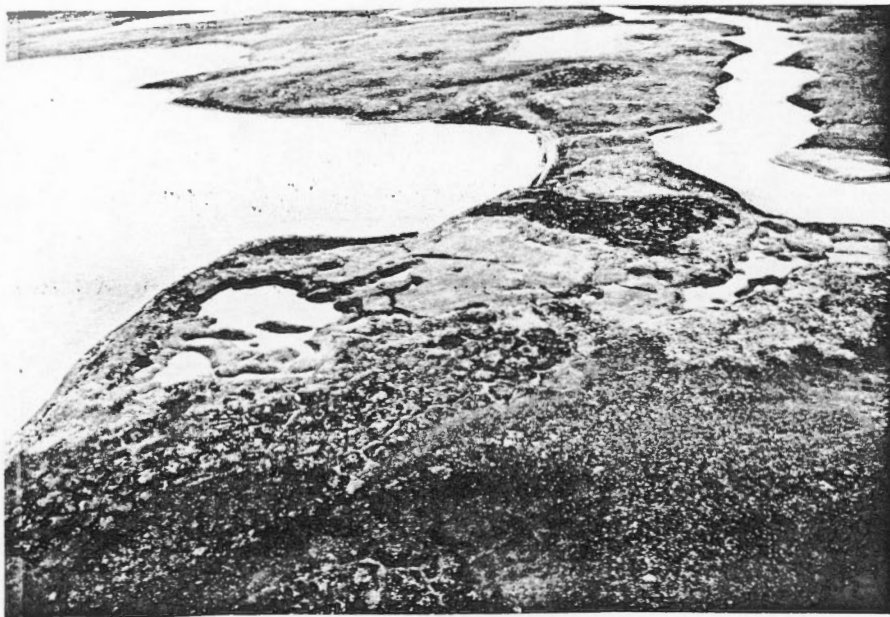
When the pit was visited in September 1991 there were several linear depressions and two large ponds. The western pond had not expanded substantially since 1985 and there were only a few tension cracks and collapse structures along its margin. The total depth of this depression was 3 to 4 metres including water depth of 0.7 to 1.3 metres. There is a drainage channel from the west pond to Fresh Water Creek. Water flow in this channel was modest in September of 1991 and this drained directly into the sandy deposits at the base of the slope. However the size of the channel, 4 to 4.5 metres deep, suggests that water flow was greater in other years or earlier in the season.

A large water filled depression [herein called the east pond] had formed on the east side of the deposit by September 1991. This depression was approximately 7,000 square metres in area and total depth was 6 to 7 metres including a water depth of 3.3 metres. Fresh tension cracks and collapse features on all margins of the pond and drowned vegetation in the centre of the pond all indicate continued rapid expansion due to melt of buried ice. Water has escaped from this pond to the undisturbed organics on the north side of the deposit and accelerated melt of ice wedges. The thickness of buried ice is unknown and it is not possible to predict how much further the pond will expand either laterally or vertically. The distance between this depression and the edge of the slope above Pikiolik Lake is less than 15 metres.

Photograph 9. Aerial view of the borrow pit at 160/161 North, looking south, September, 1991. The two thermokarst ponds are visible. Pikiolik Lake is to the left and Fresh Water Creek to the right.

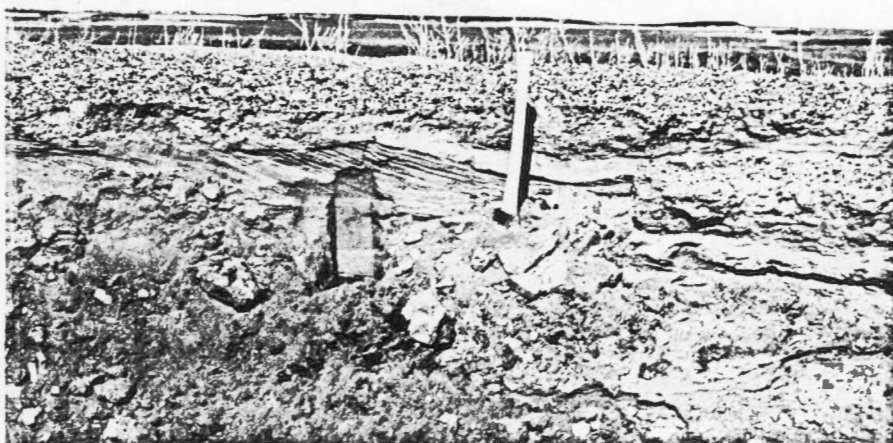
Shallow shovel pits and sections excavated during the 1991 field surveys indicate that the aggregate remaining in the base of the pit is primarily sand with some gravel sections. It may be possible to extract additional aggregate from this hill by draining the ponds and deepening the pit. However, any further work at this site can be expected to expose buried ice and cause additional thermokarst collapse and meltwater runoff. The danger of drainage to the adjacent water bodies may restrict further development. The 1985 TDC regulation that no borrow pit activities be conducted within 182 metres of Fresh Water Creek would preclude further development of the west half of this deposit.

Photograph 11. Section at 160/161 North showing granular aggregate overlying sand. Note shovel for scale.

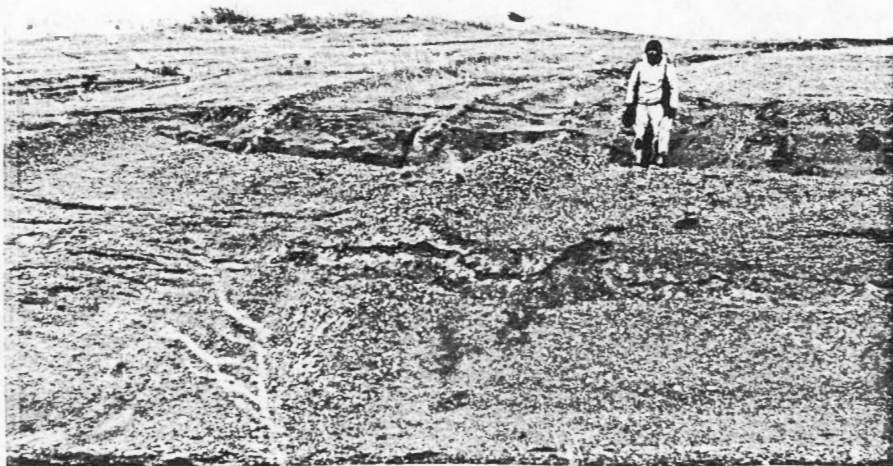
Photograph 12. Borrow pit 160/161 North showing typical unvegetated surface and linear depression.

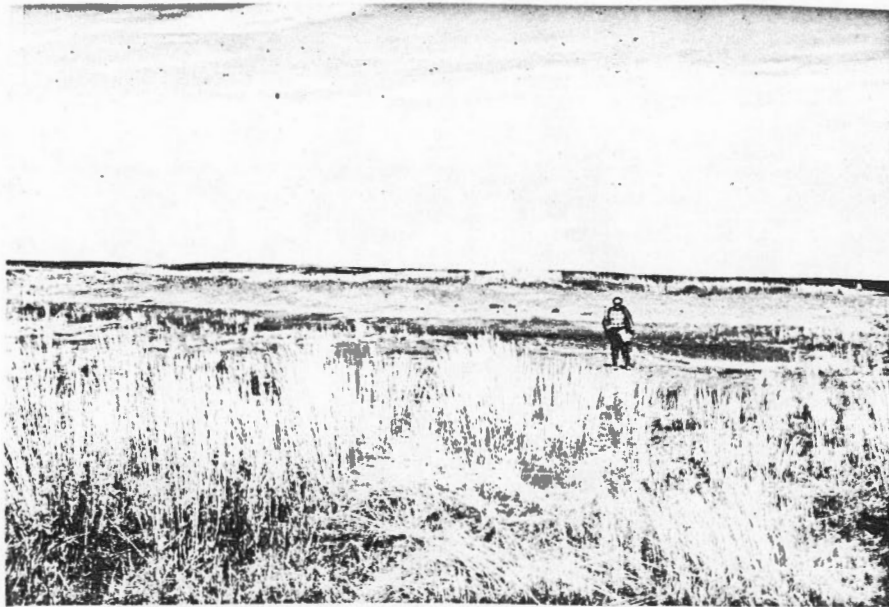
More than six years after abandonment there is almost no vegetation growth in the borrow pits. Recovery of the vegetation has been slow due to the absence of organic cover on the pit surfaces. There are no stockpiled organics on-site and any future revegetation projects will be constrained by the lack of local organic material. Vegetation is well established around the margins of most of the borrow pits where the organic cover has been disturbed or partially removed by borrow pit activities.

Photograph 13. Typical new vegetation growth along the disturbed fringe of the borrow pit where there are some organics at surface. Unvegetated surface of the borrow pit in the background.

It is recommended that the extent of drainage presently issuing from the borrow pits, rate of expansion of the ponds and properties of the water in the ponds be monitored to determine if there is potential for drainage which could have a negative impact on aquatic life and water quality in adjacent natural water bodies. In addition, we recommend experimental studies at these abandoned pits to develop methods for extracting aggregate and rehabilitating abandoned borrow pits which could maximize aggregate recoveries and minimize environmental damage. These suggested studies include determining depth of thaw and rate of melt of buried ice, evaluating methods for delimiting buried ice, and developing improved methods for storing and replacing organic material and encouraging vegetation growth.

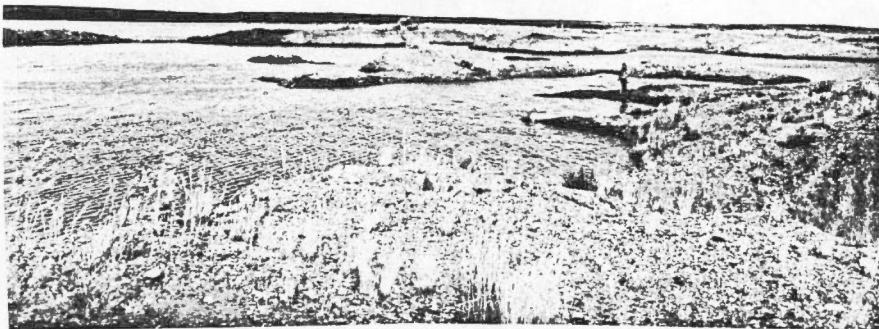
Photograph 16. Thermokarst pond at 160/161 E looking north across the narrow ridge to Lake E. Person in the right centre of the photograph for scale.

Sources 160/161 C and E are particularly unsightly because steep slopes on the margins of the pits and mounds inside the pits were left standing when the borrow pits were abandoned in the mid 1980's. The high mounds in the centre of these pits and steep slopes on the east side of Source 160/161 C and the southeast side of Source 160/161E could be regraded. It is recommended in Environmental Guidelines, Pits and Quarries (1982) that, when a pit is abandoned, slopes be graded to no steeper than 2:1 [2 horizontal to 1 vertical]. To provide such slopes would necessitate cutting back about 10 metres from the present edge of the pit. Recontouring may create additional thermokarst depressions but is still expected to improve the overall visual appearance of these pits. Recontouring of slopes above and within 30 metres of natural water bodies should be avoided to minimize potential for introduction of pit drainage to these water bodies.

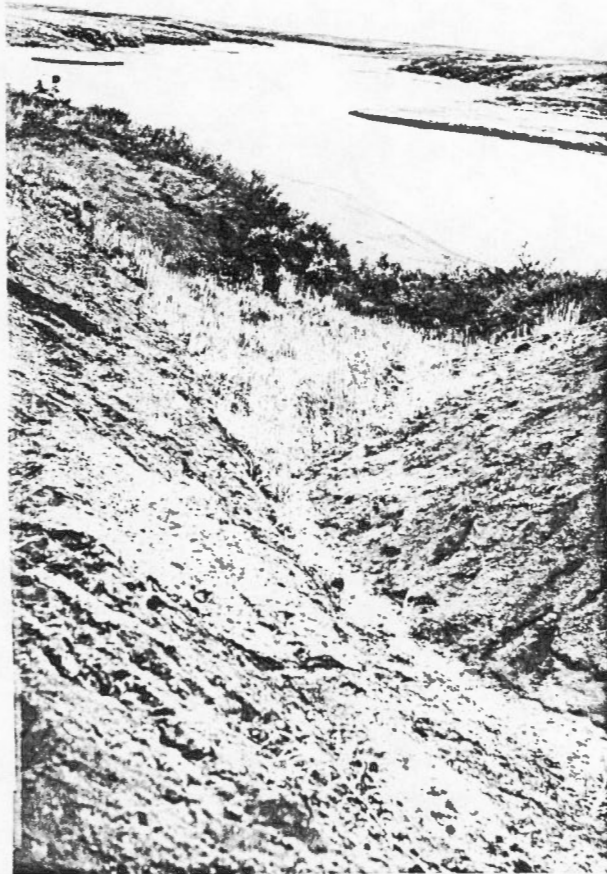
Photograph 19. Drainage channel from the western thermokarst pond at 160/161 North to Fresh Water Creek. Note person in the upper left of the photograph for scale
