Coastal Stability and Flooding at Grand Étang Fortress of Louisbourg Nova Scotia

Open File / Dossier Publique

2548

**COASTAL STABILITY AND FLOODING AT GRAND ÉTANG,
FORTRESS OF LOUISBOURG
NOVA SCOTIA**

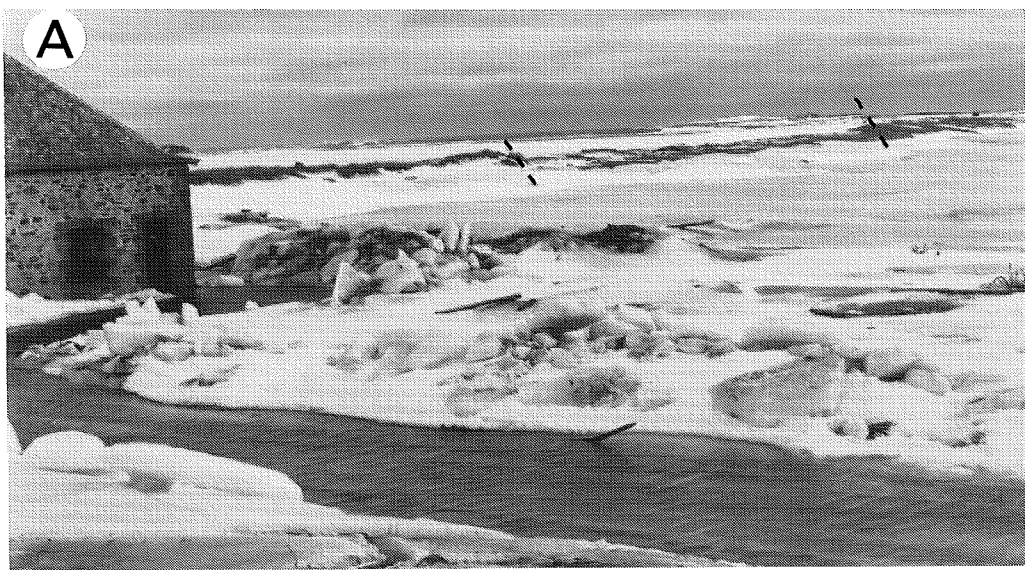
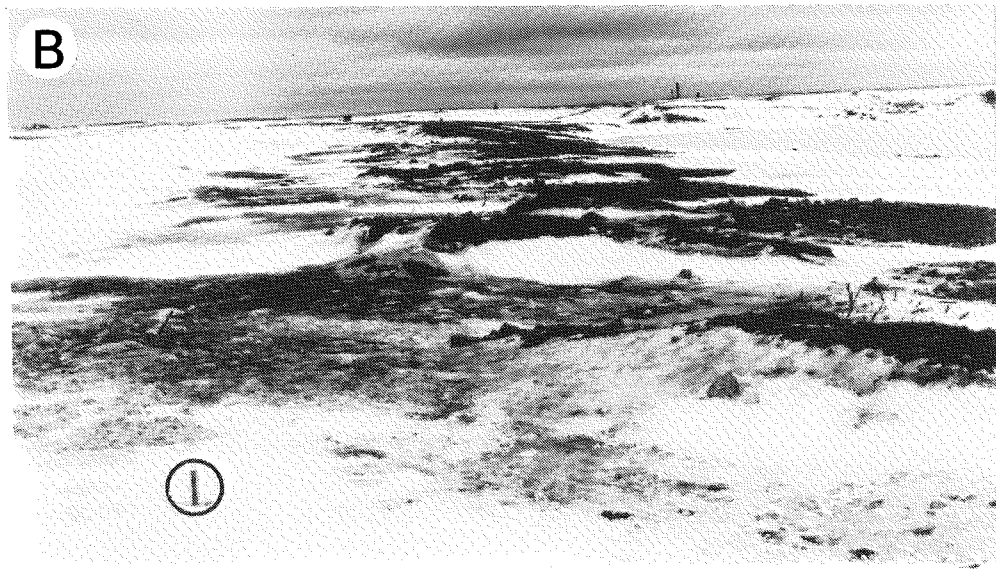
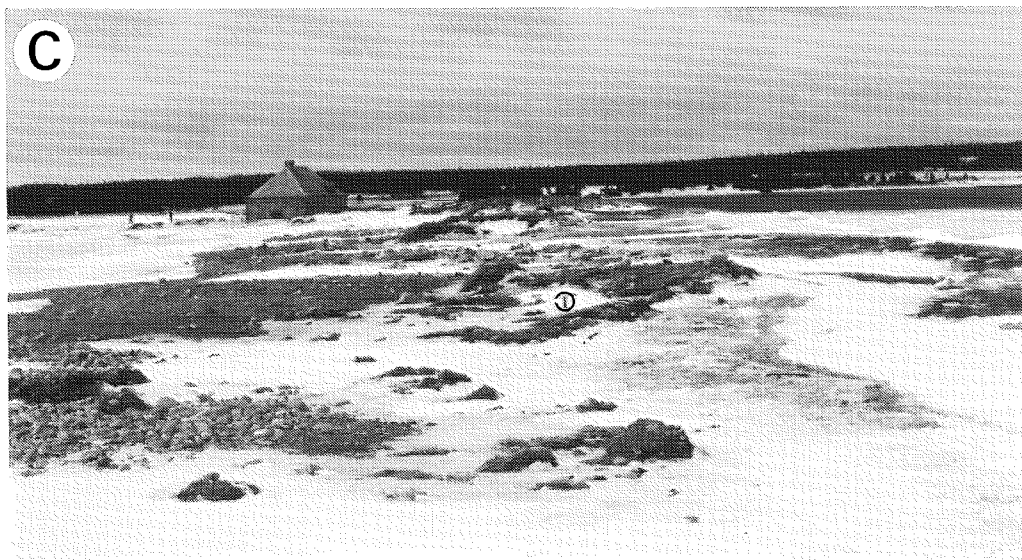
Figure 2. (a) View from the Quay wall of Corps de Garde (Sewage plant) at left and the backshore of Grand Étang barrier beach. The section of beach cut down during the February 1992 storm is outlined by dashed lines. Views toward the south (b) and toward the north (c) of the overwashed central section of Grand Étang barrier showing its degraded crest morphology following the February 1992 storm (photo - March 9, 1992). The wooden stakes (circled) mark the baseline of the 1992 survey.

wave overwash channels with a relief of 0.6-0.9 m were separated by narrow ridges of relict beach crest (Fig. 2 b,c). Pebble-cobble clasts had been deposited on the backslope forming low gradient washover fans which were partially covered by ice and snow. An icefoot which extended above high tide level also masked the seaward beach slope (Fig. 2b,c) .

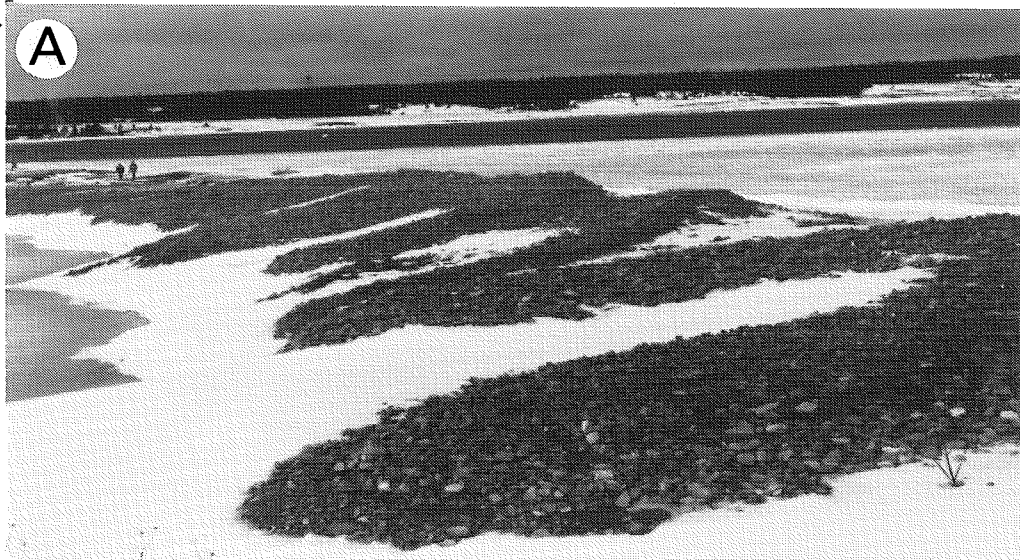
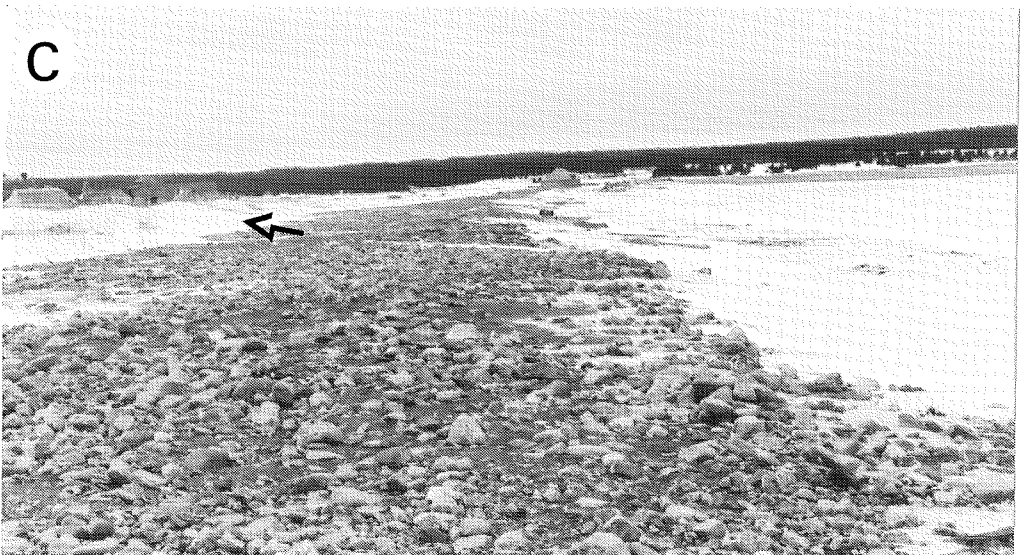
Figure 5. Photographs of Grand Étang barrier, March 9, 1992. (a) well defined washover channels with levees and discrete fan structures at the highest part of the beach. (b) beach crest composition is subangular pebble-cobbles of 40 to 100 mm diameter. (c) farther south where the beach crest is lower wave overwash was much more extensive with few channels. Sediment is now accumulating against the historic embankments (arrow) of Bastion de Maurepas.

The southern section of the barrier had a higher beach crest and a seaward slope which varied from a stepped profile with an upper scarp to a more gradual sloping ramp (Fig. 3b, L7+50). Washover lobes with well defined levees marked the highest portion of the barrier while more extensive overwash deposits covered the lower beach farther south (Fig 5a,c). The alignment of the better defined washover channels was northeastward along the long axis of Louisbourg Harbour. The crest material consisted of angular to subangular pebble cobble clasts of 40-100 mm size (Fig. 5b).
