# **LIVING WITH FROZEN GROUND**

**A field guide to permafrost in Yellowknife,  
Northwest Territories**

**Geological Survey of Canada  
Miscellaneous Report 64**

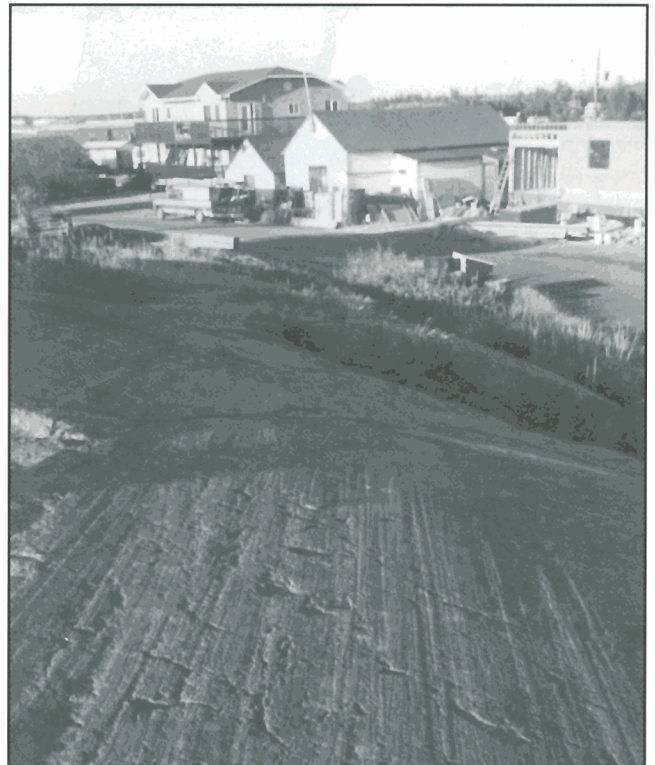
**Figure 6.** *Striations, or scratches on the rock surface, are produced when fragments carried beneath glacial ice scrape the underlying bedrock. These striations indicate that the direction of ice movement in the Yellowknife area was roughly from northeast to southwest. GSC 1998-006 B*

Glacial deposits, although common in the region, are rare in the Yellowknife area. Although *till* deposits occur north of the city near the Giant mine, they are not exposed in the downtown area. Glacial scouring and postglacial erosion resulted in the general absence of till in this area. Excellent examples of the glacial scouring of bedrock are visible throughout the city. *Striations* (Fig. 6), polished surfaces, grooves, and *whalebacks* are seen on many rock surfaces. These features indicate that the general direction of ice movement was from the northeast.

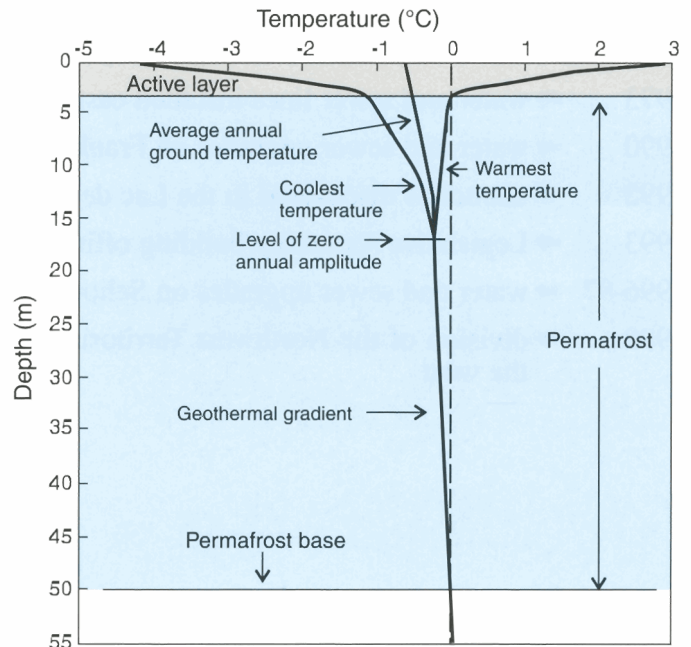
**Figure 14.** An illustration of the range in temperatures at different depths in the ground during the year. The active layer (shown in grey) thaws each summer and freezes each winter, while the permafrost layer below remains below 0°C.

Each year a portion of the ground at the surface rises above 0°C during the summer. This part of the ground, termed the **active layer**, freezes and thaws with the changing seasons. The thickness of both permafrost and the active layer depends on local climatic conditions, vegetation cover, and soil properties. The thickness of permafrost can be altered by changes in the climate or disturbance of the surface. Permafrost cools and thickens if there is a decrease in surface temperature resulting in cooling of the ground below the surface. The active layer increases in thickness and permafrost thins when ground temperatures increase.

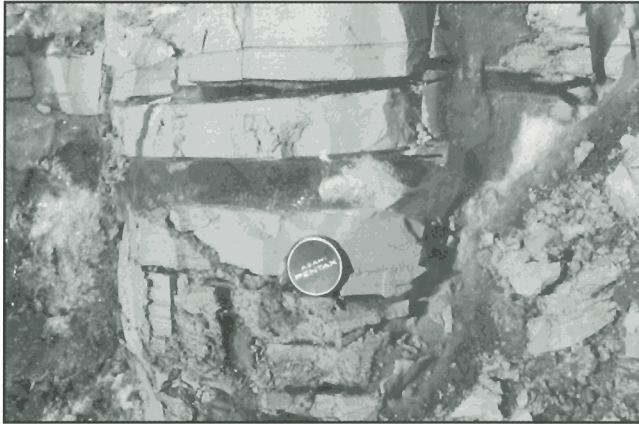
**Figure 18.** Ice lenses formed in silty clay sediments deposited by glacial Lake McConnell. The ice lenses grew in the soil as the sediments froze, creating layers of ice up to 5 cm thick. (Photo by Larry Aspler, October, 1977)

When water freezes it expands in volume by 9%. Therefore, when soil saturated with water freezes, it will expand. Under some circumstances as freezing of soil occurs, water from the unfrozen part of the soil migrates toward the colder part of the soil where it freezes and accumulates to form *ice lenses*. The formation of ice lenses results in further expansion of the soil and uplift of the surface, thus creating *frost heave*. The size of ice lenses is often much greater in fine-grained silt and clay than in coarse-grained sand (Fig. 18). In Yellowknife, ice lenses can reach thicknesses of more than 20 cm, although they are seldom more than a few millimetres thick.

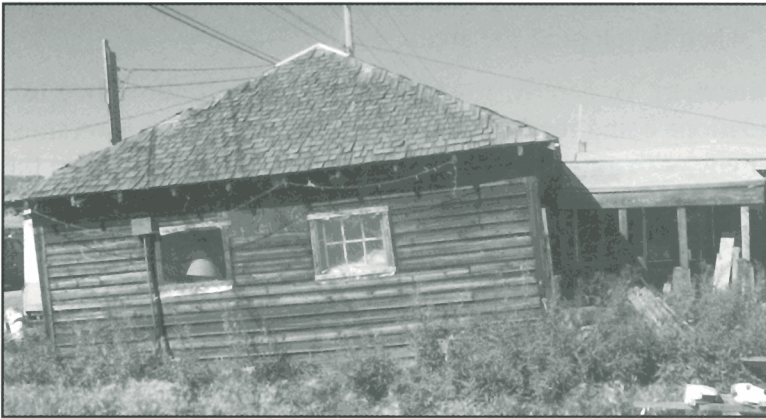
**Figure 21.**

Known locally as *Slant 6*, this building on Bretzlaff Drive is among the earliest of Yellowknife's original buildings. The underlying permafrost has thawed over time resulting in differential settlement beneath the building. GSC 1998-006 F

During early development in the North, little attention was paid to the frozen ground beneath the surface. Even in the 1960s, houses were built using traditional southern-based designs without regard for the possible effects on the underlying permafrost. In cases where the ground was thaw unstable, this resulted in differential settling of buildings (Fig. 21).

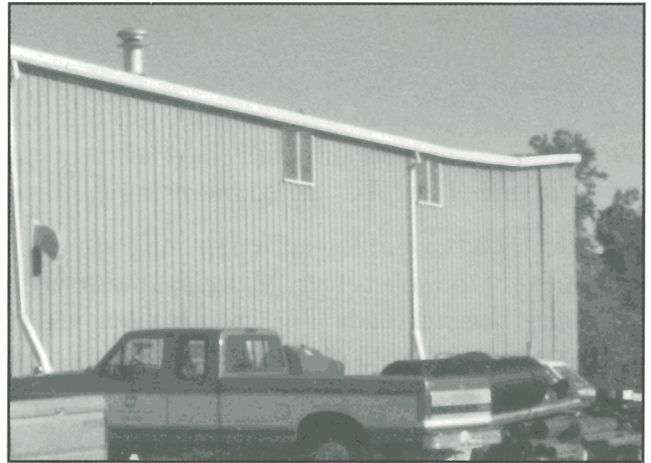
**Figure 24.** Frost jacking has lifted the right-hand corner of this building. GSC 1998-006 H

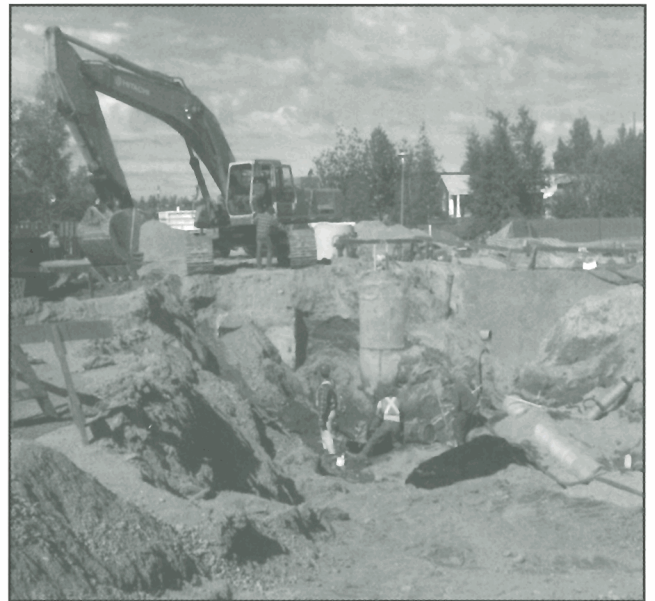
*Figure 27. Underground utilities being replaced in sandy sediments beneath Forrest Drive during water and sewer upgrades in August 1997. GSC 1998-006 J*

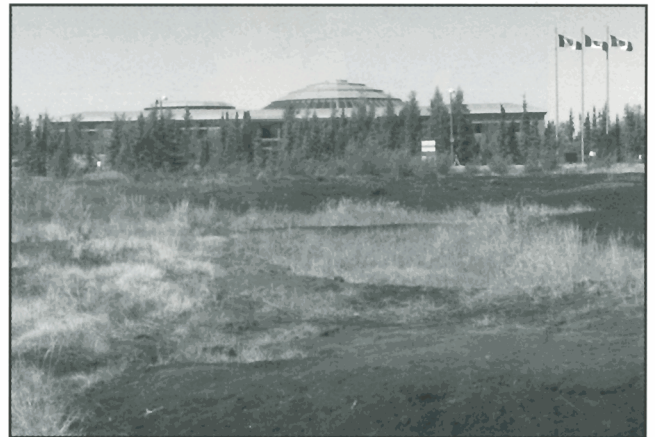
Figure 34. Stop 1 – The large peat plateau in front of the Legislative Assembly is underlain by permafrost. GSC 1998-006 K

In the centre of the road loop is a large peat plateau where the organic material is over 1 m thick (Fig. 34). This peat plateau is about 250 m long and 150 m wide and is ringed by bedrock to the north, west, and south. The peat area is underlain by frozen ground. Beneath the peat is an ice-rich silty clay that is underlain by a sandy silt containing little or no ice. These sediments were deposited by glacial Lake McConnell about 10 000 years ago.

The peat plateau grew as sphagnum moss accumulated in the damp, acidic environment. As the peat layer thickened, it acted as an insulating layer, causing frozen ground to form beneath the surface. As the ground froze, ice lenses grew within the soil and peat causing the entire surface to rise.

In summer, the upper part of the peat thaws only to a depth of about 50 cm. Much of the southwest portion of the plateau was stripped of the upper layer of peat in the early 1950s and now lacks any vegetation cover. The vegetation was stripped in an unsuccessful attempt to create a market garden on the peat. A series of ponds up to 1.5 m deep occur next to the peat plateau, and depressions can be seen as you walk toward the Legislative Assembly (Fig. 35). These depressions and ponds are the result of permafrost degradation, or thermokarst, caused by disturbance of the peat surface. The peat plateau gradually collapses as the ice-rich permafrost beneath it slowly melts.

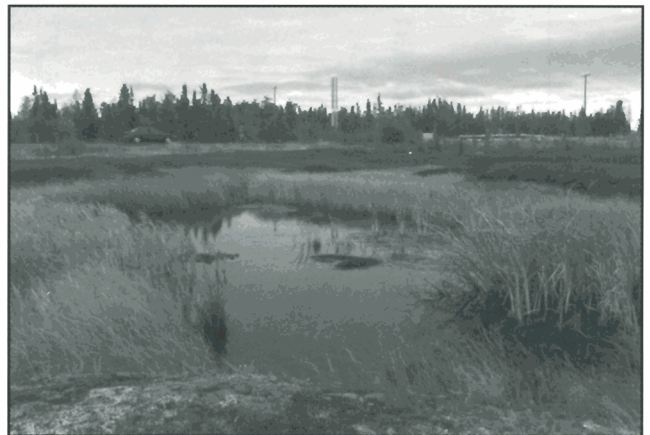
Figure 35. The ponds and depressions next to the peat plateau are the result of permafrost melting and are known as thermokarst. GSC 1998-006 L

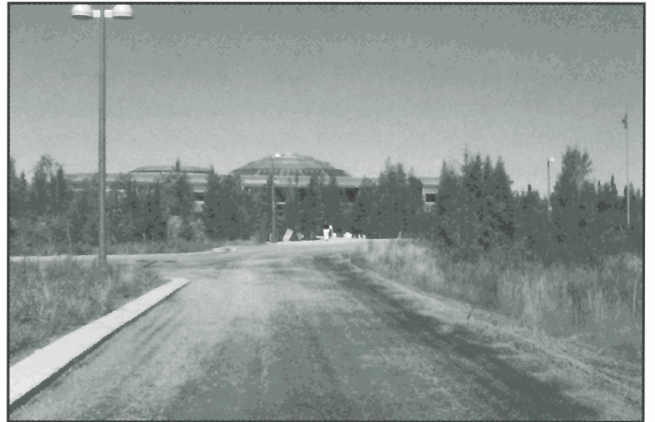
*Figure 36. Stops 2 and 3 – The Legislative Assembly. Permafrost exists beneath the gravel road in front of the Legislative Assembly building. The roadway was paved in 1997, with precautions taken to preserve the permafrost. GSC 1998-006 M*

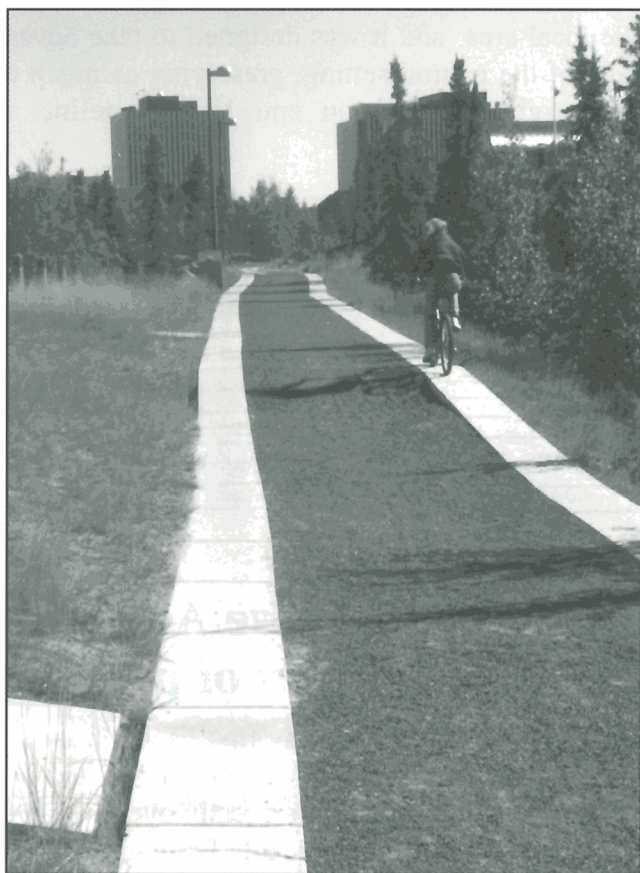
*Figure 37. Stop 4 – Settlement of the walking trail between the Legislative Assembly and Prince of Wales Heritage Centre, caused by thawing of the underlying permafrost. GSC 1998-006 N*

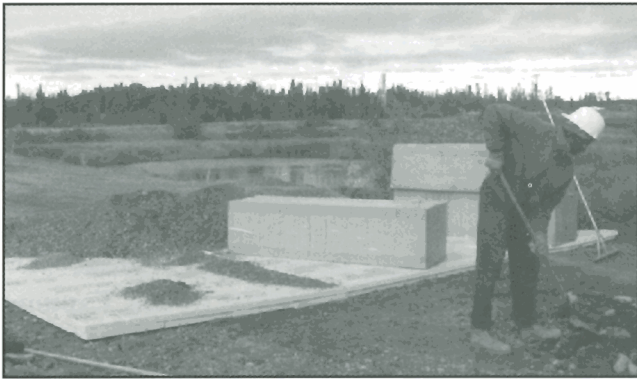
Figure 39. Insulation was placed beneath the road in order to preserve the permafrost. GSC 1998-006 O

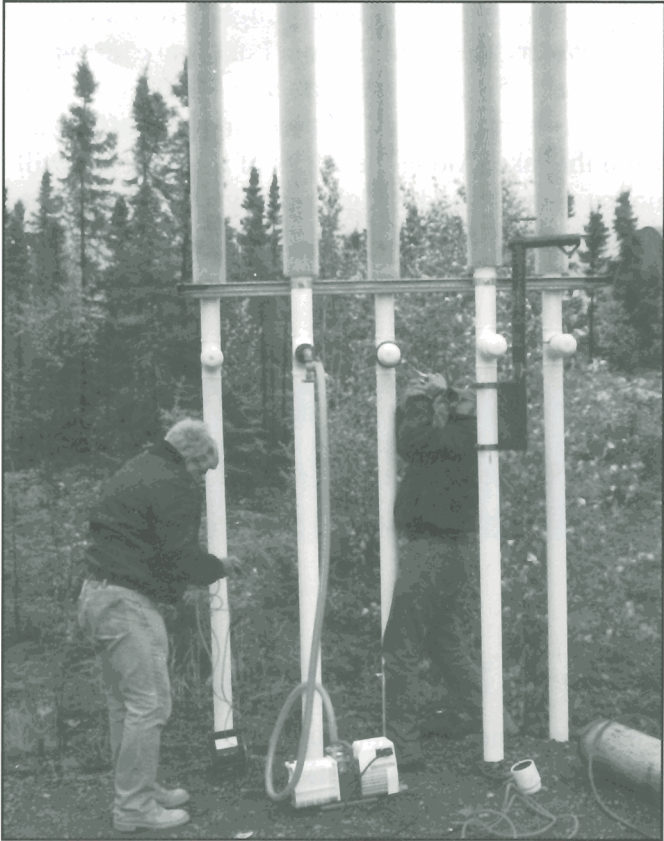
Figure 40. Stop 5 – Thermosyphons at the Legislative Assembly parking lot being charged with carbon dioxide (CO<sub>2</sub>) gas. GSC 1998-006 P

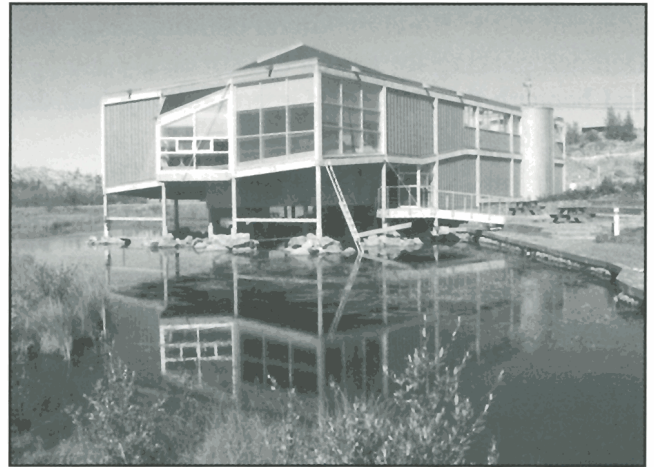
**Figure 43.** Stop 8 – Part of the Visitors Centre rests on piles. GSC 1998-006 S

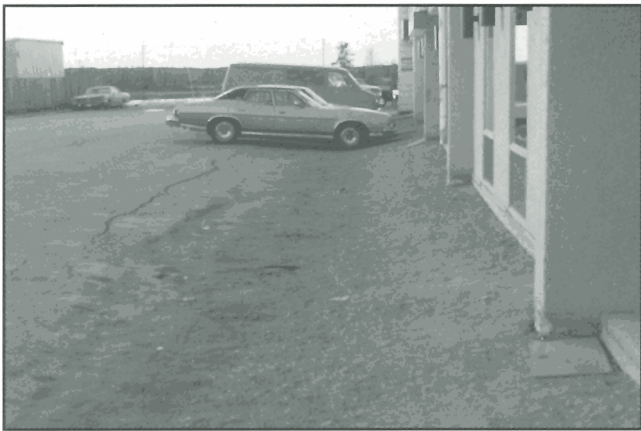
**Figure 44.** Settlement beside the Bowling Green building on 49 Street. (Photo by Larry Aspler, October 1977)

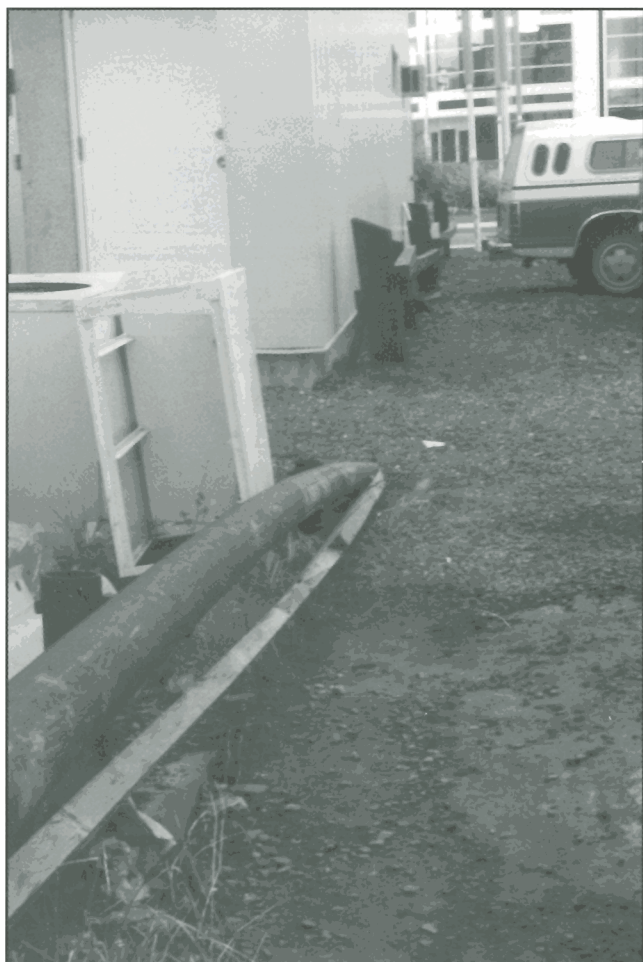
**Figure 47.** Stop 10 – Steel railing beside the northern corner of the Bowling Green building. The railing has been “swallowed” by the ground as the soil around the building has settled. A black wooden railing was put up beside the building after the steel railing had sunk into the ground. The wooden railing is now leaning towards the building because of the shifting soils. GSC 1998-006 U

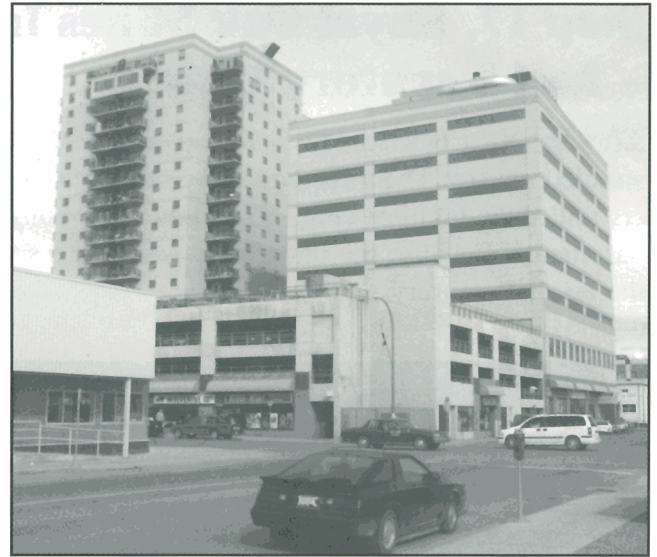
*Figure 54. Stop 15 – The Centre Square Mall, built on reinforced piles secured to bedrock. GSC 1998-006 X*

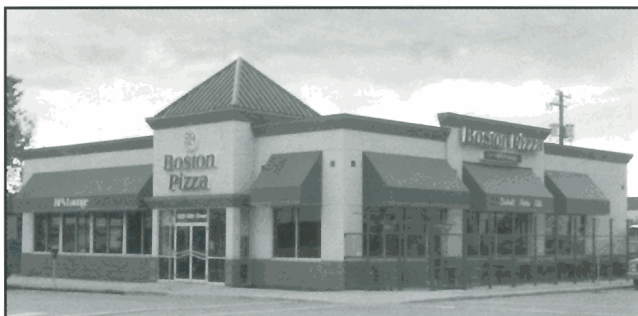
*Figure 55.*

*Stop 16 – The Boston Pizza building on the corner of 48 Street and 51 Avenue. Although the building is similar in appearance to southern-style buildings, the edges of the foundation are thickened and insulation has been placed below the ground around the building to prevent possible damage due to frost heaving. GSC 1998-006 Y*

There are many examples of different construction styles in Yellowknife. Some are similar to those used in the south, but with a northern touch. The Boston Pizza and the former Taco Time buildings are examples of these (Fig. 55). They are thickened perimeter slab-on-grade buildings. In simpler terms, they have a concrete slab foundation that is reinforced around the edges. To cope with northern conditions, flat-lying rigid insulation is laid down around the edge of the building beneath the ground. This prevents seasonal frost from freezing around the building and lifting or damaging the foundation. This method is also used in southern Canada where the risk of seasonal frost heaving around buildings might be a problem.

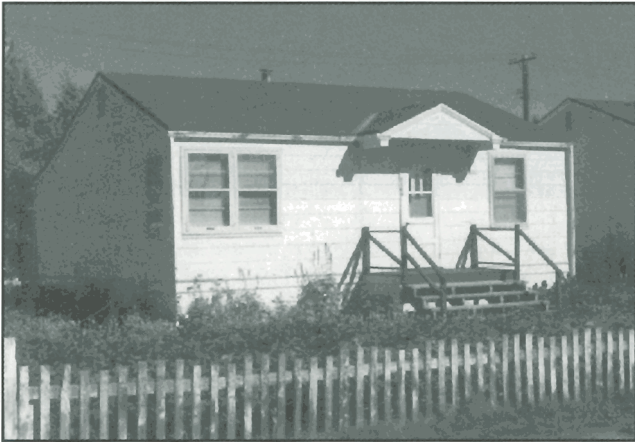
*Figure 56. Stop 17 – House built in the late 1940s to accommodate workers at the Giant mine. GSC 1998-006 Z*

After the New Town area was surveyed in 1945, Royal Oak Mines Inc. bought a block of land and constructed houses. The three houses across from the liquor store were built in the late 1940s to house miners and their families (Fig. 56). They were constructed using standard southern designs and included basements. Because the underlying soils were sandy and stable, they have fared surprisingly well over the last half century.

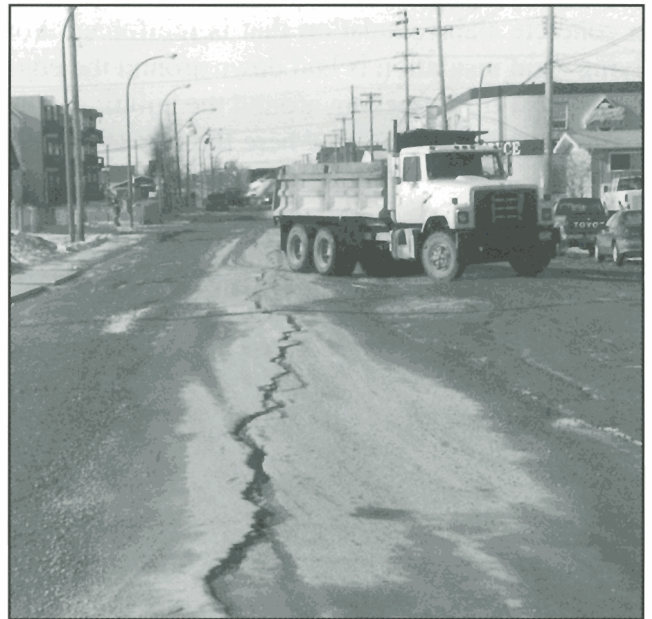
*Figure 57. Frost heaving of silty soils beneath 52 Avenue caused the road to crack and bulge. GSC 1998-006 AA*

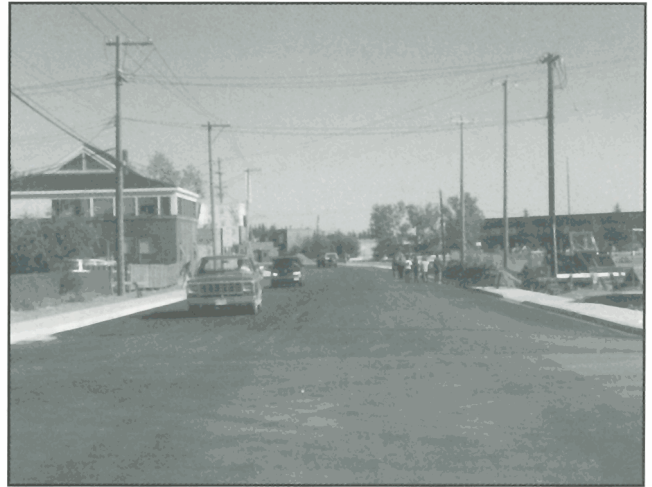
**Figure 58.** Stop 18 – The corner of 49 Street and 52 Avenue. The problem soils beneath 52 Avenue were removed and the road was repaved in the summer of 1997. How does it look now? GSC 1998-006 BB

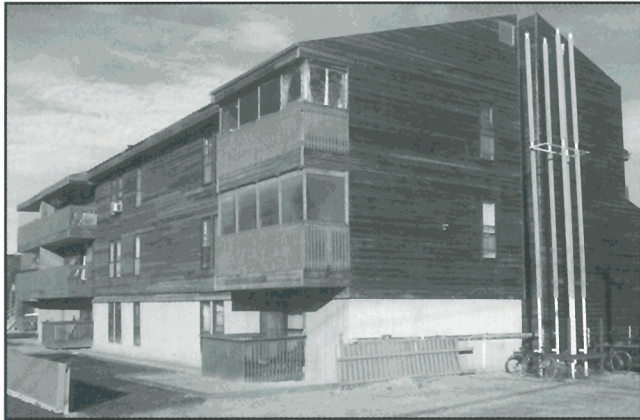
**Figure 59.** Stop 21 – Rockcliffe Apartments and thermosyphons used to stabilize the thawing of permafrost beneath the building. GSC 1998-006 CC

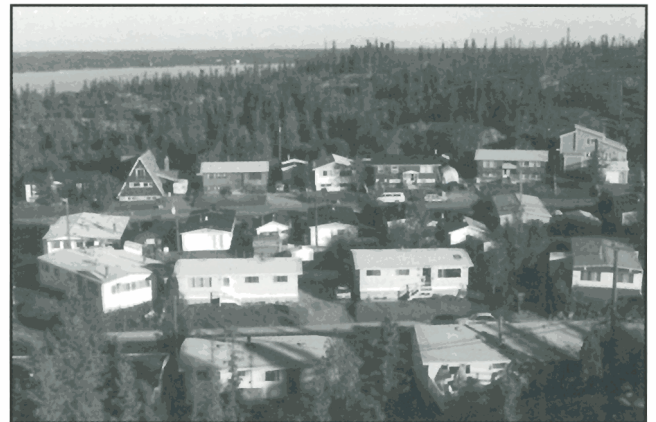
**Figure 61.** Stop 22 – School Draw subdivision. Because of settling caused by the thawing of permafrost, most of the houses in School Draw had to be removed from their foundations and the foundations rebuilt using piles anchored to bedrock. GSC 1998-006 DD

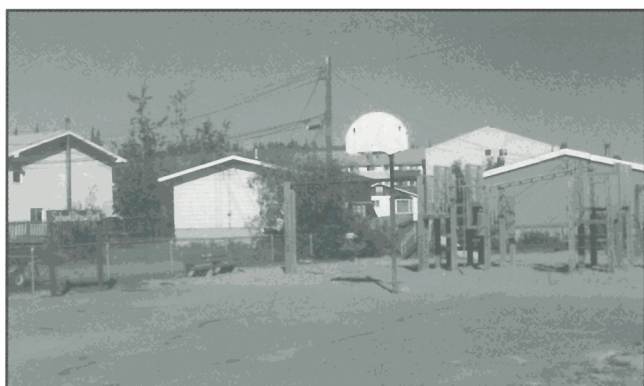
*Figure 62. Stop 23 – School Draw Park is located on the site of a former home. The house was built on unstable ground and was moved across the street (on School Draw Avenue). GSC 1998-006 EE*

School Draw Park is on unstable ground (Fig. 62). Prior to establishment of the park, a house was situated on this lot. Like many other homes, it had a standard concrete footing foundation and basement. Because of thaw settlement of the underlying soil, the house was moved across the street to number 4503. It now sits on a concrete foundation directly on bedrock and again has a basement. The original foundation was removed, the hole filled in, and an asphalt basketball court built in its place.

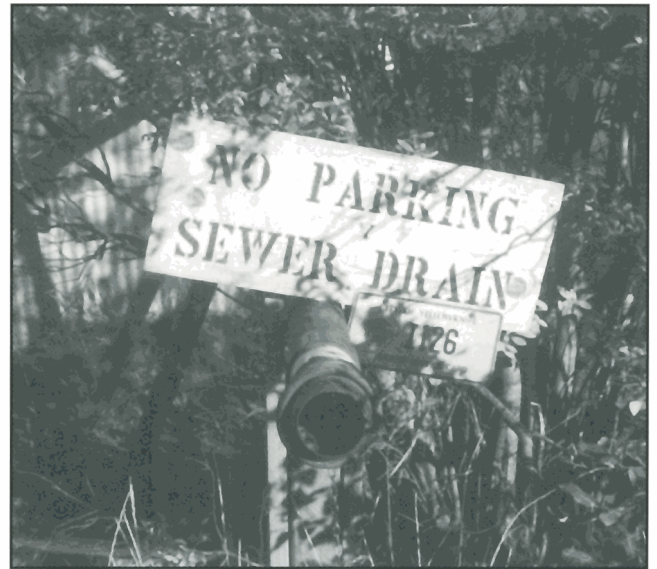
**Figure 66.** Residents of the Old Town area have sewage trucked out because of the difficulty of placing sewer lines in the rocky terrain. Water is piped into homes in the summer, and trucked in in the winter. GSC 1998-006 HH

Until the late 1940s Yellowknife existed entirely on the flat land and rocky peninsula extending into Yellowknife Bay, in the area referred to today as Old Town. At that time, outhouses were used and water supplies were hand-carried from the bay. Today, even though above-ground water and sewer utilities are used in the Old Town area in the summer, water and sewage are trucked in and out in the winter to prevent pipes from freezing (Fig. 66).

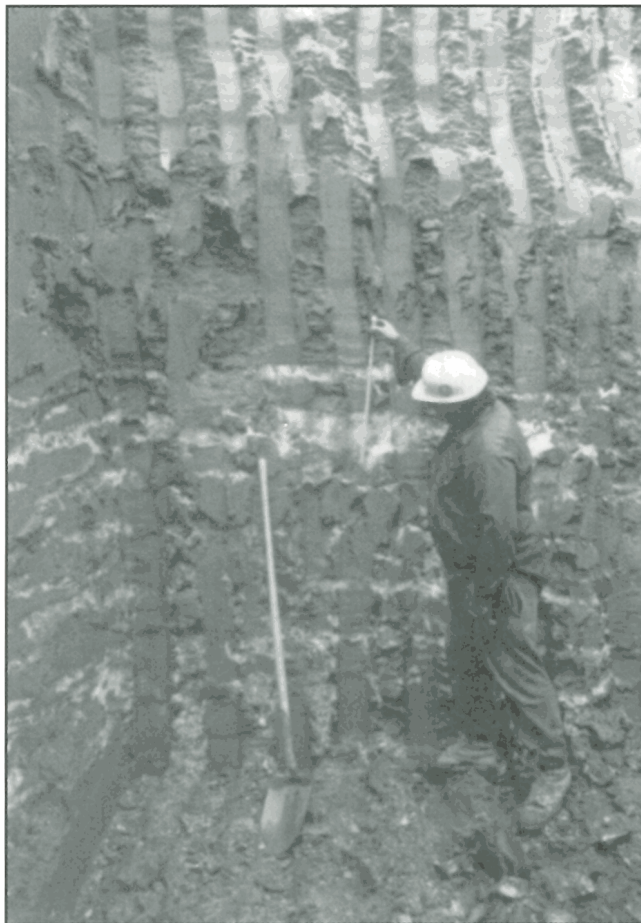
Near the base of the hill on Franklin Avenue, ice lenses were found in the clayey sediments. In an attempt to remove this ice-rich material, the ground was excavated to a depth of almost 5 m below the ground surface. The amount of ice lensing, however, increased with depth and some ice lenses were more than 20 cm thick (Fig. 68). During installation of the new water and sewer system, it was found that this ice-rich permafrost extended under much of Franklin Avenue on the west side of the road

To overcome the problems with the sensitive ice-rich permafrost, insulation was placed below the water and sewer lines to minimize thawing beneath the pipes. To do this, a trench was excavated to the top of the frozen ground and insulation was placed on top of the permafrost. Since 1990, settlement has occurred beneath the west side of the road, and the surface has been filled several times (Fig. 69).

Surveys of the road and sewer system in 1990 found a discrepancy of as much as 2 m between the original designs and existing conditions. During installation of the new water and sewer system, it was found that substantial thaw settlement had occurred on the east side of the road due to thawing of the permafrost up to 6 m away from the original uninsulated pipes. At least two older asphalt surfaces were

found beneath the existing road surface, indicating that as the road settled, it had been filled in several times. On the west side of the road, however, permafrost still existed. Because the existing pipes were on the east side, the new pipes were placed on the west side, on top of the permafrost and outside of the original thawed area.

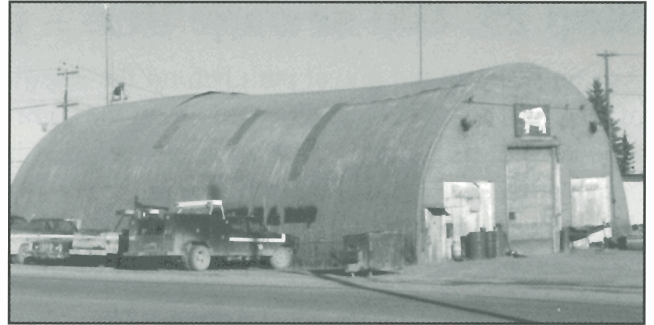
**Figure 70.** The Two-Way Enterprises building across from Fritz-Theil Park has undergone differential settlement due to thawing of permafrost. GSC 1998-006 JJ

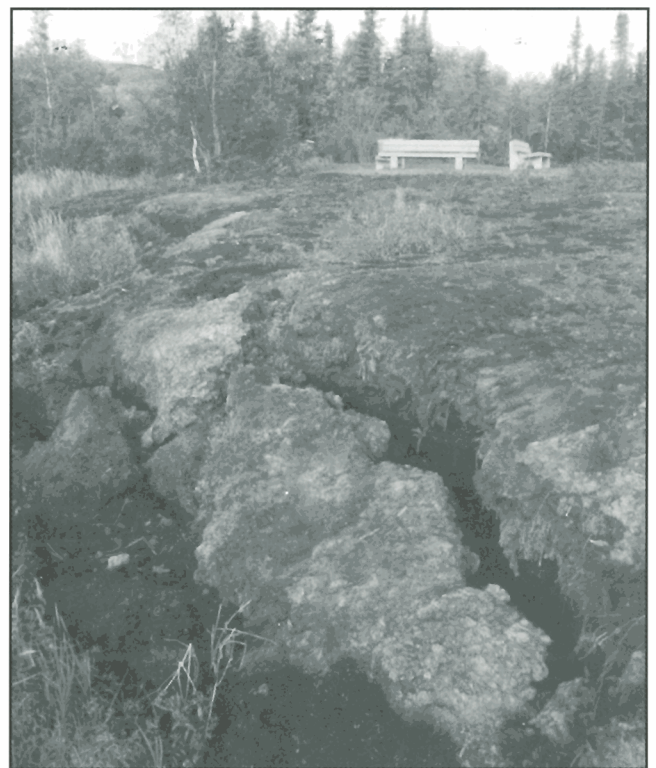
*Figure 77. The peat plateau is underlain by permafrost. The edges of the peat are slowly degrading to form thermokarst. GSC 1998-006 PP*

You are standing on a large peat plateau. This flat expanse of peat rises more than 1 m above the lake (Fig. 77). Several metres below you are pollen and other well preserved bits of plants that lived here thousands of years ago. Beneath the surface are large, ancient lenses of ice that do not melt even during the hottest days of summer thanks to the insulating effect of so much peat – remnants of the last ice age perhaps!<sup>1</sup>

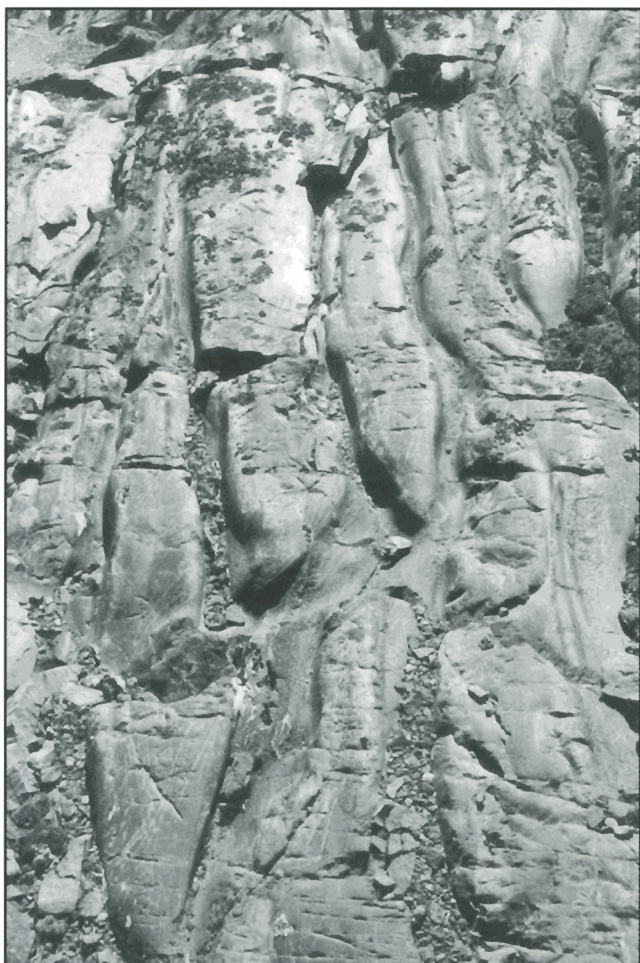
**Figure 78.** Looking as though they have just cooled, these volcanic rocks are more than two billion years old. They have been grooved and polished by glaciers, giving them a fresh appearance. GSC 1998-006 QQ

These volcanic rocks, on which much of Yellowknife is built, testify to the earliest eruptions of lava that once engulfed this land. Now only slivers or “belts” of volcanic rock remain, testimony to the awesome power of billions of years of erosion (Fig. 78).
