# LANDSLIDE DISASTERS IN CANADA 1840-1998

Prepared for Emergency Preparedness Canada  
by Stephen G. Evans, Geological Survey of Canada, 601 Booth St., Ottawa, K1A 0E8

OPEN FILE  
DOSSIER PUBLIC  
3712  
GEOLOGICAL SURVEY OF CANADA  
COMMISSION GEOLOGIQUE DU CANADA  
OTTAWA  
09/1999

Evans, S.G.  
1999: Landslide disaster in Canada 1840-1998.  
Geological Survey of Canada  
Open Files 3712 (Map with text).

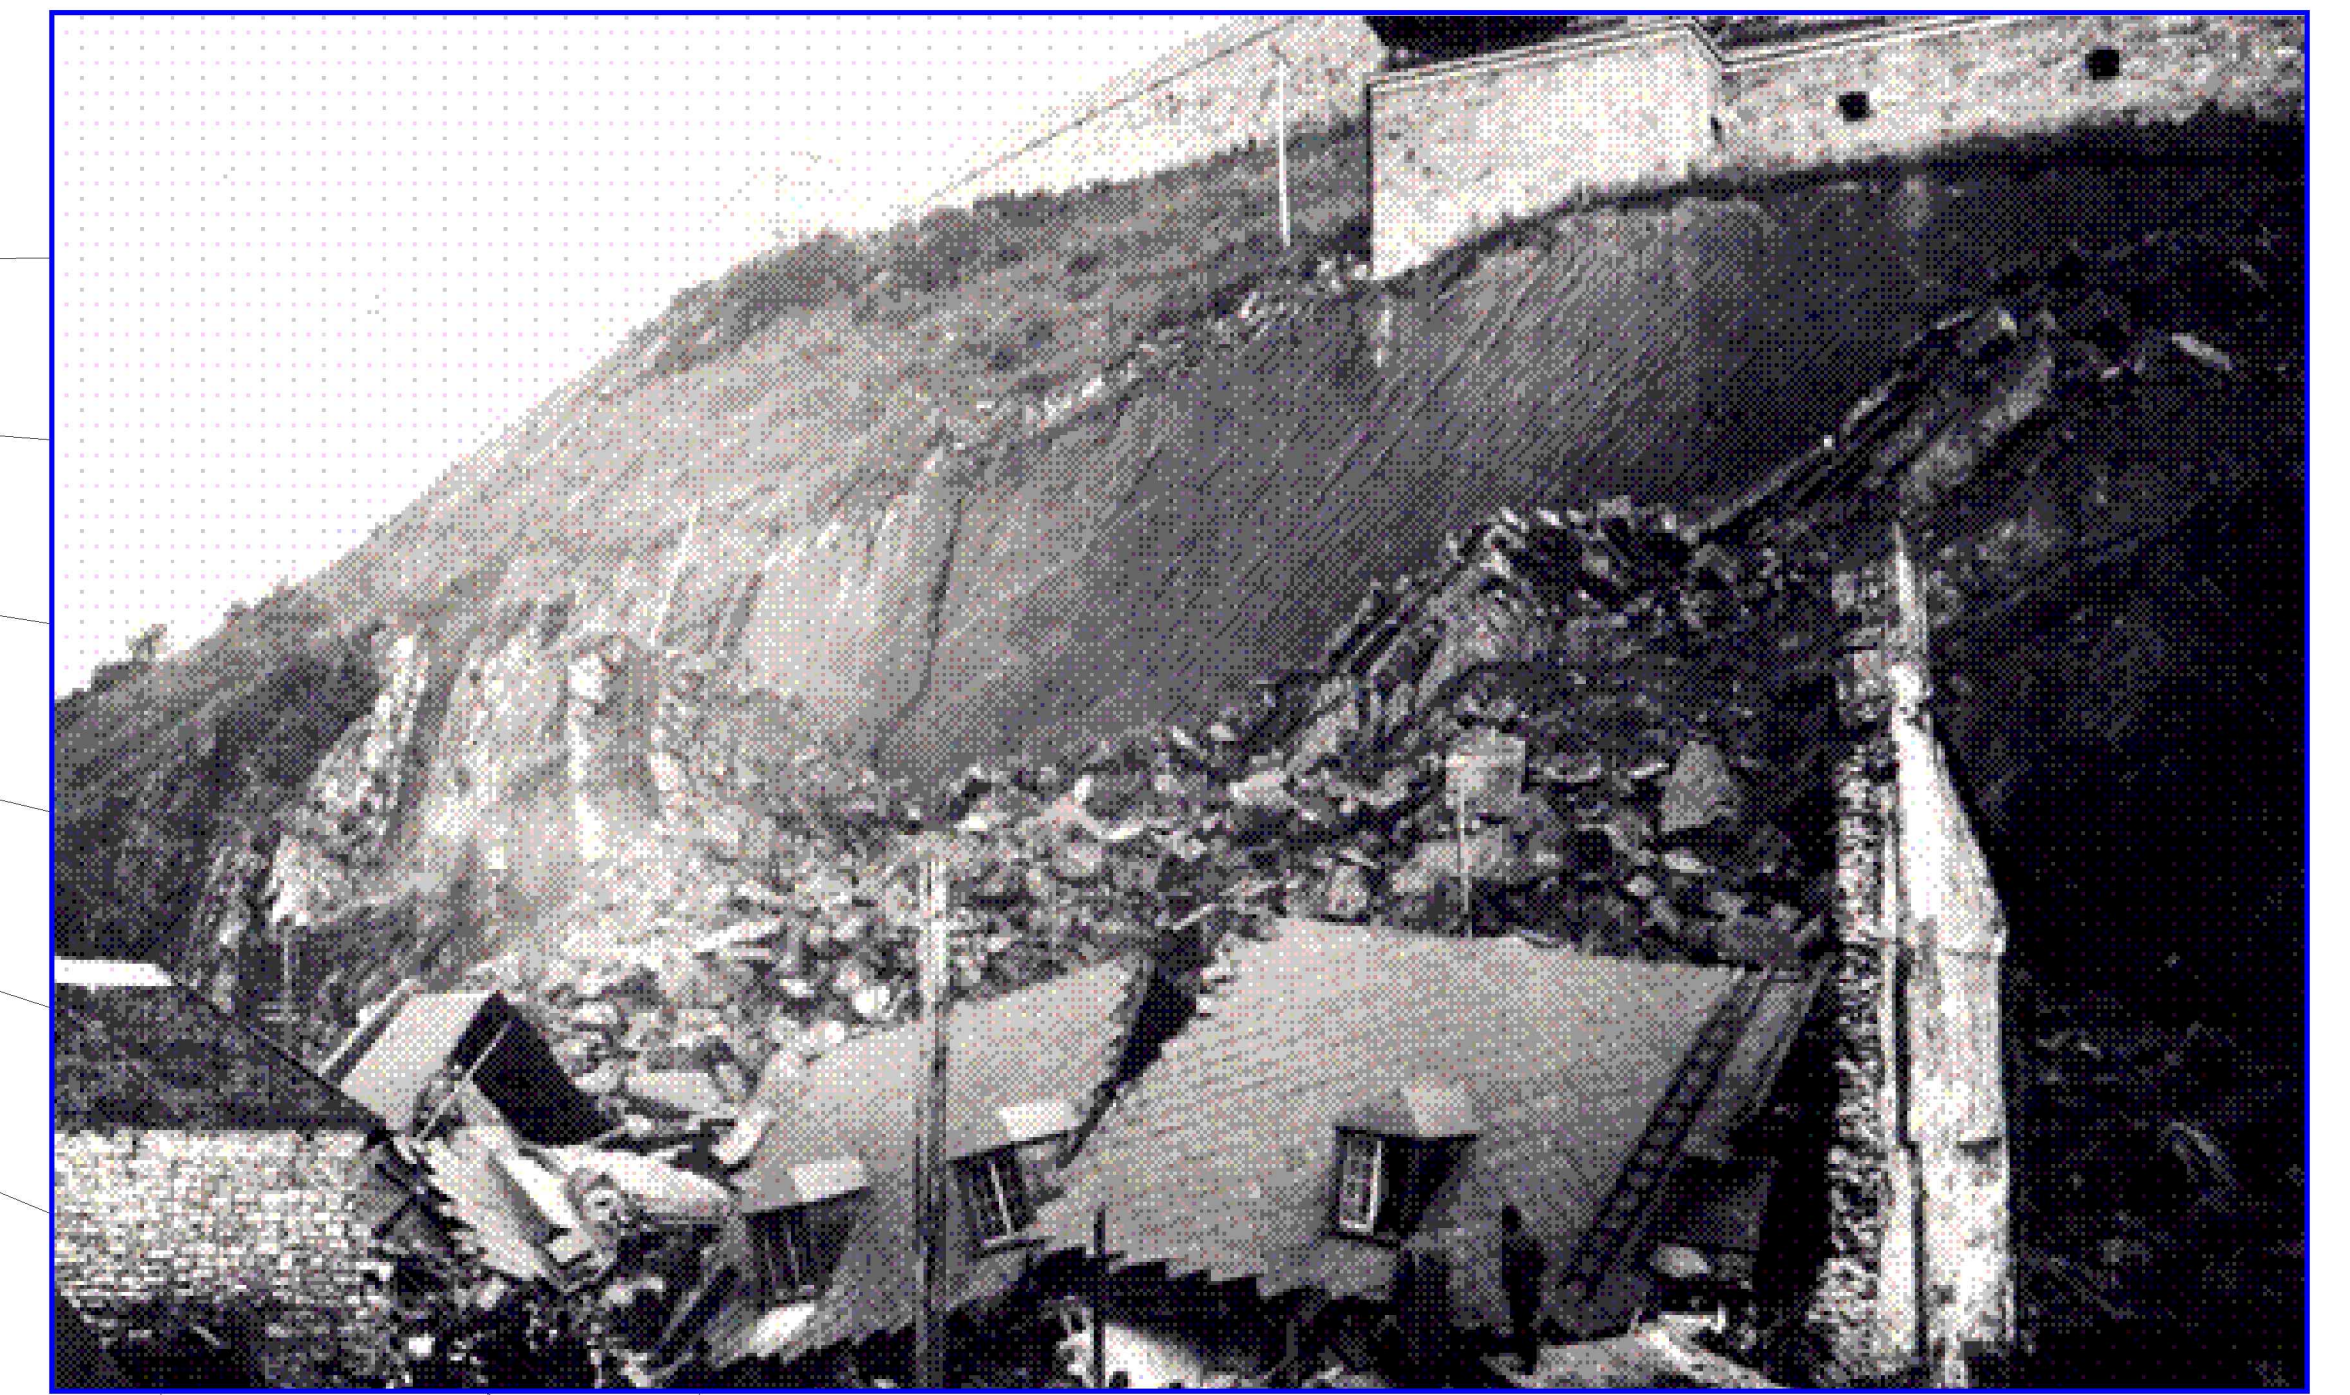
Houses destroyed by rockslide on Champlain Street, Quebec City, in September 1899. 50 people were killed in this landslide disaster (Disaster 5 in listing) which in eastern Canada's worst. The rockslide resulted from the failure of the slope behind the houses, just below the walls of the Citadel. Public Archives of Canada photograph.

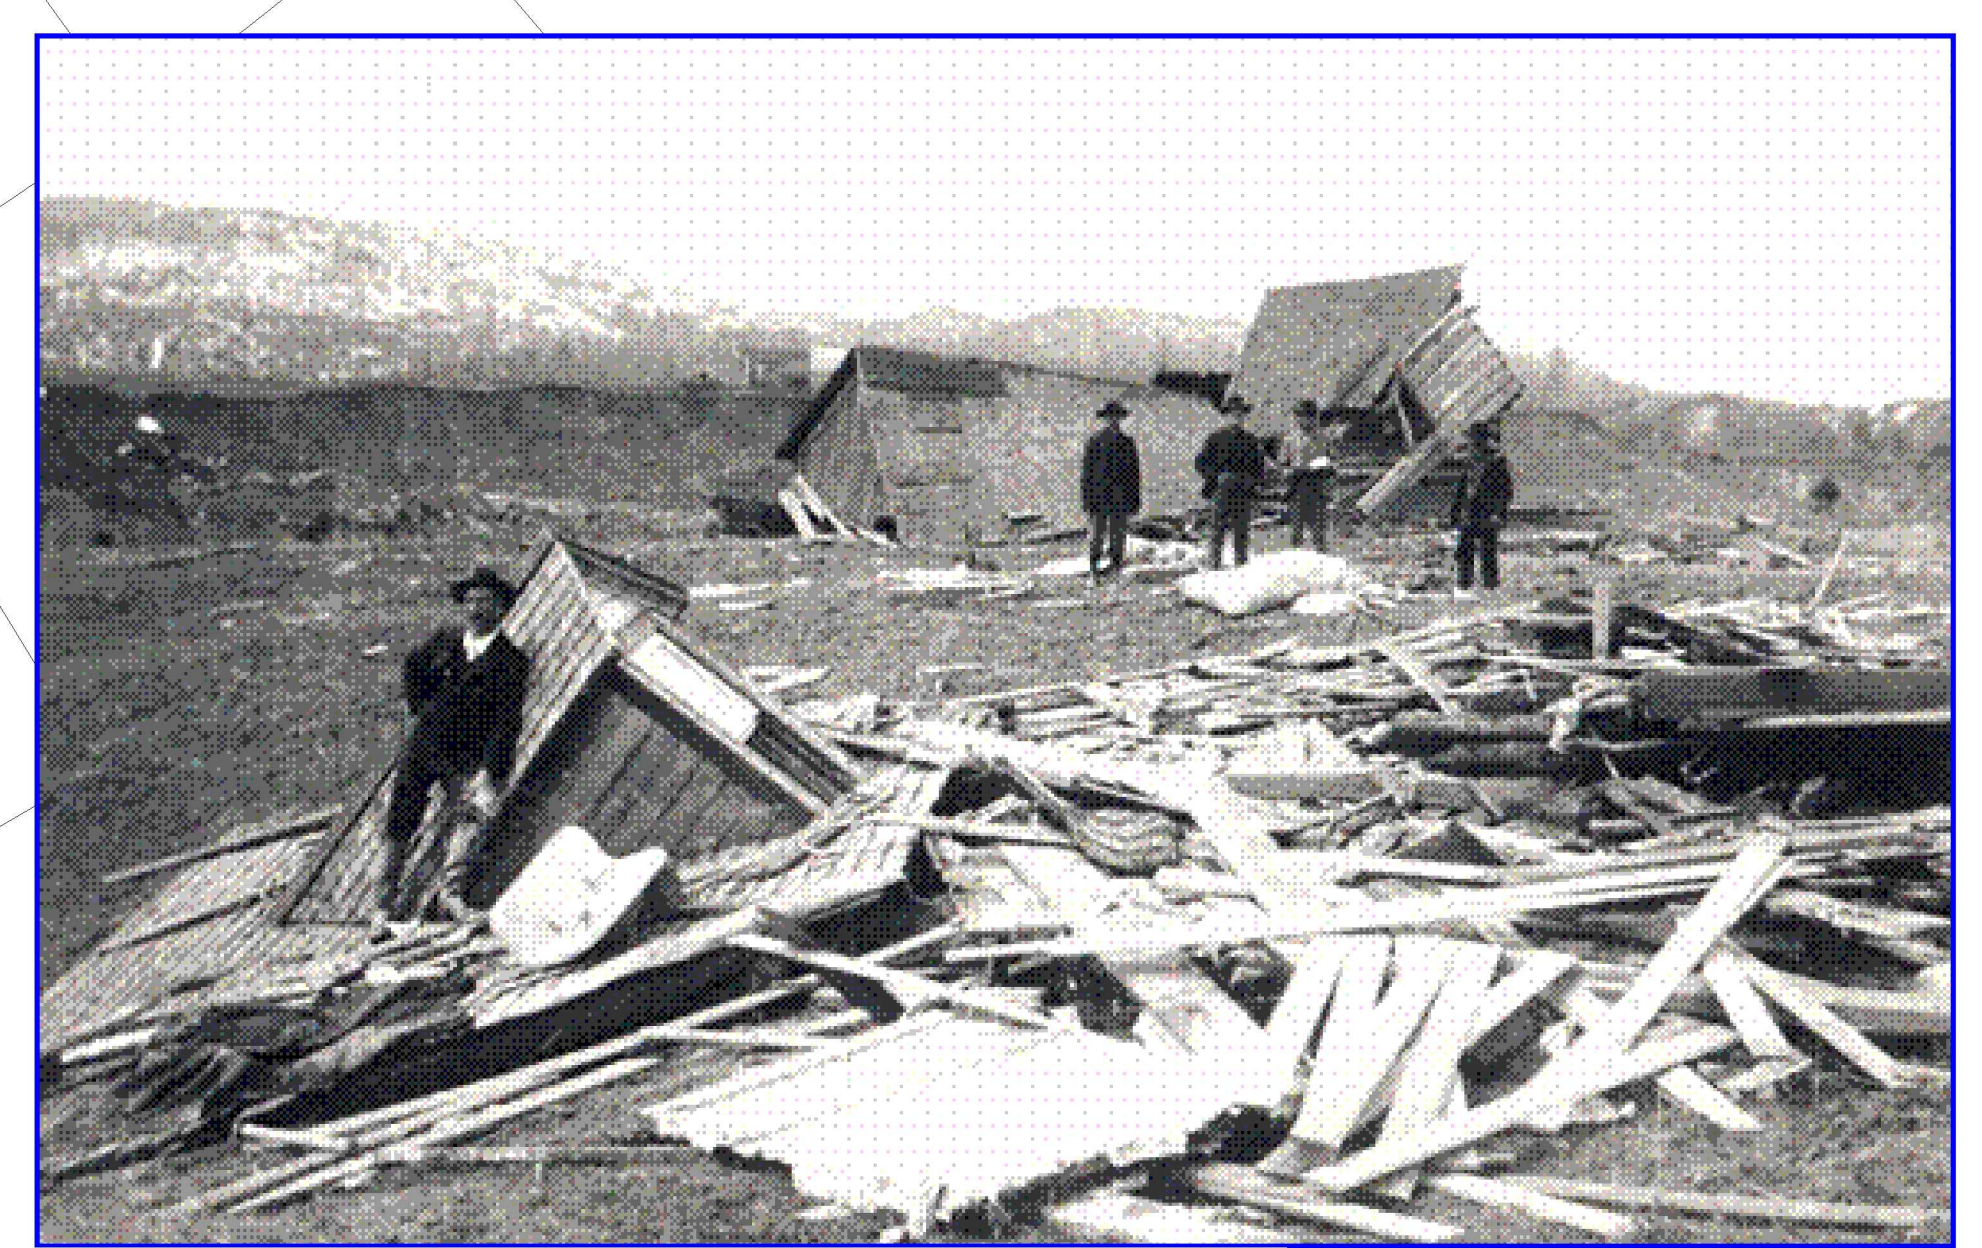
View of buildings destroyed in the village of Notre-Dame-de-la-Salette, Quebec by a wave generated by the 1908 landslide. The landslide in Leda Clay occurred on the right bank of the Lièvre River generating a wave which swept over the village on the left bank of the river, destroying 32 wooden buildings. 30 people were killed in the disaster (Disaster 15 in listing). Photograph courtesy of the Archives nationales du Québec.
