**OPEN FILE # 4426**

**Hudson 2002-011 cruise report  
Flemish Cap Margin Transect**

# FLAME 2002

### HUDSON 2002-011

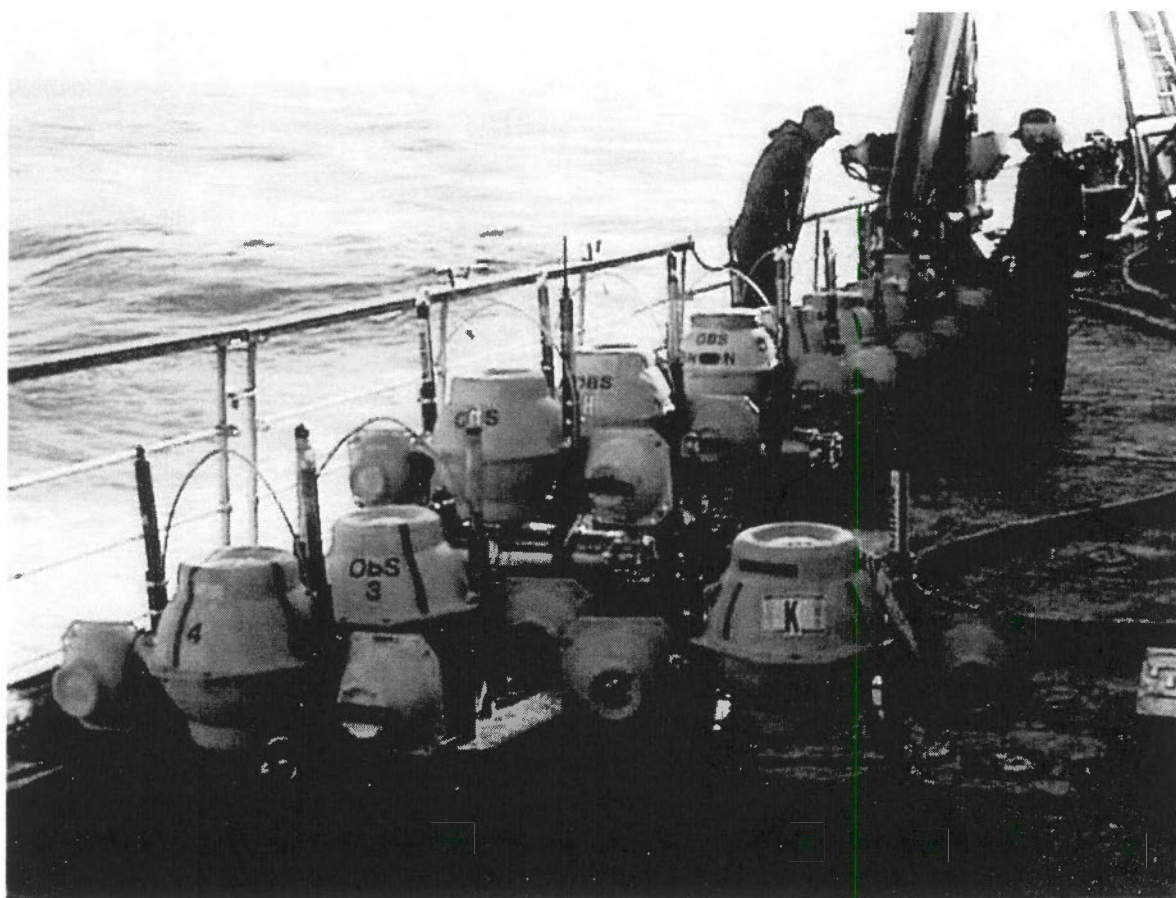
Figure 3. Bob and Walter preparing OBS for deployment on the starboard waist.
