HISTORICAL LANDSLIDE EVENTS ALONG THE SEA TO SKY CORRIDOR

Blais-Stevens, A. 2007. Historical landslide events along the Sea to Sky corridor, Geological Survey of Canada, Open File 5678.

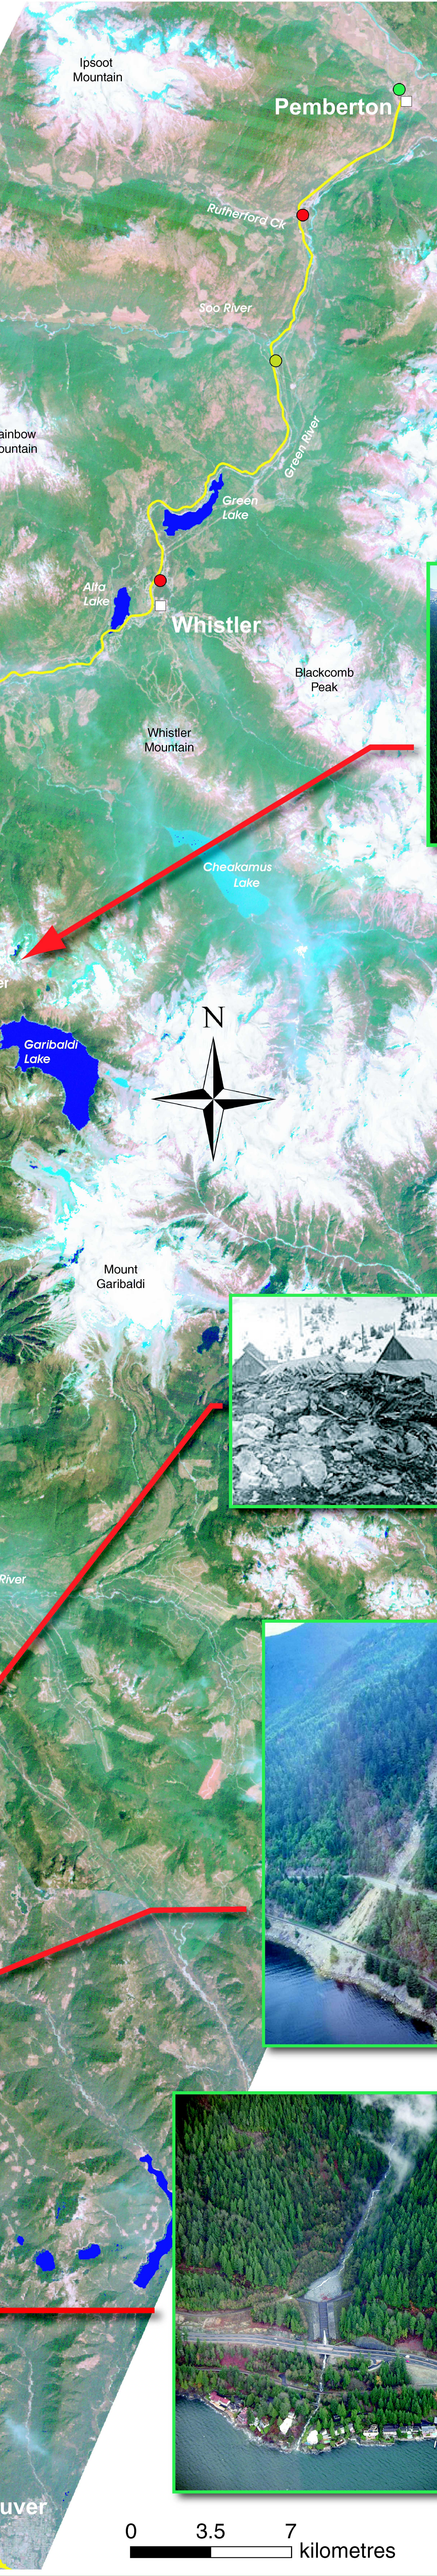
Landslide Type & Number of Events

- 1 ● Debris flow
 - 2 ●
 - 3 ●
 - 4 ●
 - 5-7 ●
-
- 1 ● Rock fall
 - 2 ●
 - 3 ●
 - 4 ●
 - 5-7 ●
-
- 1 ● Rock slide
 - 2 ●
-
- 1 ● Submarine failure
 - 1 ● Rock avalanche
 - 1 ● Debris slide

The Sea to Sky Highway (Hwy. 99) stretches 110 km through the southern Coast Mountains of British Columbia from Horseshoe Bay to Pemberton. Over 18% of Canada's total landslide-related deaths (>600) have occurred along the Sea to Sky corridor. In the last 100 years, we counted 154 landslide events reported in newspapers, technical and scientific reports (Blais-Stevens and Septer, 2006). The two main triggers, when reported, were effects of climate (54%) and construction activities (6%). The most abundant types of landslides were rock falls (44%) and debris flows (28%) based on the classification of Cruden and Varnes (1996). These were considered relatively small in volume, but were the most damaging. The highest concentration of landslide events was located in the southern part of the corridor between Horseshoe Bay and Porteau. The 1980's and 1990's saw an increase in reported events due to an increase in development, greater population, and greater awareness of landslide risk. Evolving mitigative measures undertaken since the 1970's (e.g., catchment basins along Howe Sound) have increased the safety of the population with no reported casualties since the early 1990's.

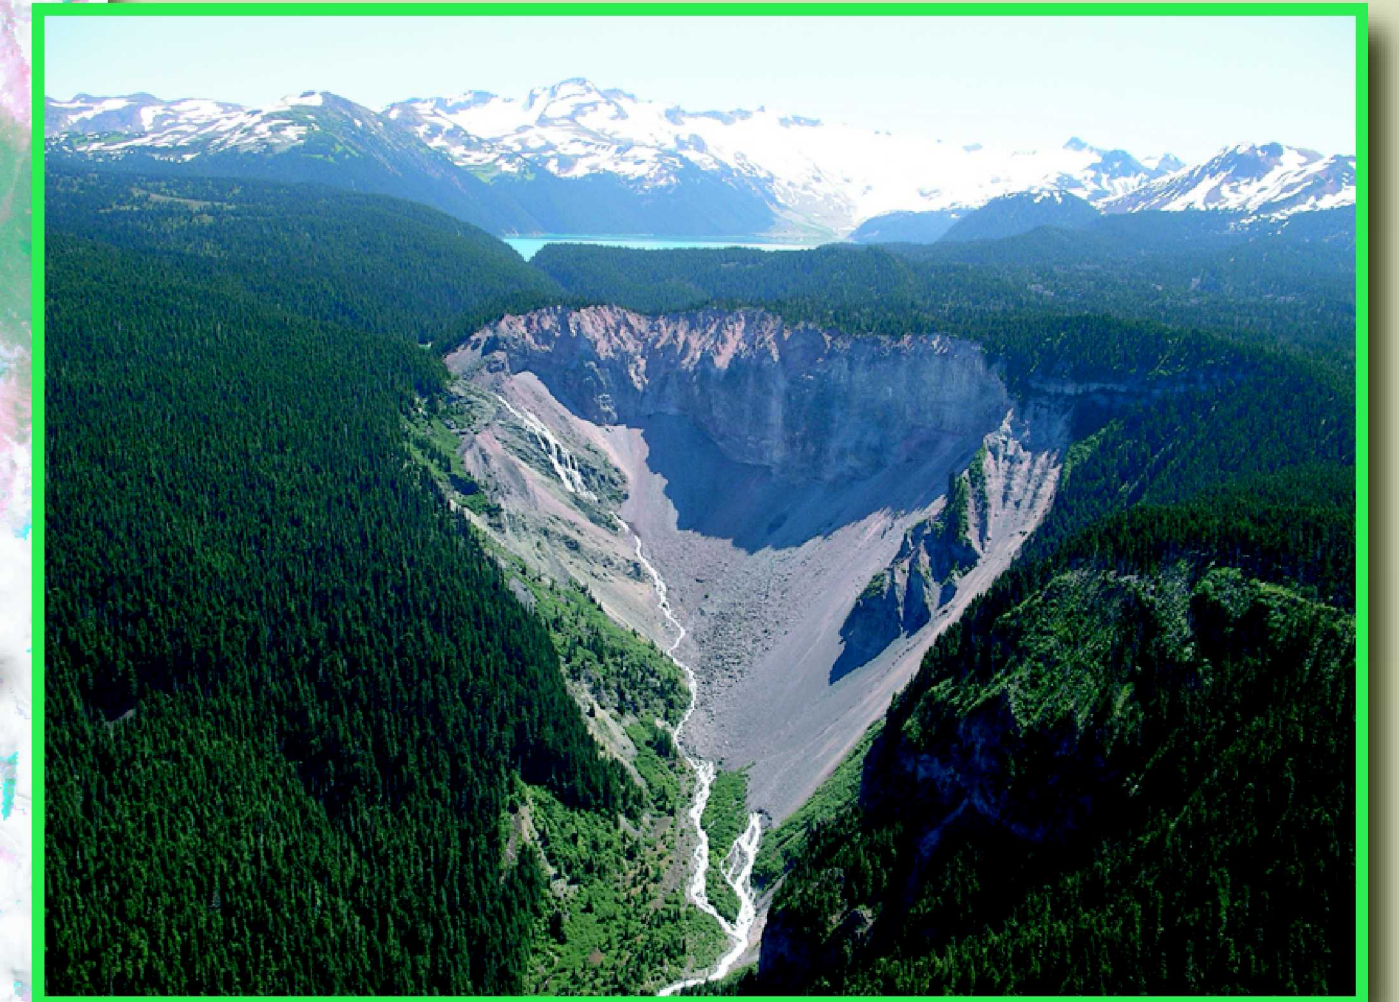
The landslide at the Barrier was the first documented historical landslide event ca. 1855-1856. Photograph by O. Hungr showing the head scarp of a rockslide. Down slope, the rockslide evolved into a debris flow (Rubble Creek).

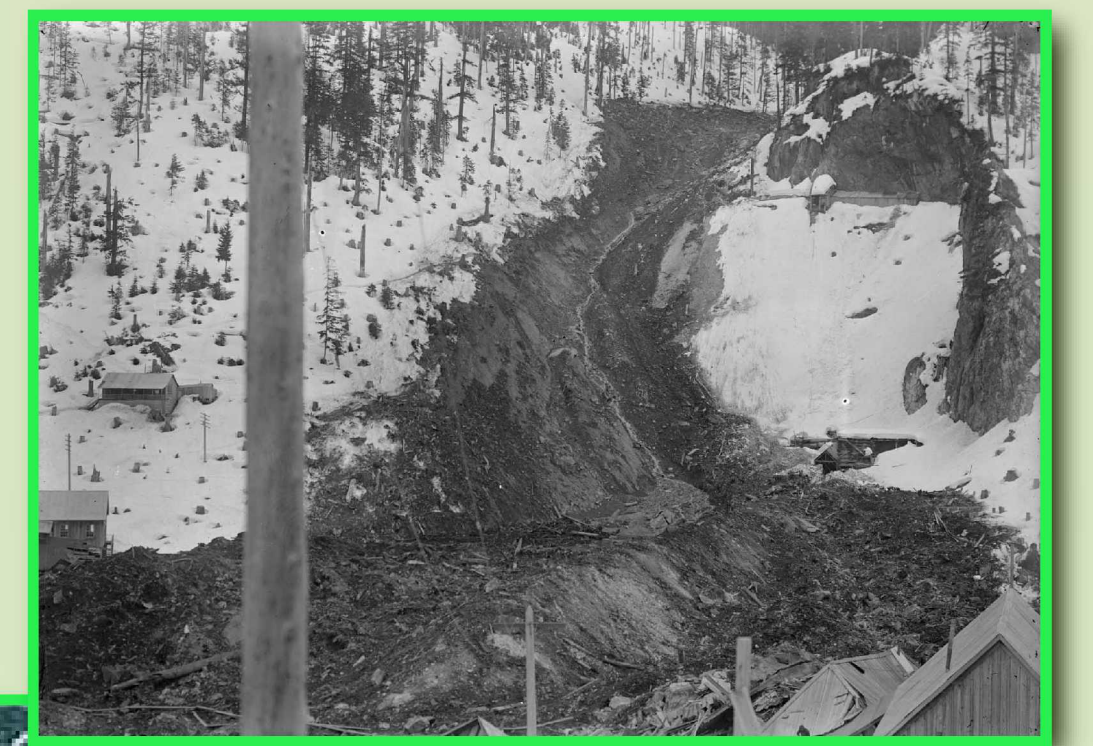
Britannia Mines' Jane Camp, March 1915. Canada's 2nd worst landslide disaster, which caused 54 casualties. Photographs of the rock avalanche provided by the GSC library and Vancouver Public library.

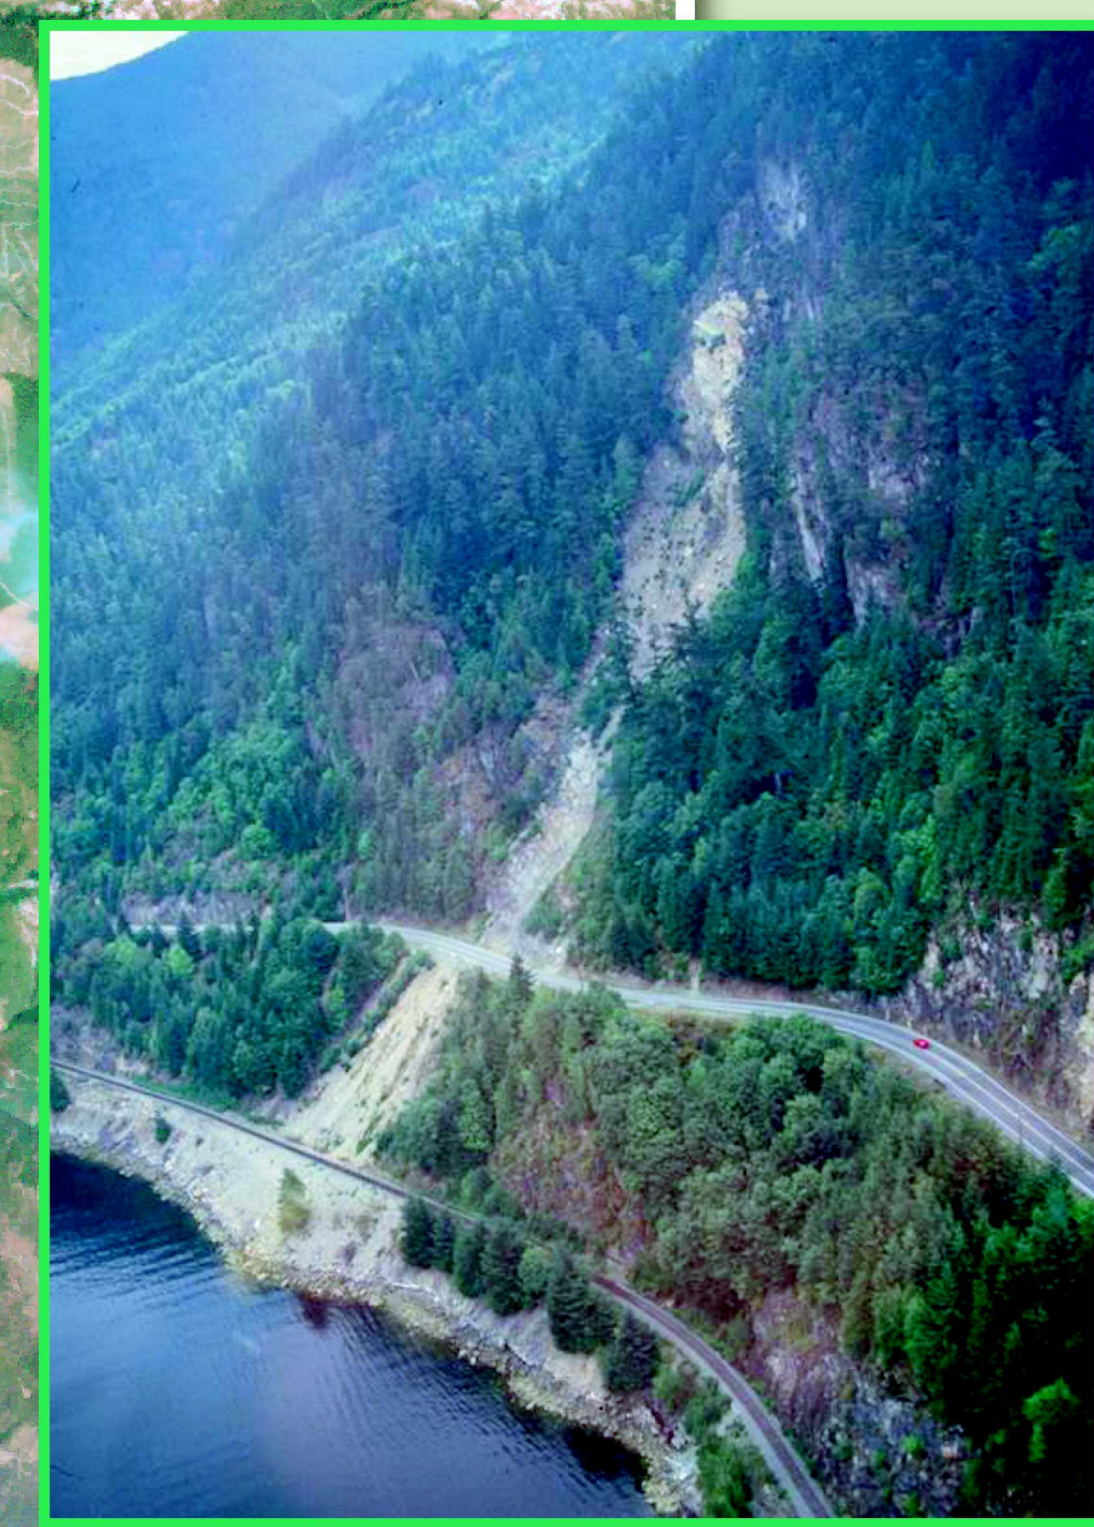
Mitigation measures at work. Catchment basin built to stop debris flow deposits at Charles Creek. Photograph taken by O. Hungr, November 2006.

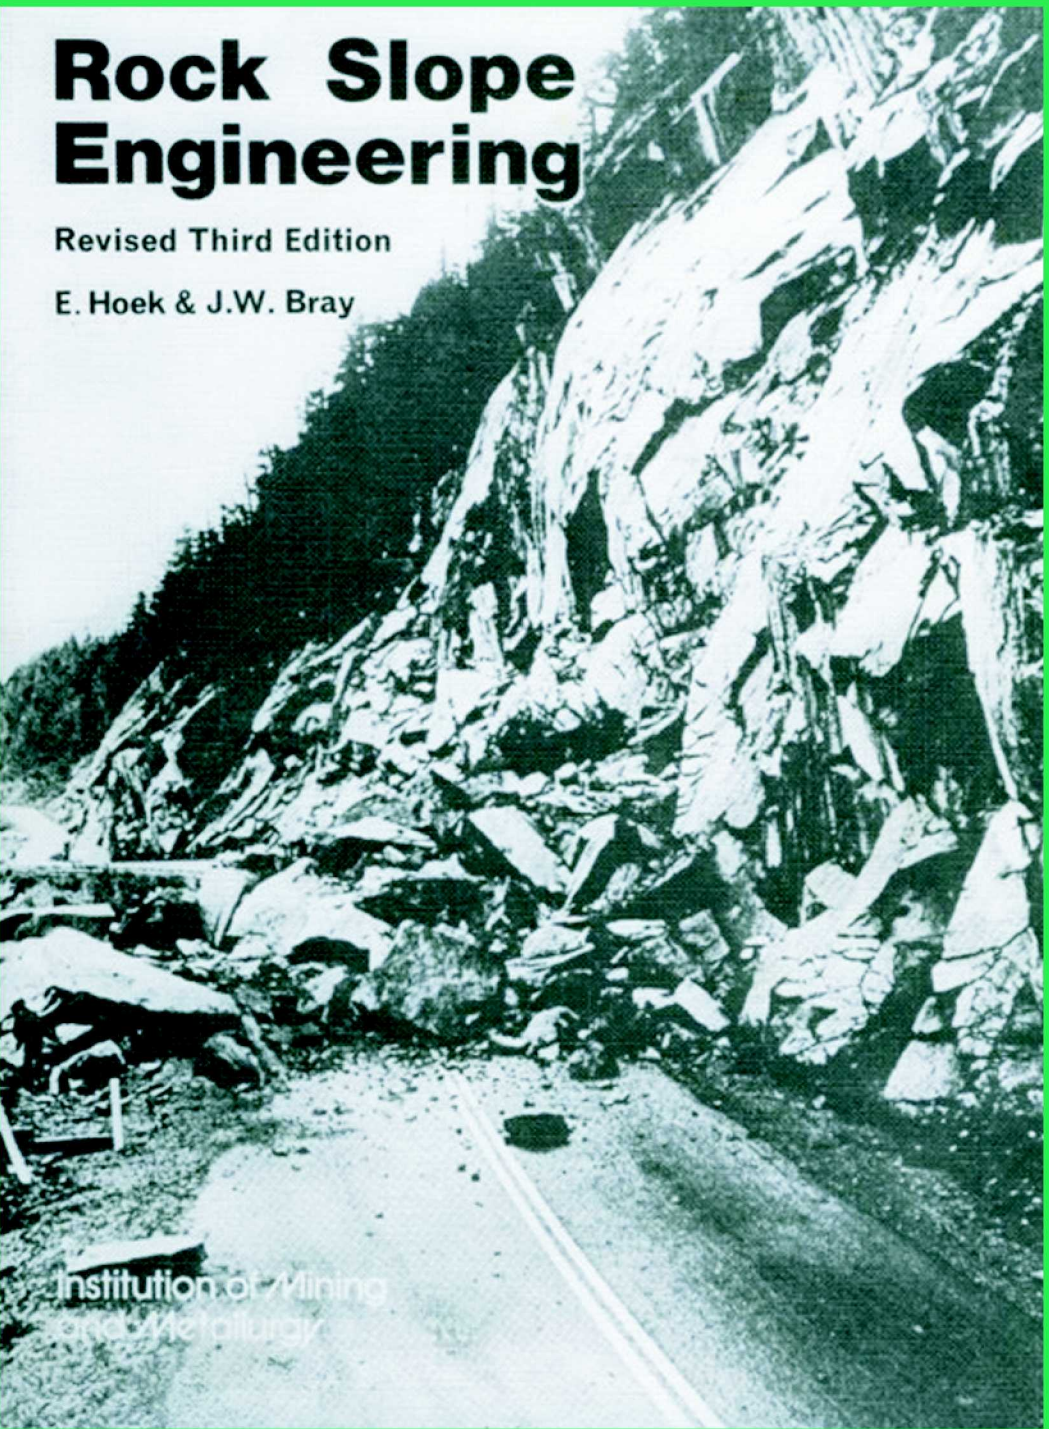
Several rockslides occurred between Brunswick Point and Porteau Cove in 1964, 1969, and 1982, which caused 4 casualties. Photograph appeared on the cover of Rock slope engineering text book by Hoek and Bray, 1981, courtesy of D. VanDine.

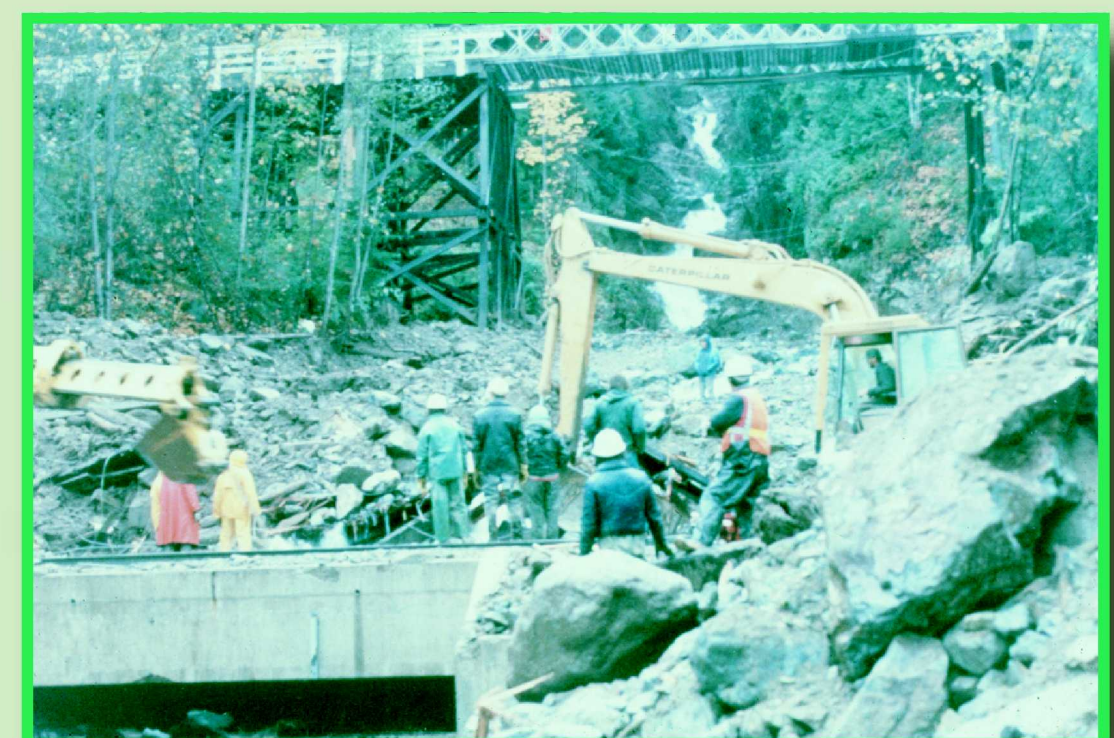
Debris flow at M-Creek, October 1981, which caused 9 casualties. Photograph by O. Hungr.
