HISTORICAL CHANGES IN COW BAY BEACH, HALIFAX REGIONAL MUNICIPALITY, NOVA SCOTIA

R.B. Taylor, D. Frobel and E. Patton

ABSTRACT

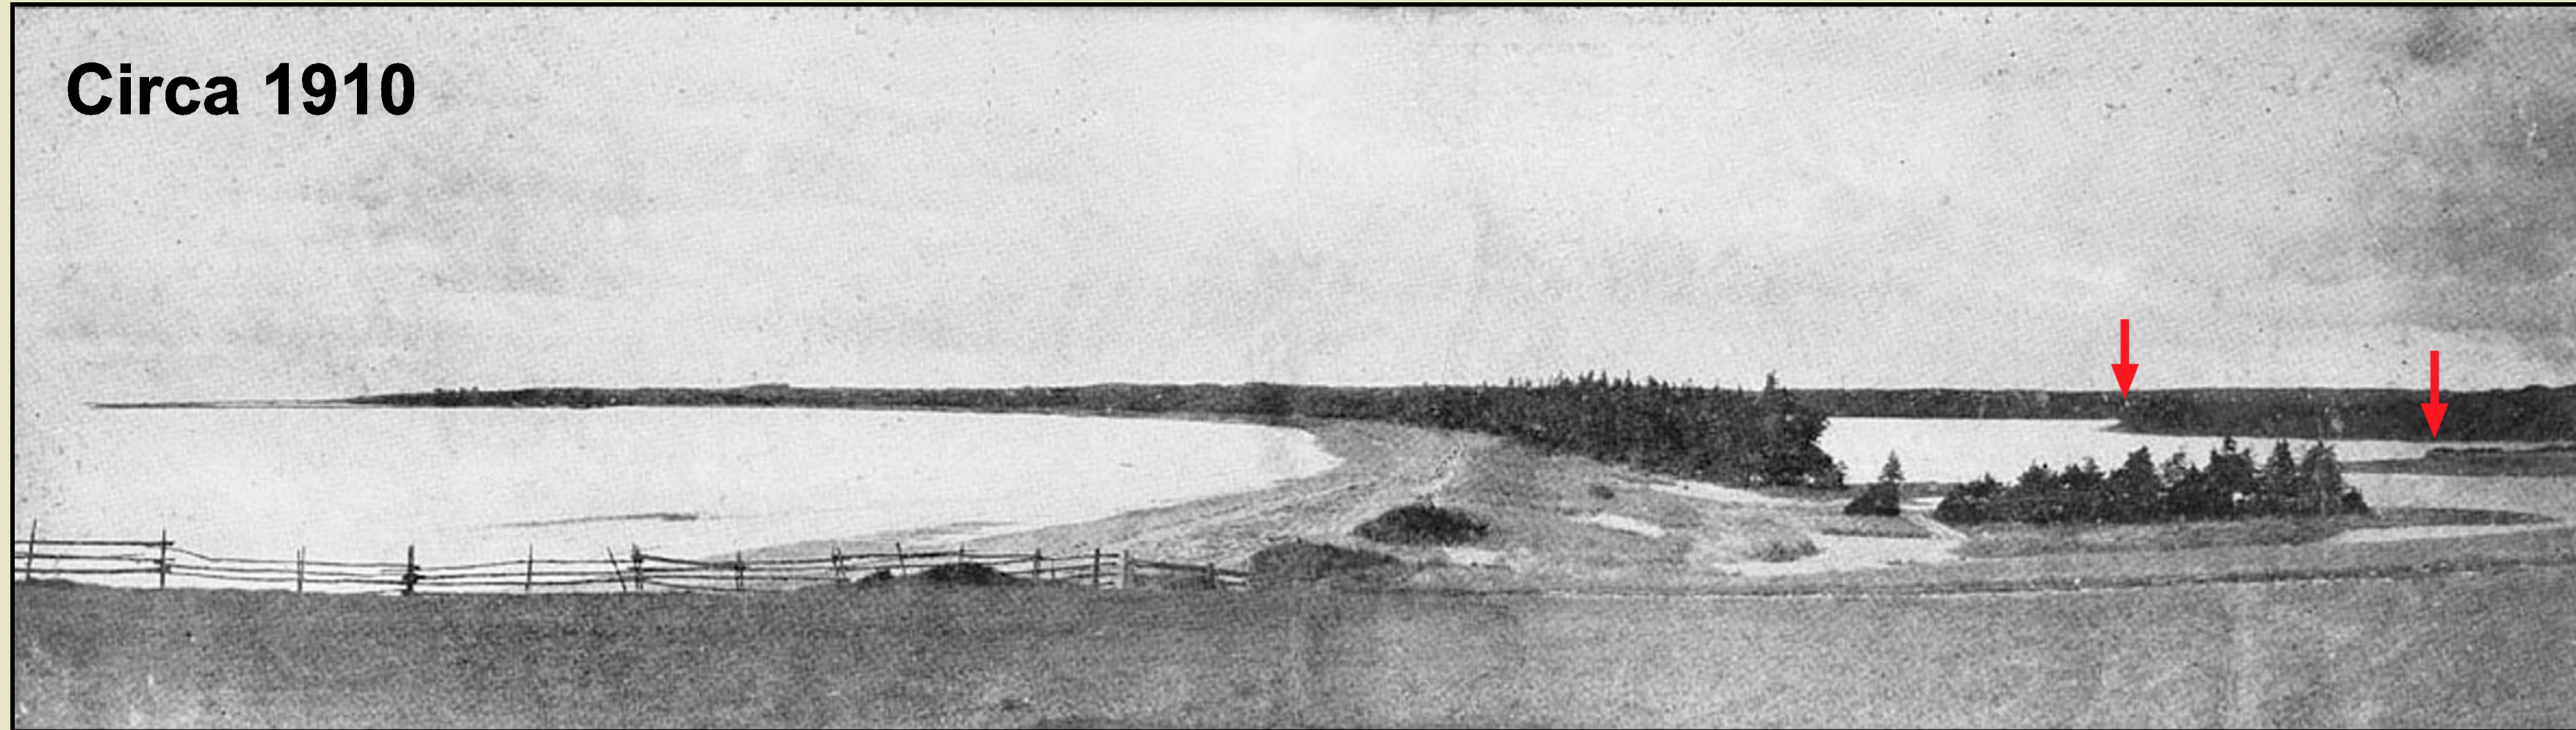
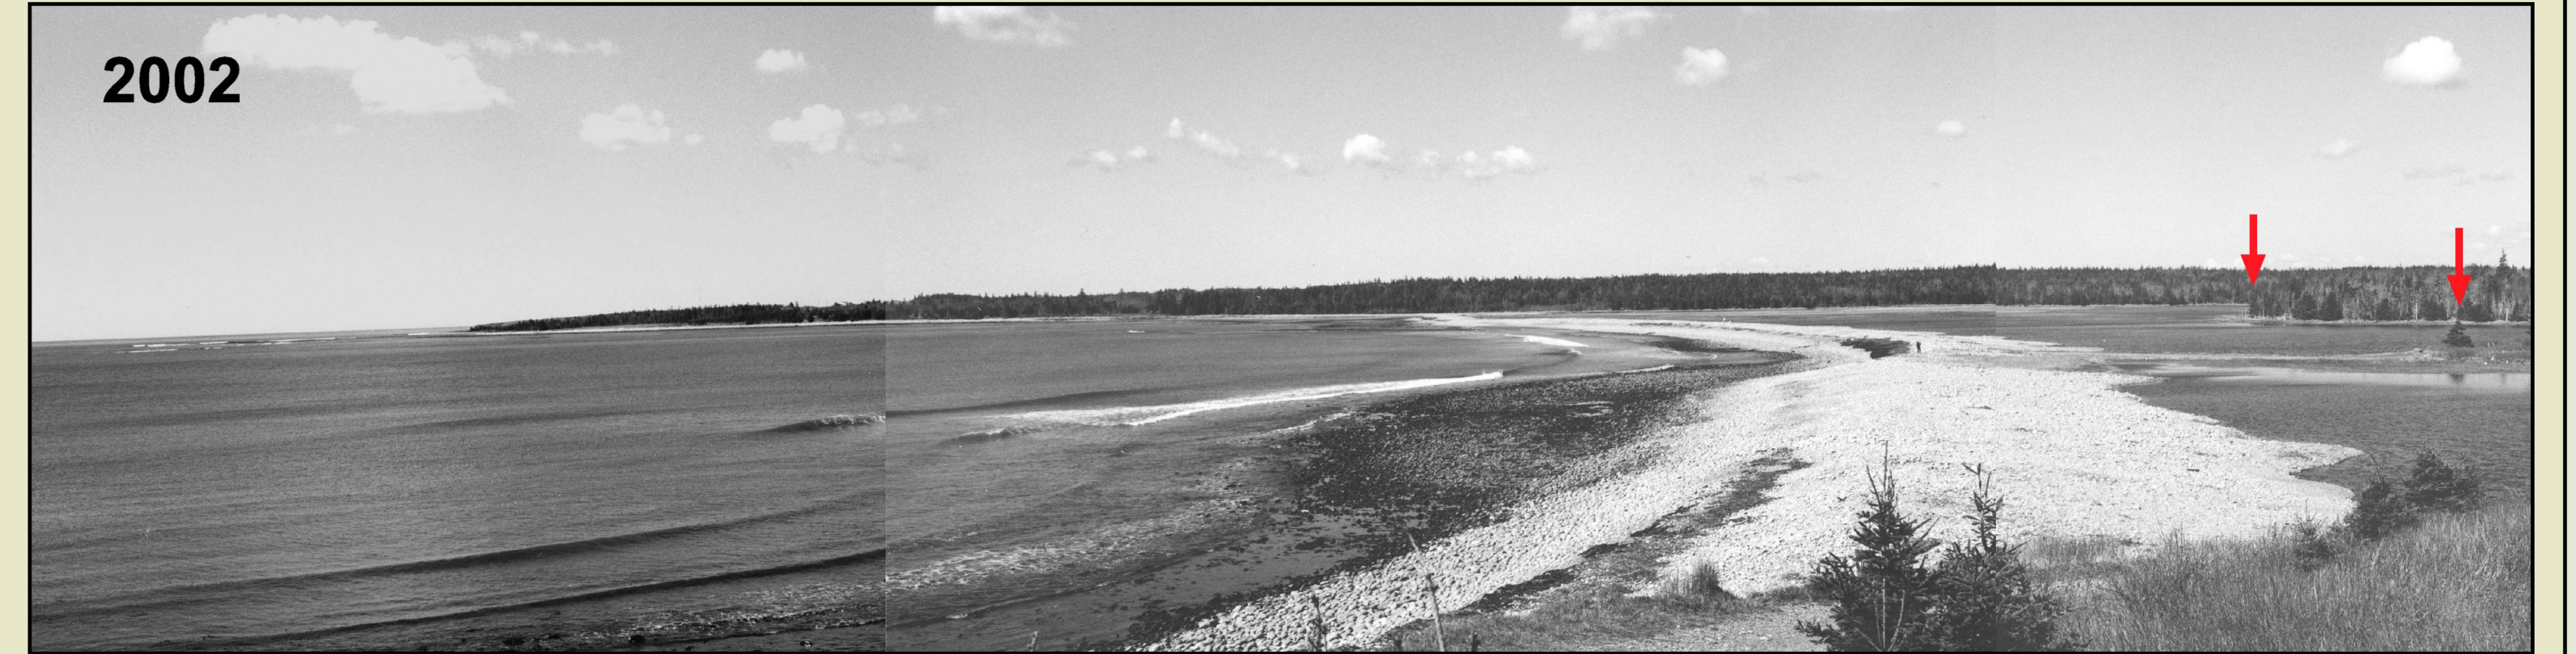
Views of Cow Bay Beach from its east end circa 1910 and 2002 showing dramatic changes in its size and forest cover. For visual reference, arrows mark the same locations in both photos.

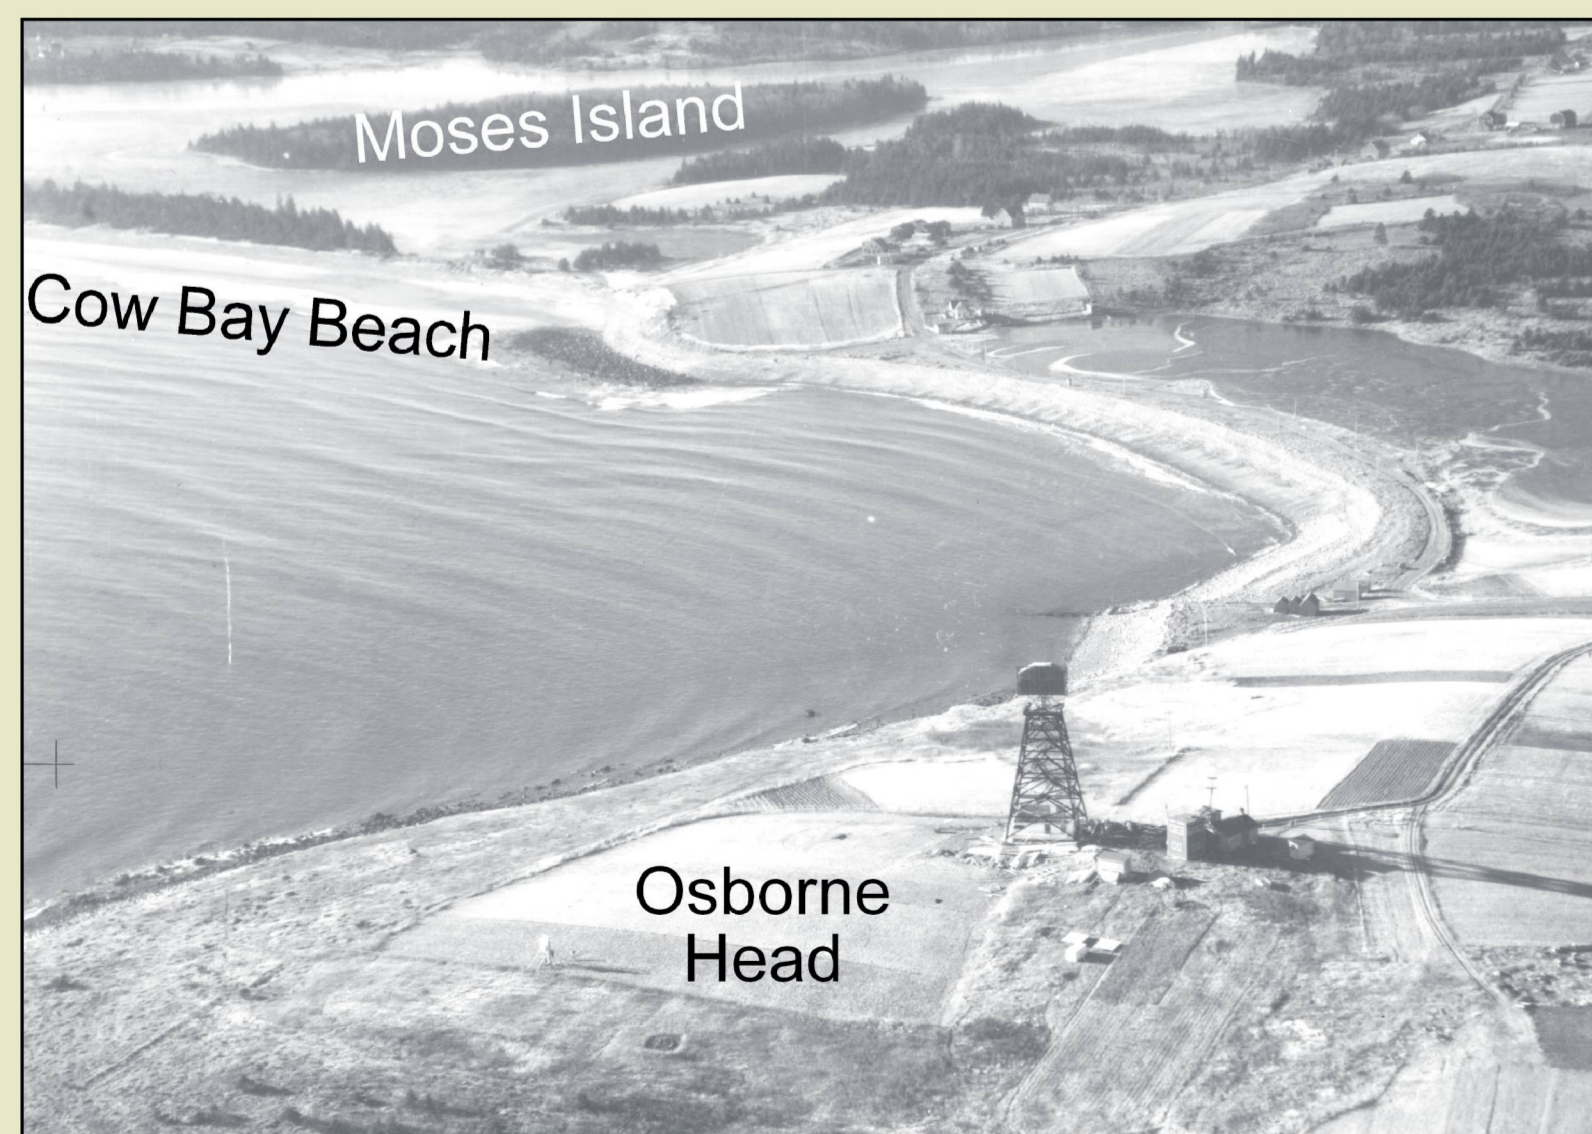
AERIAL VIEW, OSBORNE HEAD AND COW BAY BEACH 1941

Aerial view shows the extensive woods that still existed on Cow Bay Beach, including those seaward of the pond at the east end of the beach. (photo REA 251-450, courtesy of DND)

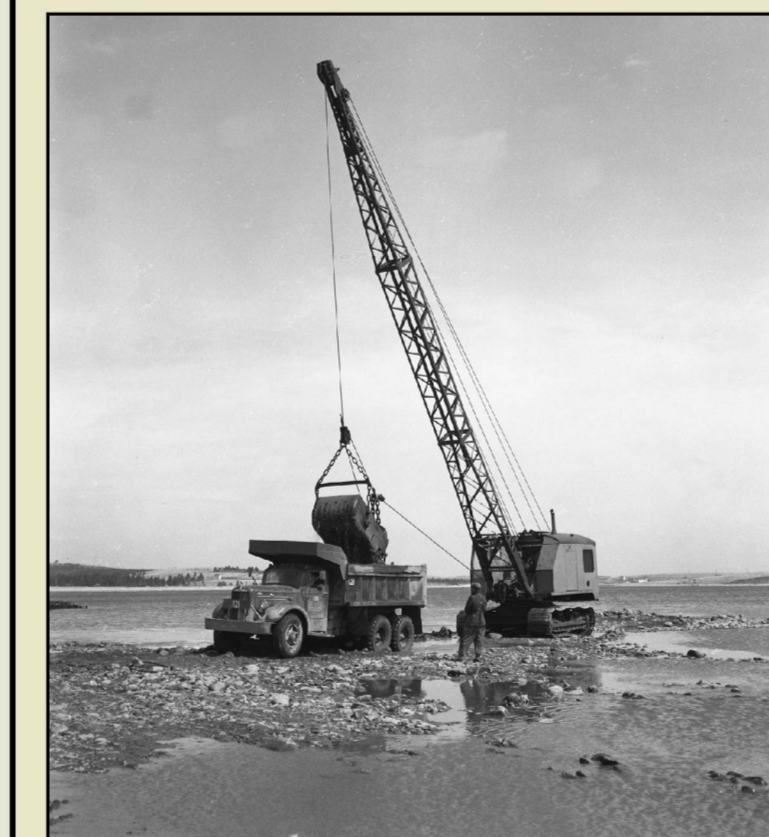
COMMERCIAL SEDIMENT EXTRACTION

In April 1957 power shovels, drag cranes and large trucks removed more than a million tons of sand and gravel. Excavation began at the west end of the beach (shown here) and continued eastward.

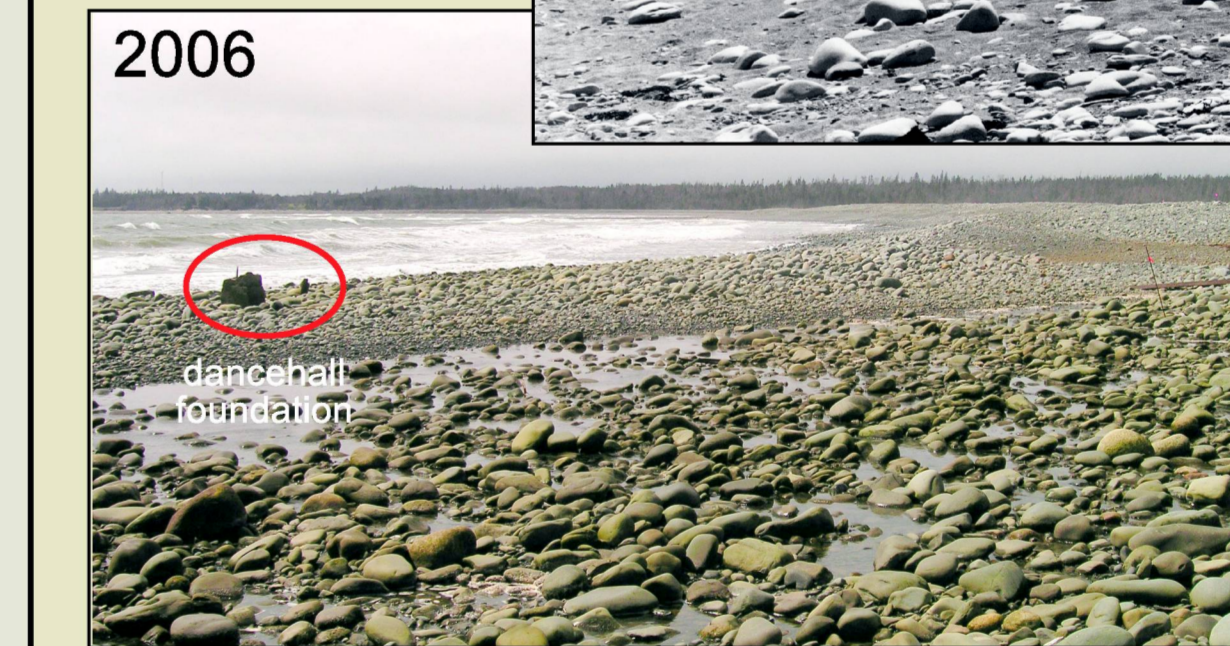
The foundation of the dancehall provides a reference for watching the beach migrate landward. In 1981, the foundation (circled in red below) existed at the back of the beach. During the 1990s it was buried in the beach and re-exposed seaward of the beach in 2004 as the beach migrated past it. At this location the beach has migrated 53 m landward from 1981 to 2006.

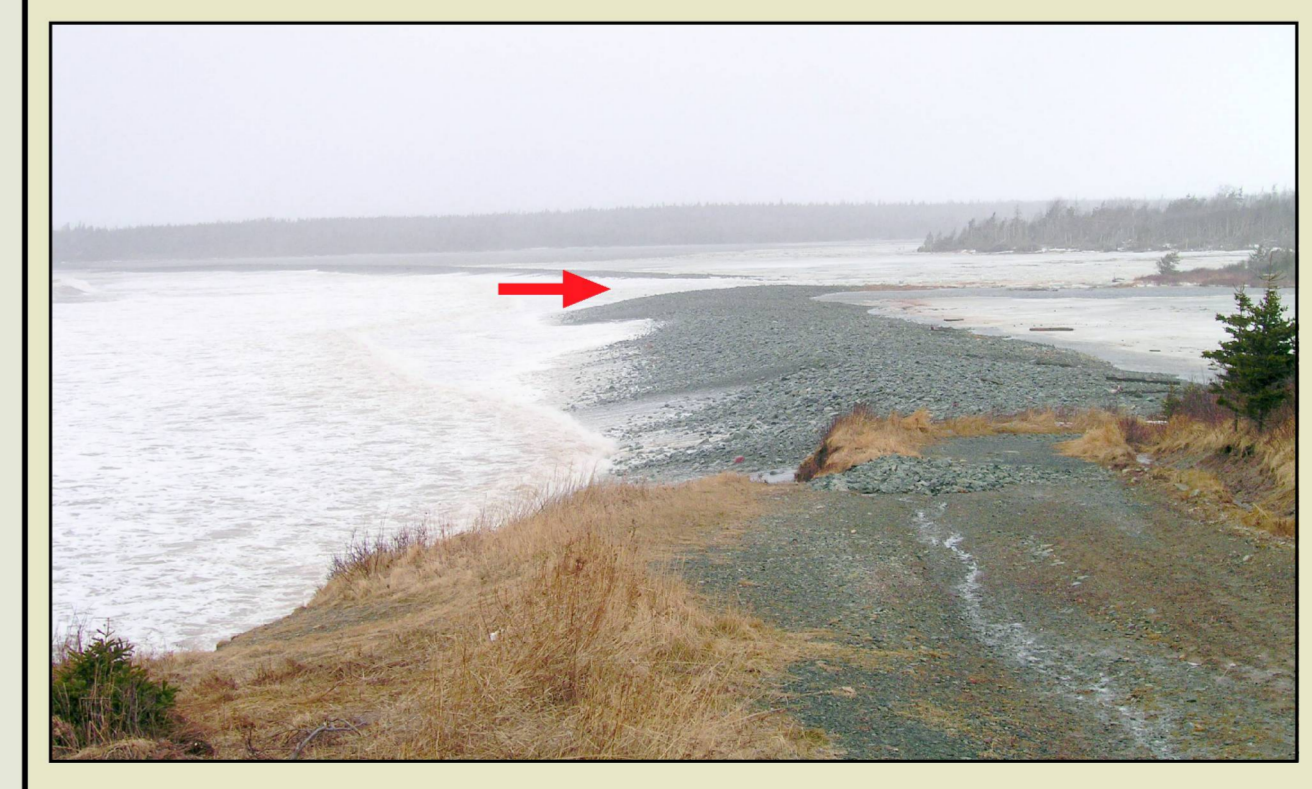
BEACH BREAKDOWN

Waves cut through Cow Bay Beach at the red arrow in March 2005. In 2006, the central barrier (left of cut) was migrating landward at 7 metres/year in contrast to <1.5 metres/year at the ends of the beach.
