**GEOLOGICAL SURVEY OF CANADA
OPEN FILE 4989**

**Irving Whale Sidescan Sonar and Sediment Sampling Program
20-26 May 1996**

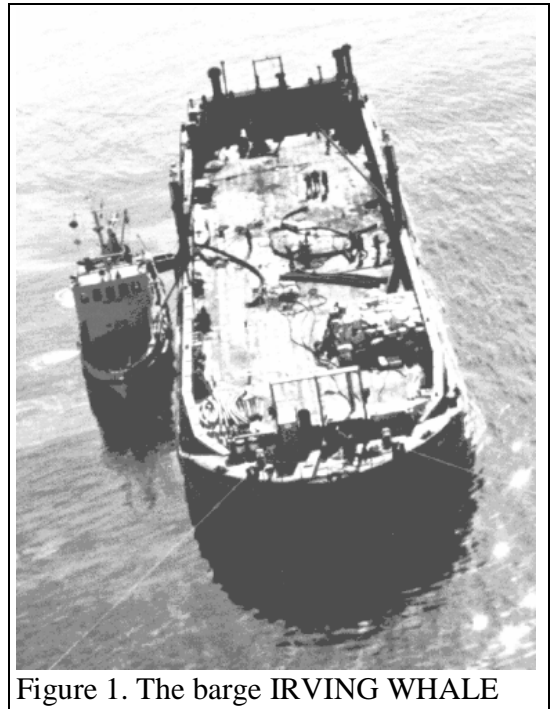
The barge IRVING WHALE was built in 1966 by the Saint John Shipbuilding and Dry Dock Company. It measured 82 metres long, 18.5 metres wide, and 5 metres deep (Fig. 1). On 7 September, 1970, the IRVING WHALE was under tow by the tug IRVING MAPLE from Halifax, NS to Bathurst, NB. The barge sank, during a storm, in about 67 metres of water on the Magdalen Shelf, Gulf of St. Lawrence (Fig. 2). At the time of sinking the barge contained about 4200 tonnes of heated No. 6 fuel oil (Bunker C). The barge settled slowly by the stern, which allowed a substantial quantity of oil to escape through the tank vents. Recent studies have shown that the heating system used on the barge to heat the fuel in the cargo tanks contained approximately 6800 litres of Therminol FR-1 which is composed of 80% polychlorobiphenyls (PCBs) (Aroclor 1242), and 20% chlorinated benzene (DFO/EC, 1996). Some contamination of seafloor sediments near the barge has occurred. Attempts to raise the barge during 1995 were halted in August, as a result of a legal injunction filed by le Societe pour Vaincre la Pollution Inc (SVP).

Figure 1. The barge IRVING WHALE

The photographs in Figures 1 and 3(a) show different views of the barge. Note the general layout of the barge with its large open deck. The various parts of the superstructure such as the navigation masts, derricks, cargo booms, and vents are quite evident. Figure 3 compares a photograph of the IRVING WHALE with a sidescan sonar image. The sidescan sonar image shows overall structure of the barge with its open cargo deck, cargo bin side bulwarks, high forepeak and stern deckhouse. The image also shows the cargo boom on the deck of the barge and various parts of the superstructure. The acoustic shadow (shown as the large dark patch behind the barge) shows the outlines of various derricks, bollards, and pipes on the barge which can be seen in the photo. Access openings through the cargo bin bulwarks can be seen as the bright spots in the shadow. Also evident on the seafloor in the sidescan sonar image in Figure 3(b) are isolated bright (light coloured) areas with small shadows (dark areas) immediately behind. These features indicate the presence of boulders on the seafloor.
