*ANALYSES OF PIT SLIDES
IN SOME INCOMPETENT ROCKS*

D. F. COATES, K. L. McRORIE AND J. B. STUBBINS

Reprinted from Trans. of the Society of Mining
Engineers of AIME , March 1963, pp. 94-101

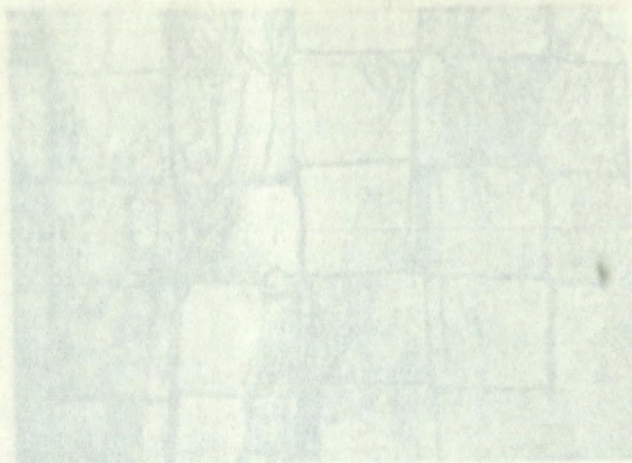
Fig. 2—Rotational block falling when a block mass subjected to pressure.

In addition, the basic nature of brittle materials is that they rupture completely on failure and thus are not likely to permit any plastic yielding or redistribution of stresses before the general failure of the mass. Consequently, when a typical brittle rock mass, without complicating structural features, is subjected to stresses high enough to cause crushing of the blocks, failure of the mass will usually occur (see Fig. 2).

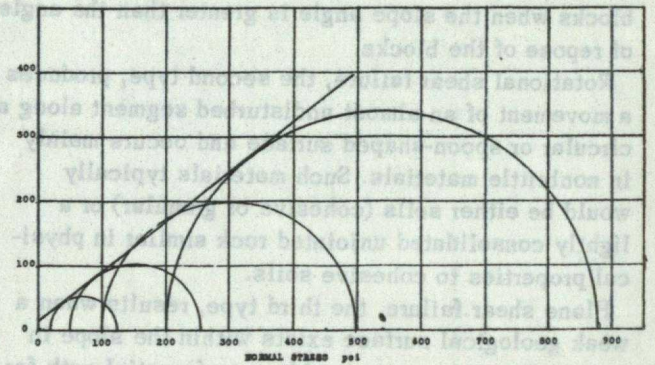
Fig. 4—Mohr diagram for paint rock with a void ratio of 0.49.

The results of one series of triaxial tests run on saturated samples with a void ratio of 0.56 showed the material to have an effective angle of internal friction of 36° and an effective cohesion of 6 psi. Another series of tests run on saturated samples with a void ratio of 0.49 produced an effective angle of internal friction of 38° and an effective cohesion of 13 psi. In both series the rate of strain was 0.288% per min. The Mohr failure envelopes for these two series of tests are shown in Figs. 3 and 4.

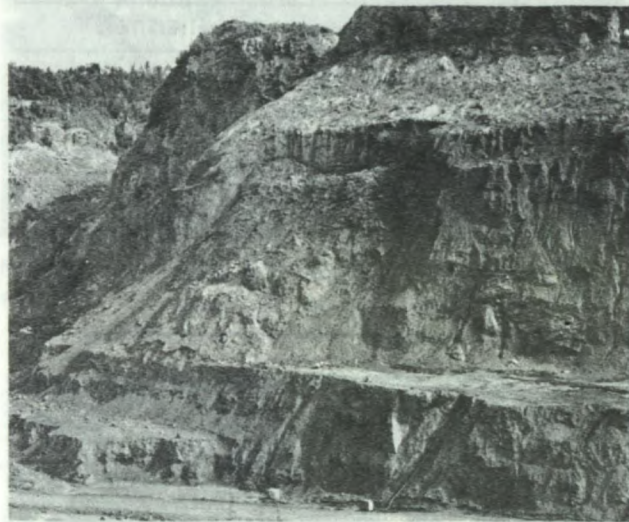
Fig. 5 shows slide No. 1 in paint rock. The height of this slide was 215 ft with an average slope angle of 51° . Fig. 6 shows slide No. 5 in paint rock. The height of this slide was 138 ft with an average slope angle of 56° . Fig. 7 is a face-on shot of the same slide, demonstrating that the end effects would be very important and would, if not eliminated, seriously

Fig. 5—Slide No. 1 in paint rock.

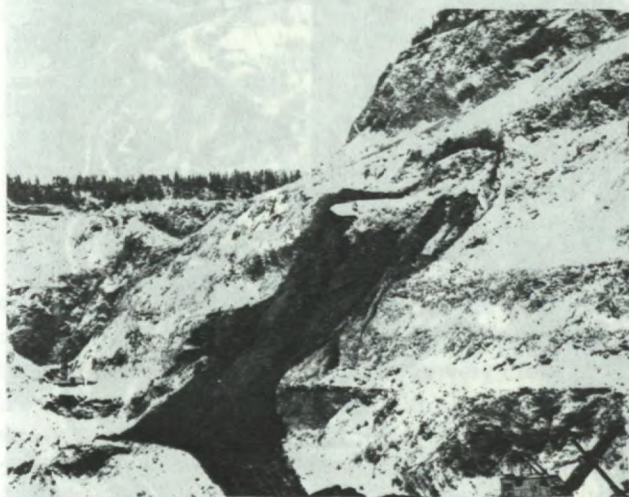
Fig. 6—Slide No. 5 in paint rock.

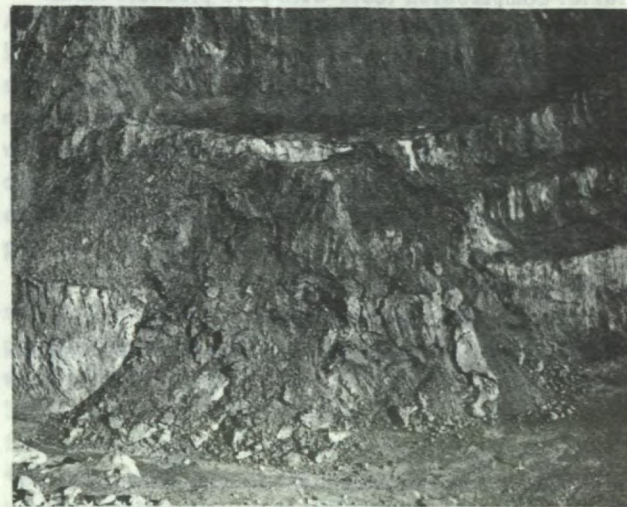
Fig. 8—Slide No. 7 in paint rock.

distort the computed cohesion. Fig. 8 shows slide No. 7 in the paint rock. The height of this slide was 86 ft with an average slope angle of 49° . Since the slide is on a nose of wall the resistance on the ends of the sliding segment would be very small.

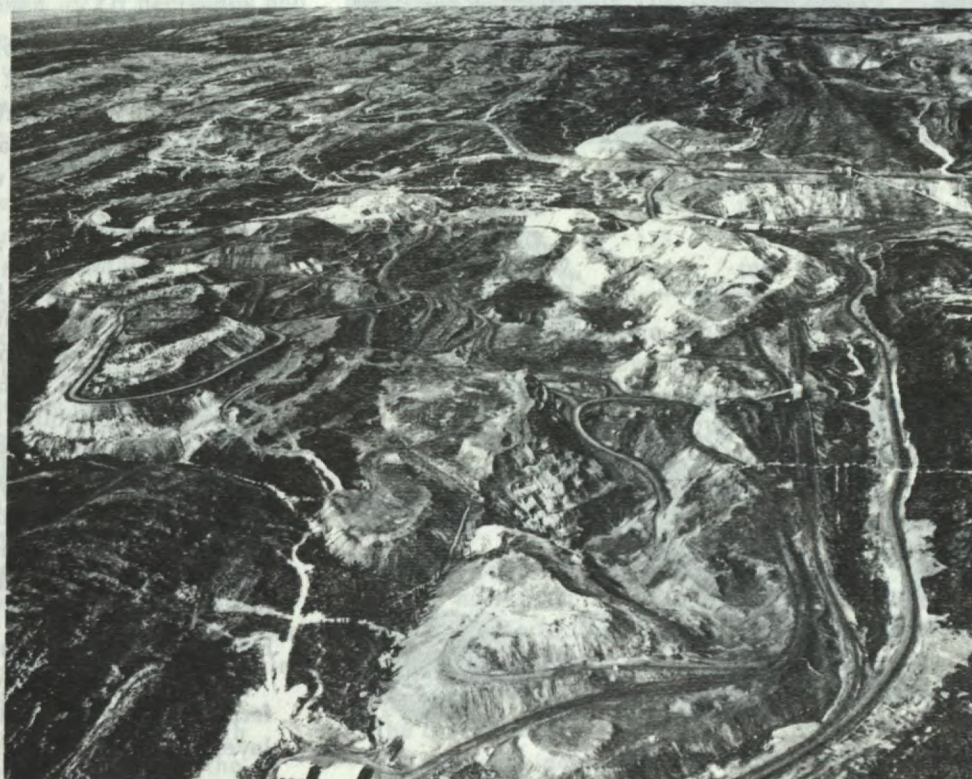
Fig. 9—Aerial photograph of Ruth Lake mine, September 1962 (photo by Hunting Survey Corp. Ltd., Toronto).

Fig. 9 is an aerial photograph of Ruth Lake mine

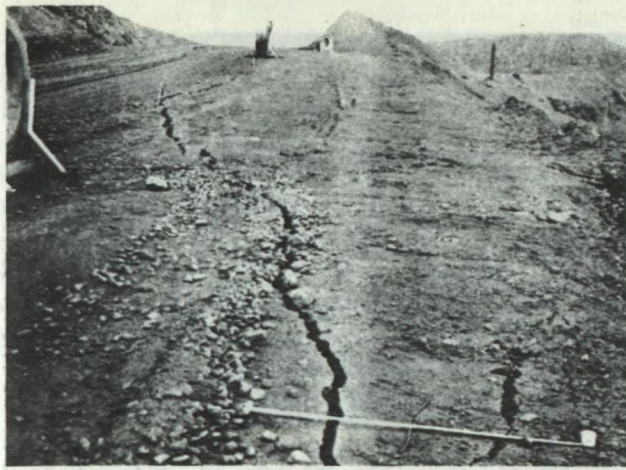
Fig. 10—Tension cracks developing at the top of the slope of slide No. 2 in altered slate and quartzite.

taken in September 1962. Fig. 10 shows tension cracks developing in the haul road at the top of the slope of slide No. 2. The average height of the wall at that time was 136 ft at an angle of 41° . Fig. 11 shows slumping at the crest of slide No. 2 as it appeared one year later. Fig. 12 shows some of the remains of slide No. 6.

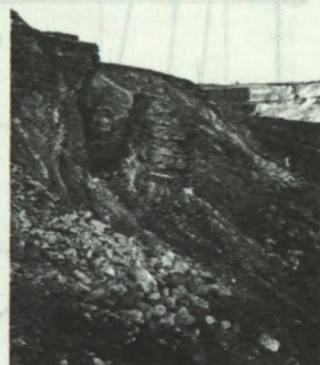
Fig. 12—Some remains of slide No. 6 in altered slate and quartzite.

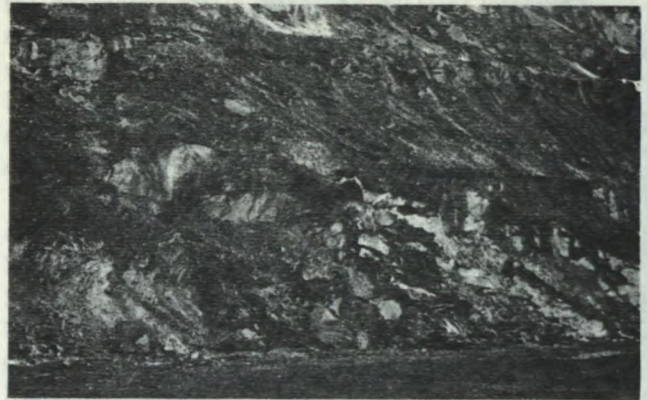
Fig. 13 shows slide No. 6 in ash rock. The height of this slide was 84 ft at an average angle of 46.5° . Fig. 14 shows slide No. 7 in ash rock. This wall was 445 ft high at an angle of 51° before the slide. The appearance of the wall after the slide leads one to conclude that the failure was by block flow.

Fig. 13 - Slide No. 6 in ash rock.

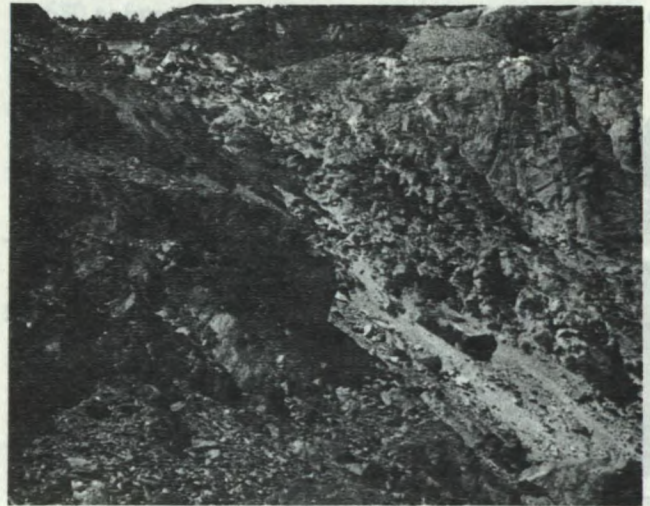
Fig. 14 - Slide No. 7 in ash rock.

It is probable that slide No. 7 is an example of block flow failure. In this case the underlying assumption of plastic redistribution of stress concentrations enabling average shear stresses to be compared to average shear strengths would not be applicable.

Furthermore, it is possible that the frictional resistance would not be mobilized before the cohesion in the material was broken down. In an attempt to appraise this possibility the angle of internal friction of the rock in slide No. 7 was assumed to equal zero, and the critical average shear stress was computed. This stress amounted to 17,600 psf or 122 psi. This is still considerably lower than the shear strength of the core samples of the competent rock where the average uniaxial compression strength was about 4500 psi. Consequently, the mechanism of stress concentrations on blocks within the formation and progressive failure probably was effective in this case.
