ELEVATED-TEMPERATURE PEELING FAILURE OF GALVANIZED COATINGS

J. J. SEBISTY AND D. PAPENFUSS

PHYSICAL METALLURGY DIVISION
OCTOBER, 1971

Research Report R 245

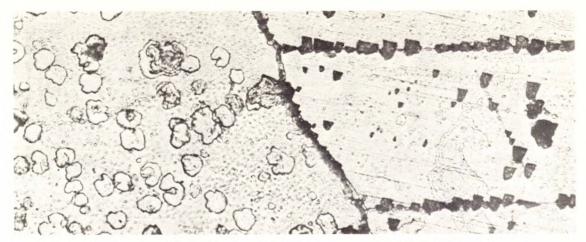
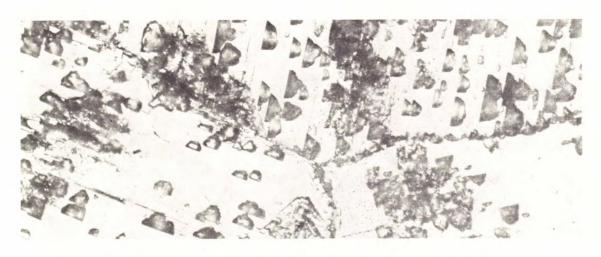
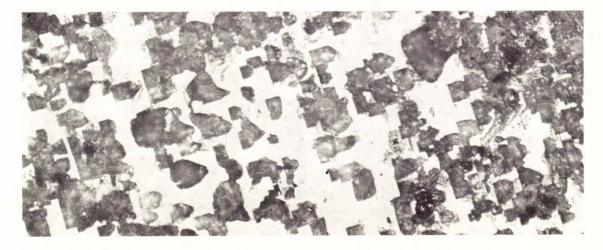
(a) One-minute coating after 5 hours at 275°C (525°F).

(b) One-minute coating after 12 hours at 275°C (525°F).

(c) Ten-minute coating after 8 days at 300°C (570°F).

Figure 1. Surface pitting on coatings containing 1.0% Pb.

The same pitting features were reproduced on all the leaded coatings heated at 300°C (570°F) and 400°C (750°F). As before, the rate of pit nucleation and growth and of zinc depletion progressively increased with temperature. The effect of coating thickness was also more clearly revealed; for equivalent exposure conditions, fewer pits formed and the growth rate was significantly reduced as the coating thickness increased. As also to be expected because of the thicker outer-zinc layer, the eventual pit size attained was larger with thicker coatings as shown in Figure 1(c).

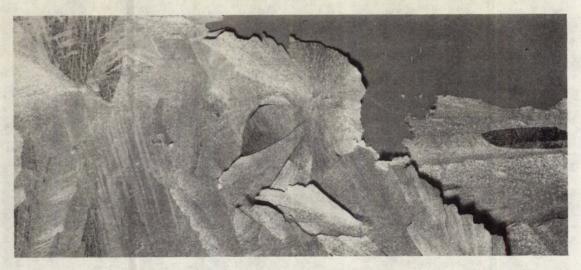
Figure 2. Peeling and break-up of coating (0.5% Pb, 0.10% Al, 1.20% Sn, 0.30% Cd, 0.30% Cu, 0.03% Fe) after heating for 16 hours at 335°C (635°F). X3

bond had been weakened by the diffusion voids formed. Such a secondary shearing-stress action has been proposed as a factor contributing to spalling of aluminized coatings (17). It could account for the "popping" type of failure illustrated in Figure 2.

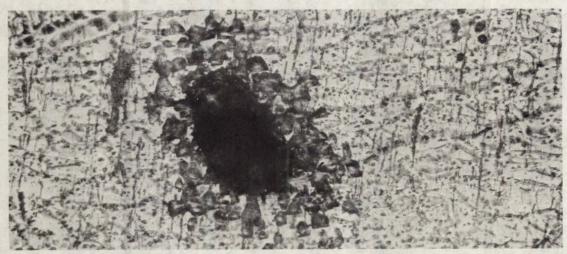
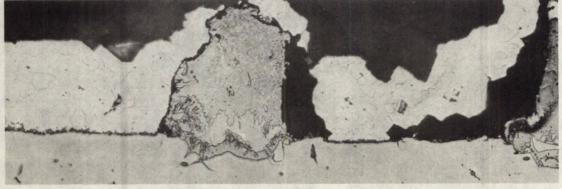
(a) Surface pitting around local iron-zinc alloy growth. X300

(b) Cross-section of growth in (a) X500

Figure 3. Continuous-strip coating heated for 1 week at 300°C (570°F). X500

A connection between surface pitting and the iron-zinc diffusion reaction was further provided from prior tests with continuous strip coatings (1,2). In this case, heating normally produces nodules of iron-zinc alloy as the first major stage in deterioration. These were frequently observed to be surrounded by a ring of faceted pits as in Figure 3(a). The cross section in Figure 3(b)

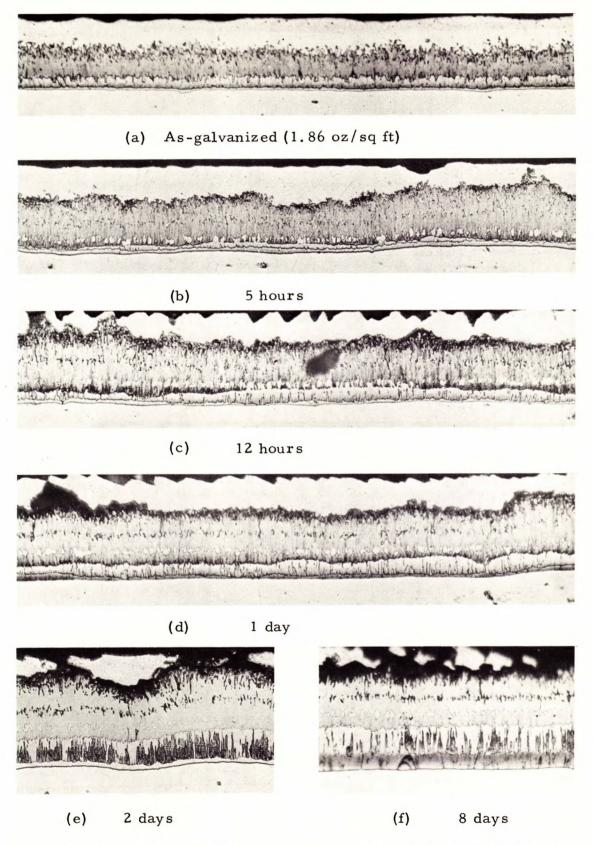
Figure 4. One-minute leaded coatings (1.0% Pb) heated at 275°C (525°F). X500

The initial microstructural evidence of separation after 5 hours was etch-darkening along the Zn- ζ interface, as shown in Figure 4(b). At 12 hours, dissolution of the matrix zinc between the outermost crystals of the ζ layer was observed as in Figure 4(c) and the more or less continuous gap formed effectively destroyed the Zn- ζ bond. The zinc layer could be easily peeled away with adhesive tape to expose a black oxidized finish yielding a powdery residue on rubbing. This stage corresponds to the reaction failure time given in Table I. The peeled layer had the appearance of fine lacework and readily broke up into individual grains because of complete loss of cohesion at the grain boundaries. An exaggerated form of such break-up in an alloyed coating heated at a higher temperature is illustrated in Figure 2. This is more representative of an in-plant type of failure where the separated zinc pulls away completely. Such "popping" was not observed with the experimental coatings and, although separated, the zinc layer retained some mechanical keying and remained in place unless deliberately chipped or peeled away.

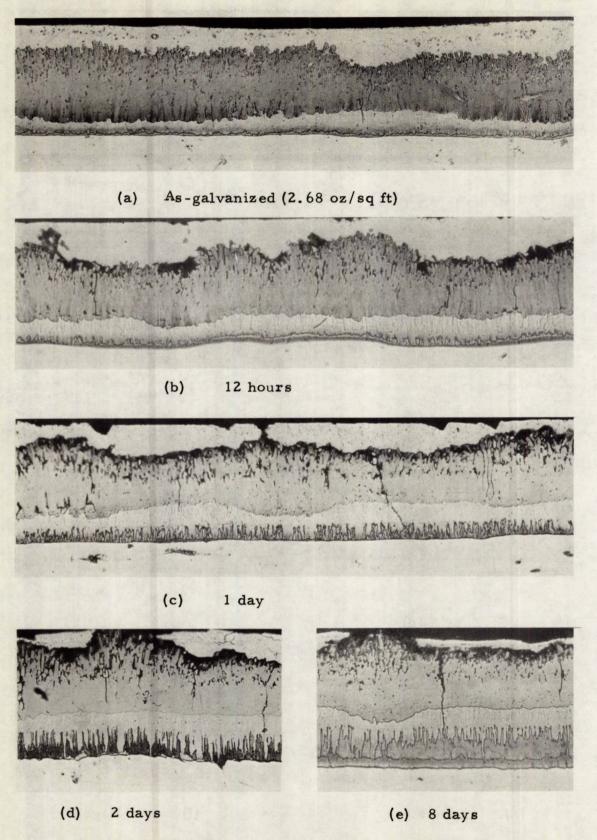
Figure 5. Four-minute leaded coatings (1.0% Pb) heated at 275°C (525°F).

Figure 5 shows that the peeling and microstructural effects described above were duplicated in the 4-minute coatings heated at $275^{\circ}C$ ($525^{\circ}F$). With the longer diffusion path, however, the various deterioration stages were slowed down. For equivalent exposure times, pitting of the outer zinc layer was less pronounced as mentioned earlier. Etch-darkening at the $Zn-\zeta$ interface was not apparent until 8 hours and well-defined cavities formed at around 12 hours as in Figure 5(b). More notably, up to 24 hours heating was required before the layer could be peeled away (Table I). The subsequent rates of zinc dissolution and fragmentation and of iron-zinc alloy transformation changes were also retarded. Nucleation and growth of the "coherent" δ_1 needles at the expense of the Γ phase is again evident in Figures 5(c) and (d).

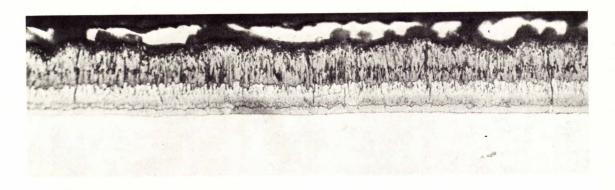
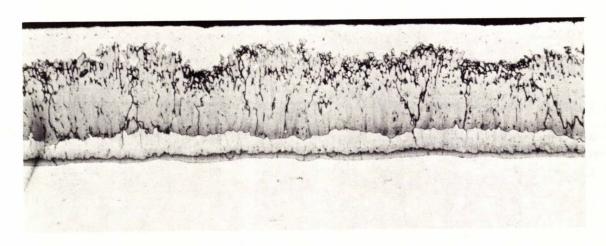
(a) One-minute coating

(b) Four-minute coating

Figure 6. Leaded coatings (1.0% Pb) heated for 30 minutes at 400°C (750°F). X500

The coating microstructures in Figures 6 and 7 are of interest for other reasons. In particular, Figures 6(b), 7(b), and (c) provide more conclusive proof that separation of the zinc layer is initiated by reaction dissolution of the matrix zinc surrounding the fringe crystals of the ζ layer. The disappearance of intergranular particles of zinc contained well down in the columnar ζ further indicates that the reaction is not confined to a band along the Zn- ζ boundary as is the case with thin coatings. The marked fissuring disintegration of the ζ phase and the well-defined evidence of a duplex- Γ structure in Figure 7(d) are also of interest. Significantly, the secondary layer next to the steel base appears in a more uniform and

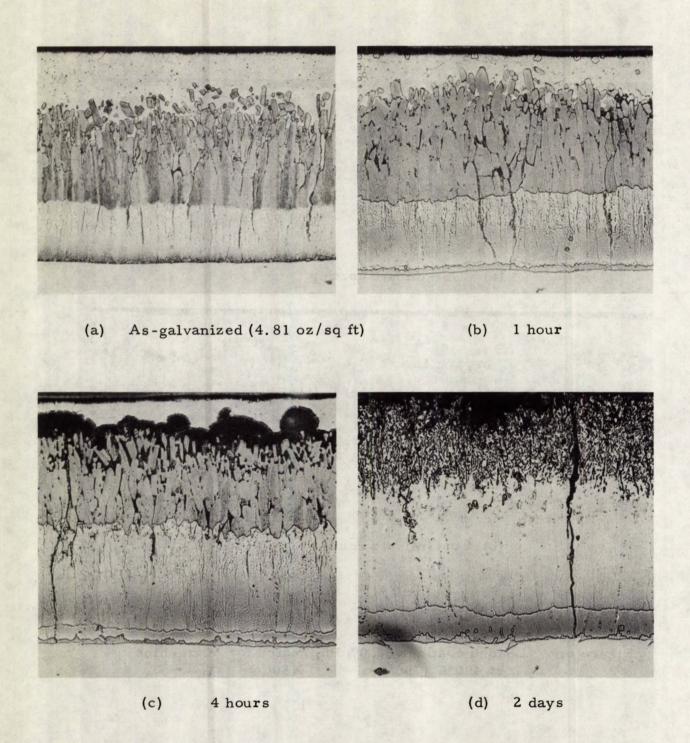
Figure 7. Twenty-minute leaded coatings (1.0% Pb) heated at 400°C (750°F).

Equally striking in Figure 11(d) is the almost total absence of fissuring which contrasts with the pronounced break-up of the exposed ζ phase in the leaded coating of Figure 7(d). The enhanced resistance to deterioration of the δ_1 phase was thus clearly demonstrated. The duplex- Γ structure can also be seen with the layer adjacent to the steel surface again being more uniform and continuous at the shorter heating time in Figure 11(c). The leaded coatings in Figure 7 showed the same sacrificial re-solution with increased heating time. This was also characteristic of the Γ phase as discussed previously and illustrated in Figures 4 and 5 and in 9 and 10.

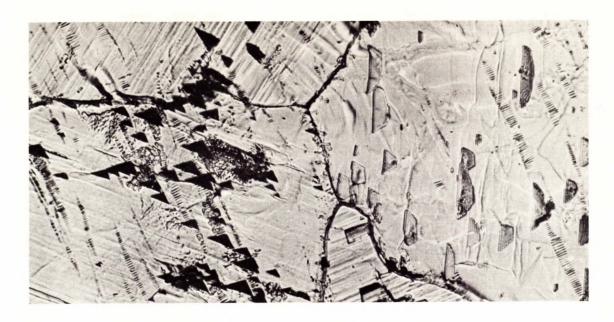
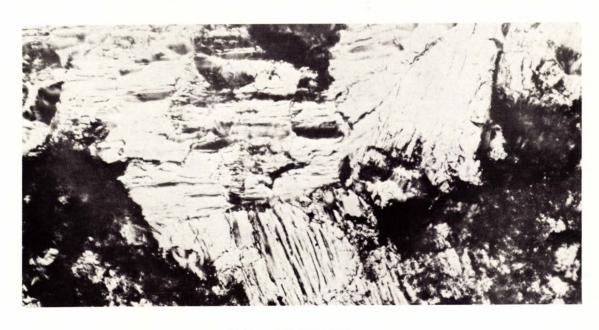
(a) 5 hours

(b) 12 hours

Figure 8. Surface pitting and zinc depletion on 1-minute lead-free coatings (<0.001% Pb) heated at 275°C (525°F). X500

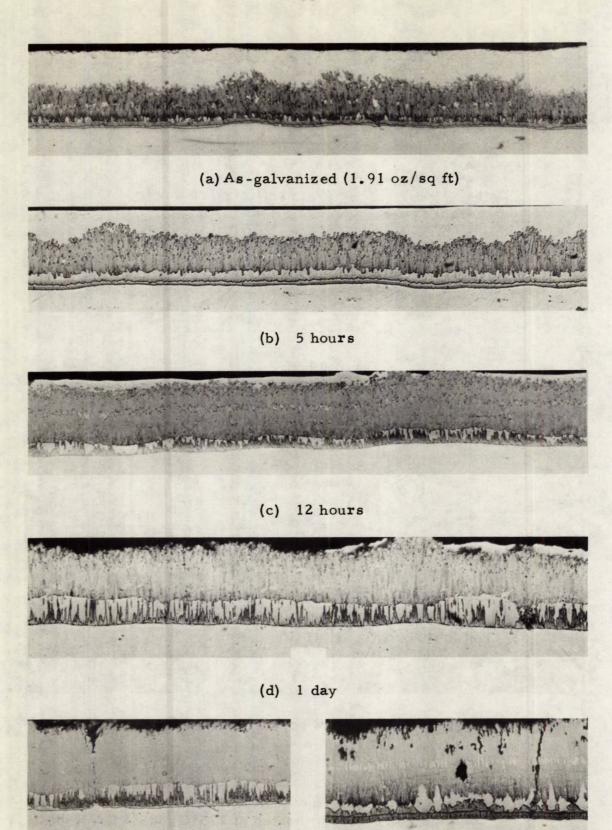
Figure 9. One-minute lead-free coatings (<0.001% Pb) heated at 275°C (525°F). X500

Typical metallographic effects observed with the 1- and 4-minute coatings at 275°C (525°F) are shown in Figures 9 and 10. Both series provide positive evidence of the different reaction mode of the lead-free coatings. Rapid and continuing transformation of the outer zinc layer to iron-zinc alloy was always reflected in total absence of any bonding deterioration at the Zn- ζ interface. On all flat sheet sections examined, cavity formation at the interface was practically non-existent except for randomly scattered holes as in Figures 9(d) and 10(c). These developed in advanced stages of the zinc thinning process and, being isolated localized defects, they had no detrimental effect on the bonding of the surrounding zinc. As discussed later, special instances of cavity development were observed in the open fan-like iron-zinc alloy structure at corners and, to a lesser extent, on small-radius convex surfaces.

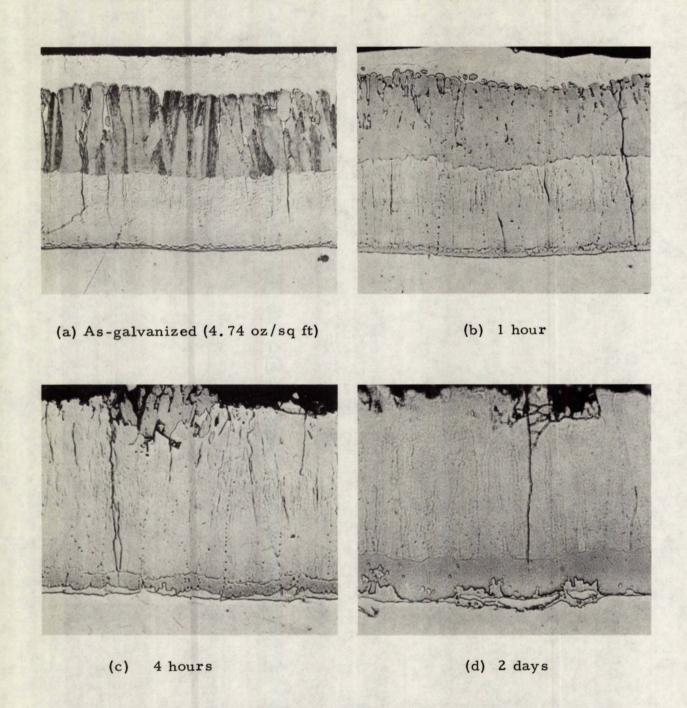
Figure 11. Twenty-minute lead-free coatings (<0.001% Pb) heated at 400°C (750°F). X500

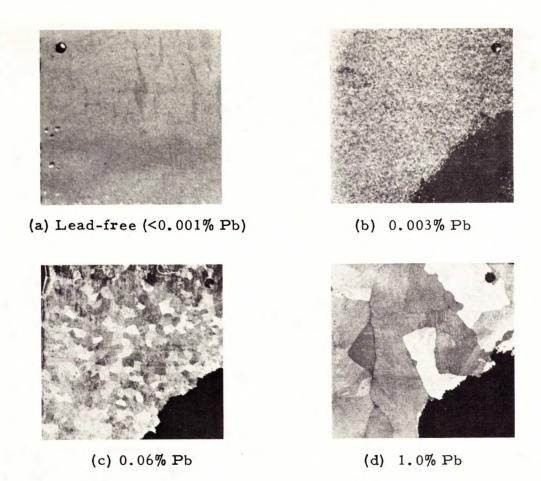
Figure 12. Surface appearance of 1-minute coatings with lead content indicated, after heating for 8 hours at 300°C (570°F).

Dark corner patches are areas where zinc was peeled away. X1

To establish the minimum lead content which would cause separation of the outer zinc layer, coatings were prepared with different amounts of pure lead (99.99%) added to iron-saturated special high-grade (99.99%) zinc. The latter contained <0.001% Pb as previously noted. The additions were varied in several steps over the range 0.0015 to 1.0% as indicated in Table I. Samples were galvanized for 1 and 4 minutes at 450°C (840°F) and subsequently heated at 300°C (570°F). Coating weights are listed in Table I, and some typical surface and metallographic effects are illustrated in Figures 12 and 13.

It is to be noted that lead also produces marked grain coarsening in the outer layer (Figure 12). Thus, the more rapid failure rate with high-lead coarse-grained coatings, having less grain boundary area, discounts grain boundary diffusion as a dominant factor in the separation process. The irrelevance of zinc grain size was further demonstrated by the separation failure of the coatings with only 0.0015% Pb even though the grain size was as fine as in the lead-free coatings. At the same time, the inherently higher diffusion rate at grain boundaries may have contributed to the sustained and higher reaction rate with the fine-grained lead-free coatings. It is unknown whether this is cause or effect, or is otherwise immaterial with respect to the retention of Zn- ζ bonding.

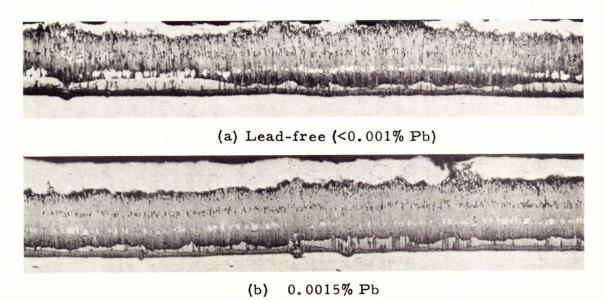
Figure 13. Lead-free and low-lead coatings (1-minute immersion) after heating for 4 hours at 300°C (570°F). X500

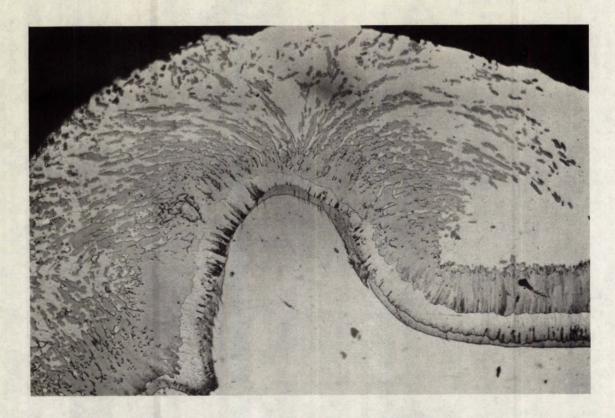
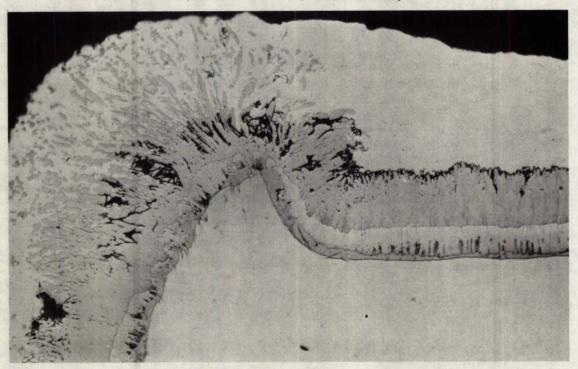
(a) Lead-free (<0.001% Pb)

(b) 0.0015% Pb

Figure 14. Corner effects with lead-free and low-lead coatings (4-minute immersion) after heating for 8 hours at 300°C (570°F). X500

Attention is drawn to special cases of interface cavity development at corners or on curved surfaces with coatings containing <0.001% Pb. Figure 14(a) is typical and shows fine intergranular voids in the open fan-like ζ structure at a corner. The normal structure adjacent to the corner is expectedly free of any interface deterioration. In contrast, Figure 14(b) shows the gross cavitation at a corner, merging into distinct separation of the zinc layer away from this area, when 0.0015% Pb was present. A larger radius of curvature, as with 1-in. diameter tubing, was also found to be somewhat susceptible to cavity formation. This was revealed in heating tests after regalvanizing of commercial tubing in special high-grade zinc. From these results, it appears that the role of lead can be influenced by the morphology of the ζ phase.

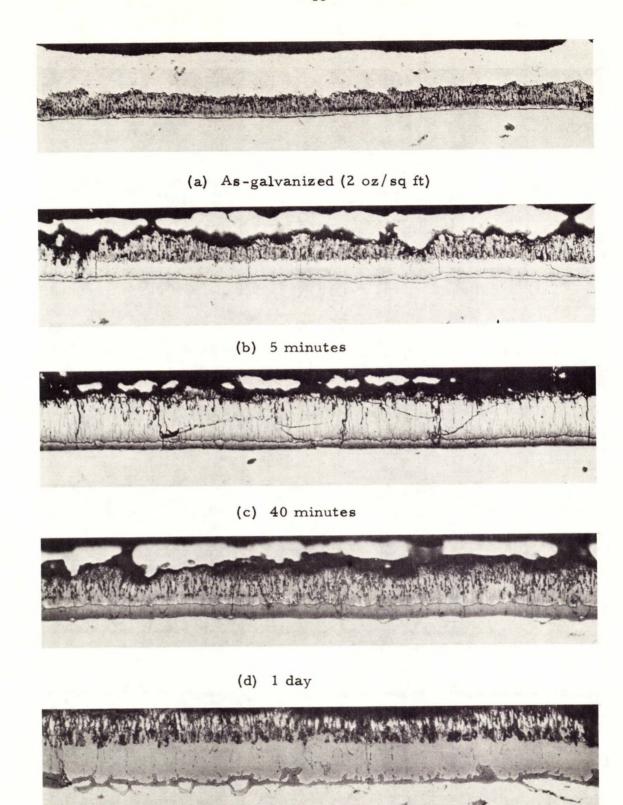
Figure 15. Commercial coating heated at 400°C (750°F). X500

In all respects, the coating behaved like the leaded experimental coatings of similar thickness. Zinc layer separation was complete after 4 hours at 300°C (570°F) and after 5 minutes at 400°C (750°F). The latter failure, along with typical microstructural changes after longer exposures, can be seen in Figure 15. Within 40 minutes, for example, there was almost total conversion of ζ to δ_1 , as evident in Figure 15(c). At the later stage in Figure 15(d), significant Γ growth is apparent. With the more prolonged

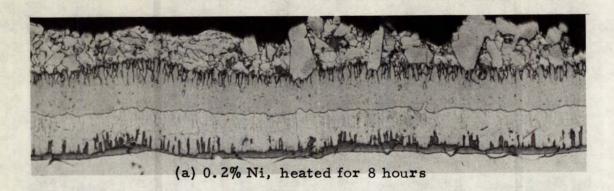
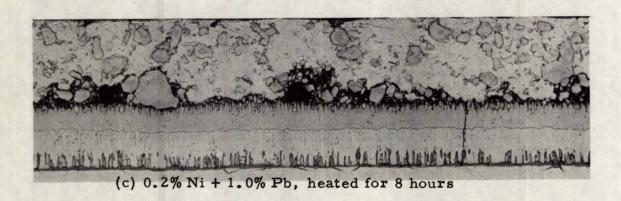
Figure 16. Nickel - containing coatings with and without lead (4-minute immersion), heated at 300°C (570°F). X500

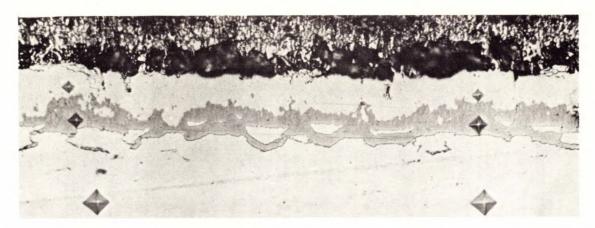
Figure 19. Microhardness variation in duplex-T layers (4-minute leaded coating heated for 2 weeks at 400°C (750°F). X500

Evidence of the secondary- Γ layer previously referred to in Figures 7, 11, and 15 is complemented by the additional long-time microstructures in Figures 19 and 20. Reference may also be made to earlier tests with continuous strip in which similar structures were observed ⁽²⁾. In all cases, the secondary phase layer was distinguished by its dark-etching response, by irregular and uneven growth, by a well-defined boundary with the normal. Γ phase, and by its tendency to penetrate the steel intergranularly. The layer frequently contained a random scattering of fine particles, believed to be inclusions or other steel base constituents. Otherwise, it appeared to have a single phase structure.

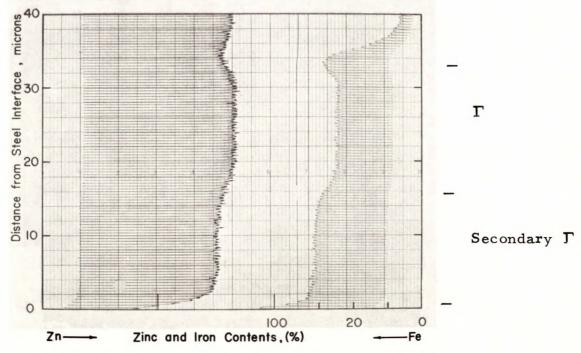
(a) Charted iron and zinc data for traverse in (a)

Figure 20. Electron-probe microanalysis of 4-minute leaded coating heated for 4 weeks at 400°C (750°F).
