A STUDY OF SURFACE CARBIDES,
DIFFERENTIAL STEEL ATTACK
AND PORE FORMATION IN THE
GALVANIZING PROCESS

J. J. SEBISTY

MINES BRANCH
RESEARCH REPORT

R 6

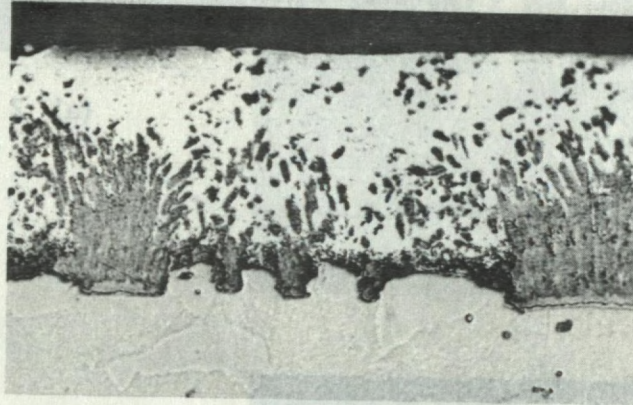
X750, nitramyl and picral etch.

Fig. 1. - Negligible reaction of carbides in aluminium-free bath. (Carbides are shown as structureless grey particles in steel matrix.) 0.5 minute dip at 445°C (833°F) in bath containing 0.5% Pb, 0.03% Fe;

Observations in the detailed investigation (1), and in preliminary work leading up to it, indicated that the behaviour of carbide inclusions was markedly influenced by the galvanizing conditions. In an iron-saturated, aluminium-free bath, no apparent reaction was noted at a relatively low bath temperature (445°C, 833°F) and short immersion time. The typical behaviour is illustrated in Fig. 1 which shows a series of separated carbide particles at the steel surface. Negligible alloy formation is apparent above the carbides, which contrasts sharply with the vigorous attack of the surrounding steel surface. Under-cutting of the inclusions by the adjacent heavy attack was a characteristic feature of coating structures prepared under these galvanizing conditions.

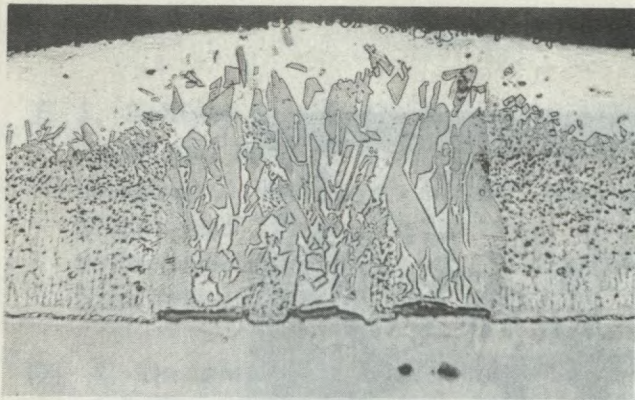
(a) 2 minute dip at
450°C (842°F)

Fig. 2. - Behaviour of carbides in aluminium-containing bath (0.1% Al, 0.5% Pb, 0.03% Fe). X500, nitramyl and picral etch.

- (a) Pronounced outburst of columnar crystals due to presence of carbides which have partially transformed.
- (b) An advanced stage of carbide transformation at long immersion time, showing break-up and floating away of dark-etching transformation products.
- (c) No apparent reaction of carbides at low bath temperature.

The addition of 0.10 per cent aluminium to an iron-saturated bath effected a pronounced change in the behaviour of the carbides. The normal well-defined alloy layers which formed on a carbide-free surface in such baths were completely broken up into a loosely-packed colony of angular crystals embedded in zinc as shown in Fig. 2 (a). These exhibited pronounced columnar growth towards

the surface. Extension of such an outburst above the level of the adjacent normal alloy growth resulted in the formation of a raised pimple on the surface. Where many such pimples formed, solidification of the eta layer was apparently so affected that spangling did not take place.

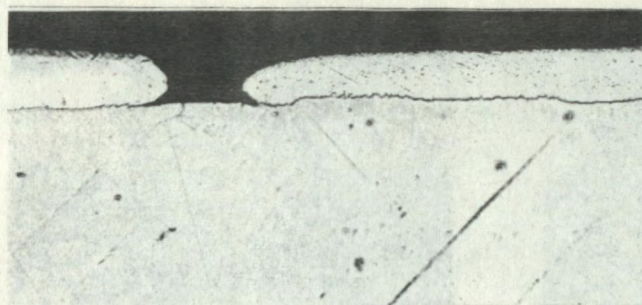
(a) X500, nitramyl etch.
1 minute dip at 455°C
(851°F).
Bath composition:
0.2% Al, 0.03% Fe.

Fig. 3. - Behaviour of carbides in high-aluminium baths.

- (a) Carbide not attacked or wetted, causing bare spot in coating.
- (b) Block crystal growth in coating, indicating reaction between carbide and zinc bath.
- (c) Little or no effect of carbide adjacent to local iron-zinc growth.

In baths containing 0.15 and 0.20 per cent aluminium the carbides behaved in an erratic manner. In some cases the particles were not wetted by the zinc so that small bare spots or pinholes

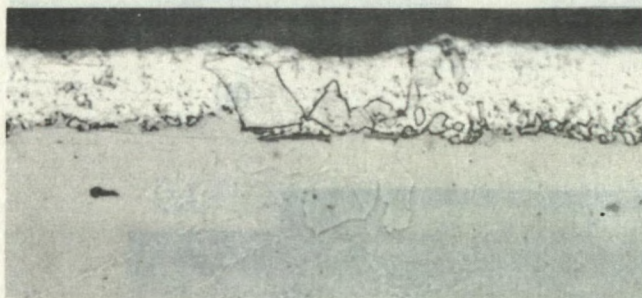
(b) X750, nitramyl etch.
2 minute dip at 450°C
(842°F).
Bath composition:
0.15% Al, 0.75% Pb,
0.03% Fe.

were formed in the coating, Fig. 3(a). In others, some reaction was indicated by the presence of the typical dark-etching phase at the surface of the carbides, and the relatively large blocks of crystals above these, Fig. 3(b). Although the coatings were thin, the crystals were buried in the eta layer and did not cause pimple formation on the surface. Where a carbide was located at or near a local iron-zinc alloy growth in the coating, the structure of the growth did not appear to be appreciably affected, Fig. 3(c).

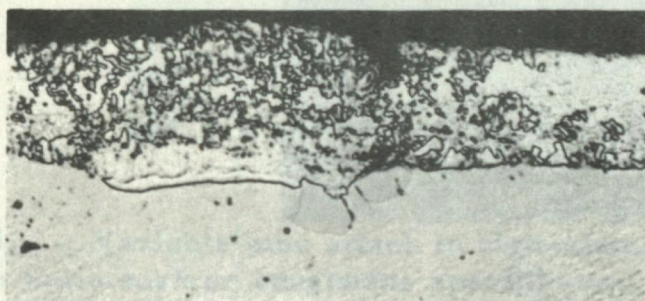
(c) X750, nitramyl etch.
2 minute dip at 450°C
(842°F).
Bath composition:
0.15% Al, 0.75% Pb,
0.03% Fe.

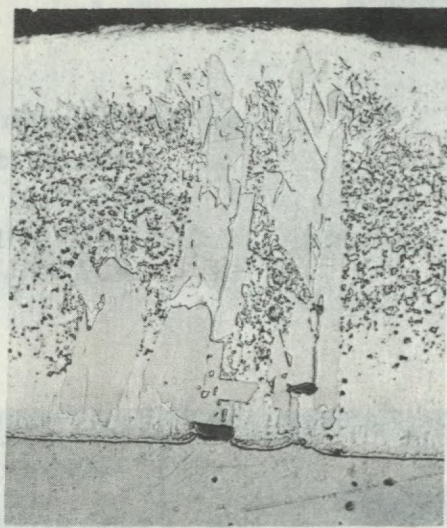
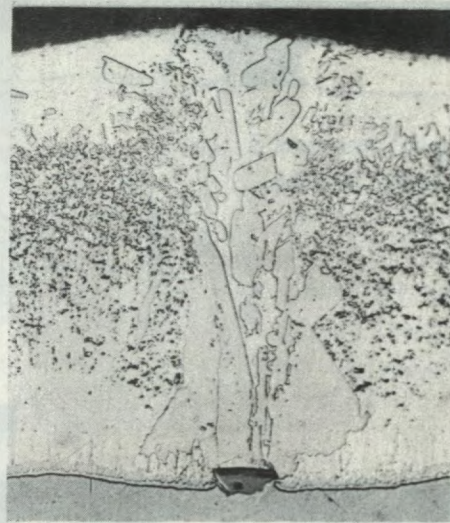
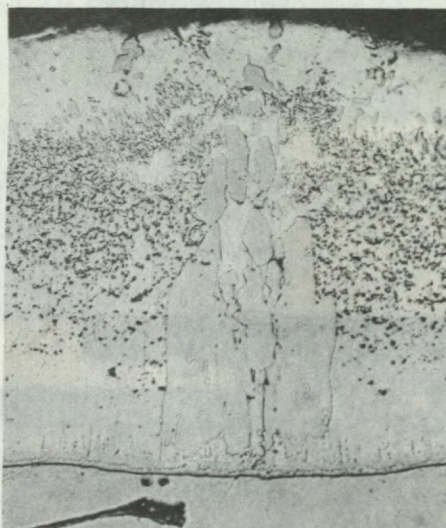
Fig. 4. - Structures at different levels through single iron-zinc alloy outburst, showing that the massive isolated crystals in (c) are related to the presence of carbide particle on the steel surface. 4 minute dip at 455°C (851°F). Bath composition: 0.1% Al, 0.5% Pb, 0.03% Fe.

(X500; nitramyl and picral etch.)

On closer study it was observed that some of the more prominent block crystals appeared to be related to the disrupted alloy structure associated with the carbide inclusions. To confirm this, various samples were lightly reground and repolished a number of times and photomicrographs taken at the different levels. A typical series is shown in Figs. 4(a), (b), (c). The isolated massive crystal formation in Fig. 4(c) is similar to that illustrated by Haughton(2). As indicated by this series, the group of crystals shown in this latter photomicrograph appeared to be related primarily to the presence of a carbide inclusion on the steel surface, and this is supported by comparison of these photomicrographs with Fig. 2(a)(2 minute dip). In the various samples examined it could not be established that a long dipping time was solely responsible for the formation of such crystals; on carbide-free sheet

subjected to similar galvanizing conditions, only a small number of isolated block crystals were observed and these were much smaller than that shown in Fig. 4(c).

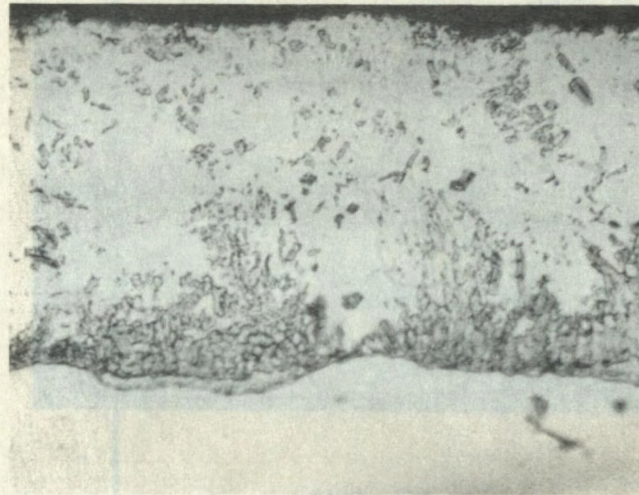
(a) X750; nitramyl and picral etch.

Fig. 5. - Variable zinc attack in high-aluminium bath of steels processed to same surface roughness specification. 2 minute dip at 450°C (842°F). Bath composition: 0.15% Al, 0.75% Pb, 0.03% Fe.

- (a) Extensive iron-zinc alloy growth and very heavy coating on smoother but more reactive steel.
- (b) Normal coating on steel with rougher "as received" surface finish.

Specimens of both No. 5 finish materials were galvanized under similar conditions in baths containing 0.15 per cent aluminium. Stripping tests revealed that coating weights on one lot of steel were more than twice those on the other. Micro-examination showed many separated patches of heavy alloy growth on the thickly-coated steel sheet despite the high aluminium level, Fig. 5(a). The eta layer was also very thick. The other steel represented more normal behaviour with a structure as illustrated in Fig. 5 (b). Only a thin uniform fringe of alloy was evident at the steel surface.

Macro-examination of the "as received" materials provided a probable explanation for these marked differences. In the case of the steel with normal coating structure, the surface profile imparted by temper rolling was moderately rough but uniform. On the other material the high spots on the roughened surface appeared to have been subjected to a rubbing or galling action indicating these areas had been heavily worked. It is suggested that the activity of the two steels in the zinc bath is related to the type and degree of surface working during temper rolling, assuming all other production conditions were similar. The actual physical roughness was not significant since comparison of the surface profiles with a Talysurf instrument revealed that the heavily-coated steel had a smoother surface.

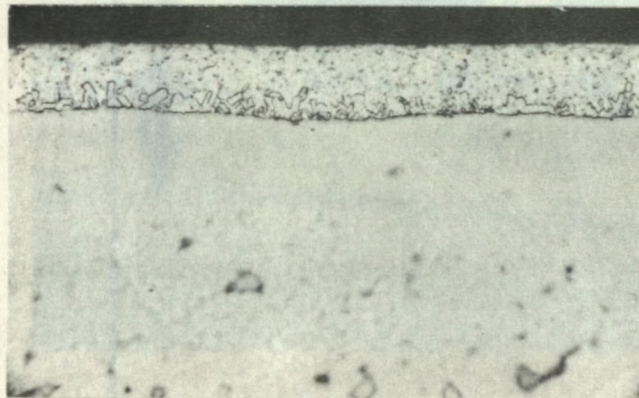
(b) X750; nitramyl etch.

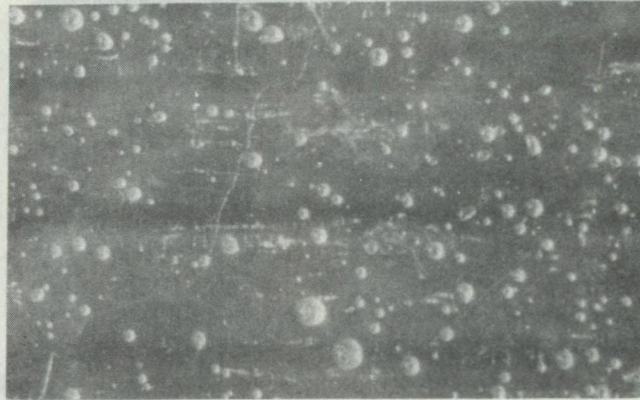
(a) X30.

Fig. 6. - (a) Typical pore depressions on coating surface.
(b) Structure through pore, showing penetration into eta layer and embedded zeta crystals at the pore periphery.

A common defect observed on experimentally galvanized panels was the occurrence of numerous small depressions or pores on the coating surface, Fig. 6(a). The most significant feature of these was their shape, and with few exceptions they resembled perfectly formed ball or oval-shaped impressions. At high magnification, one or more angular-shaped inclusions were seen to be embedded in each pore.

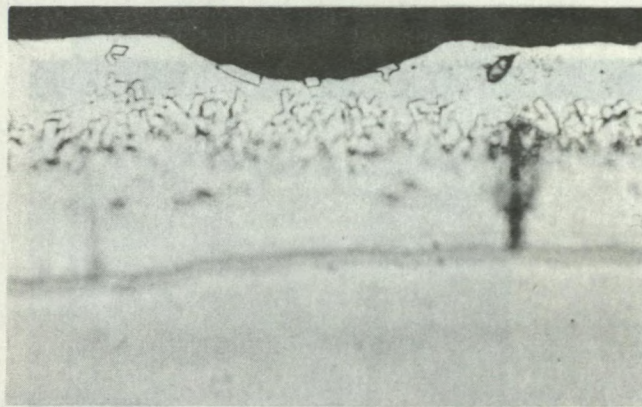
(b) X1000, nitramyl etch.

Micro-examination of cross-section samples confirmed that the pores were spherical or oval-shaped depressions which penetrated to various depths depending on the coating structure. In coatings where the various iron-zinc phases were present the pores seldom penetrated beyond 50 per cent of the thickness of the eta layer. Where alloy growth had been suppressed and the coating consisted essentially of zinc, the pores were of varying depth; in isolated cases, particularly when such coatings were very thin, the base of the pore was only slightly separated from the steel surface. The embedded inclusions were revealed to be particles of the zeta phase which had floated away from the alloy layer. As illustrated in Fig. 6(b), the size and shape of the inclusions corresponded to the fringed structure of the zeta layer, and the etching behaviour was also similar.
