# **COMPARISON OF NOTCH-DUCTILITY AND WELD- ABILITY OF THREE HIGH-STRENGTH STRUCTURAL STEELS**

W.P. Campbell

JANUARY 1977

MINERALS RESEARCH PROGRAM  
PHYSICAL METALLURGY RESEARCH LABORATORIES  
CANMET REPORT 77-38

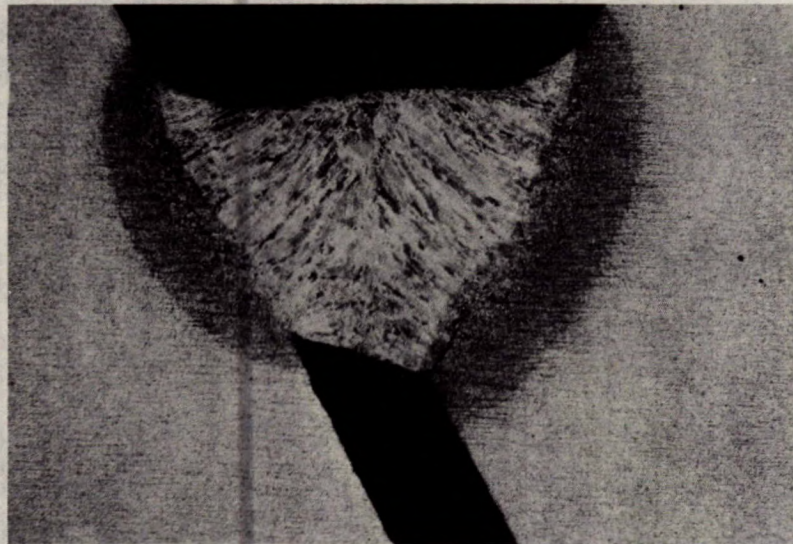
Fig. 7. Moderate cracking in Y-groove test.

Table 5 summarizes valid comparative tests performed on the three steels. Figures 7 and 8, although from tests in a C-Mn steel [9], are reasonably illustrative of moderate and severe cracking, respectively, found in the tests summarized in Table 5. Metallographic examination confirmed that cracking in these tests initiated at or close to the junction of the root gap and the weld and extended upward in the HAZ. In sections judged to show severe cracking, frequently the crack had changed direction and propagated into the weld as illustrated in Fig. 8. In other cases, the crack remained entirely within the HAZ, or after deflecting into the weld from the HAZ, it then changed direction and travelled from the weld back into the HAZ. The path of severe cracking was observed to vary considerably, even in adjacent sections of the same test weld.

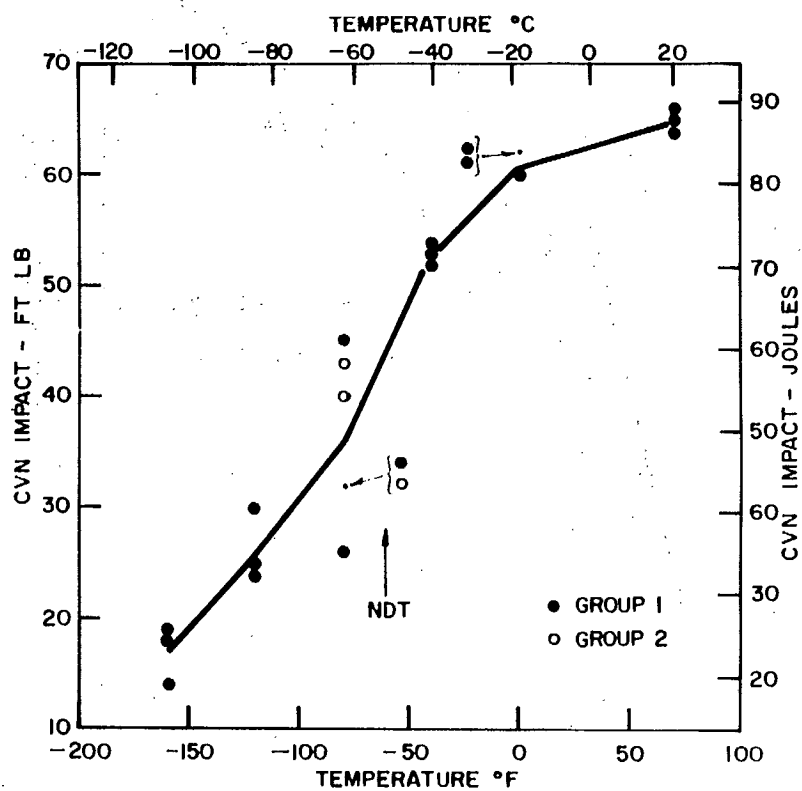
Fig. 12. Charpy V-notch properties - weld in 1-in. (25-mm) CHT-100 plate.

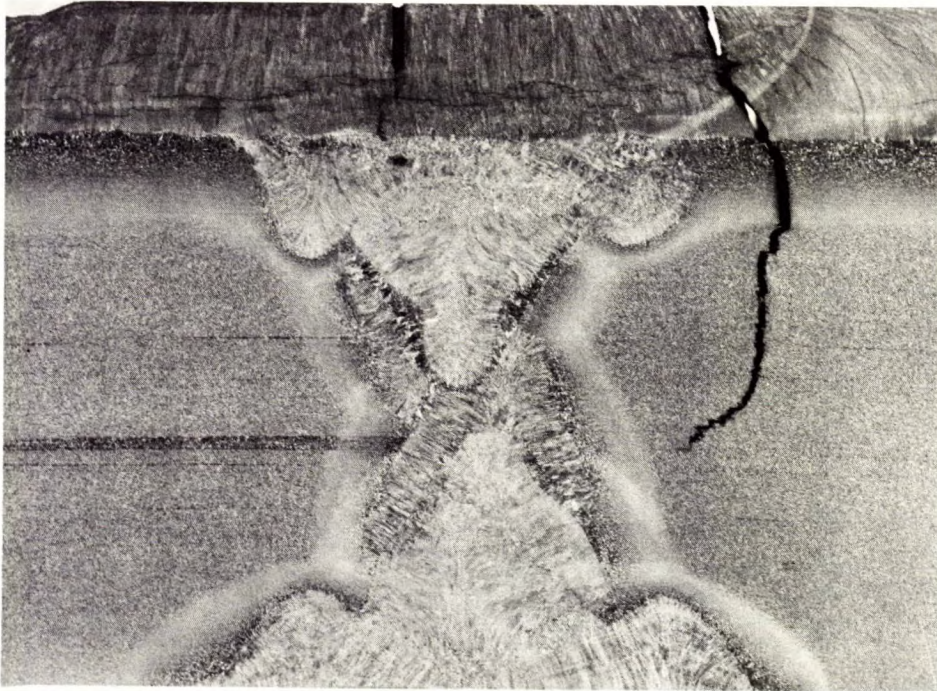
Fig. 13. Illustrating anomalous behaviour in drop-weight test of a specimen from a CHT-100 weld.

With the first set of CHT-100 welded specimens, and both sets of Cu-Ni welded specimens, anomalous transverse cracking occurred in the Hardex N bead in many tests. In several tests, this cracking propagated to the edge(s) of the specimen, and, as for the prime plate tests (see Table 4), such an occurrence was classed as a break. However, because the cracking was about 1/2 in.

(13 mm) away from the notch, the crack path was in the plate material rather than in the weld being tested (Fig. 13). In view of this experience, as well as the earlier experience with similar cracks when testing all three prime plate steels, it was decided to undertake some auxiliary studies to evaluate this anomalous behaviour.

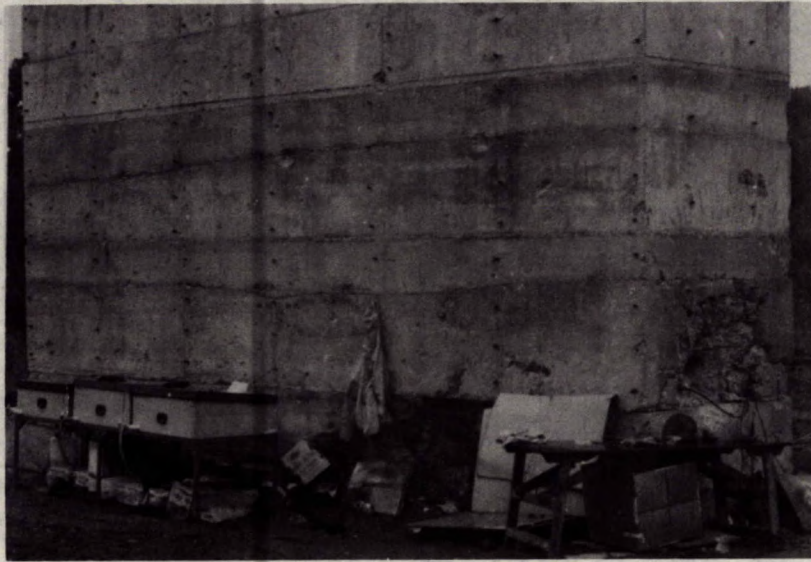
Fig. 15. Cooling baths located on one side of concrete wall.

Testing was conducted at the site, shown in Fig. 14, on the demolition range of the Canadian Forces Base, Petawawa, Ontario. Each specimen was cooled to the required test temperature in one of the three cooling baths placed on one side of the thick concrete wall, and then rapidly positioned on the die assembly seated on the concrete footing on the opposite side of the wall (Fig. 15, 16). The explosive charge was held at a fixed distance above the specimen by means of a cardboard box (Fig. 17) and connected to a detonator inside an armoured personnel carrier located on the other side of the wall. After all personnel were safely inside the carrier, the charge was detonated.

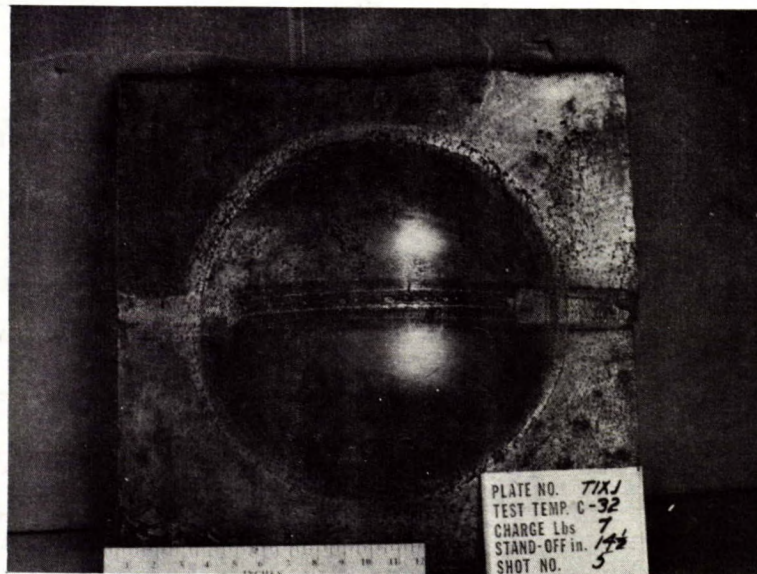
Fig. 18. T-1 steel weldment TLXJ after 5 shots at  $-32^{\circ}\text{C}(-25^{\circ}\text{F})$ . No cracking after 4 shots and 9% thickness reduction. On the fifth shot, two cracks, each about  $3/4$  in. (19 mm) long, developed on the surface, at a total thickness reduction of 10-11%. See also Fig. 19.

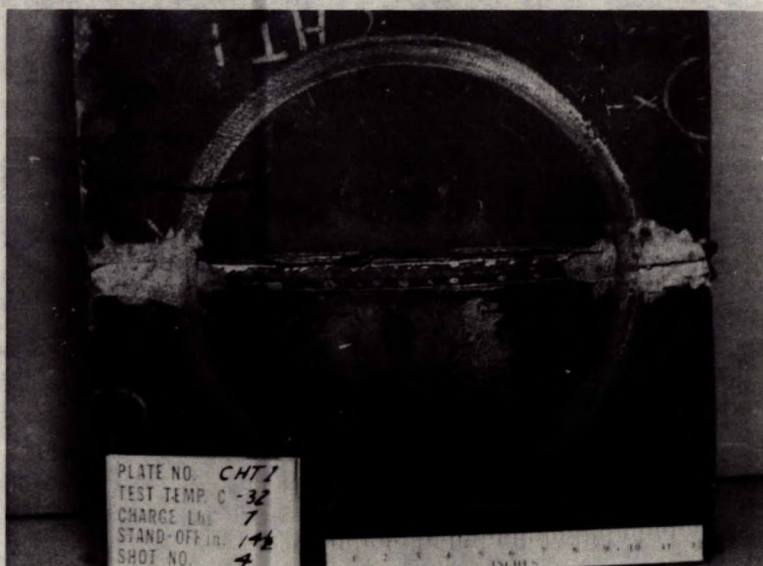
Fig. 20. CHT-100 steel weldment CHT1 after 4 shots at  $-32^{\circ}\text{C}$  ( $-25^{\circ}\text{F}$ ). No cracking after 3 shots and 7% thickness reduction.

CHT1: In the bulge region, most of the fracture path in the lower half of the fracture appeared to be in the plate, at or close to the weld fusion line, as traces of the weld bead pattern were visible. On the upper half of the fracture, the path appeared to travel through the weld.

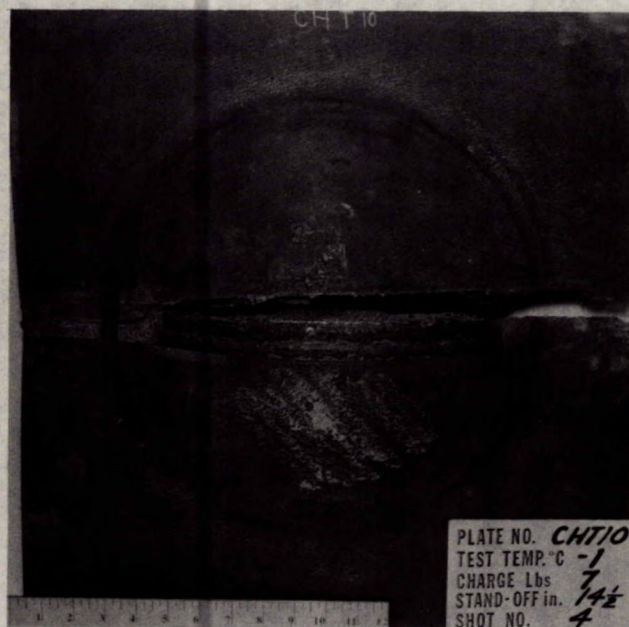
Fig. 24. CHT-100 steel weldment CHT10 after 4 shots at  $-1^{\circ}\text{C}$  ( $30^{\circ}\text{F}$ ). No cracking after 3 shots and 5% thickness reduction.

CHT10: In the central 3-in. (76-mm) region, the visual appearance indicated that the fracture had extended from the weld toe through the plate outside the HAZ. On either side of this central region, the fracture was closer to the weld outline but without showing any traces of weld bead pattern. Thus the fracture path was judged to be either in the HAZ away from the weld fusion line, or in prime plate outside the HAZ.

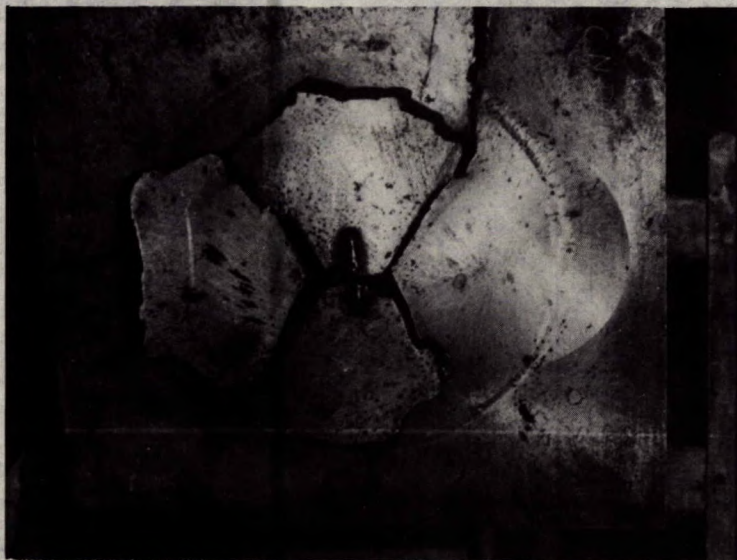
Fig. 28. Explosion-bulge crack-starter test on Cu-Ni plate after 1 shot at  $-65^{\circ}\text{C}$  ( $-85^{\circ}\text{F}$ ).

At -65°C (-85°F), the plate broke into several pieces on the first shot (Fig. 28). The primary fracture initiation was in the crack-starter bead about 1/4 in. (6 mm) from the notch.
