**EXPLORATORY CORROSION TESTS IN THE
CANADIAN ARCTIC**

G.J. Biefer

MARCH 1977

MINERALS RESEARCH PROGRAM
PHYSICAL METALLURGY RESEARCH LABORATORIES
CANMET REPORT 77-45

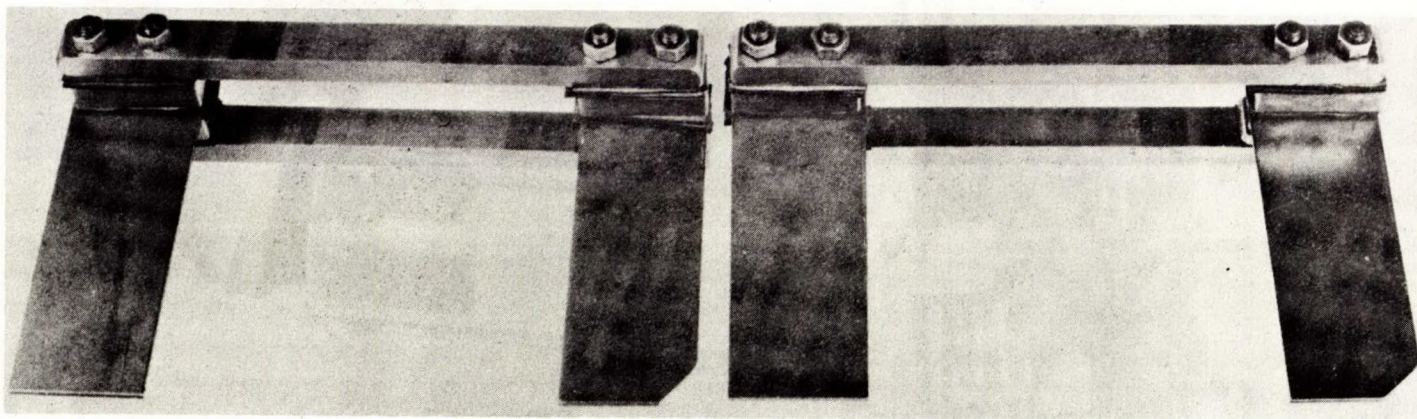
Fig. 1. Specimens in racks prior to sea-water test at Musquash Harbour, N.B.
X 1/3

Two panels, approximately 150 x 50 mm, were prepared for each steel, the rolled surfaces being left in the as-received condition. Under the direction of R.K. Buhr of PMRL, two specimen racks were fabricated (Fig. 1). Each was designed to hold two specimens, one of each alloy, the specimens being isolated from galvanic effects by means of rubber spacers. The rack could then be clamped onto some suitable submerged structure. Under the supervision of F. McKinnon of the Department of Transport, the two racks were installed on the mooring chain of a buoy at Musquash Harbour, N.B., in the Bay of Fundy, a few miles west of Saint John. The buoy was in 18 m of water at low tide; one assembly was 4.5 m below the buoy and the other 13.7 m below the buoy. The average difference in level between high and low tide at Musquash Harbour has been stated to be approximately 6 m.

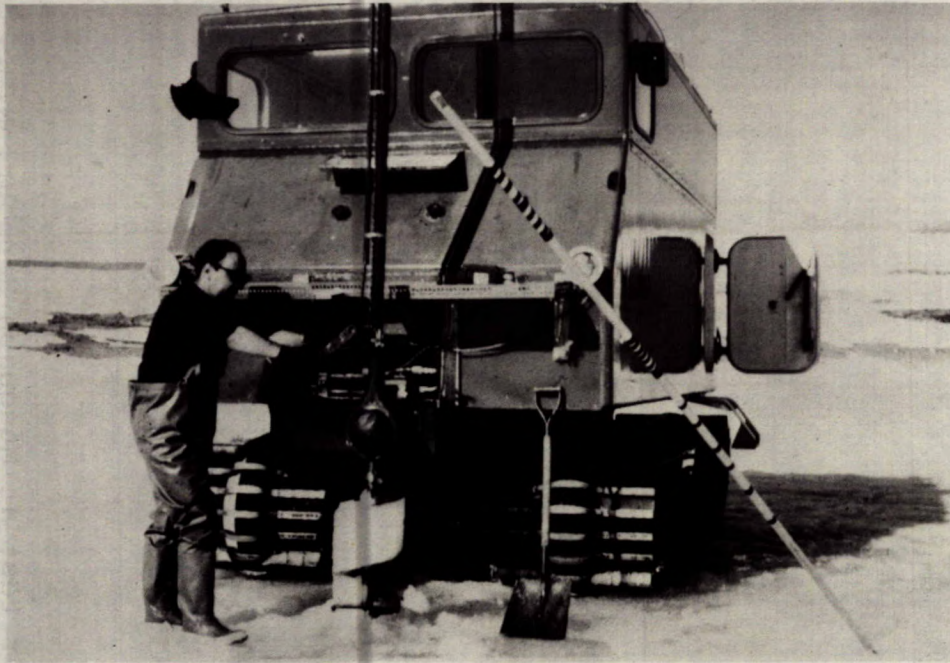
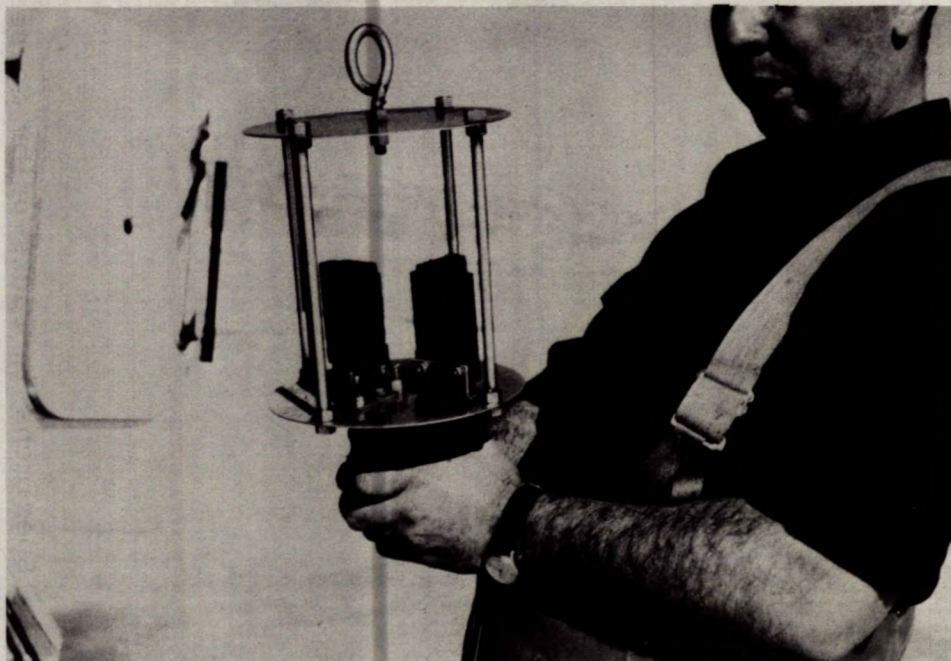
Fig. 2. Recovery of specimens at d'Iberville Fiord:
(a) drilling a hole through the ice;
(b) specimen rack.
(Photographs supplied by R.A. Lake of Environment
Canada).

The steel tested was Stelco G40.8 Grade B (since 1973, G40.21 Grade 38T) 12.5-mm thick plate having the composition shown in Table 1. Specimens about 50 x 80 x 12.5 mm were cut from the plate. After surface-finishing on a belt grinder using 80 grit, four specimens were mounted on a Type 304 stainless steel "birdcage" rack, shown in Fig. 2. Care was taken to electrically insulate the specimens from the rack.

requirements of the Frozen Sea Research Group necessitated recovery of the specimens on June 18, 1973. This involved drilling a hole through the ice, hooking the float, and raising the assembly to the surface. The rack and specimens were then dried immediately in warm air and stowed in a dessicated plastic bag for shipment to PMRL. Figure 2 illustrates phases of the recovery operation.

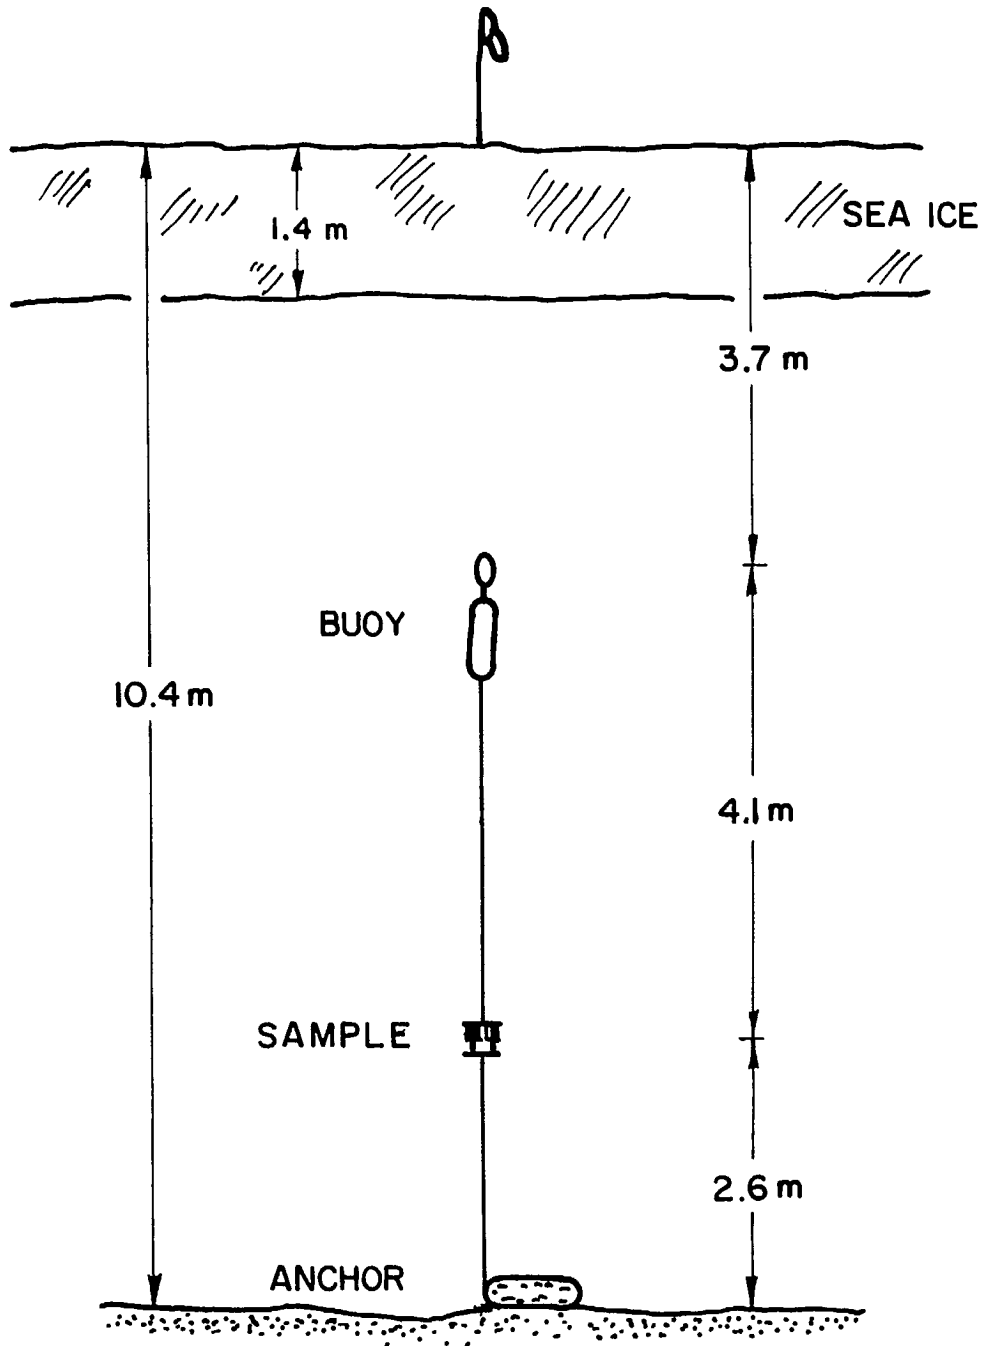
Fig. 3. Sketch showing method used to moor specimens at d'Iberville Fiord (supplied by R.A. Lake of Environment Canada).

Personnel of the Frozen Sea Research Group (Environment Canada) immersed the rack of specimens in sea water at d'Iberville Fiord (80°35'N, 80°00'W) on March 28, 1973. Because the fiord was frozen over, it was necessary to drill a hole through the ice. An anchor was fastened to the bottom of the rack and a float to the top, and the assembly was lowered through the hole. A flag was used to mark the position of the rack (Fig. 3). Operational

R.A. Lake, who was in charge of the operation, supplied the sketch reproduced in Fig. 3, showing how the rack was suspended about 2.5 m above the bottom, in sea water about 10 m deep. Lake stated that, in April, the sea water had the following characteristics: temperature, -1.28°C ; salinity, 31.20 0/00; pH, 7.4-7.8;* dissolved oxygen, 10 ml/l; current velocity (estimate), ~ 1 cm/sec or less.

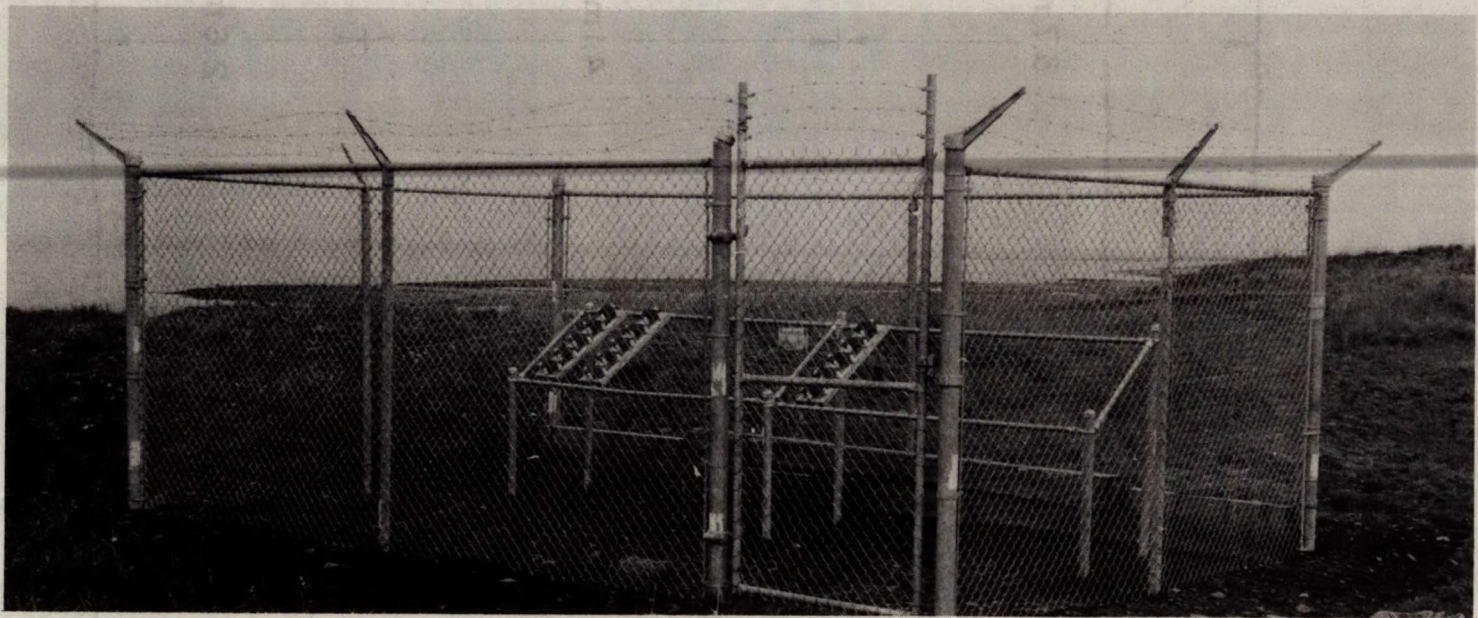
Fig. 4. Atmospheric testing station at Tuktoyaktuk, N.W.T., July 1973.

An atmospheric corrosion testing station was constructed at Tuktoyaktuk, July 1-10, 1973, by PMRL personnel assisted by local labourers provided by PCSP. It consisted of conventional south-facing racks protected by a 2-m high chain link fence enclosing a compound about 6 x 3.7 m in size. The compound was located adjacent to the PCSP base camp and the Tuktoyaktuk landing strip and was about 70 m from the Beaufort Sea (Fig. 4).

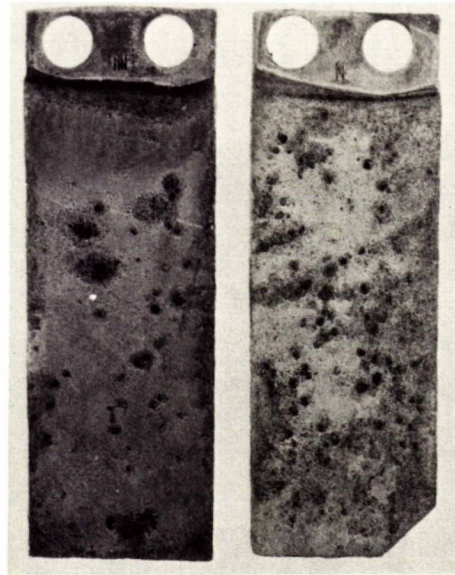
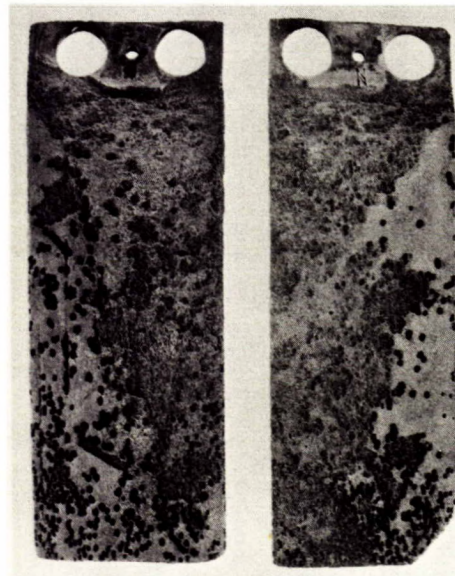
Fig. 5. De-rusted specimens after 195-day test at Musquash Harbour, N.B.

- (a) specimens at 4.5-m depth;
- (b) specimens at 13.7-m depth.

The as-received specimens were free from adherent organic growth, but were pitted and partially coated with loose rust. The specimens were de-rusted in inhibited acid, then weighed and examined. The appearance of the de-rusted specimens, shown in Fig. 5, indicates that pitting was more severe at the 13.7-m depth. Weight losses are given in Table 2.

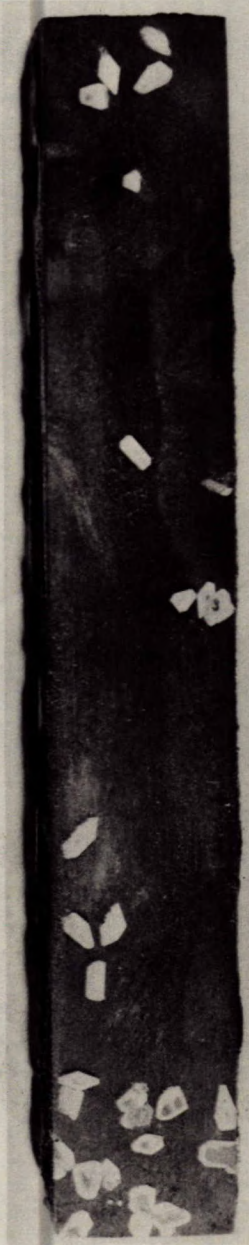
Fig. 6. Edge view of specimen 4 after immersion in d'Iberville Fiord for 82 days, showing CaCO_3 deposits. X2

The as-received specimens exhibited loosely adhering red rust and light-coloured crystalline deposits, as shown in Fig. 6. Analysis of the latter showed them to be primarily calcite (CaCO_3). After de-rusting in inhibited acid, specimen surfaces showed only a very slight, uniform etching in some areas and virtually no attack in other areas. Pitting was negligible.

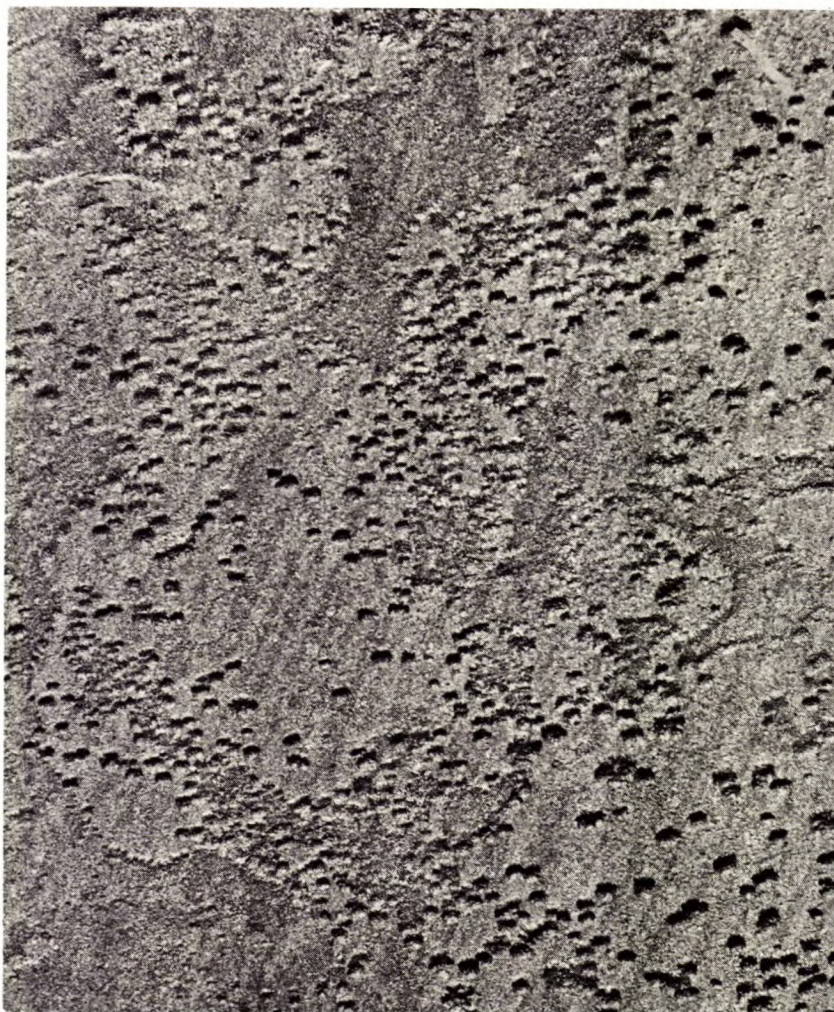
Fig. 7. Surface of specimen 2, after immersion for 107 days in Halifax Harbour, showing corrosion pits. Because of an optical illusion, these may appear either as depressions (correct) or protuberances.

Specimen 3 (82 days' exposure) showed relatively uniform corrosion attack but the other two specimens, immersed 107 days, showed definite pitting attack. An example of this is given in Fig. 7, photographed after the specimen had been de-rusted in inhibited acid. Weight losses are given in Table 2.

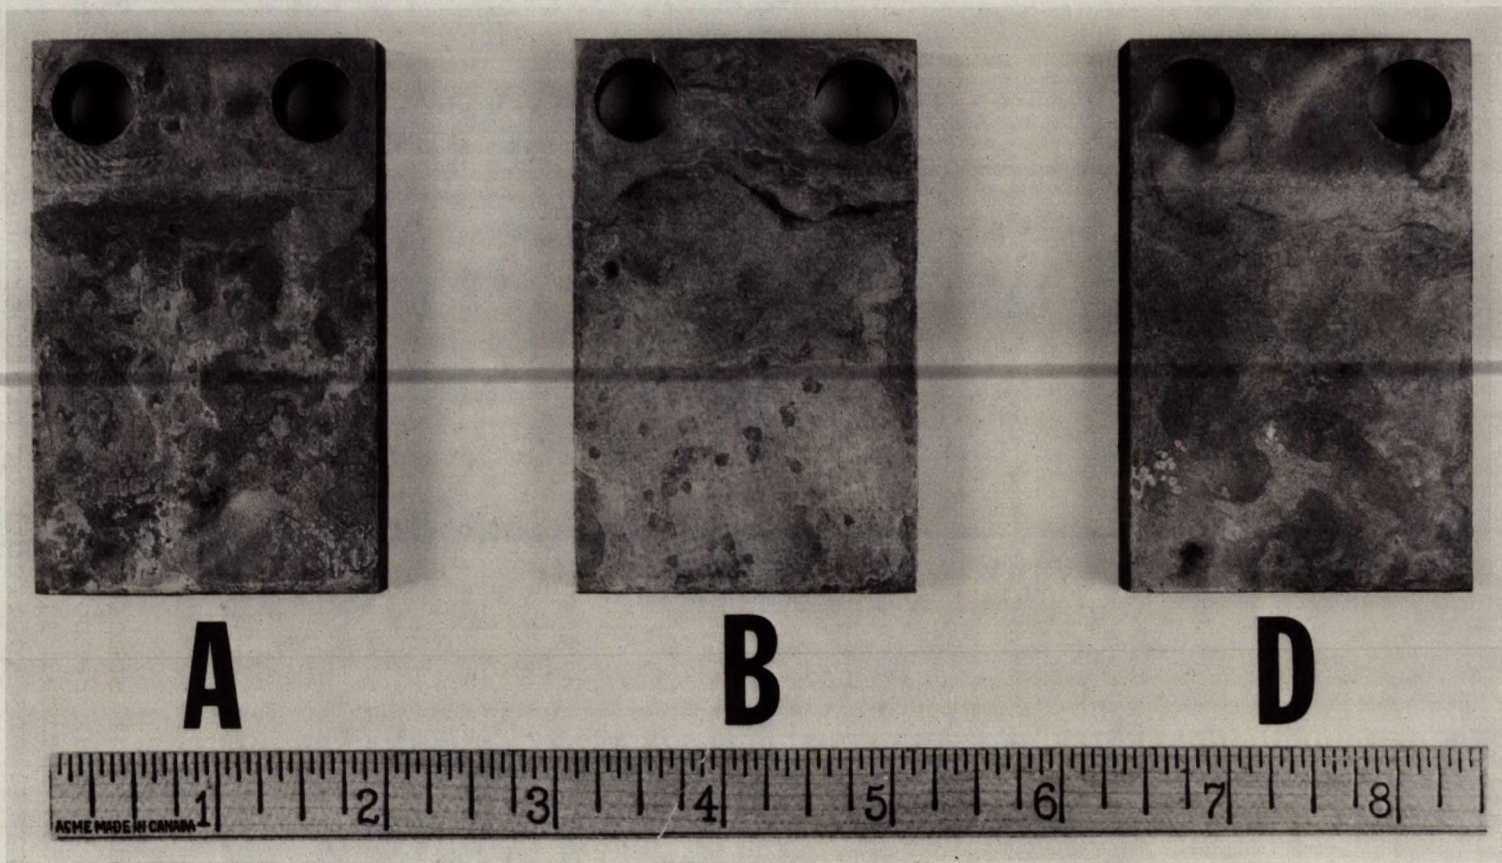
Fig. 8. De-rusted specimens after 1 year in sea water at Devon Island, N.W.T.

Subsequent to de-rusting in inhibited acid, weight losses by corrosion were shown to be those in Table 2. Specimen surfaces were relatively smooth, with only large, shallow pits and etched areas to be seen (Fig. 8). The depths of some of these were measured relative to the very lightly corroded rim which had been in contact with a plexiglass backing. The maximum depths thus measured (not necessarily the deepest penetrations) are shown in Table 2.

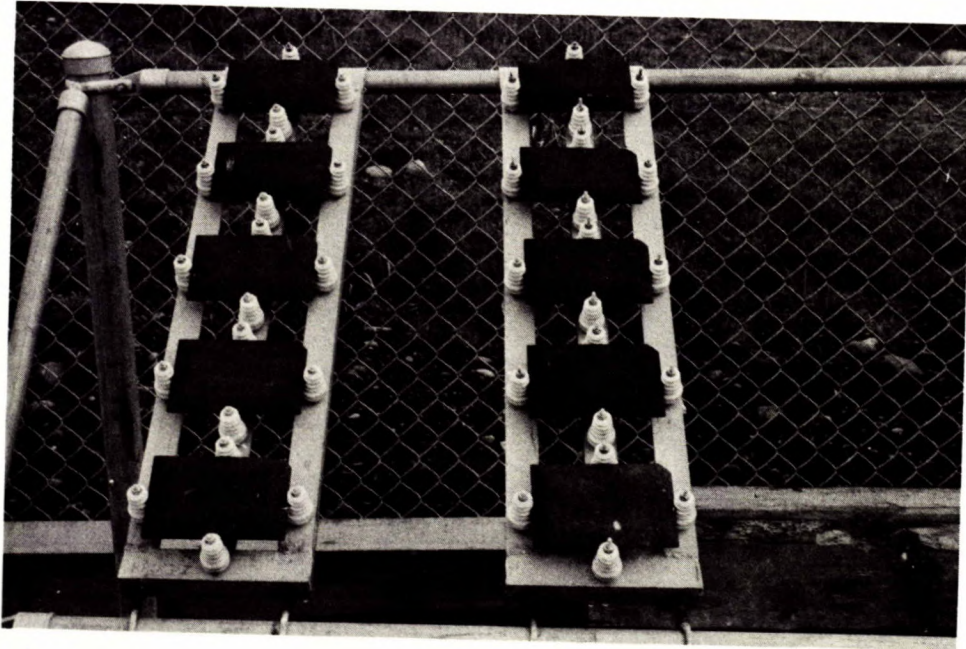
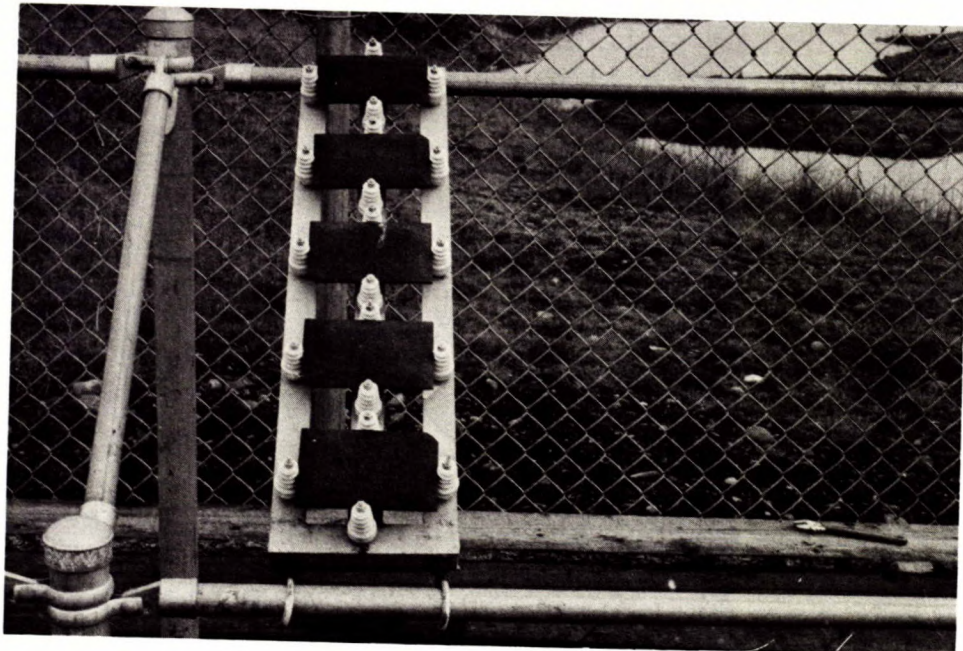
Fig. 9. Specimens of structural steel after one-year's exposure at Tuktoyaktuk, N.W.T.

After exposure to the atmosphere at Tuktoyaktuk for one year, the structural steel specimens showed rusty surfaces, as did all uncoated steel nuts, bolts, etc., used in the construction of the compound and the racks. The galvanized steel was in excellent condition except for minor staining at a few places. These features can be seen in Fig. 9, showing the specimens after exposure for one year at Tuktoyaktuk. Very little additional corrosion appeared to have occurred after three years exposure.

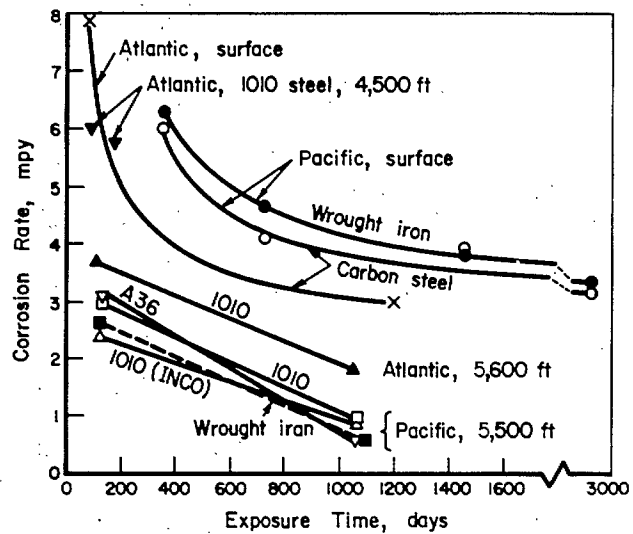
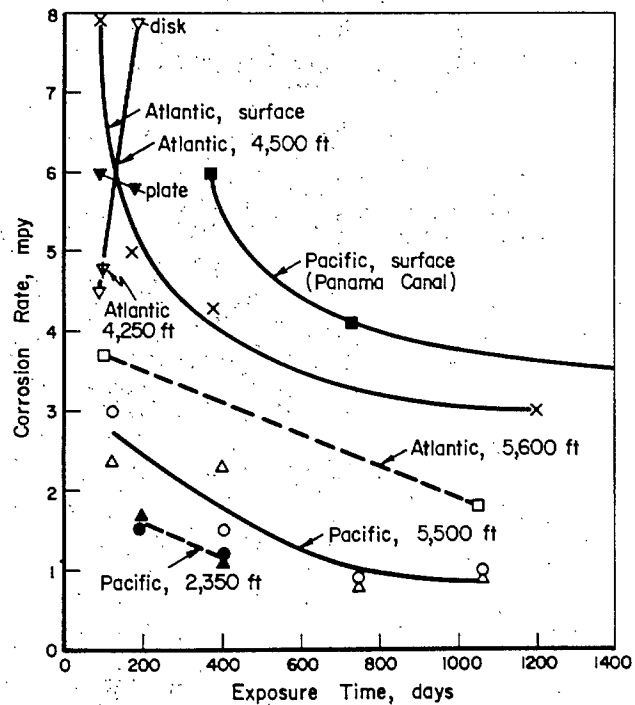
Fig. 10. Figures extracted from reference (1), showing sea-water corrosion rates as a function of exposure time (1 mil = 25.4 μm).

Steels in low-velocity sea water generally show their most rapid corrosion rates immediately after immersion; there is then a decline in the corrosion rate which may approach a steady state, usually after a year or more on test(1). This is illustrated by the results reproduced in Fig. 10.

Corrosion rates for each specimen are plotted versus exposure time (Fig. 11). It can be seen that corrosion rates in the Arctic tests are considerably lower than those observed in Maritime waters. Comparison with the data in Fig. 10 suggests that corrosion rates in Maritime waters are somewhat higher than those generally observed at the surface of the Atlantic and Pacific oceans. The corrosion rates observed in the Arctic, on the other hand, resemble those obtained in deep sea water, with d'Iberville Fiord providing the least corrosive conditions of the four test locations.

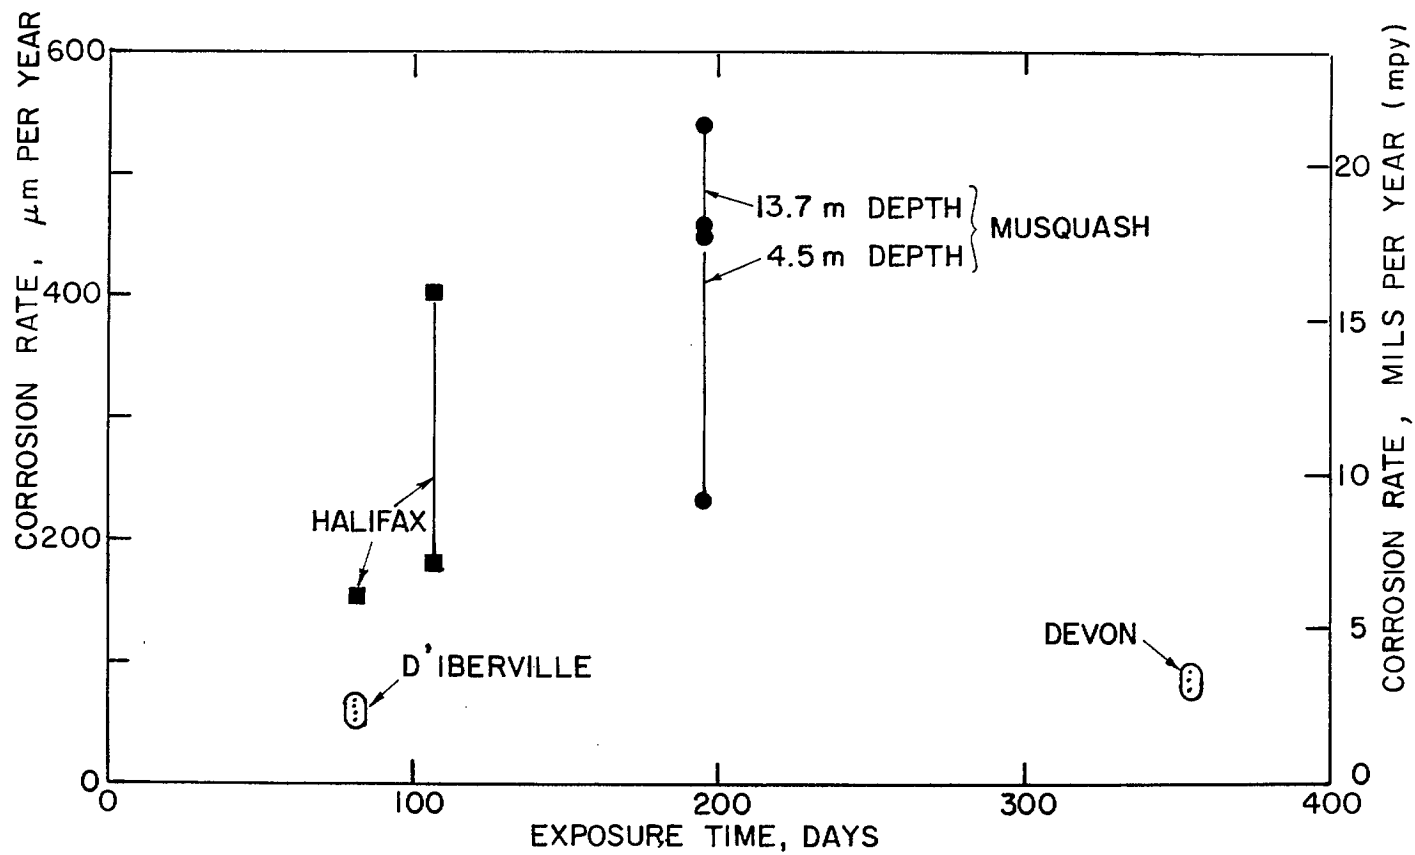
Fig. 11. Average corrosion rates of carbon and alloy steels in the sea-water tests.

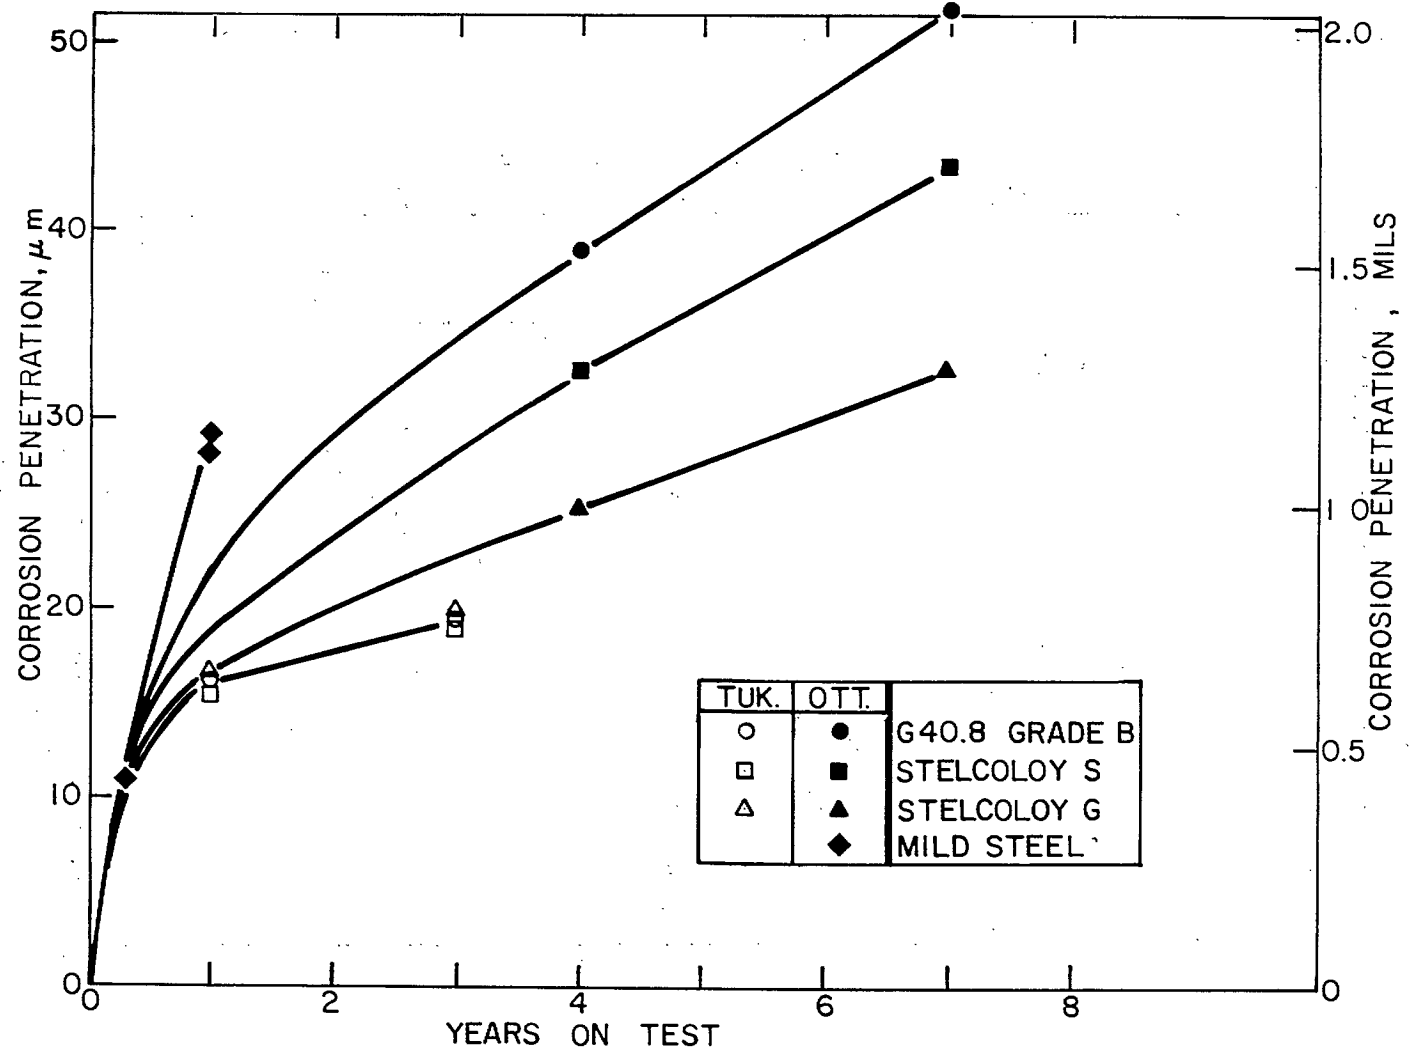
Fig. 12. Atmospheric corrosion behaviour of steels at Tuktoyaktuk, N.W.T., and Ottawa, Ontario.

The results obtained in the test at Tuktoyaktuk are presented graphically in Fig. 12. Also shown are the results obtained in tests on the same alloys and a mild steel (see Table 1 for composition) performed on the roof of the PMRL Building, Ottawa. The corrosion rates are evidently lower at Tuktoyaktuk, averaging 1.6-1.9 $\mu\text{m}/\text{yr}$ for all three alloys over the one- to three-year period (Table 3). Average penetration by corrosion after three years is about 20 μm . It is interesting to note that obvious differences between the three structural steels in Ottawa are not observed in the Tuktoyaktuk tests.
