GEOLOGICAL SURVEY OF CANADA

OPEN FILE 8545

**Decommissioning of shallow observation wells in the
McCully gas field area, New Brunswick**

2019

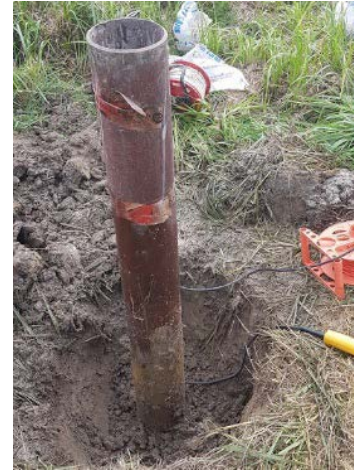
Figure 4 - Hole dug around the well

1. A hole was dug around the well to a depth of approximately 0.6 to 0.8 m (Figure 4) according to the guidelines (Government of New Brunswick, 2010);
2. The casing was then cut 0.6 m below the ground surface (Figure 5)

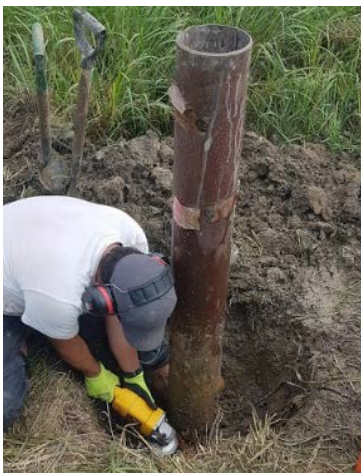
Figure 5 - Cutting of the casing

prevent skin irritation and for protection against dust (Figure 8). Cutting the casing using a grinder leads to other risks such as metal dust inhalation and earing discomfort. To prevent this, earmuffs were used in addition to the security glasses (see Figure 5).

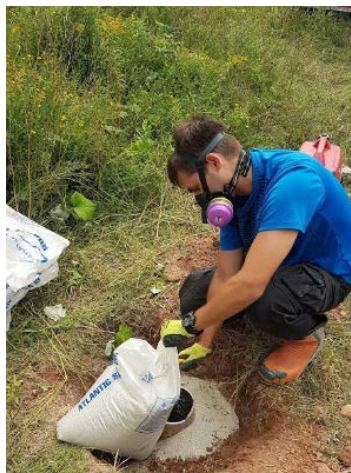
Figure 6 - Pouring of sand in the well

3. After having measured the well depth and casing length, silica sand was poured into the observation well to fill the “open” section (with no casing), up to at least 3 m below the metal casing (Figure 6);

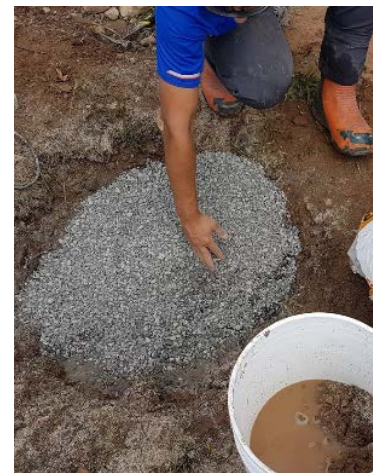
Figure 7 - Mix of silica sand, bentonite chips and overburden material

5. At the surface, the hole dug was filled with a mixture of silica sand, bentonite chips and local overburden material (Figure 7).

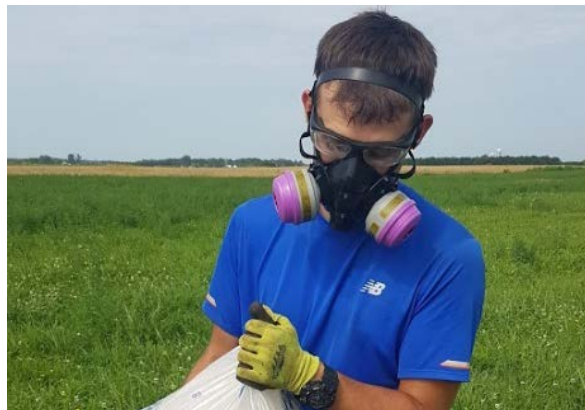
Figure 8 - Half mask respirator and gloves used while manipulating silica sand and bentonite

Using silica sand and bentonite chips entails some health risks, including silicosis and other respiratory diseases over the long term. To avoid any breathing discomfort or unpleasantness, half mask respirator with multi-contaminant cartridge and P100 filter (for debris and materials that are larger than 0.3 microns or greater) were used when working with these materials. Gloves and security glasses were also used to

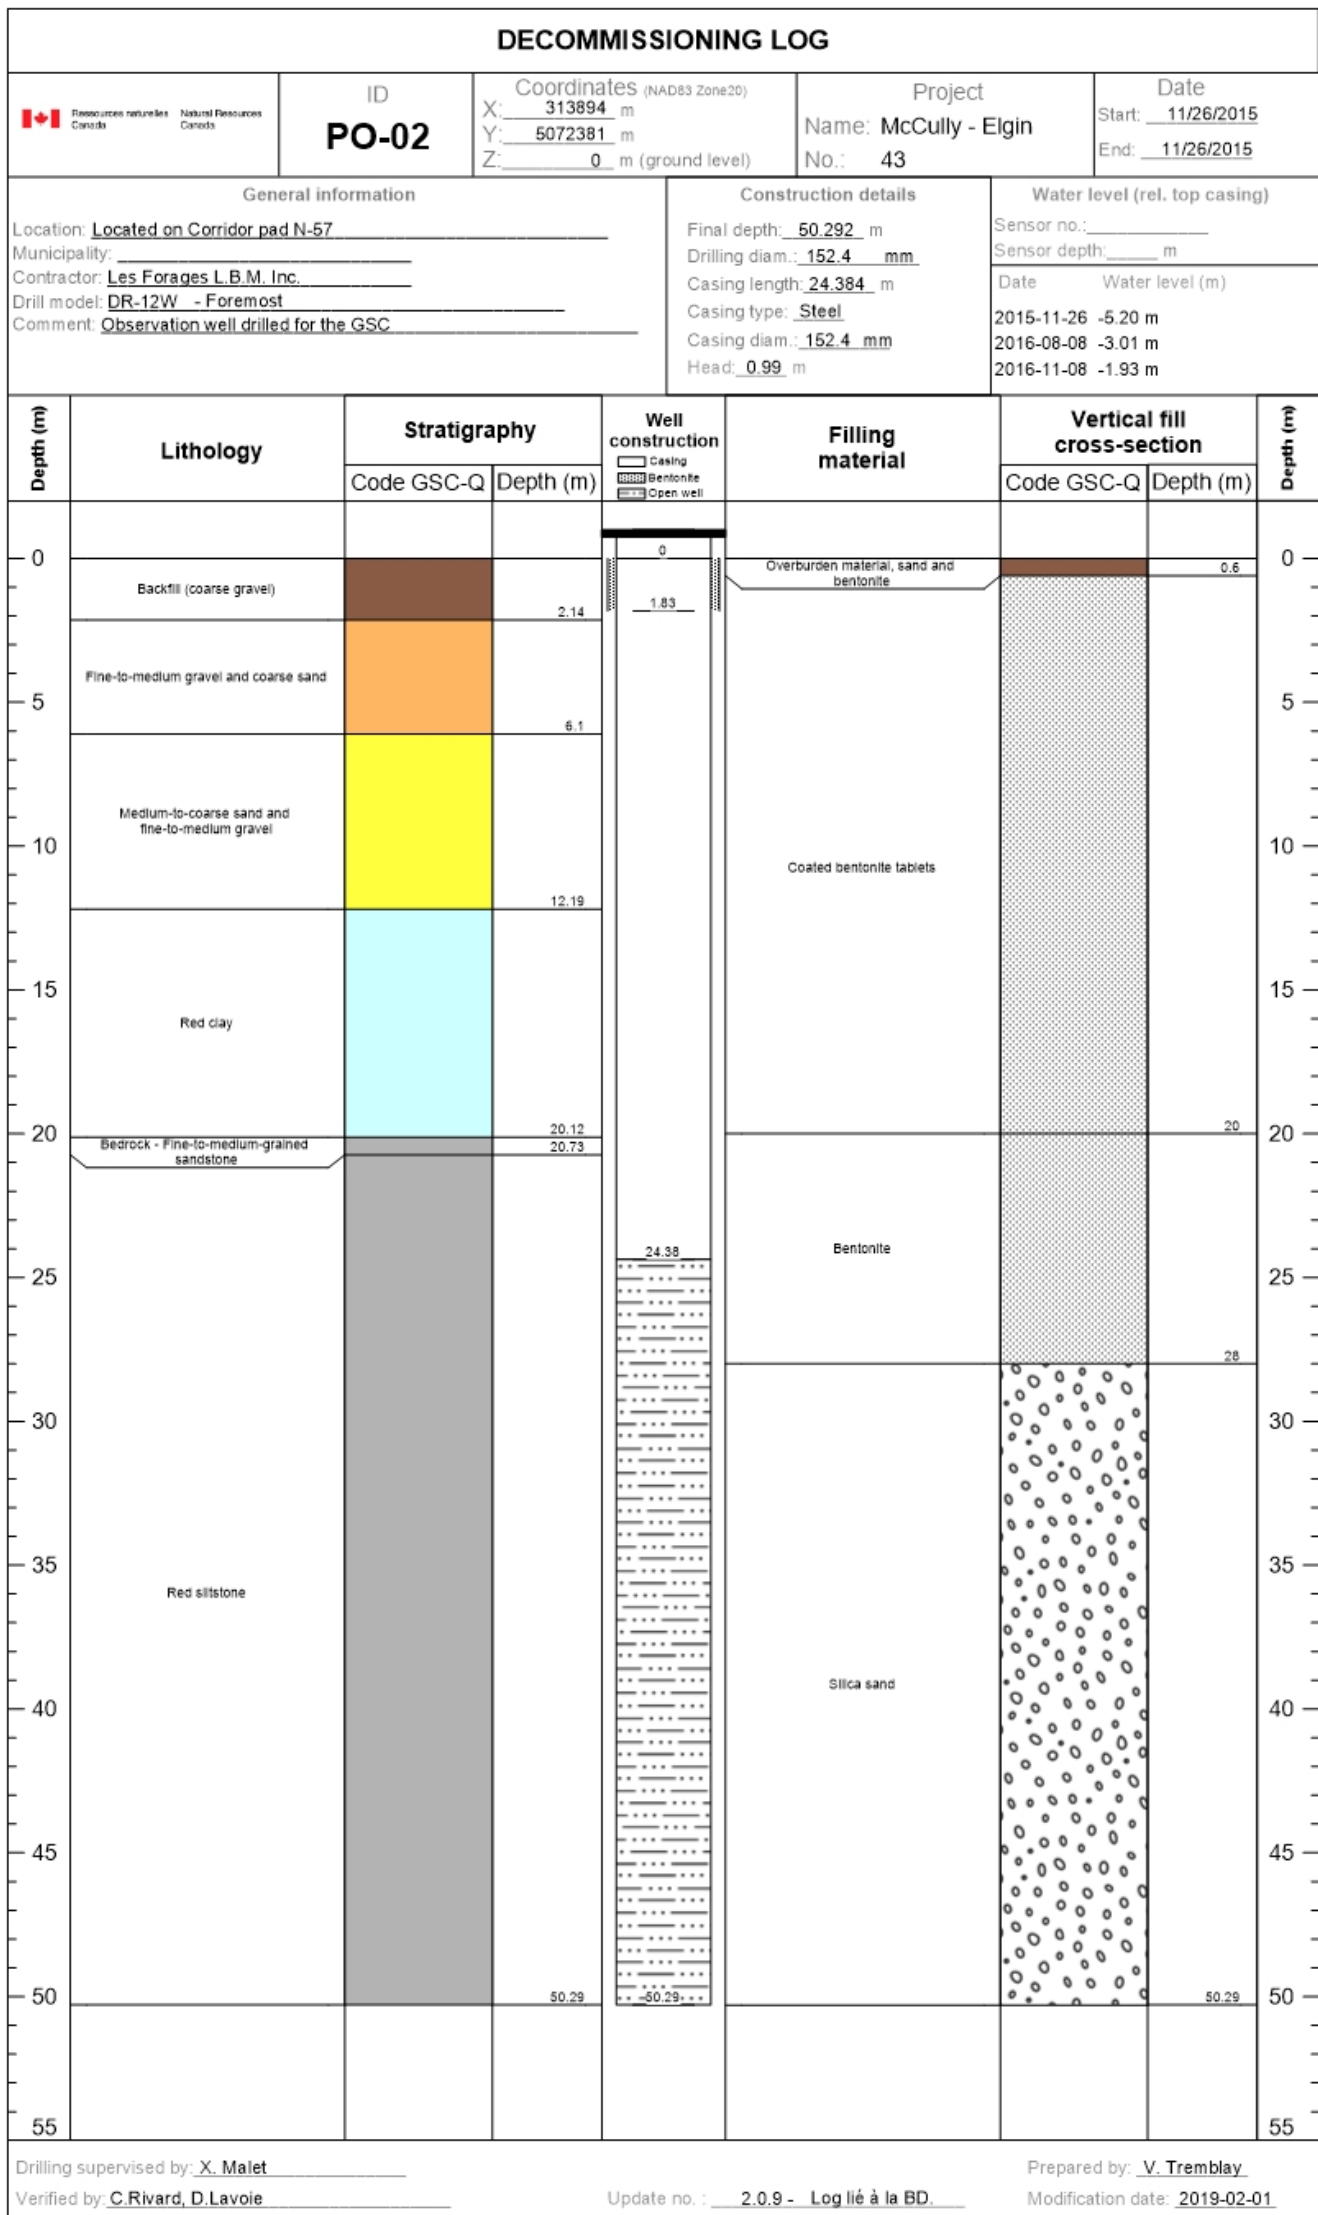
Figure 10 - PO-02 decommissioning log

Figures 9 to 19 present the well logs, showing to the left the geological log and to the right, the “decommissioned well log” or “vertical fill cross-section”, i.e., the material used to fill them with associated thickness / length.

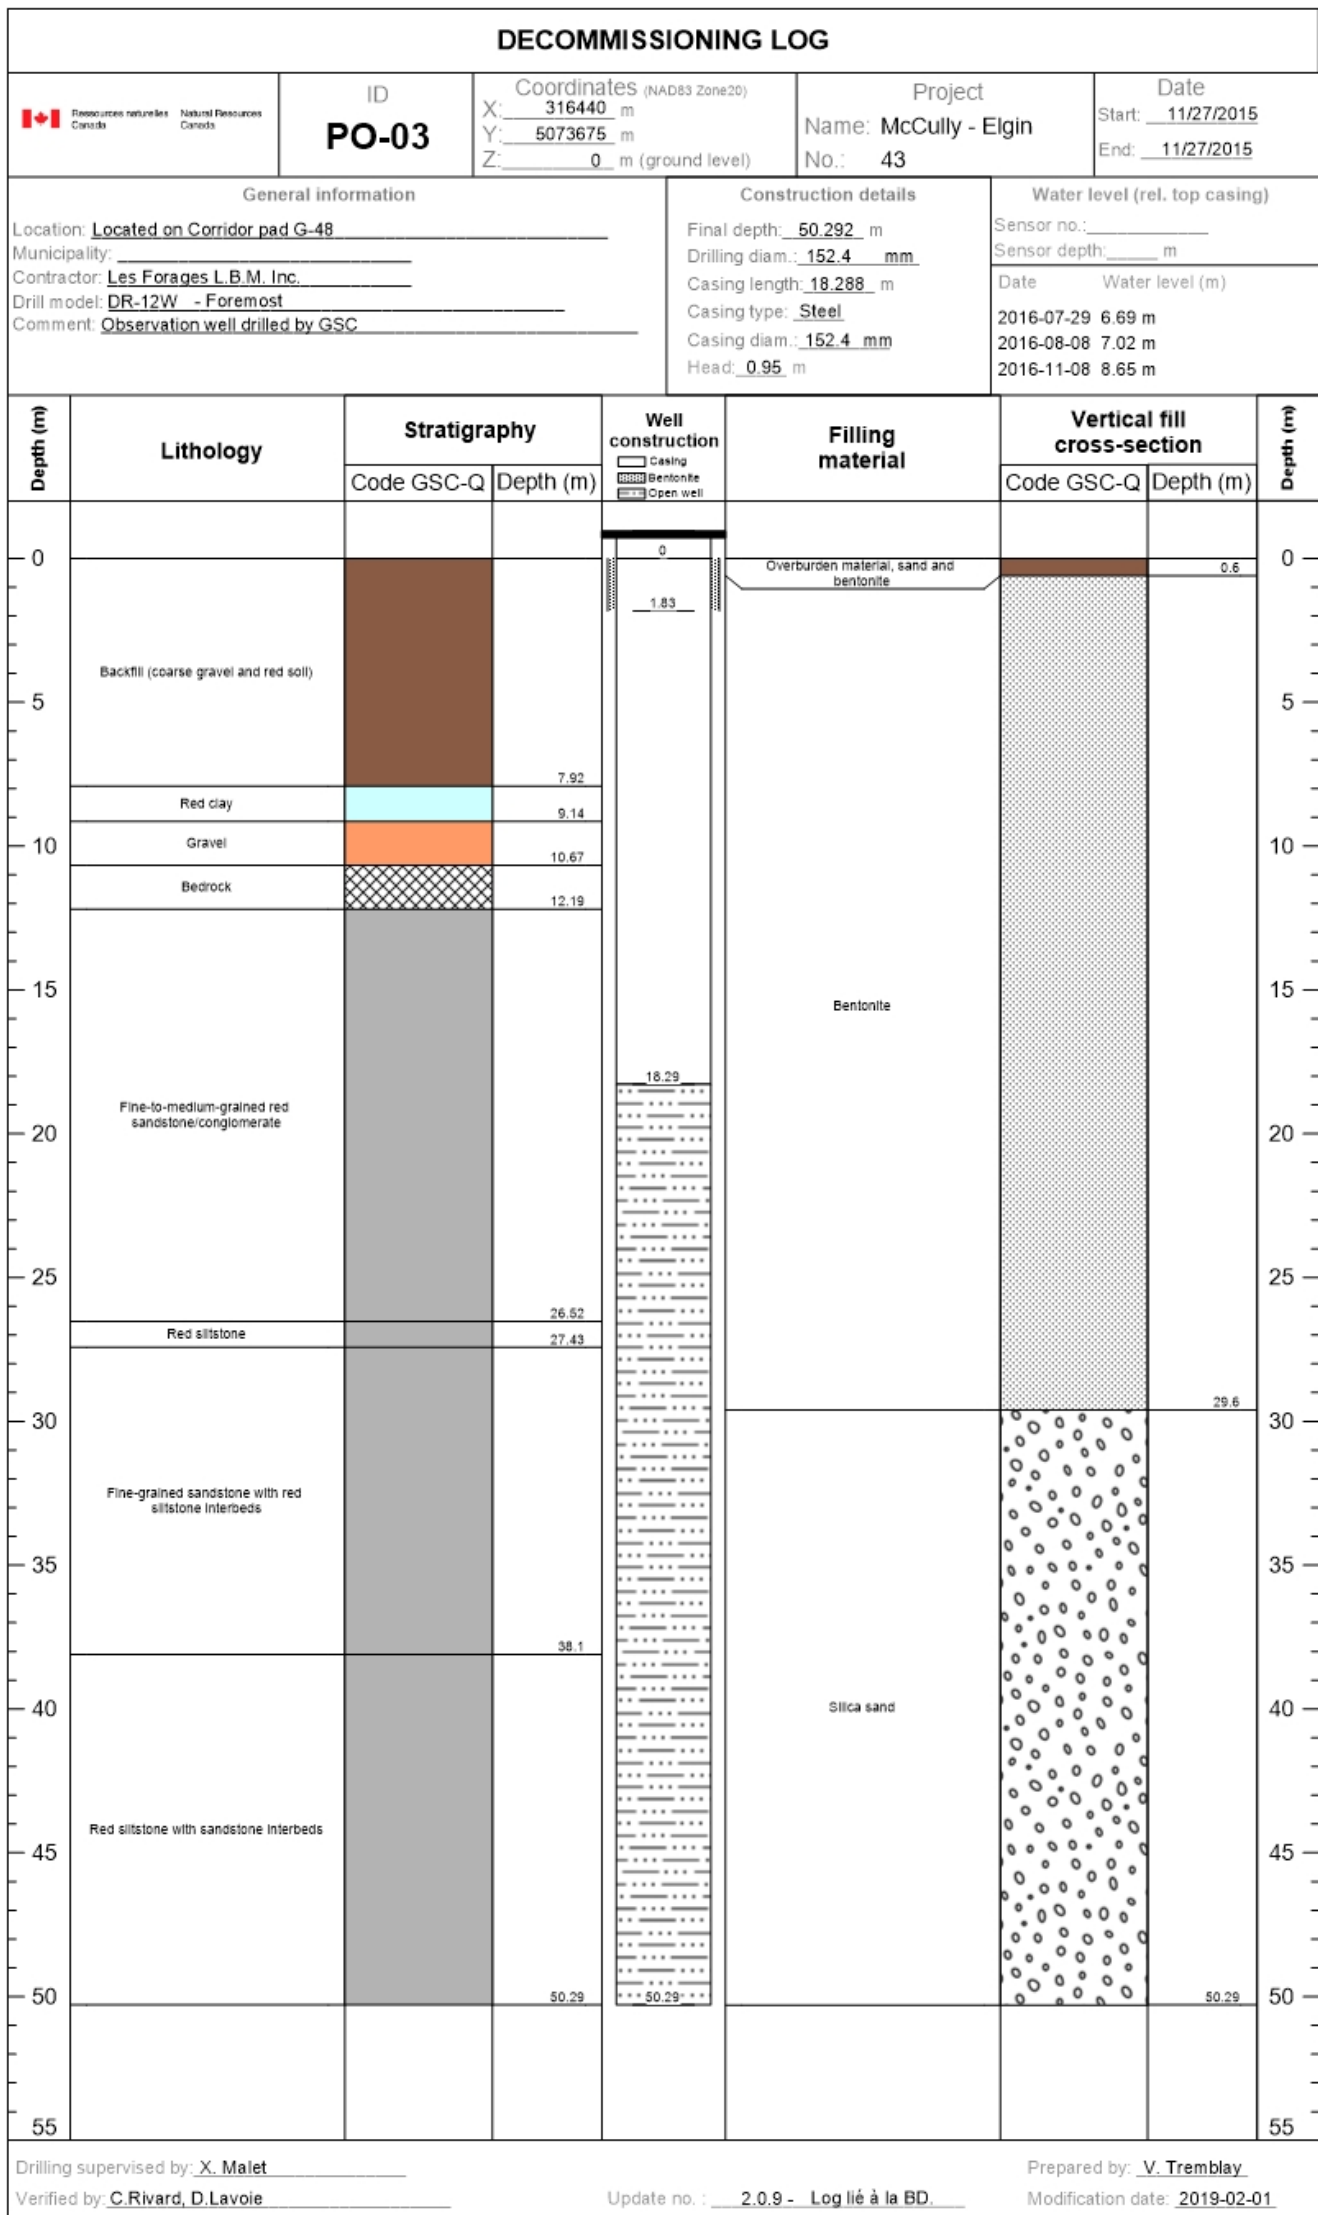
Figure 11 - PO-03 decommissioning log

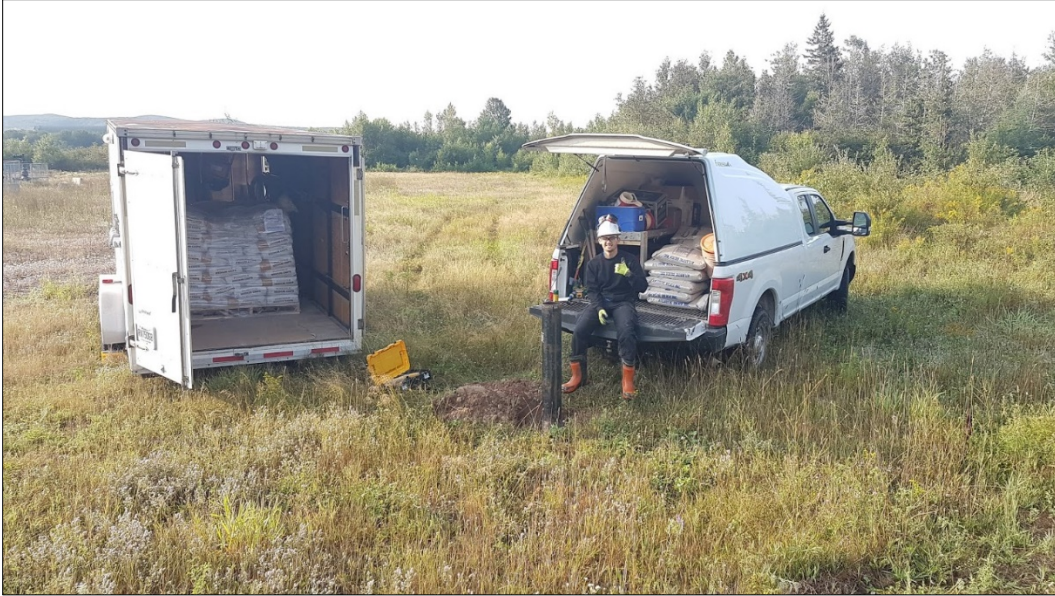
Figure B.1 - Observation well PO-01 before its decommissioning (August 24, 2018)

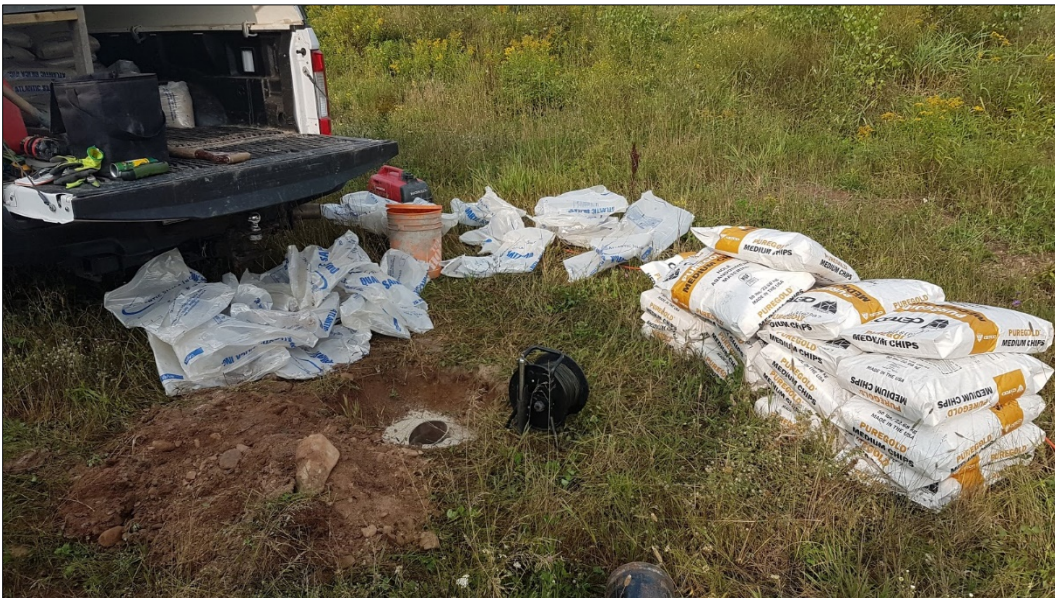
Figure B.2 - Observation well PO-01 after the casing was cut at 60 cm below the ground surface (step 2) (August 24, 2018)

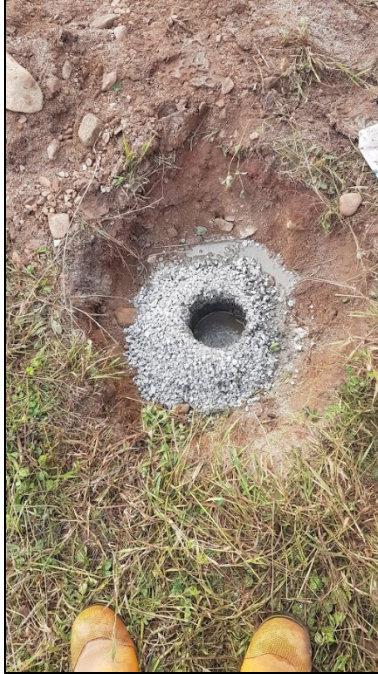
Figure B.3 - PO-01 during at the final stage (step 5) of the decommissioning (August 24, 2018)

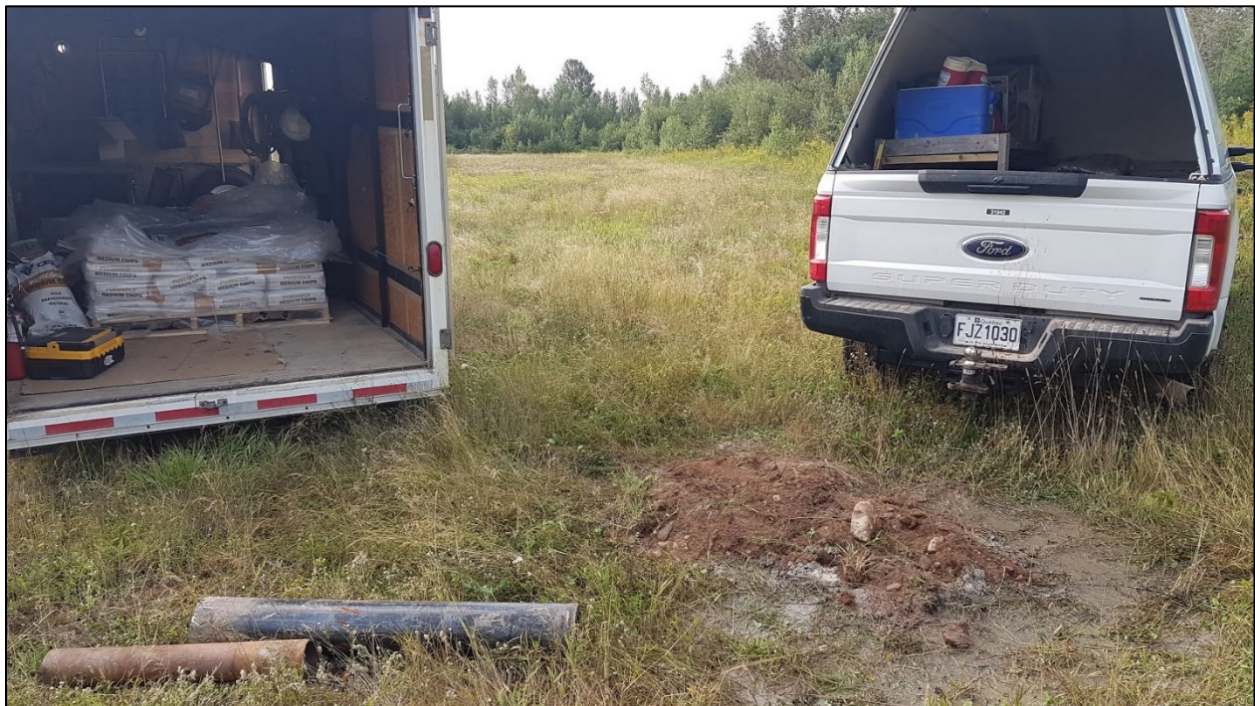
Figure B.4 - Observation well PO-01, after its decommissioning (August 24, 2018)

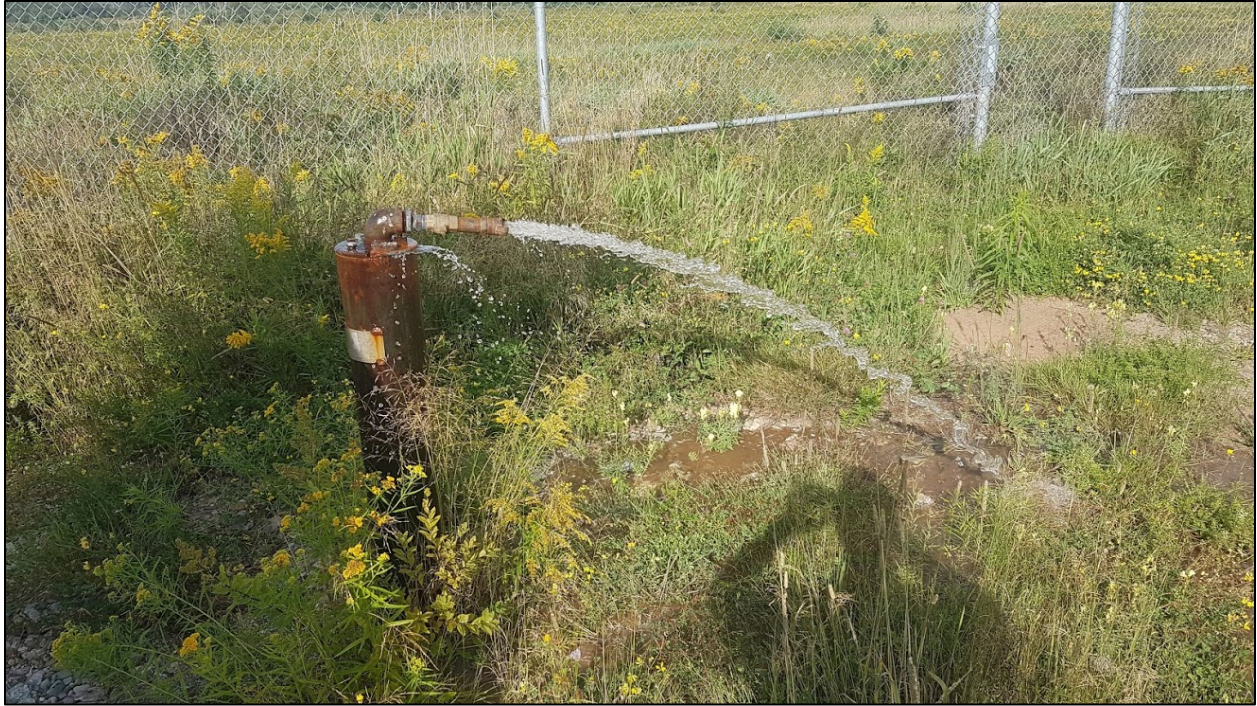
Figure B.5 - Observation well PO-02 showing artesian condition before its decommissioning (August 26, 2018)

Well casings were cut at a depth of 0.6 m to 0.8 m, which is the approved method for monitoring wells. For technical reasons, it was found that cutting the casing before filling the well is more practical than cutting it after. It is easier because heavy bags/pails do not need to be lifted as high and it is much easier to cut the casing of an empty well on a dry ground. Experience showed that quickly filling an artesian well with coated bentonite works well.

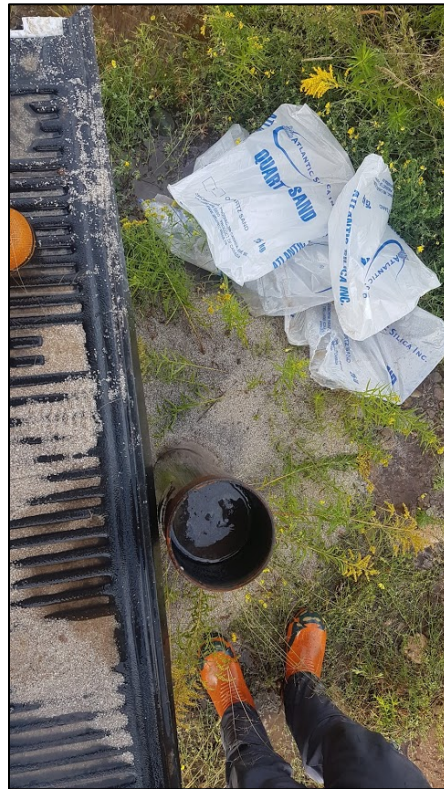
Figure B.6 - Observation well PO-02 during decommissioning (step 3) (August 26, 2018)

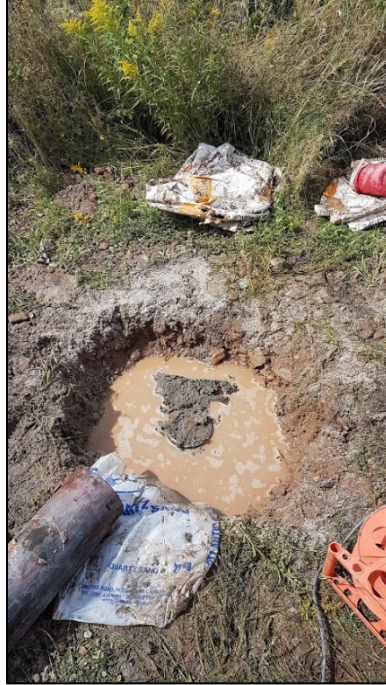
Figure B.7 - Observation well PO-02 completely filled (end of step 4) (August 26, 2018)

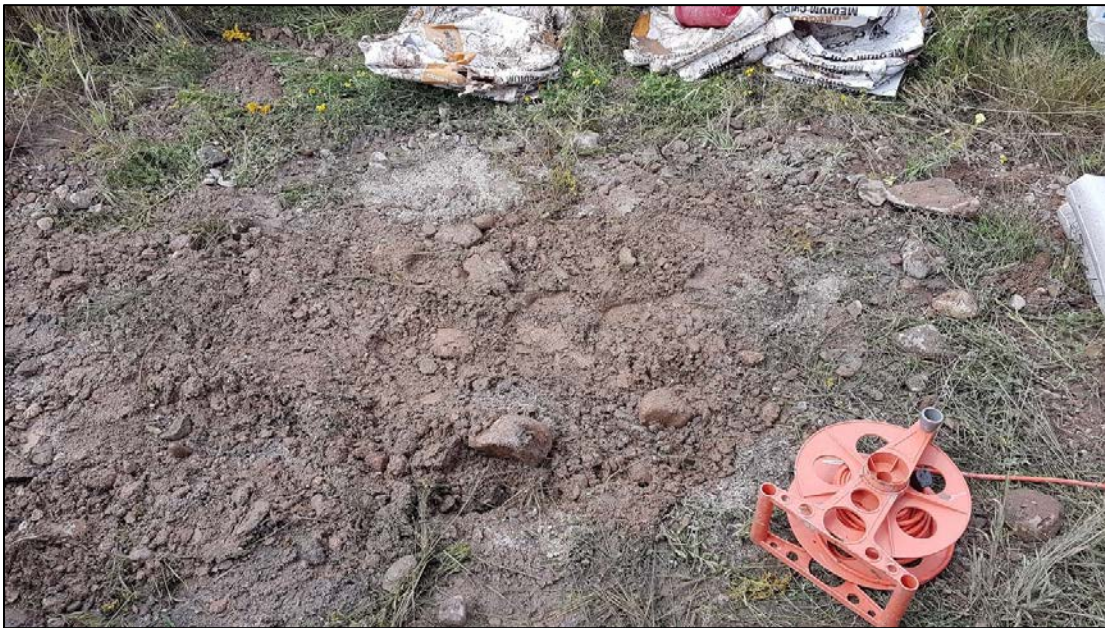
Figure B.8 - Observation well PO-02 after its decommissioning (August 26, 2018)

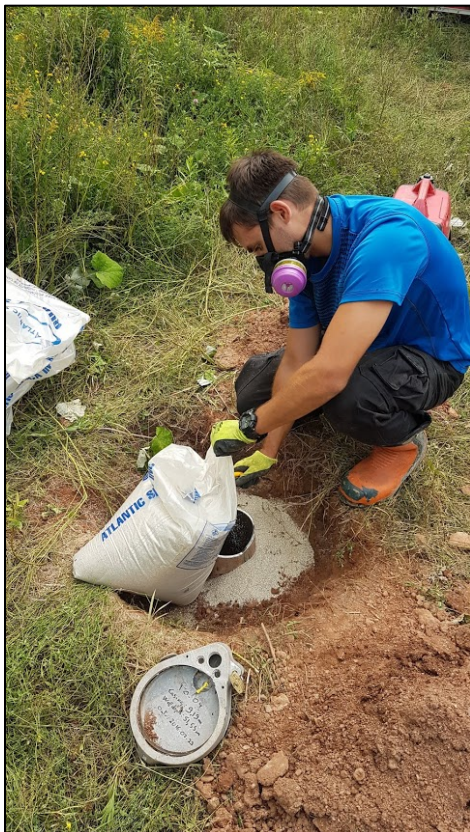
Figure B.9 - Observation well PO-04 during its decommissioning (step 3) (August 24, 2018)

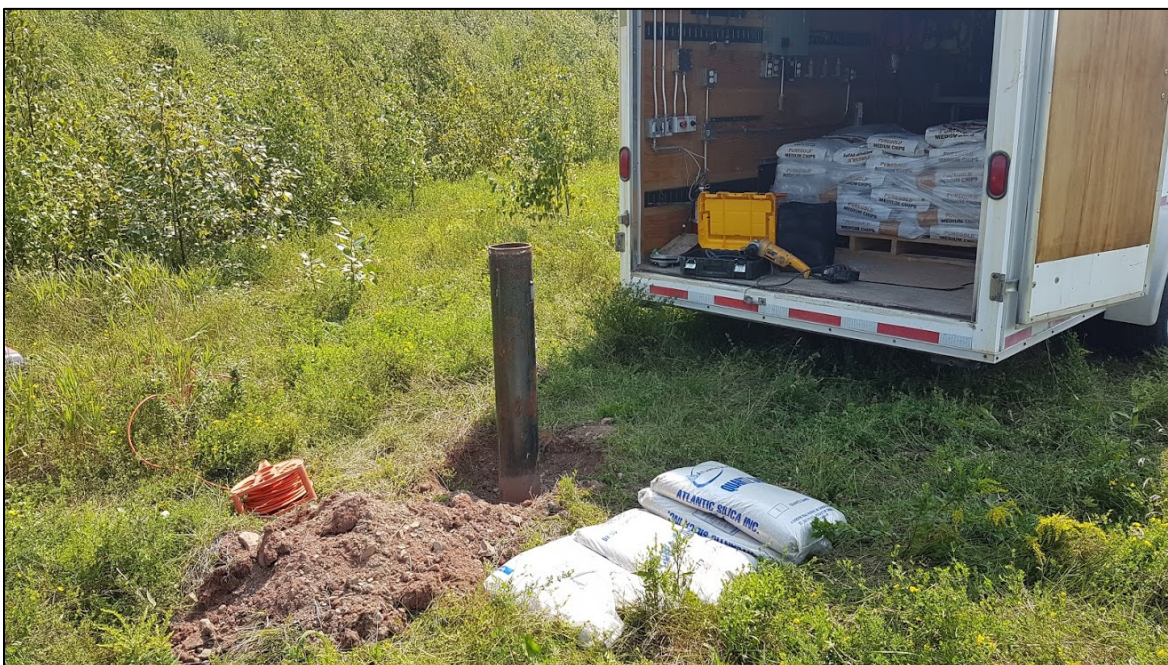
Figure B.10 - Observation well PO-05 before its decommissioning (August 25, 2018)

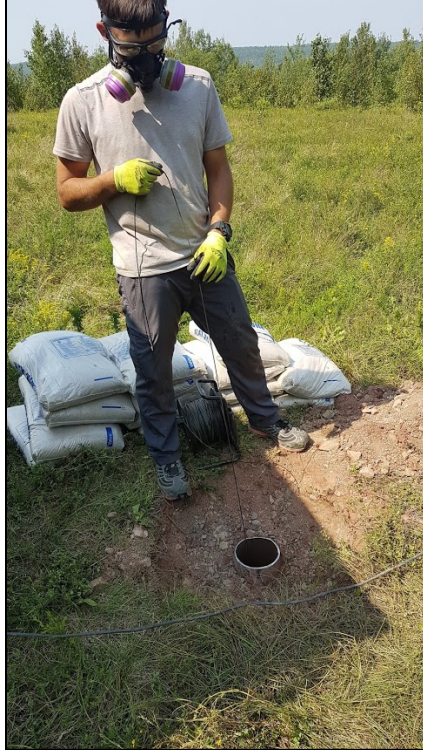
Figure B.11 - Observation well PO-05 during its decommissioning (step 3) (August 25, 2018)

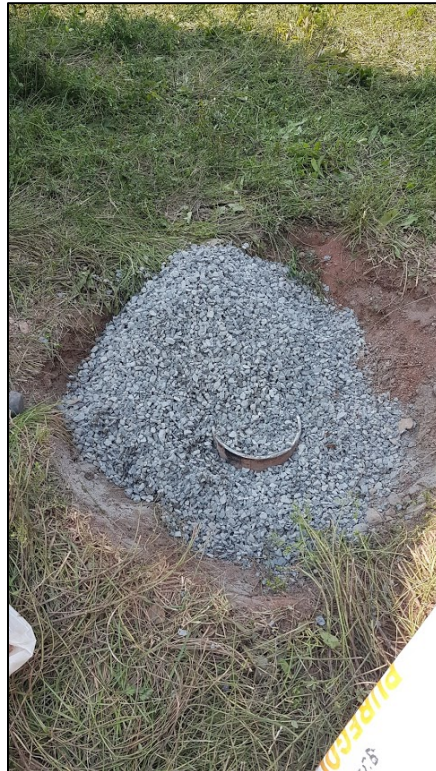
Figure B.12 - Observation well PO-05 after its decommissioning (step 5) (August 25, 2018)

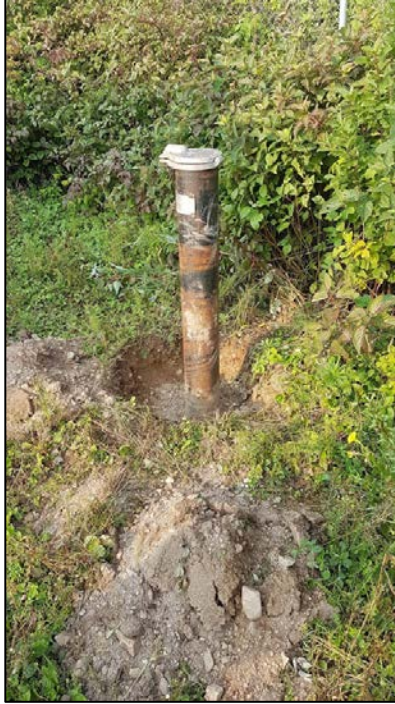
Figure B.13 - Observation well PO-06 before its decommissioning (August 25, 2018)

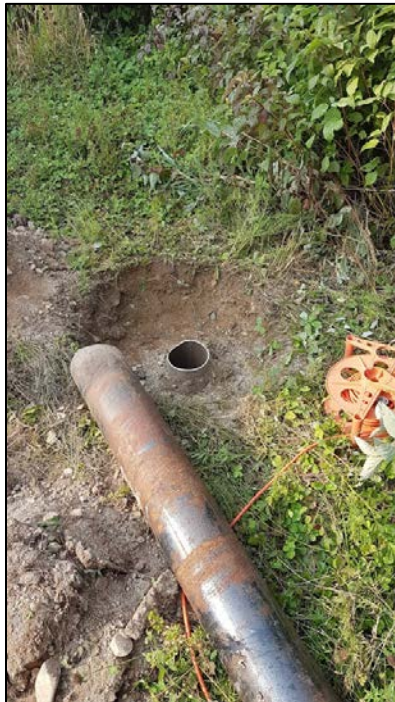
Figure B.14 - Observation well PO-06 after step 2 (casing cutoff) (August 25, 2018)

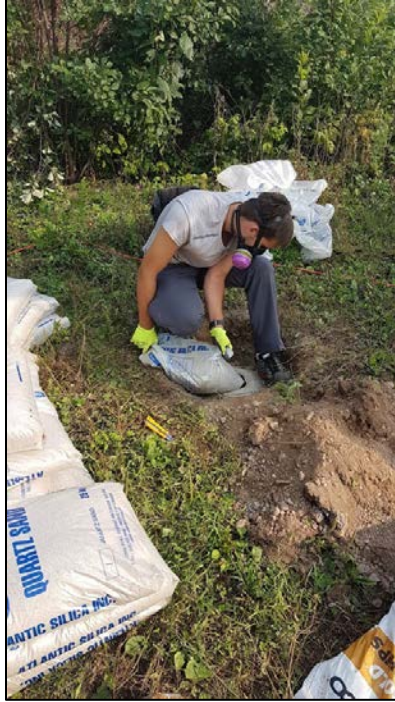
Figure B.15 - Observation well PO-06 during its decommissioning (step 3) (August 25, 2018)

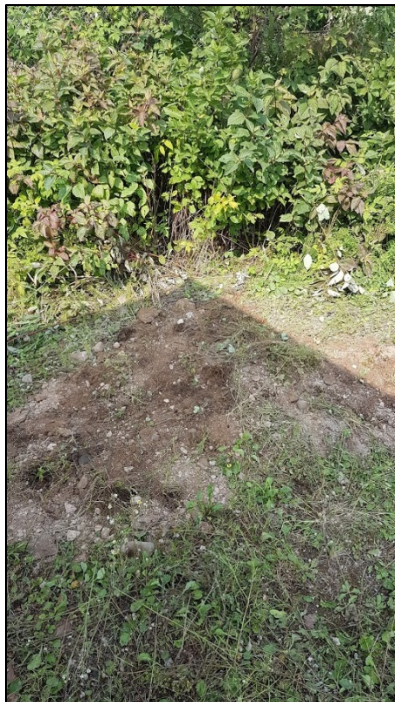
Figure B.16 - Observation well PO-06 after its decommissioning (August 25, 2018)

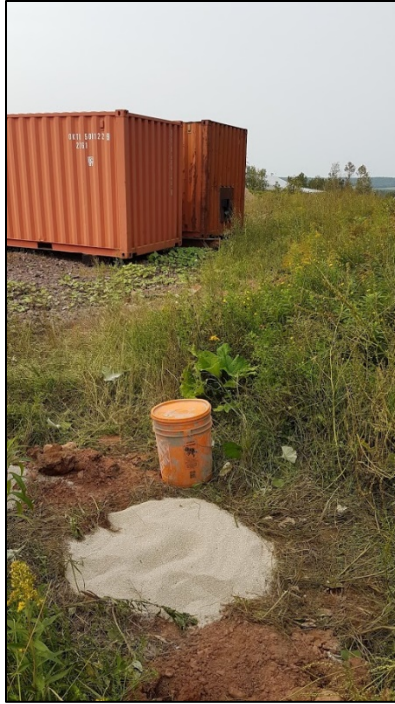
Figure B.17 - Observation well PO-07 at the final stage of its decommissioning (August 24, 2018)

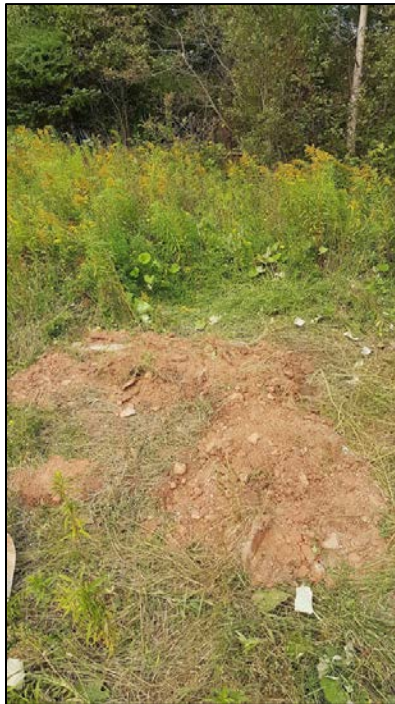
Figure B.18 - Observation well PO-07 after its decommissioning (August 24, 2018)

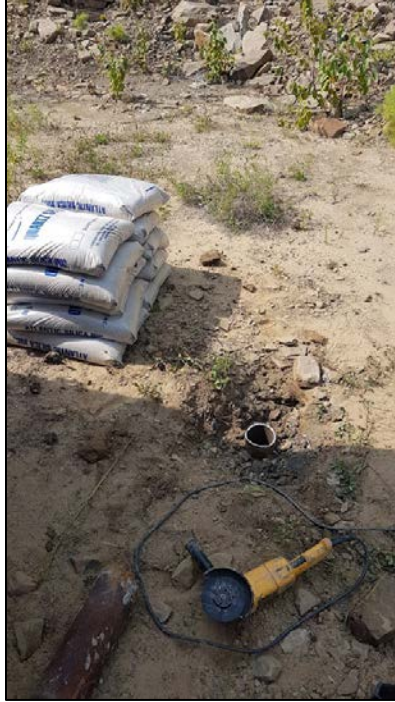
Figure B.19 - Observation well PO-08 during its decommissioning (step 2) (August 25, 2018)

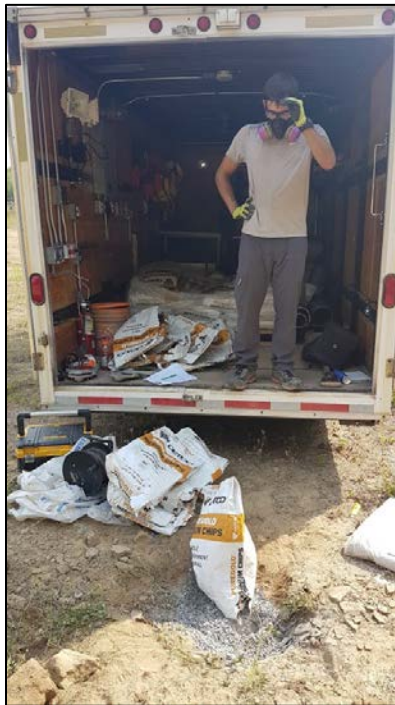
Figure B.20 - Observation well PO-08 during its decommissioning (step 5) (August 25, 2018)

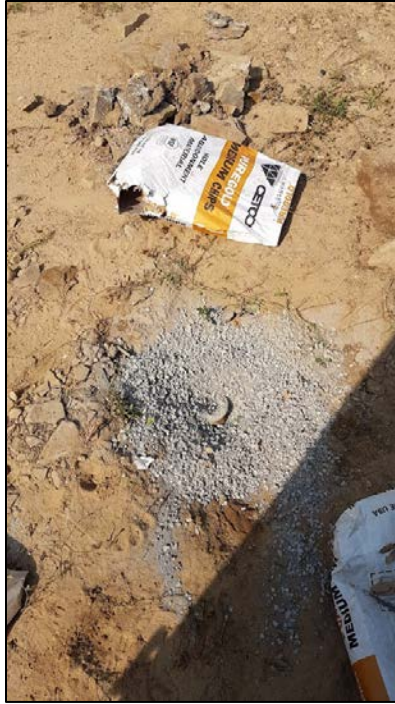
Figure B.21 - Observation well PO-08 in the decommissioning final stage (step 5) (August 25, 2018)

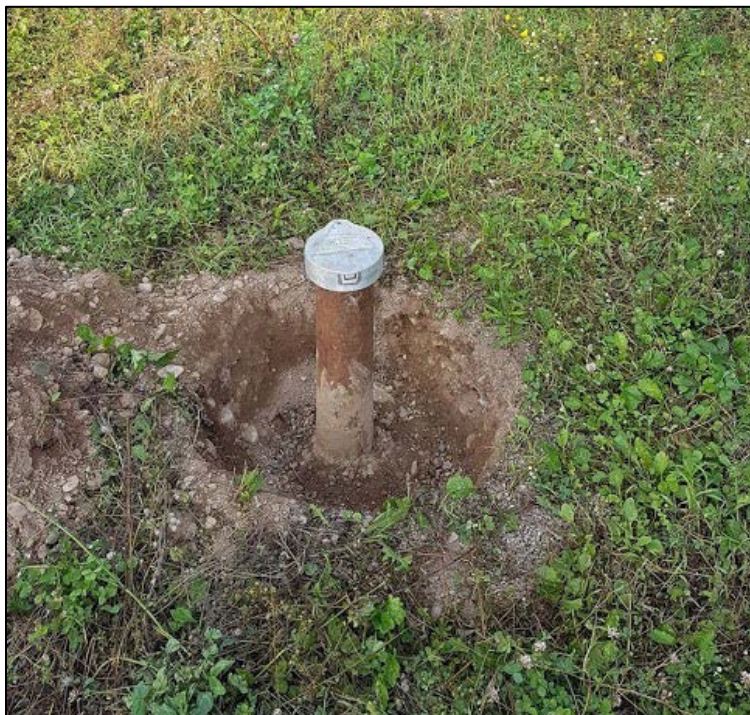
Figure B.22 - Observation well PO-09 during its decommissioning (step 1) (August 25, 2018)

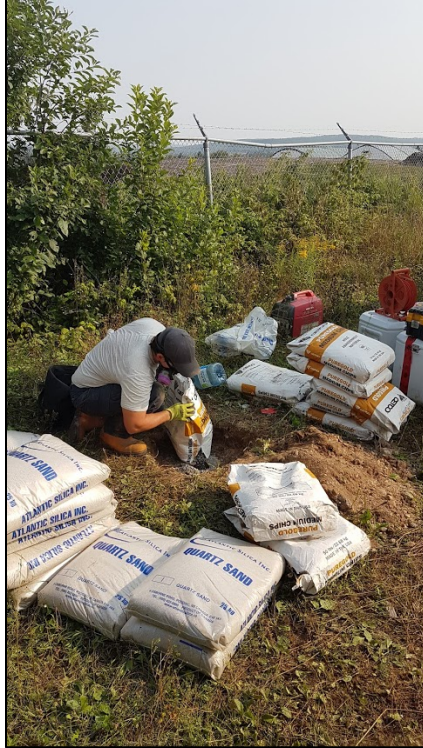
Figure B.23 - Observation well PO-09 during its decommissioning (step 4) (August 25, 2018)

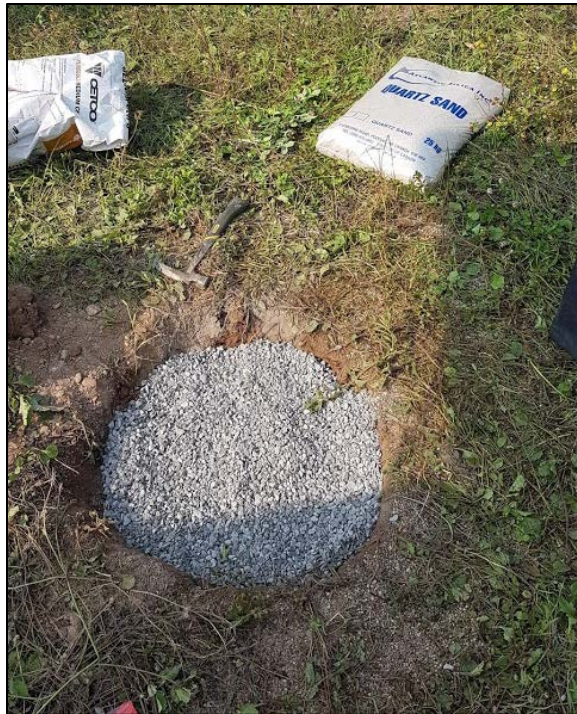
Figure B.24 - Observation well PO-09 in the decommissioning final stage (step 5) (August 25, 2018)

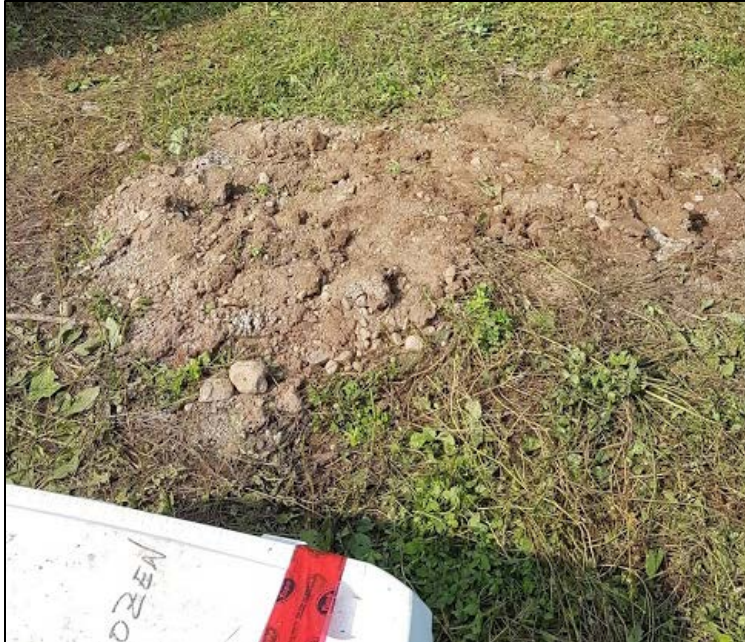
Figure B.25 - Observation well PO-09 after its decommissioning (August 25, 2018)

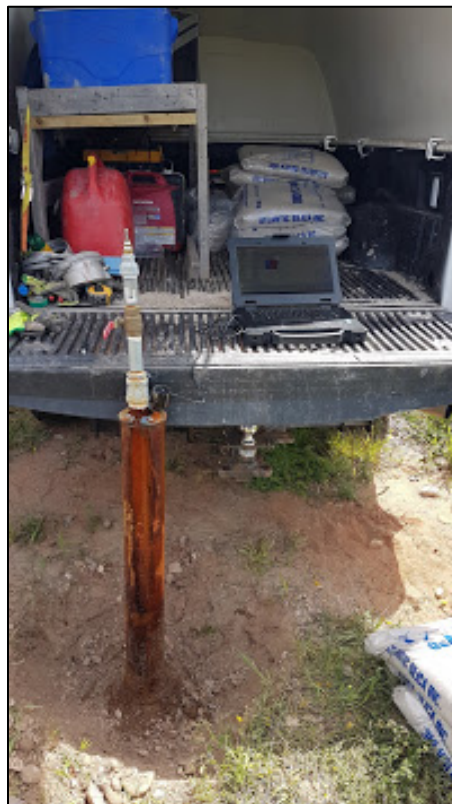
Figure B.26 - Observation well PO-13 before its decommissioning (August 26, 2018)

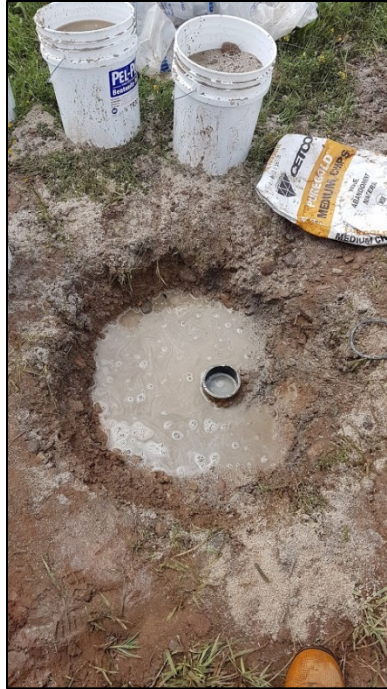
Figure B.27 - Observation well PO-13 during its decommissioning (step 4) (August 26, 2018)

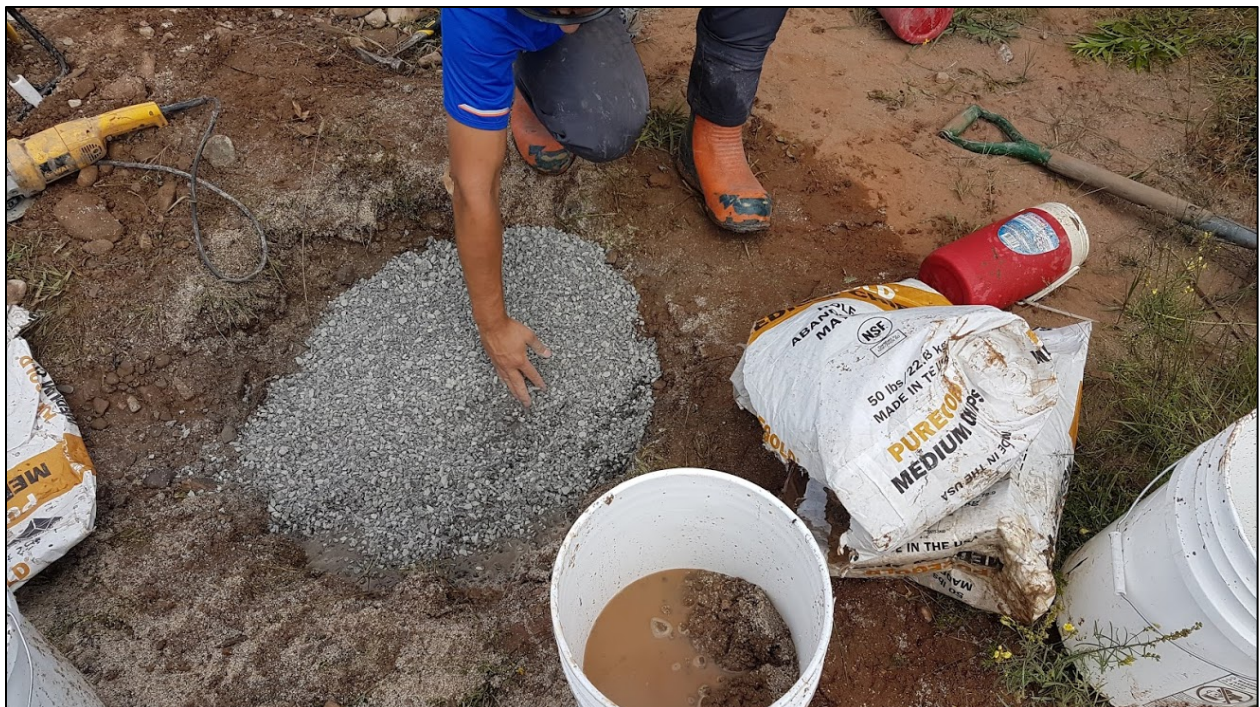
Figure B.28 - Observation well PO-13 in the final stage (step 5) of its decommissioning (August 26, 2018)

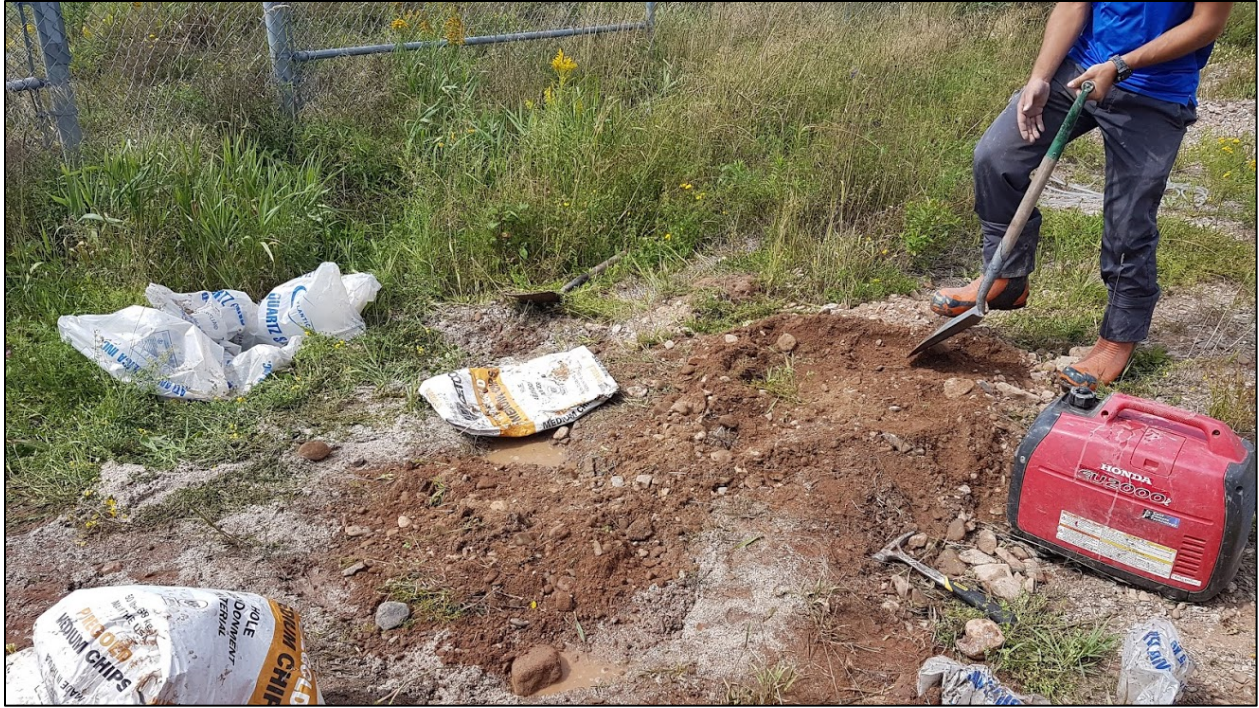
Figure B.29 - Observation well PO-13 after its decommissioning (August 26, 2018)
