PROACTIVE INFRASTRUCTURE MONITORING AND EVALUATION (PRIME) INSTALLATION IN CANADA: PROTECTING NATIONAL RAILWAYS BY MONITORING MOISTURE IN AN ACTIVE LANDSLIDE NEAR ASHCROFT, BRITISH COLUMBIA

O P E N F I L E DOSSIER PUBLIC 8548 2019 elles sont publiées 2019

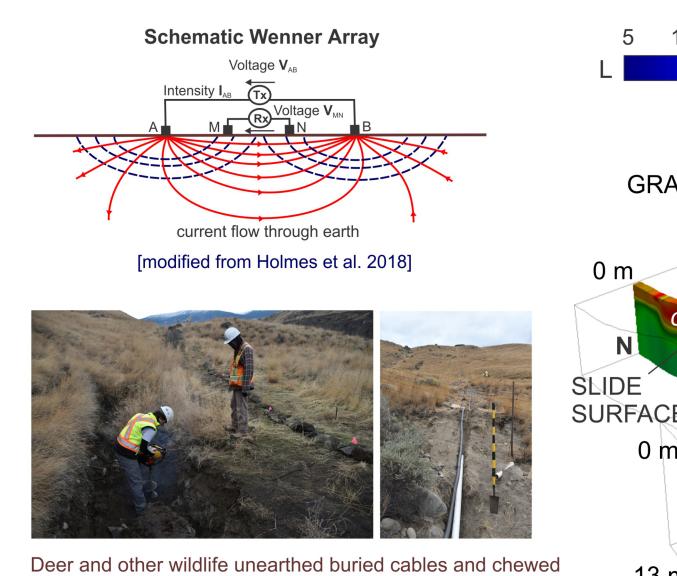
Between August and November 2017, continuous (real-time) ERT monitoring was deployed to characterize the long-term hydrological behaviour of geological unit in the landslide (cf. Uhlemann et al. 2017). Two intersecting Wenner arrays were permanently installed in 20 cm-deep trenches dug across the slide body and crown: a north-south array was 91 m-long with 45 evenly spaced ground electrodes; and an east-west array was 54 m-long with 27 electrodes (Fig. 4 e). Cables and electrodes were wrapped in foam to insulate against the elements and encased within plastic pipe in high-traffic areas, then buried with soil and capped with small boulders to protect against damage by animals (Fig. 6).

through wires at several locations on the arrays. Buried cables and electrodes armoured by cobbles and boulders

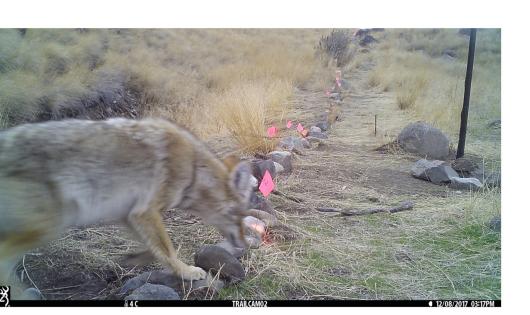
December 08, 2017 4°C; precipitation falling as rain on slope; soil unfrozen

Between late fall (November) and early spring (February), resistivity values increase in glacial deposits as snowfall blankets the slope, the ground freezes (<0°C) to an estimated depth <2 m, and the river reaches its lowest level (Fig. 7 b). The greatest displacement rates indicated by GNSS and InSAR occur with during winter and spring when transitional ground conditions allow snow melt and rainfall to penetrate deep into the still-frozen (or thawing) slide body by way of tension cracks, planar fractures and bedding surfaces

From late spring (March) to early fall (October), when ground temperatures are >0°C (i.e., unfrozen), infiltrating precipitation results in a progressive decrease in resistivity at depth as the moisture content of sub-surface clay-rich units increases. Over this period, Thompson River levels are high (Fig. 7 b) and support the submerged portions of the toe slope. It is during this period that GNSS and InSAR monitoring indicate minimum rates of surface displacement

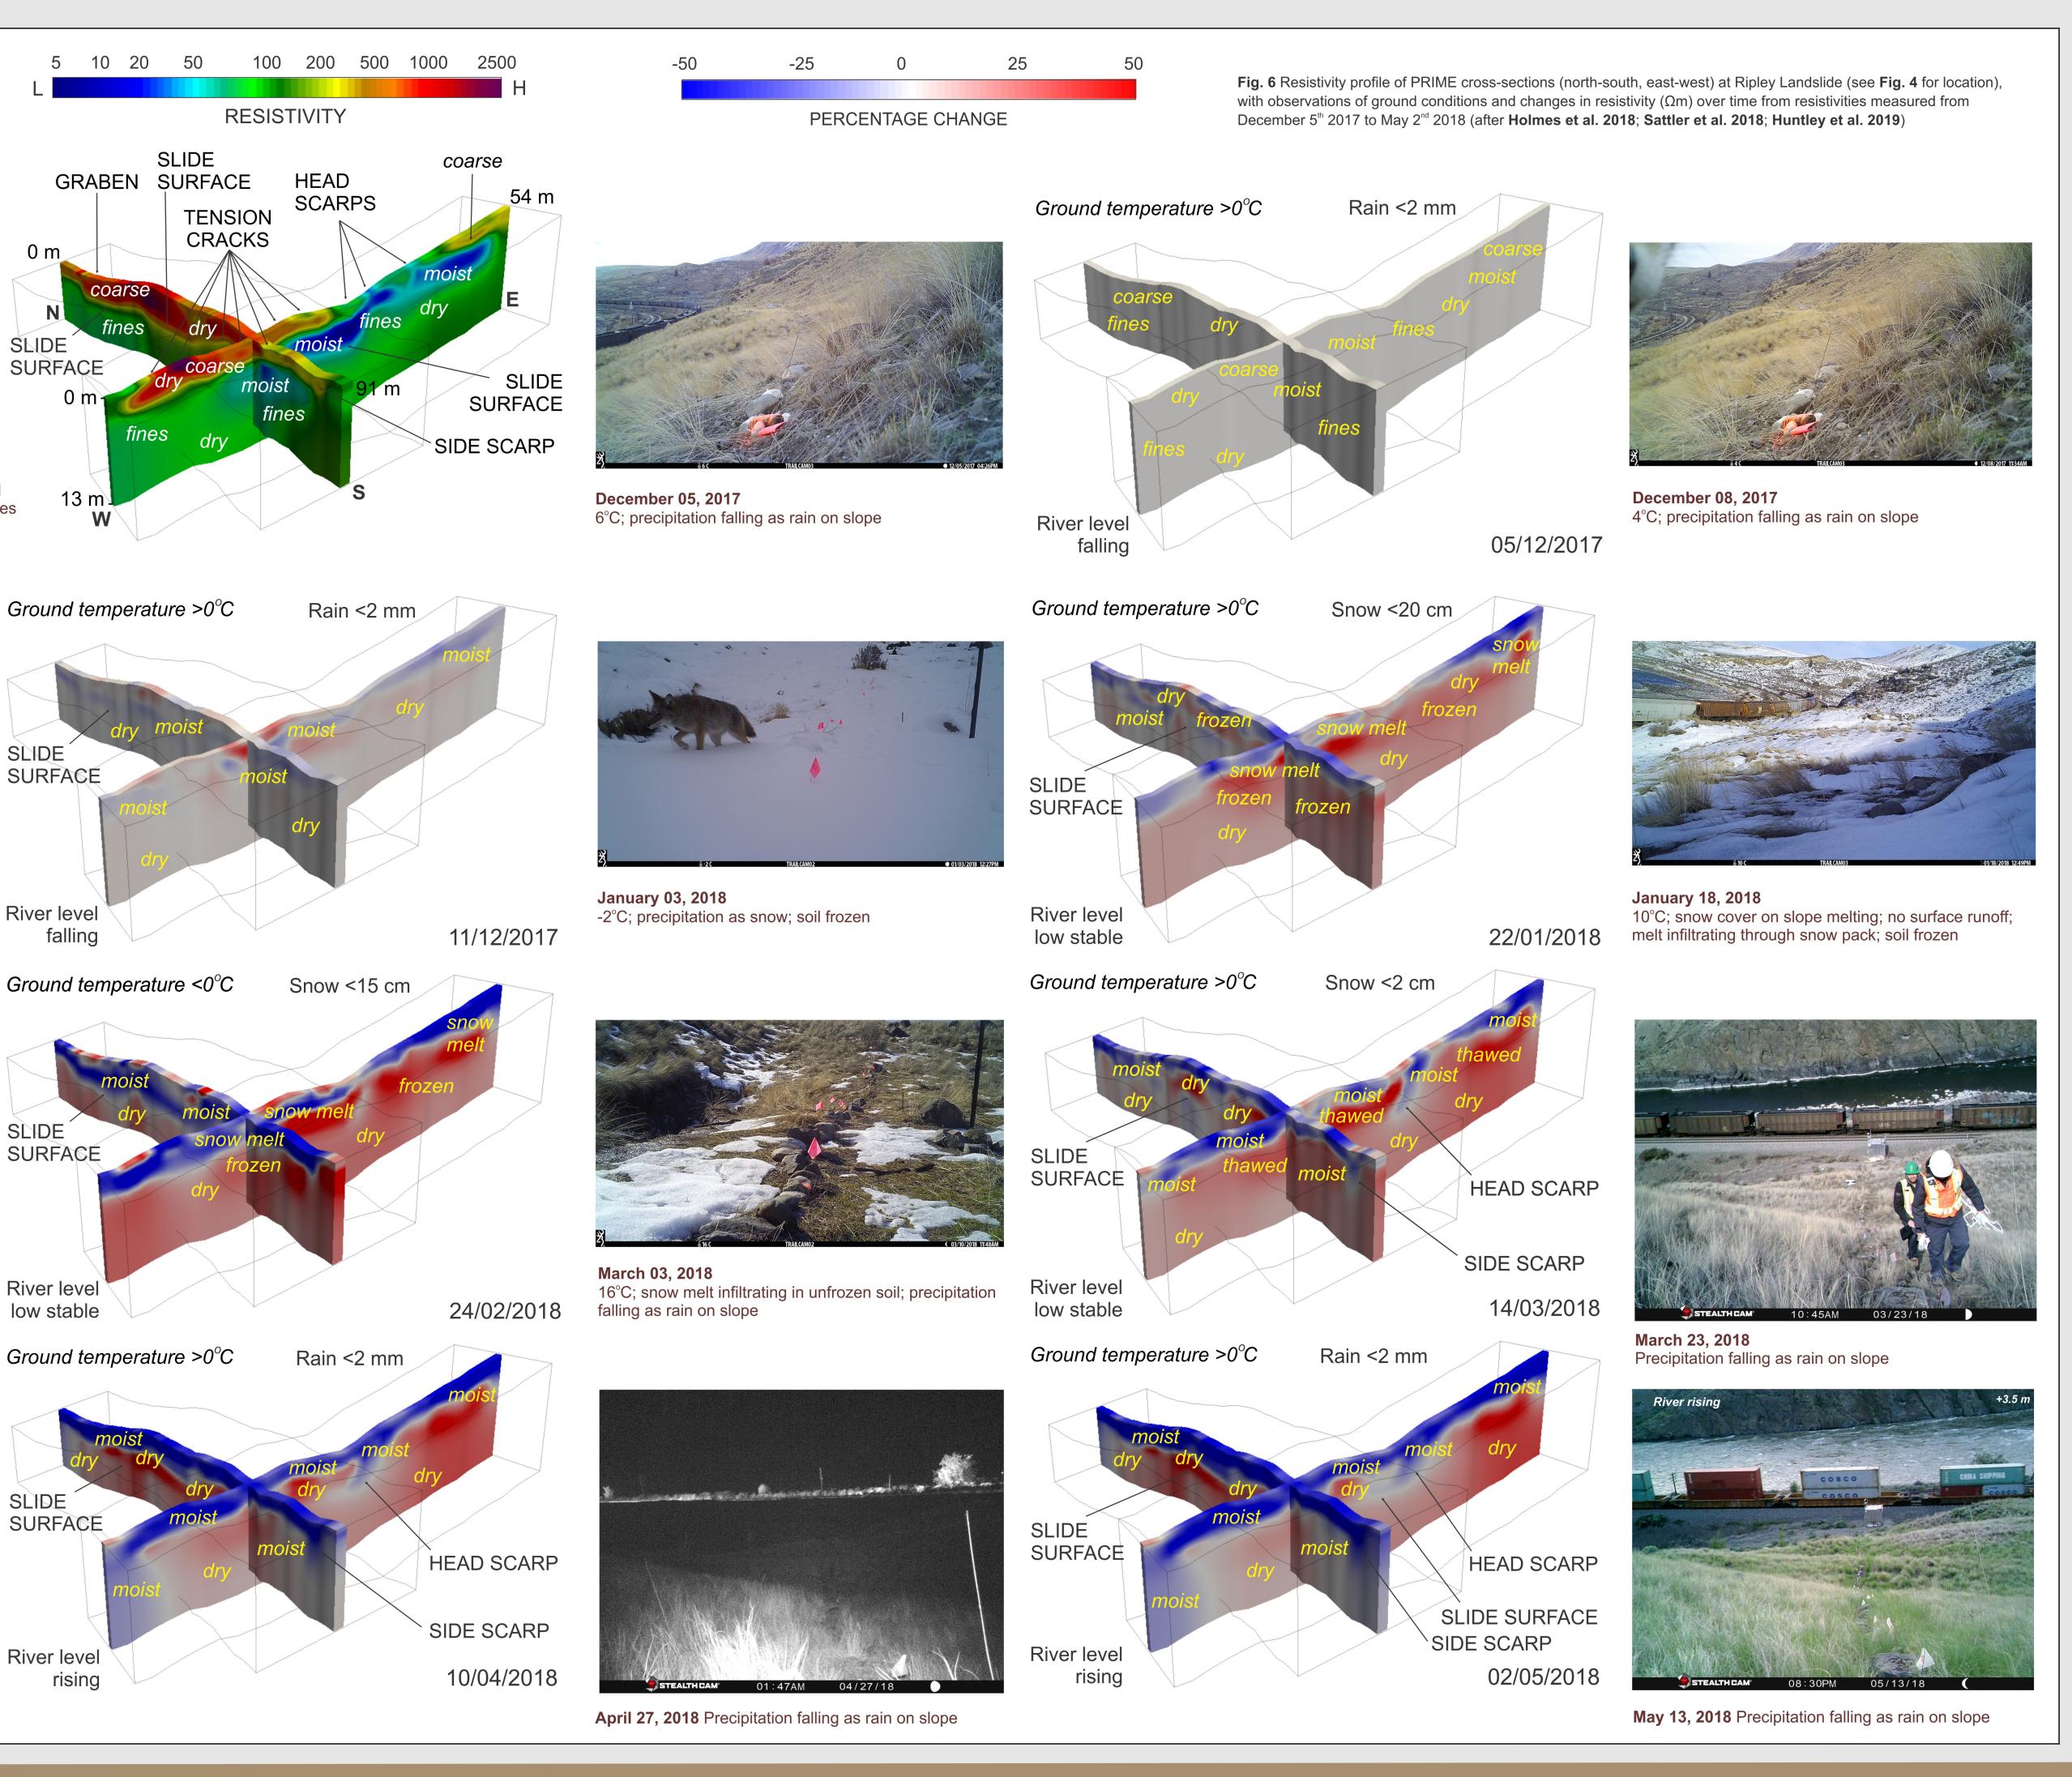
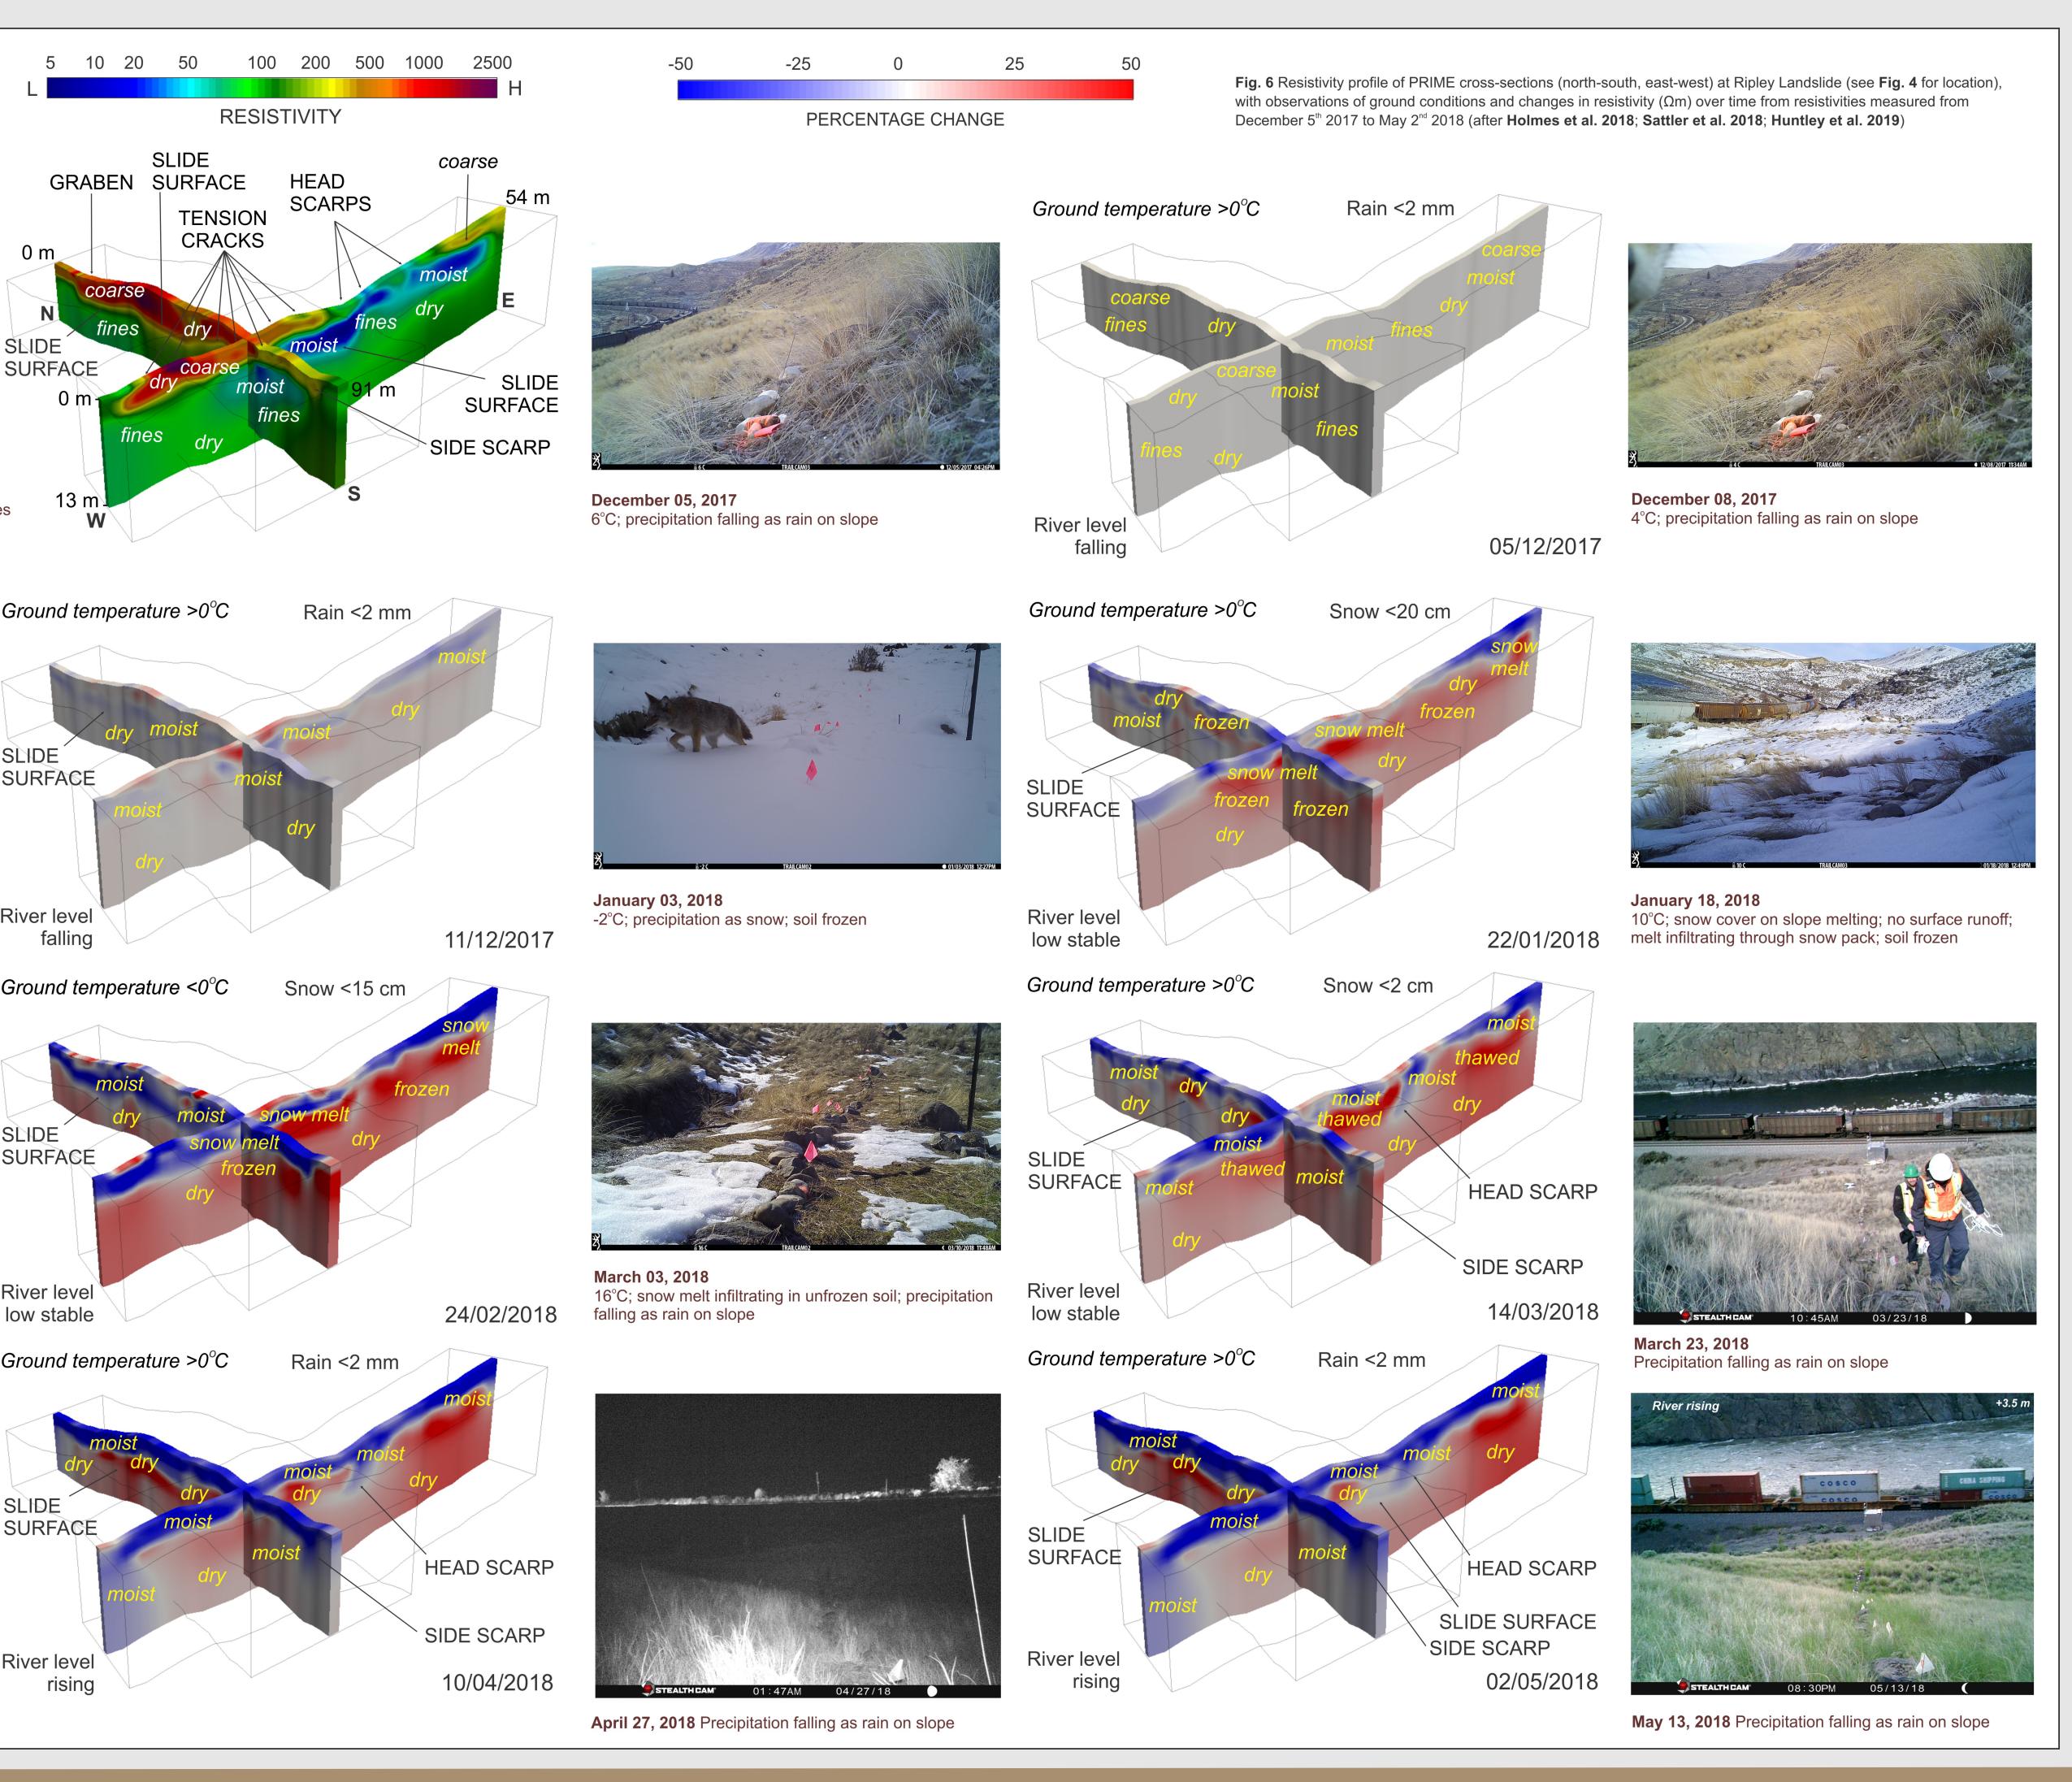
The pseudo-3D model shows a significant portion of the landslide lying below river level (approximately between 230 m and 270 m elevation), with the main slide body represented as an ovate conductive zone (<80 Ωm) containing inliers of resistive material (>120 Ωm) along the northern, eastern, and southern flanks (Fig. 5). These latter features are interpreted as locally-derived bedrock blocks that were remobilized during glaciation. Surface and borehole monitoring indicate the landslide moves very slowly (cumulatively <55 mm/yr) on gentle (>2° February 17, 2018 -1°C; precipitation falling snow on slope; soil frozen

April 15, 2018 Precipitation falling as rain on slope

From 2017 to 2018, changes in ground resistivity are attributed to seasonal variation in sub-surface moisture. Precipitation (rain and snow) and ground temperature (Fig. 7 a) are recognized as important controls on the distribution of infiltrating soil water and groundwater flux in the slide body. Slope stability at this site is highly sensitive to moisture content.
