THE EARTHQUAKE OF JULY 14, 1977

OBSERVATIONS OF EFFECTS

SEISMOLOGICAL SERVICE OF CANADA

INTERNAL REPORT 77-10

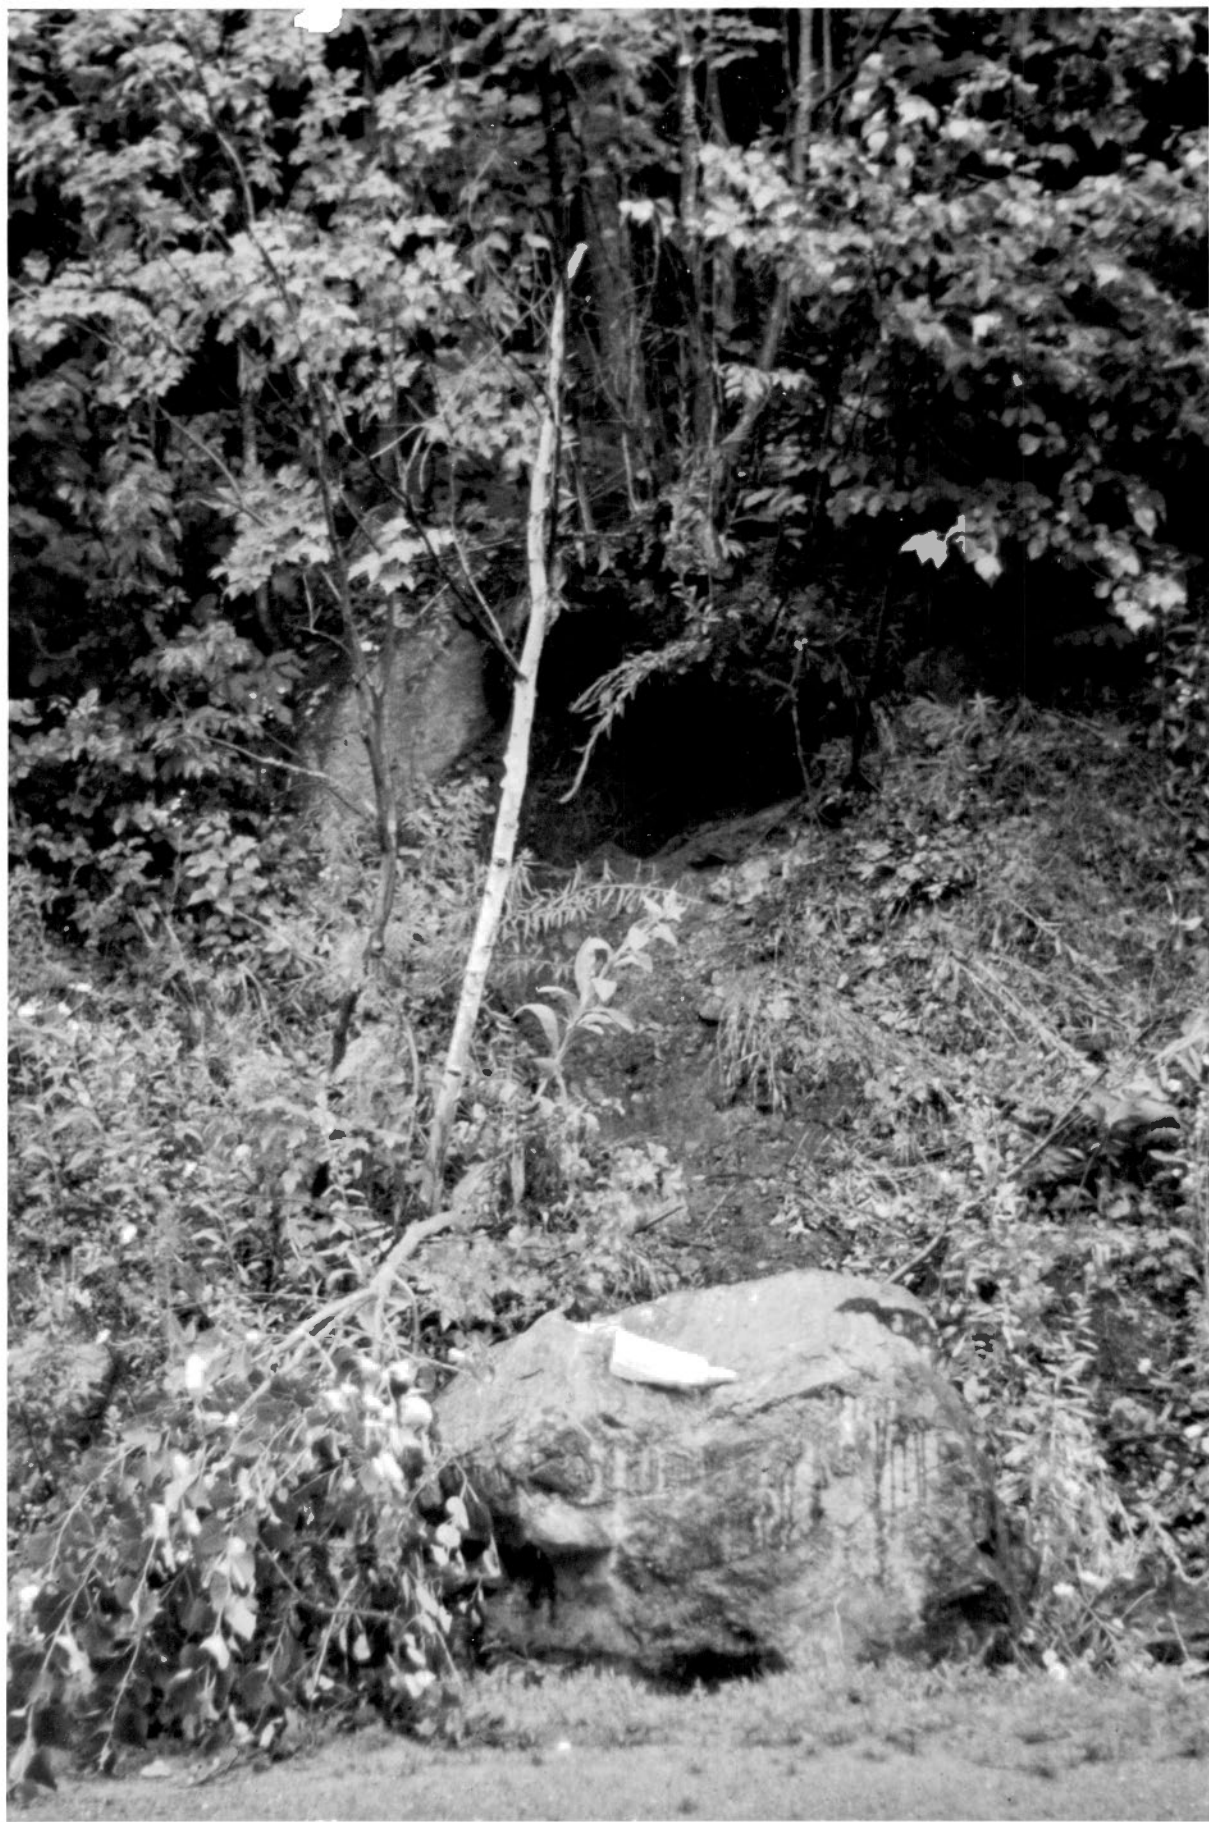
ROAD CUT BOULDER
WEST OF MORIN HEIGHTS

- See 'B' on map
- family reported dishes rattling, and feeling vibrations for about one minute
- reported boulder that had fallen out of a road cut that night

- boulder verified to be large (3'x3'x3') angular boulder that had very recently dislodged from the road cut and slid down about 5' into the ditch, knocking over a small (8', 1 " diameter at base) poplar tree. The road cut here is fractured anorthosite with roots and some soil in the fractures. The boulder in question was obviously in a very sensitive position, however upon inspection its seat was intact and not washed out by rain or other mechanical effects. In retrospect, it had fallen out of the hillside in the same direction (south) as the woodpiles at Lakeview, i.e. to the south. The very distinct possibility remains however, that a passing truck may have caused the dislodgement at this time. The position of the boulder is indicated as 'B' on the map.

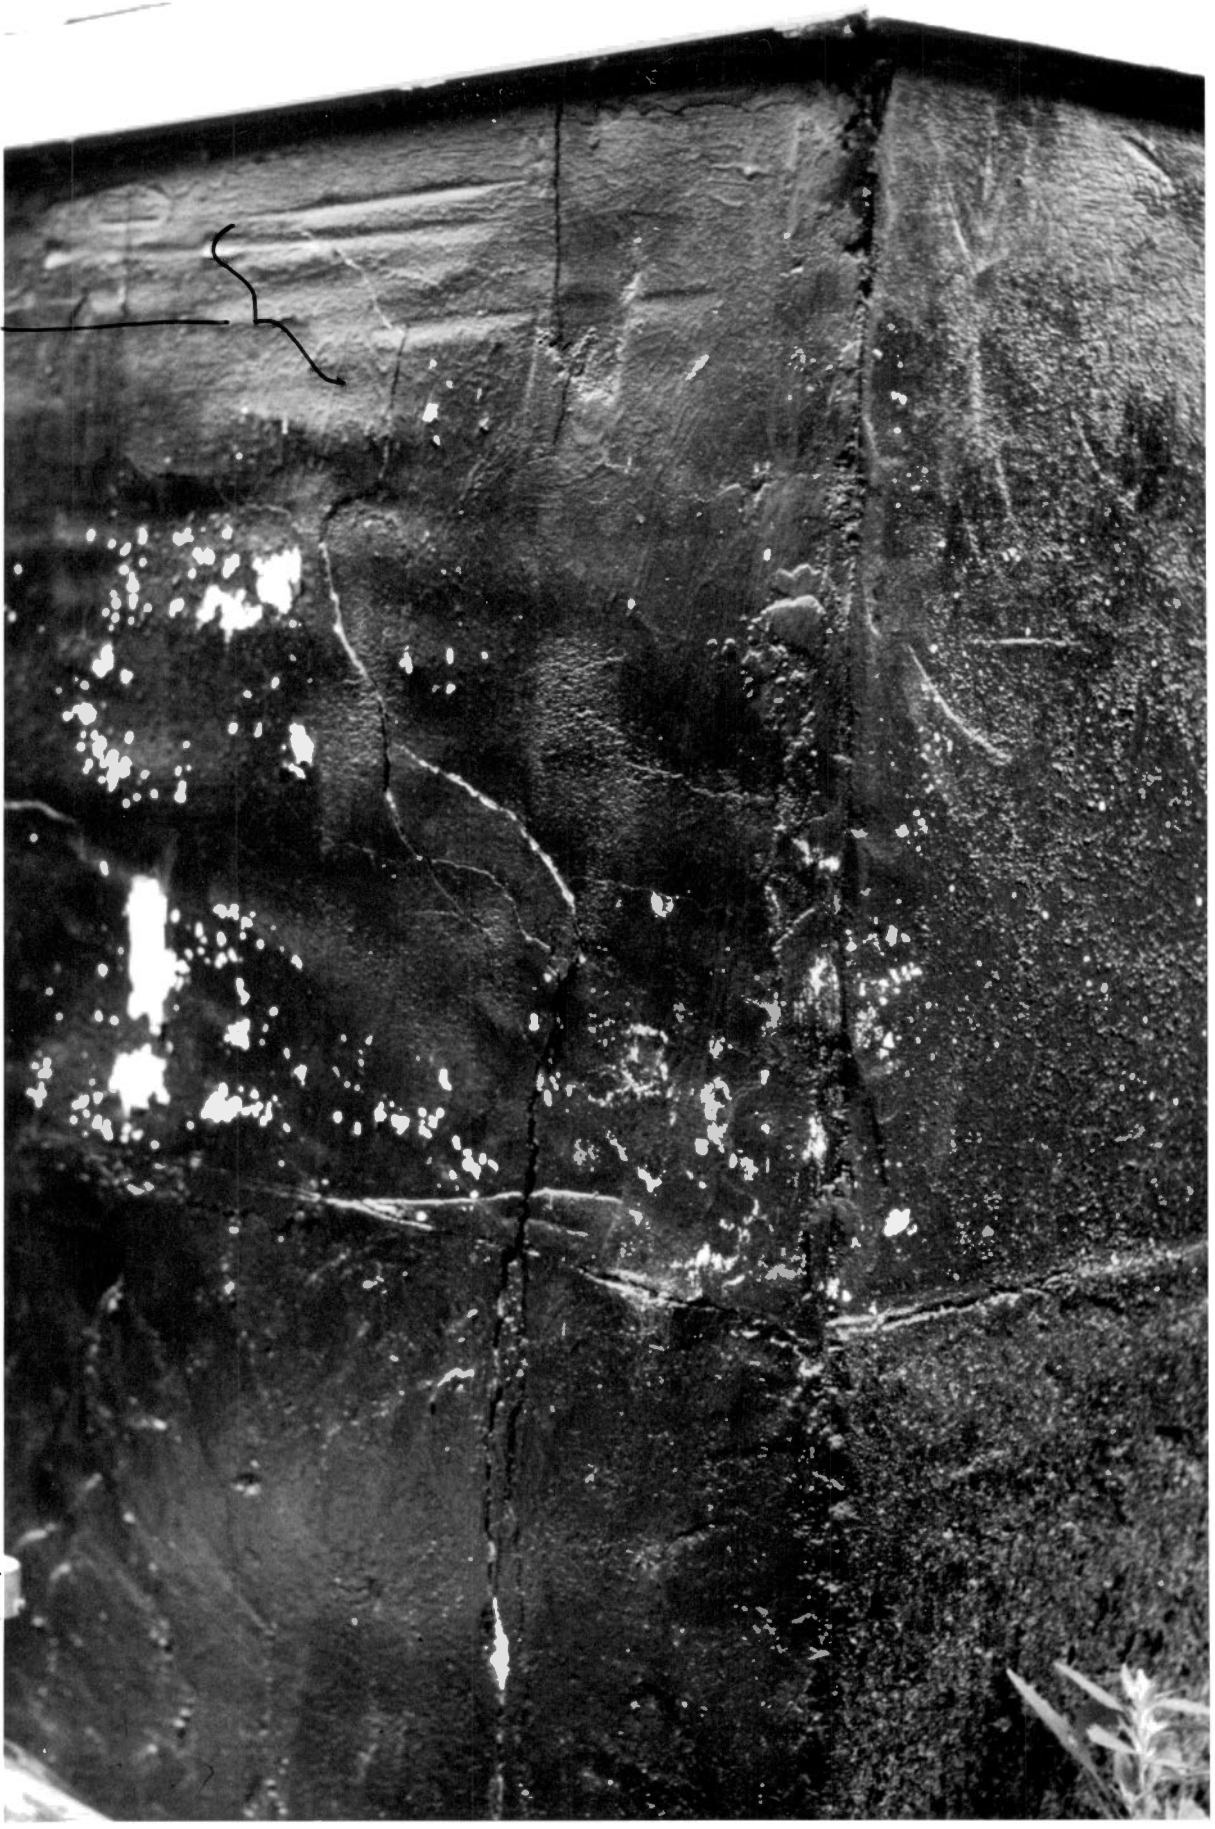
LAKE SHORE SUBURB

NEW
CRACK
SEE CLOSE
-UP

REACTIVATED
CRACKS

3.5cm
1 1/2"

FOUNDATION

8" CONCRETE BLOCK

By comparing the earthquake effects reported by the telephone survey with those observed by the field party in the various centres, it can be said the telephone survey leads to maps of reduced intensity. Observations from St. Adolphe d'Howard exemplify this fact. While our interlocutor mentioned only a weak tremor, we observed hairline cracks in basement walls and heard testimony of strong vibrations.

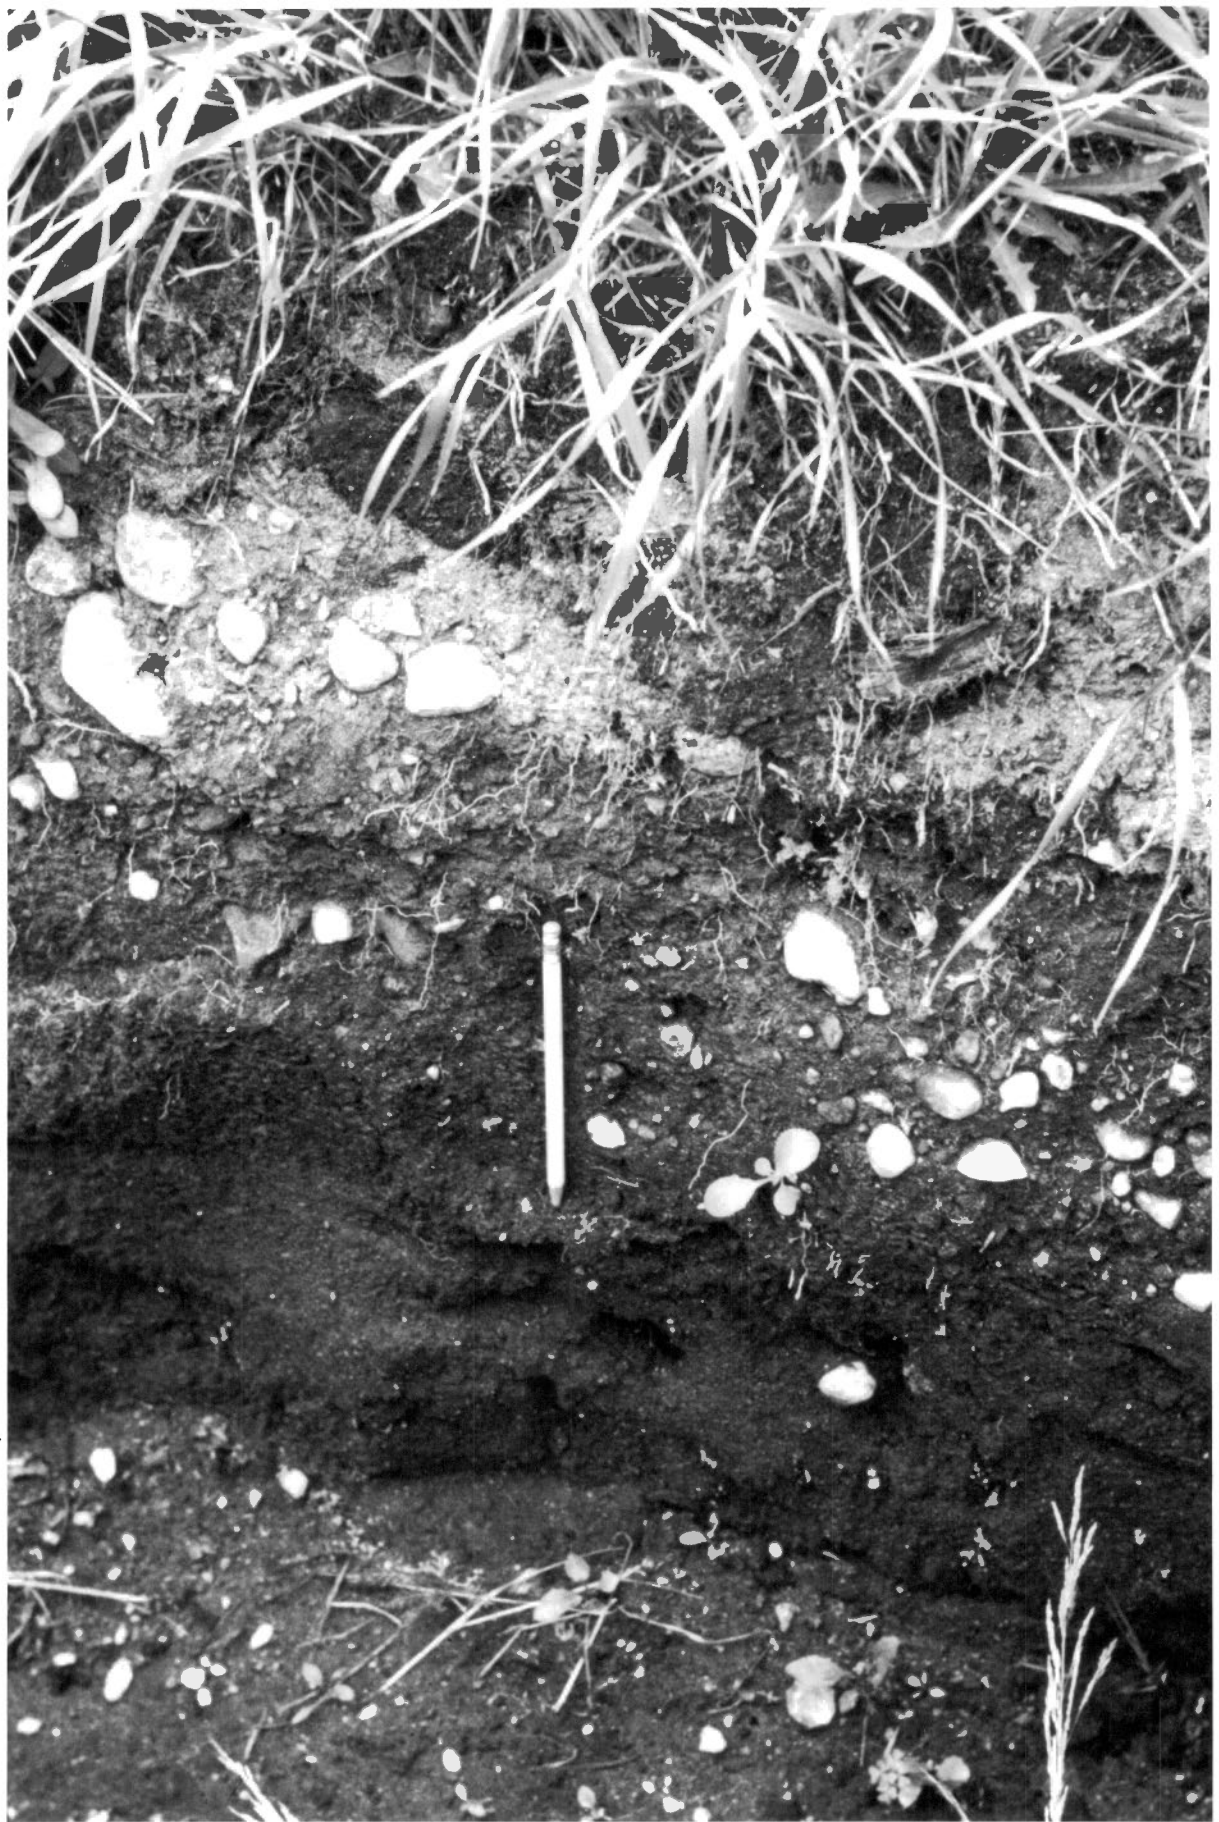
SOIL TYPE <100' FROM CRACKED FOUNDATIONS

SAND
LENSES

OLD
BEACH
DEPOSITS.

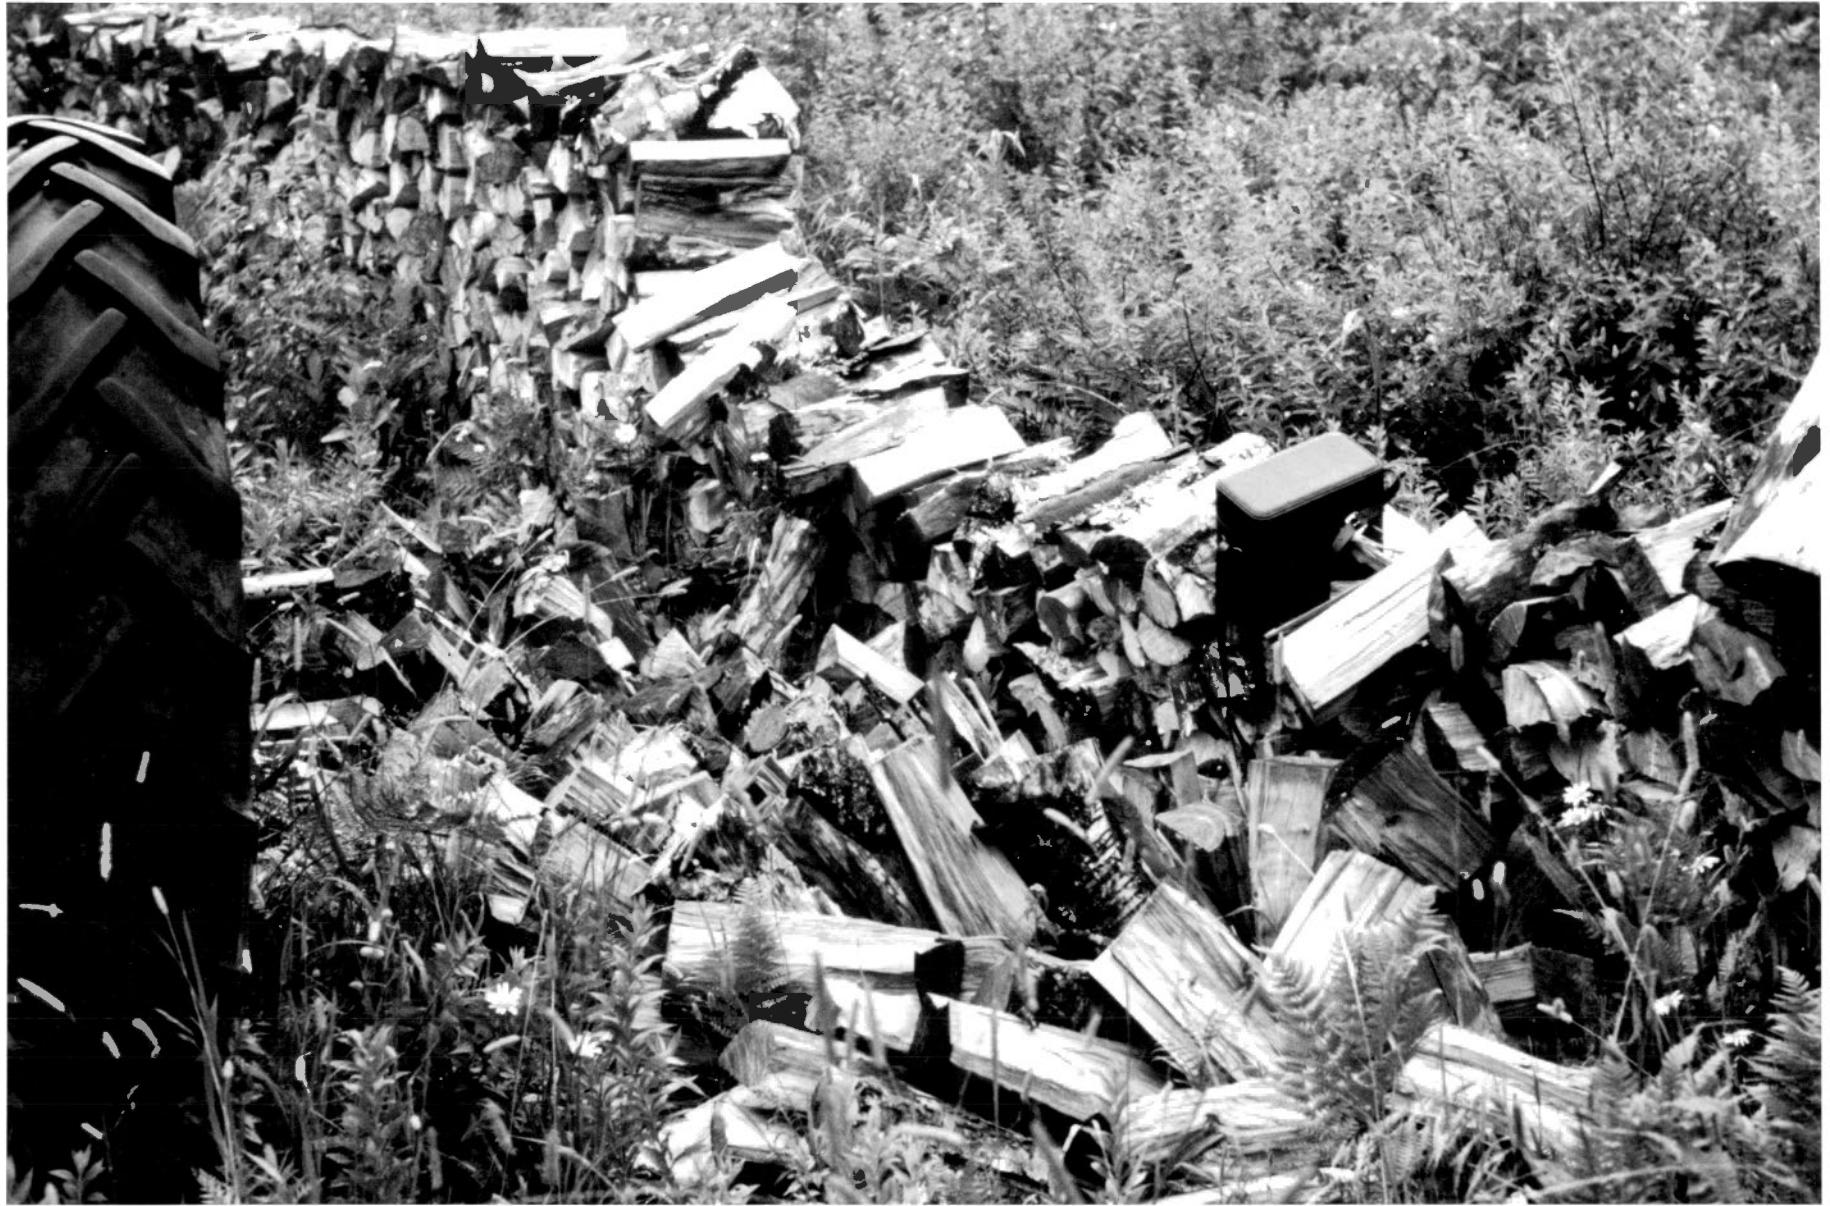
WOODPILE LAKEVIEW

- loud bang like thunderclap was heard
- beds shook and general strong vibrations were felt
- people awakened in general
- in general store cigarettes fell off shelf
- part of general store is on jacks, footings of store are on sand
- woodpiles in stream along side of stream valley fell over to the south
