**GEOGRAPHICAL PAPER No. 26**

# **Shoreline Changes in Egmont Bay and Bedeque Bay, Prince Edward Island**

*Charles N. Forward*

**GEOGRAPHICAL BRANCH  
Department of Mines and  
Technical Surveys, Ottawa**

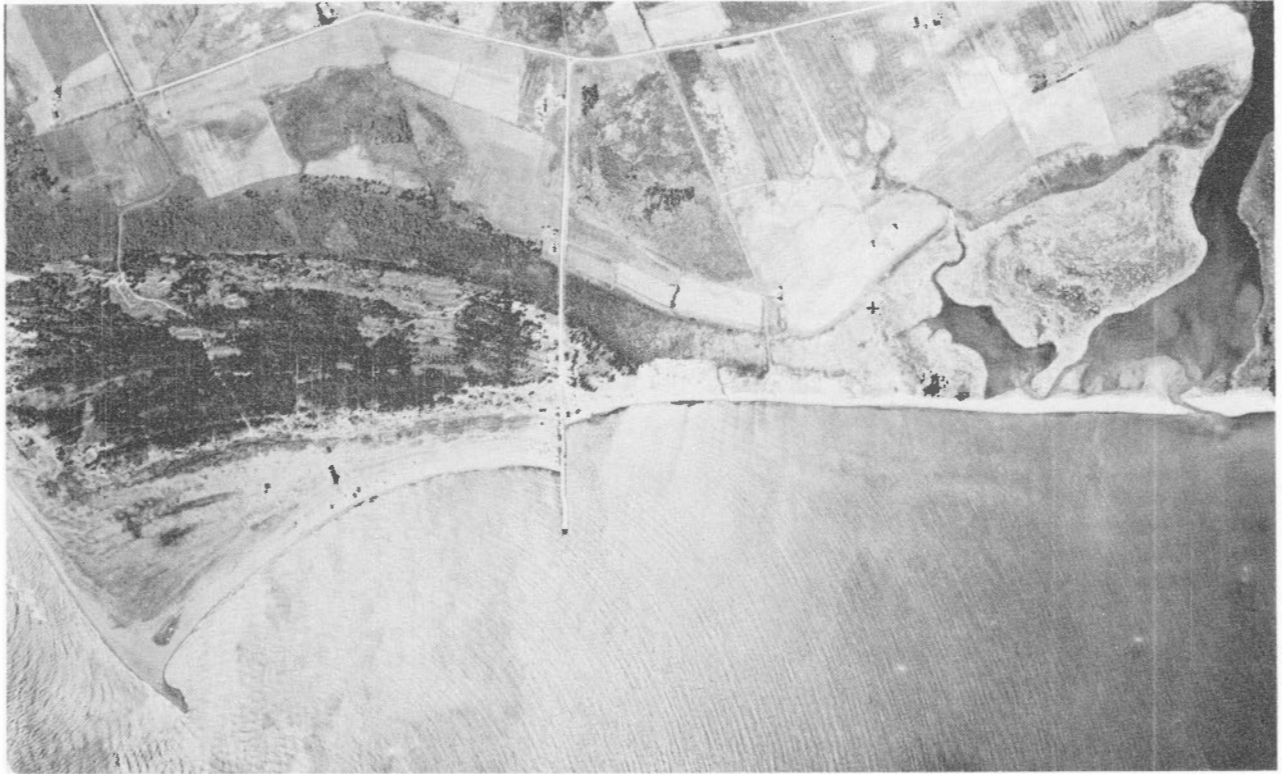
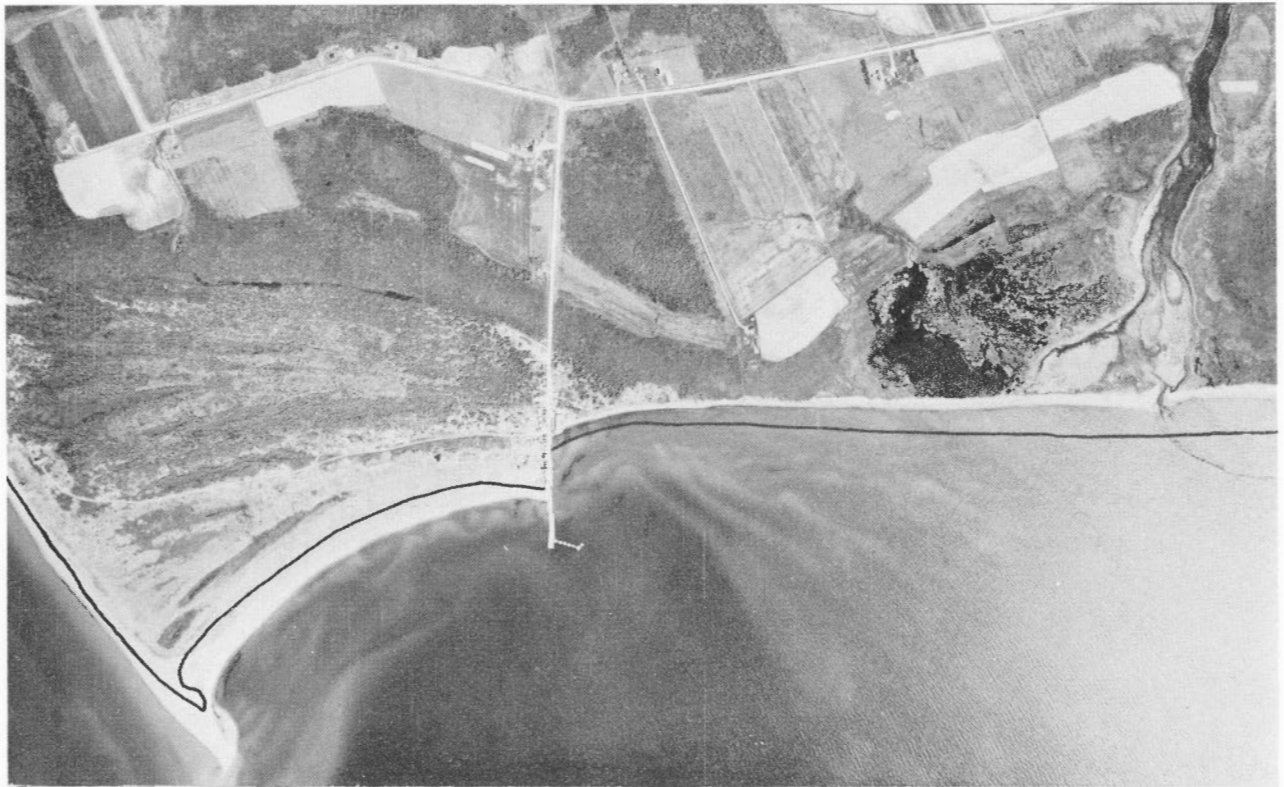
Figures 4 and 5. At West Point a succession of beach ridges has been built up with sand drifted from the west coast of the island. As evidenced by the photographs, considerable deposition has taken place since 1935. While deposition is occurring west of the wharf, the low shoreline east of the wharf is retreating rapidly.

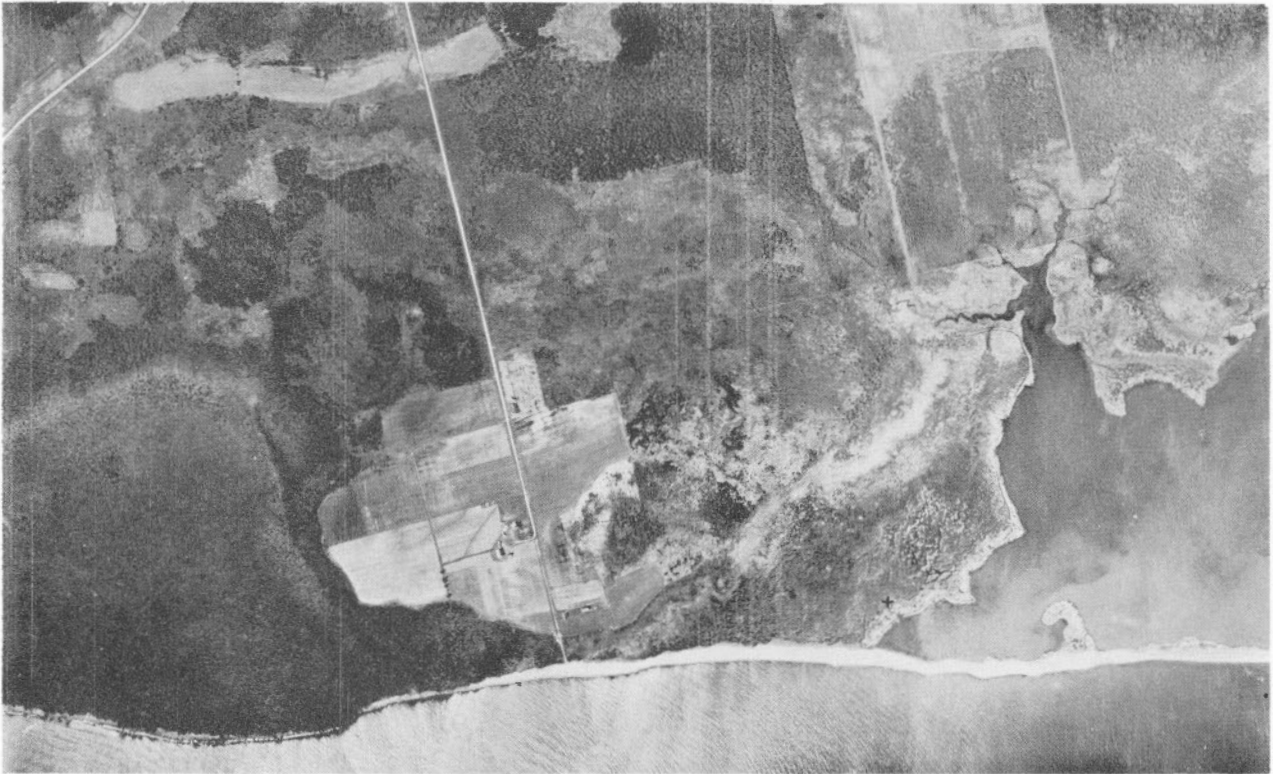
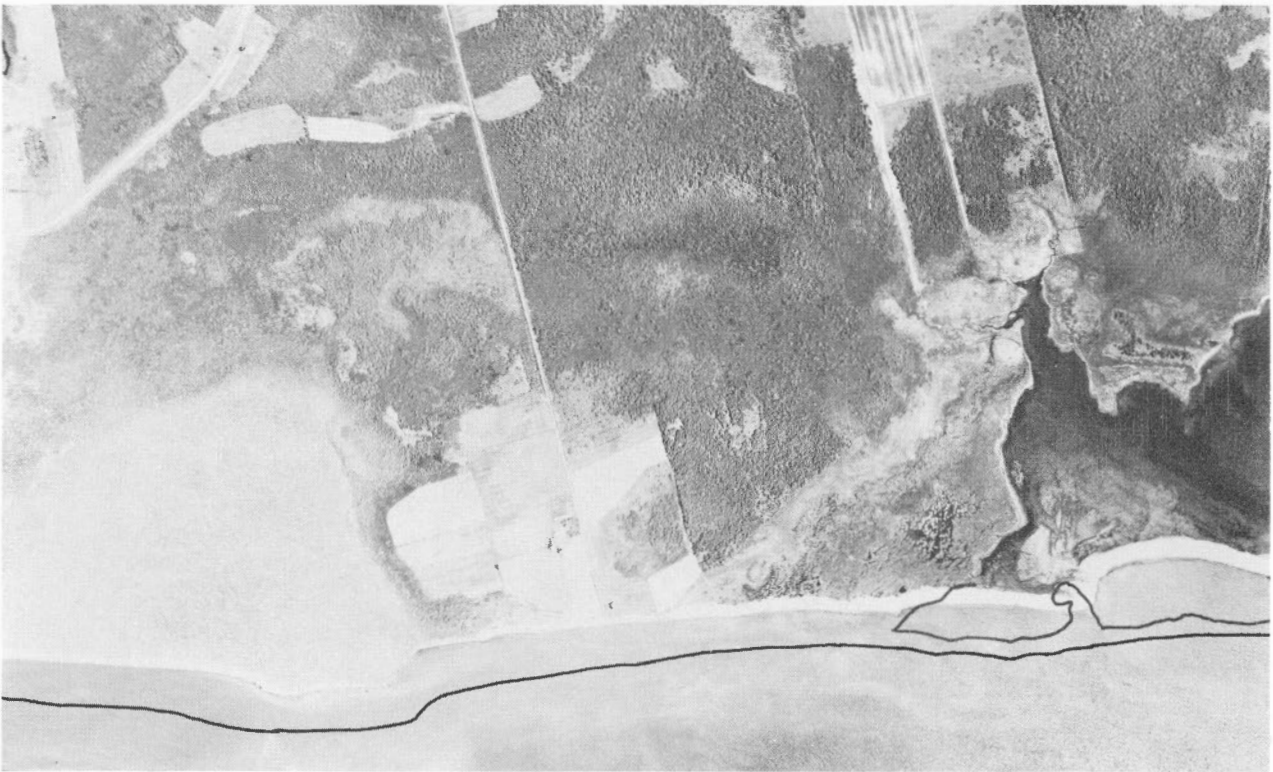
Figures 6 and 7. This rapidly eroding section is composed of a peat exposure 4 to 7 feet in height on the left and a low bank of unconsolidated material on the right. Along the base of the erosion face at left, wave action has exposed a tangled mass of tree stumps that had been covered by several feet of peat. The sea is now encroaching on the cultivated land (centre), and is threatening the nearest house with inundation in a few years' time.

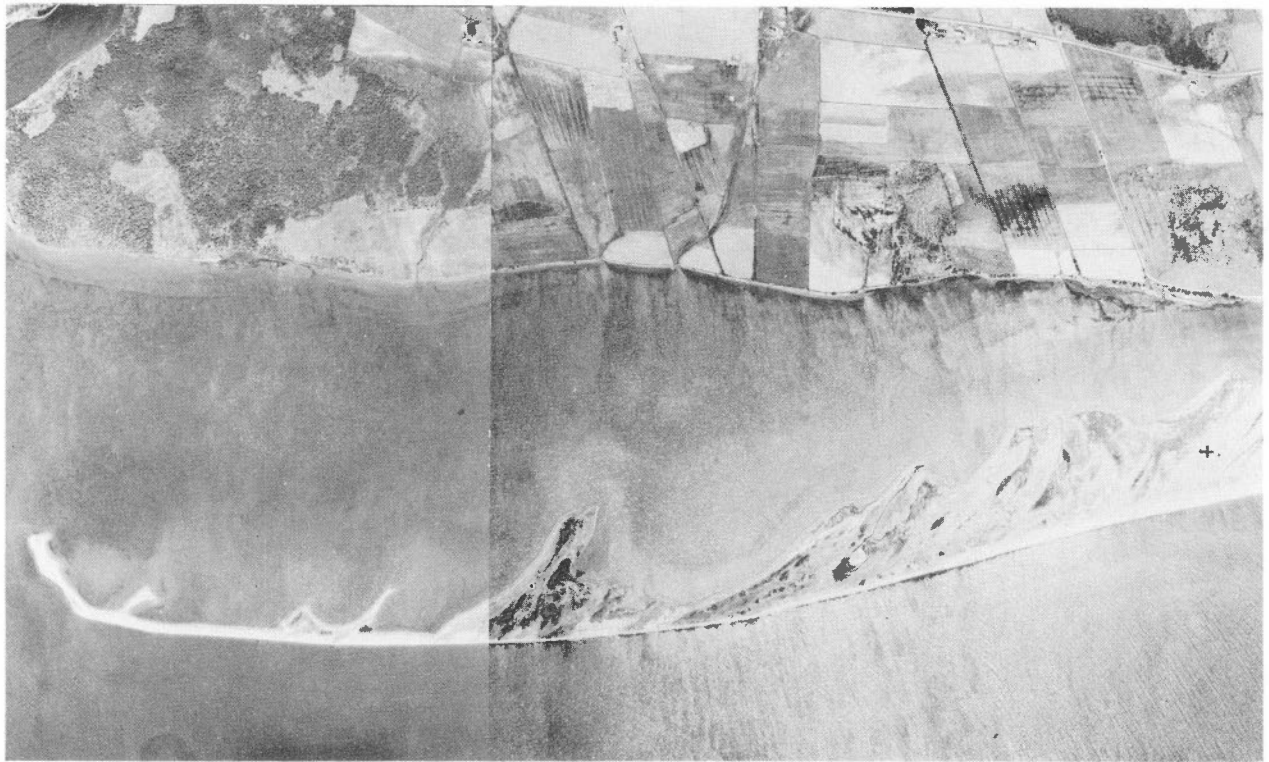
Figures 8 and 9. A striking change in the position of this bar has occurred and a large quantity of sand has been removed. The western end of the bar has moved eastward and much closer to the shore. The curved ends of earlier bars that extended much farther seaward can be distinguished on the right.

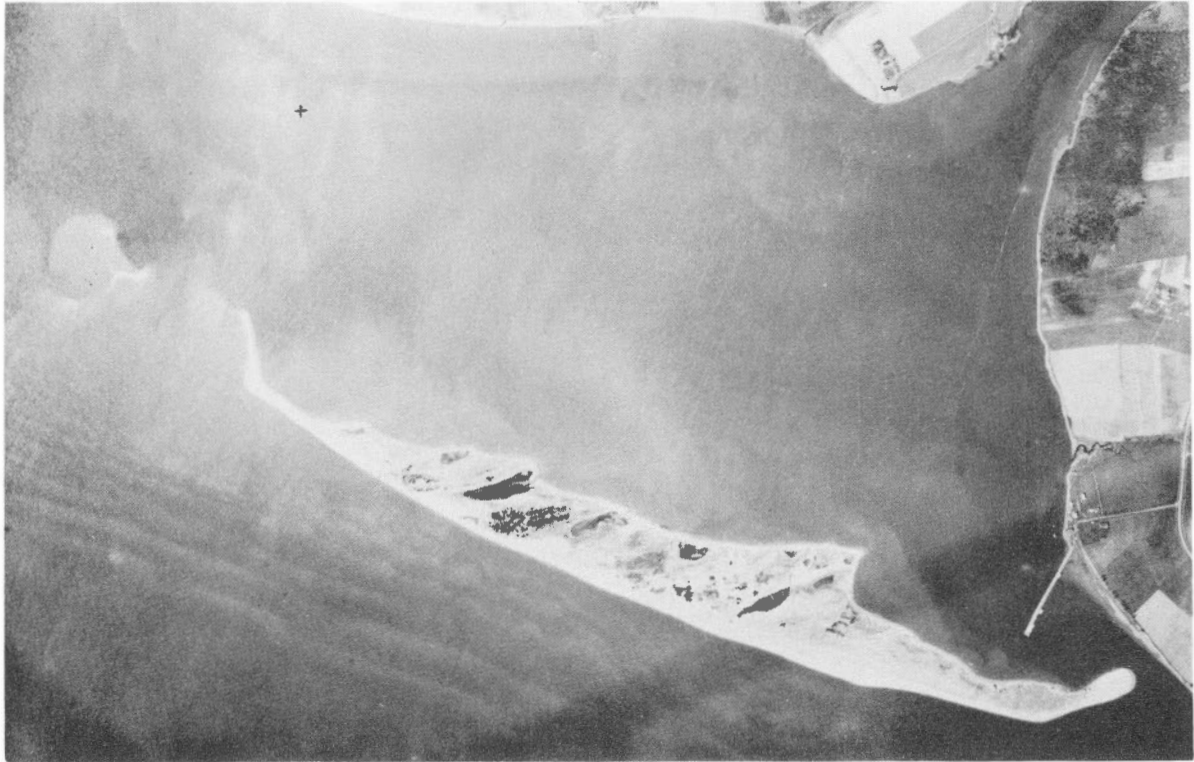
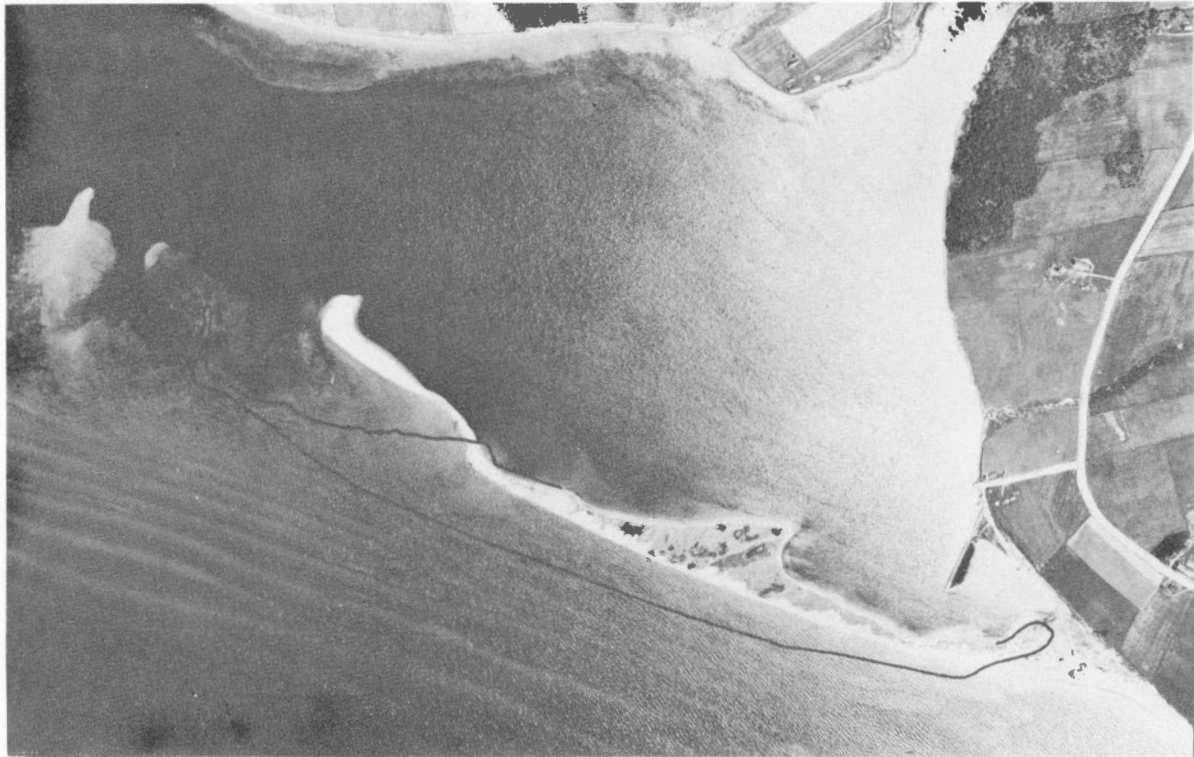
Figures 10 and 11. During the 23-year interval a large part of the bar has been sliced away and sand has been deposited in abundance at the eastern end, joining the bar to the land. That this bar was once much larger is indicated on the 1839 Admiralty chart (Figure 2). At top right, the fact that the barn situated on the point is much closer to the water in Figure 11 than in Figure 10 is evidence of shoreline retreat.

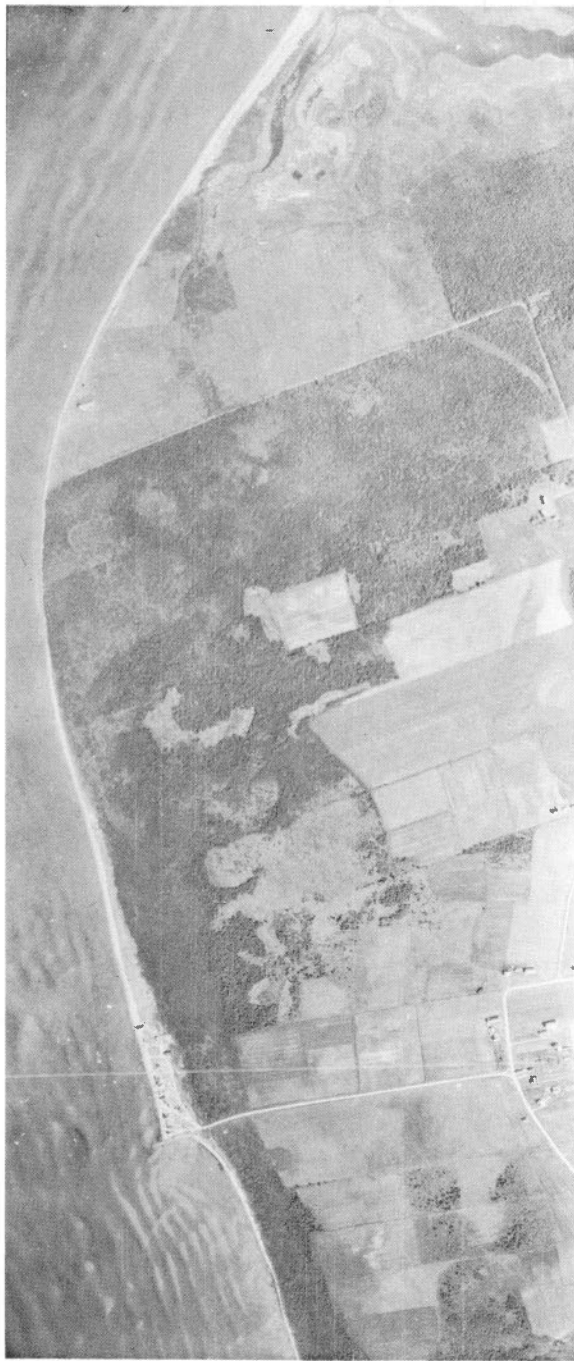
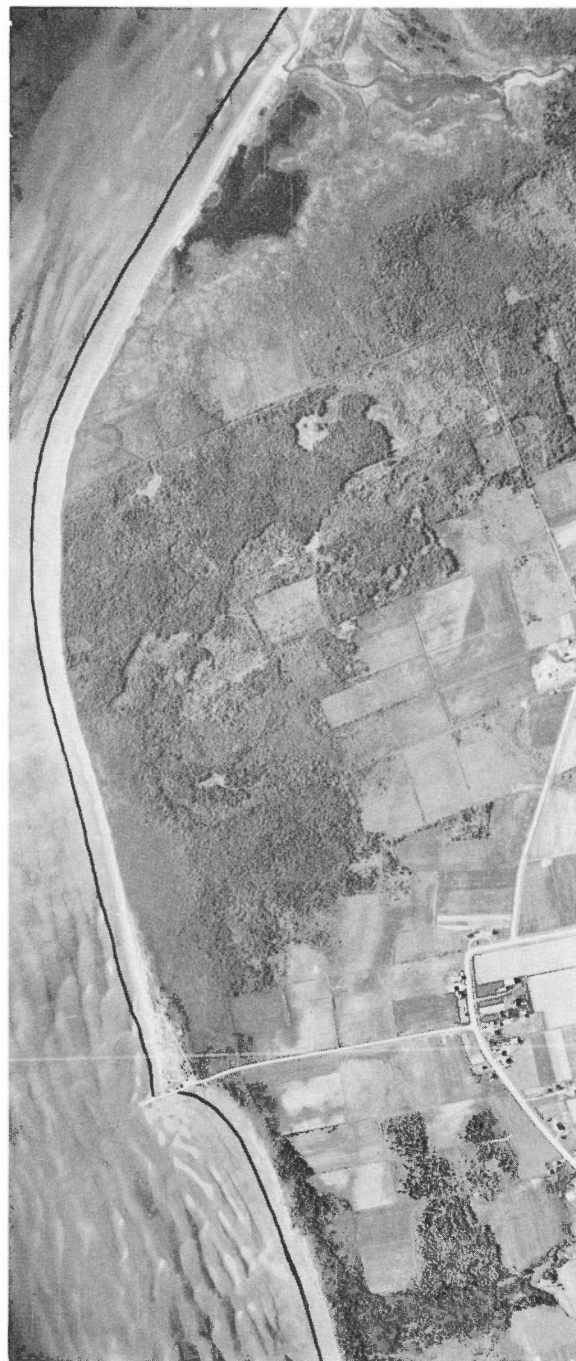
Figures 12 and 13. The coast near St. Chrysostom is composed of unconsolidated material and the erosion face ranges from 2 to 5 feet in elevation. The shoreline has retreated at a rate of approximately 5 feet per year. Sand that had accumulated north of the wharf before 1935 was eroded away during the succeeding quarter century.

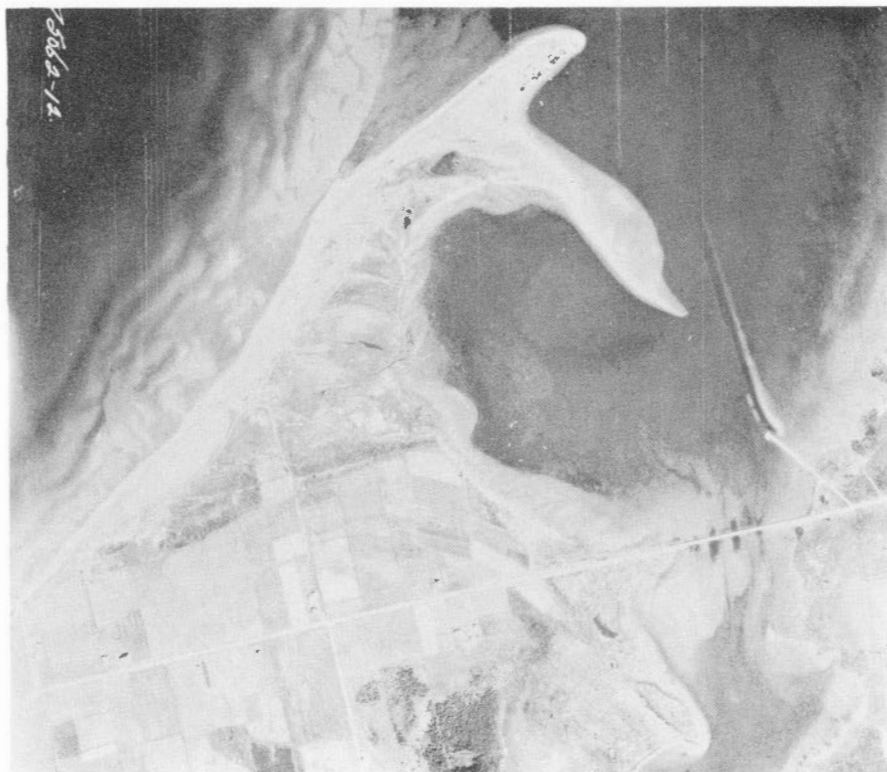
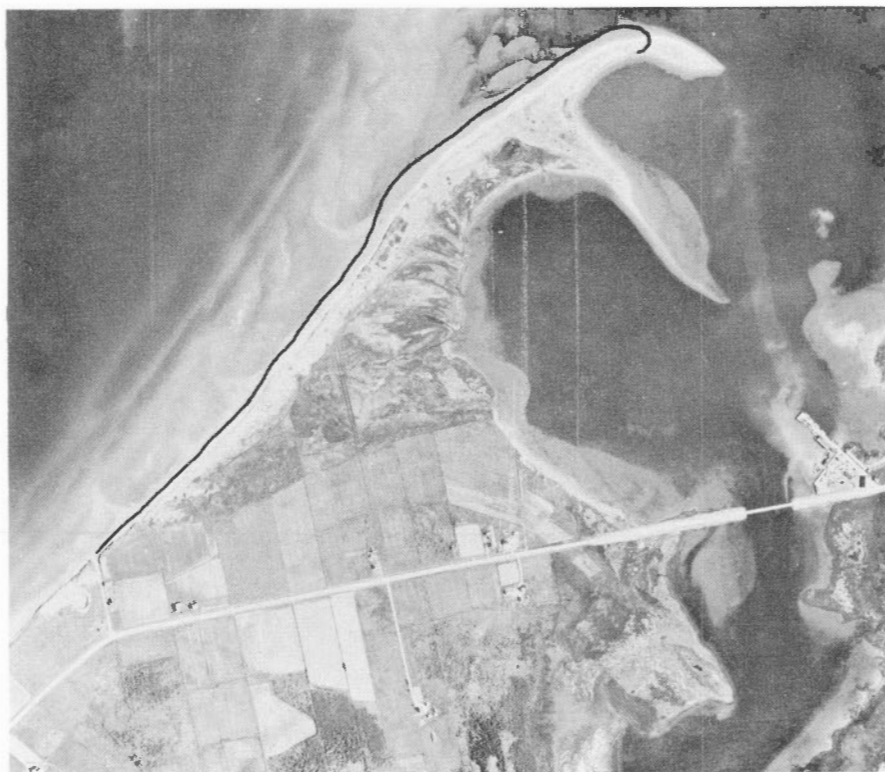
Figures 14 and 15. Successive sand ridges show that this compound, recurved spit has been altered in shape frequently. Since 1935 rapid erosion has occurred on the seaward side and the secondary point of the spit has curved landward. Only the primary recurved point existed in 1839, as indicated by the Bayfield survey.

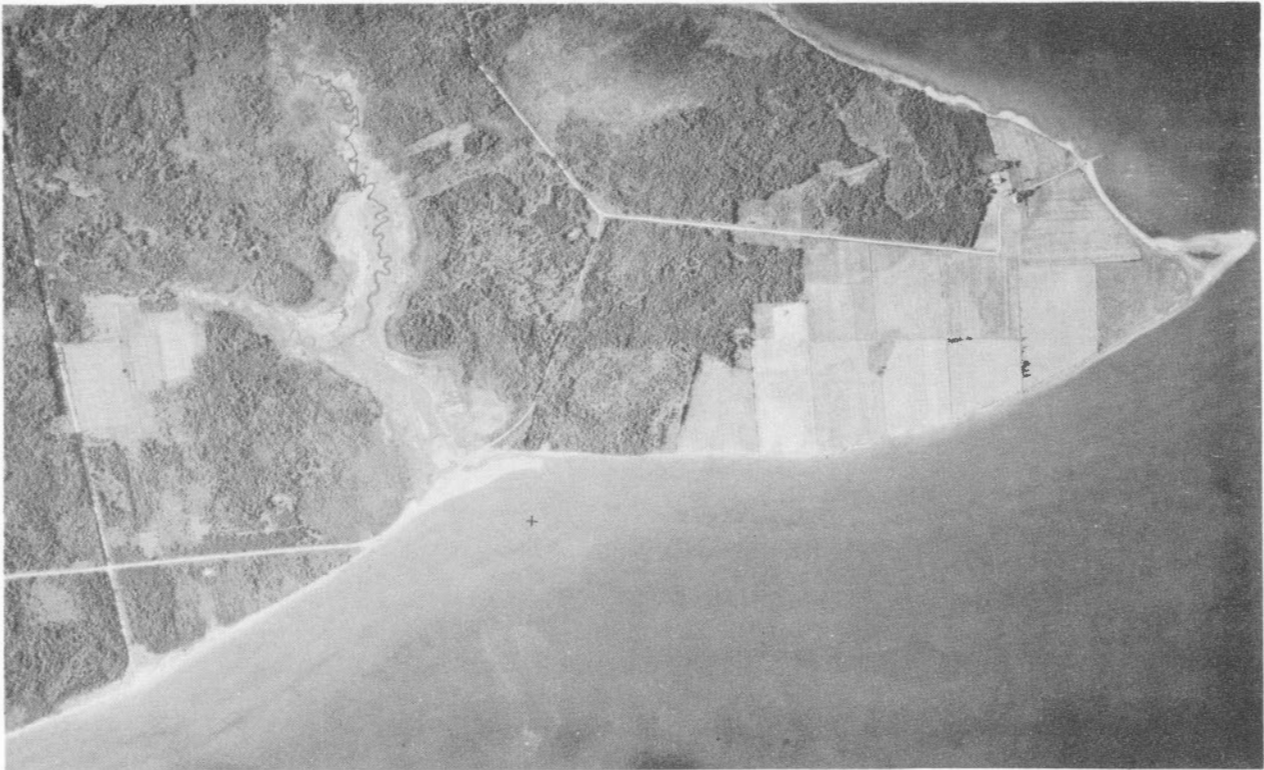
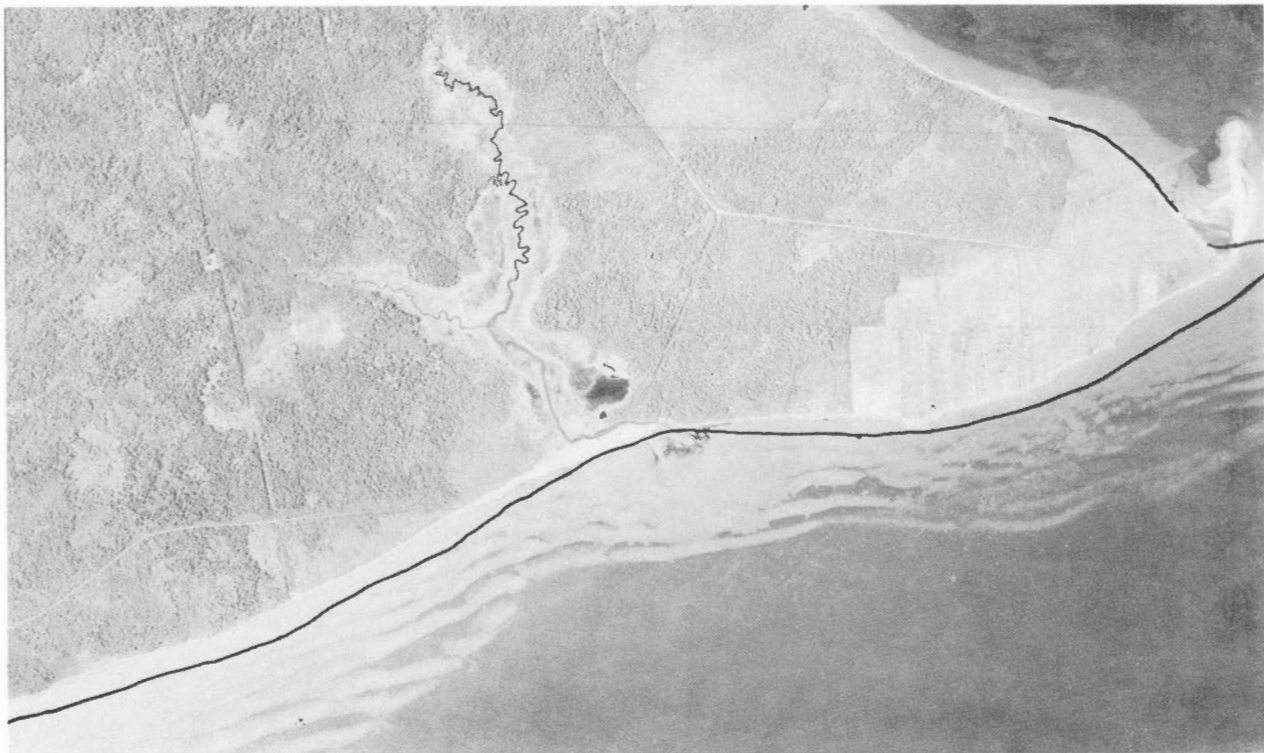
**Figures 17 and 18.** Sunbury Point is a remarkable example of rapid shoreline retreat. Except for a short section of rock, the coastline is of unconsolidated material. The rate of retreat varies, being slightly lower where the rock offers greater resistance and where deposition has occurred at the stream mouth. Shoreline retreat on the north side of the peninsula has been far less severe. The cusped bar at the end of the point has turned north and taken the form of a spit.

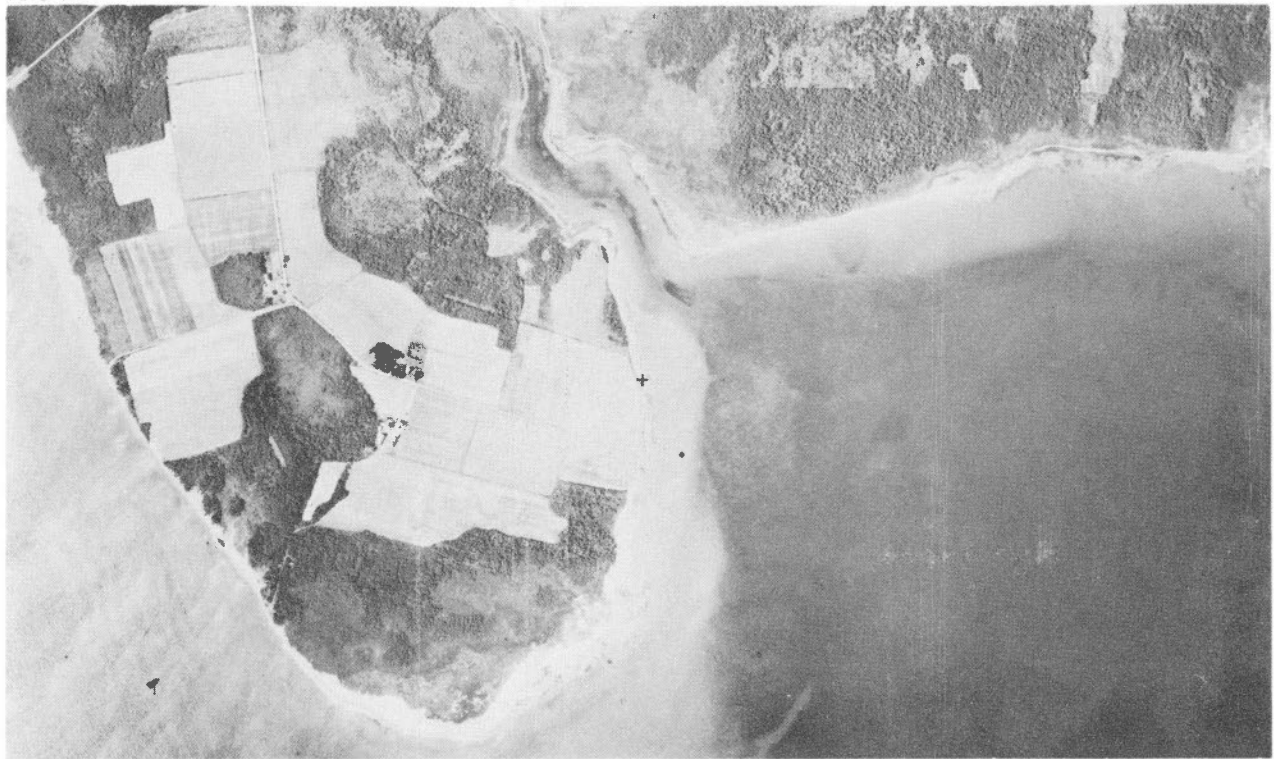
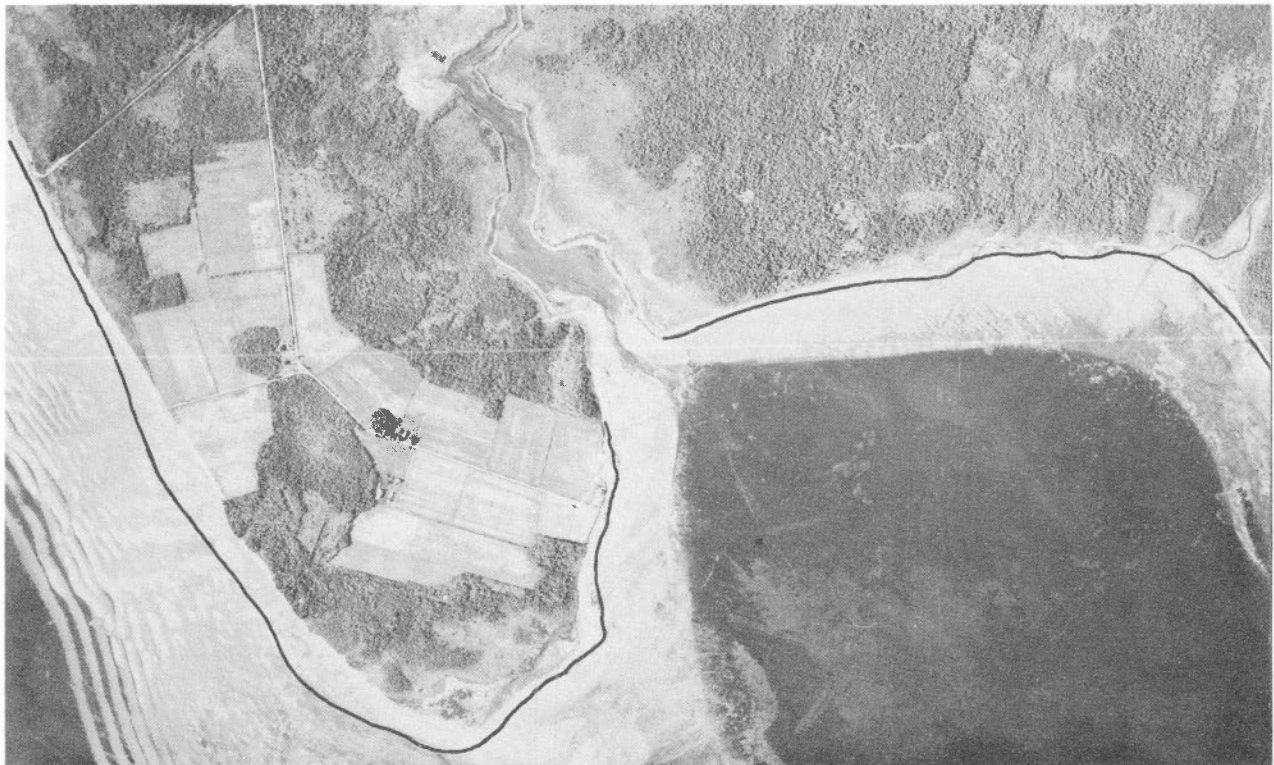
Figures 19 and 20. Miscouche Point has experienced a most alarming loss of land. On the west side of the peninsula the rate of retreat reaches nearly 13 feet per year at some points. The erosion face, of unconsolidated material, varies in height from 2 to 5 feet. During the brief span of 23 years large parts of several cultivated fields have been removed and the acreages of the farms considerably reduced.

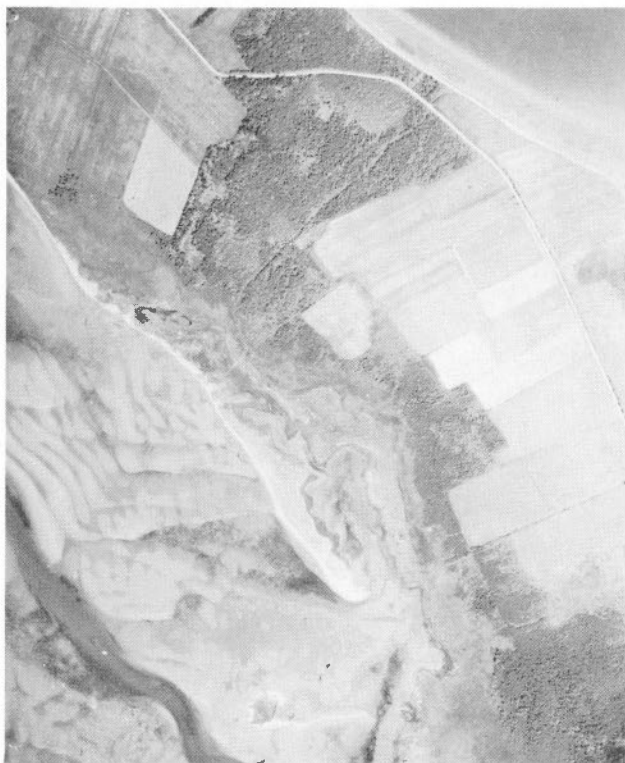
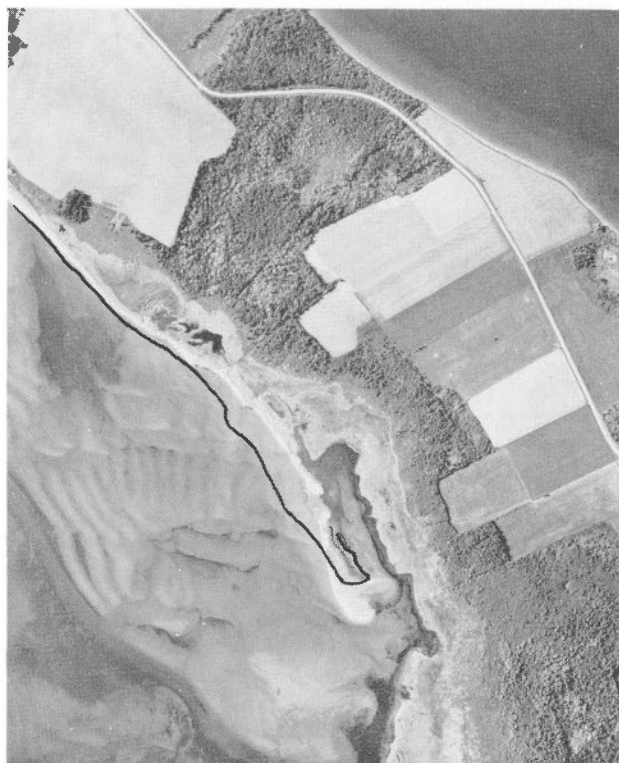
Figures 21 and 22. This small spit has been pushed landward and slightly lengthened. The low bank at the base of the spit has also retreated at a rapid rate.

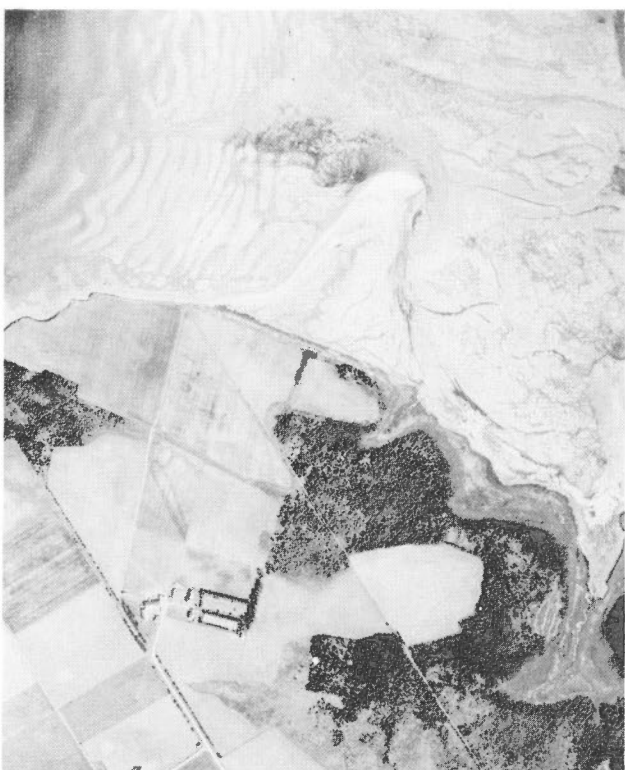
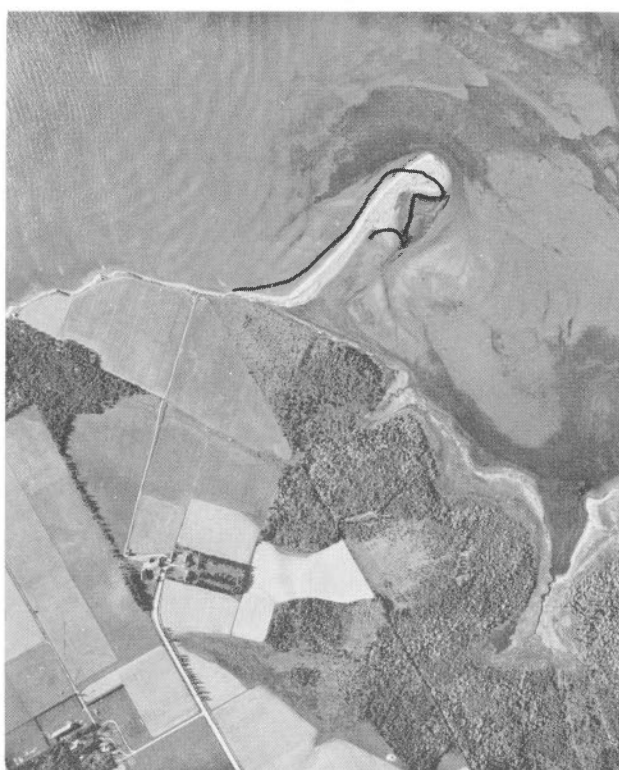
Figures 23 and 24. Situated on the opposite side of Salutation Cove is a spit which was formerly of much greater size. The 1839 chart shows a substantial sand feature that reached almost to the northern shore of the bay, constituting a baymouth bar. Since 1935 the spit has lengthened and become more attenuated.
