**GEOGRAPHICAL PAPER No. 48**

# Roadside Erosion and Resource Implications in Prince Edward Island

**POLICY RESEARCH and COORDINATION BRANCH**

*With special reference to western Prince County*

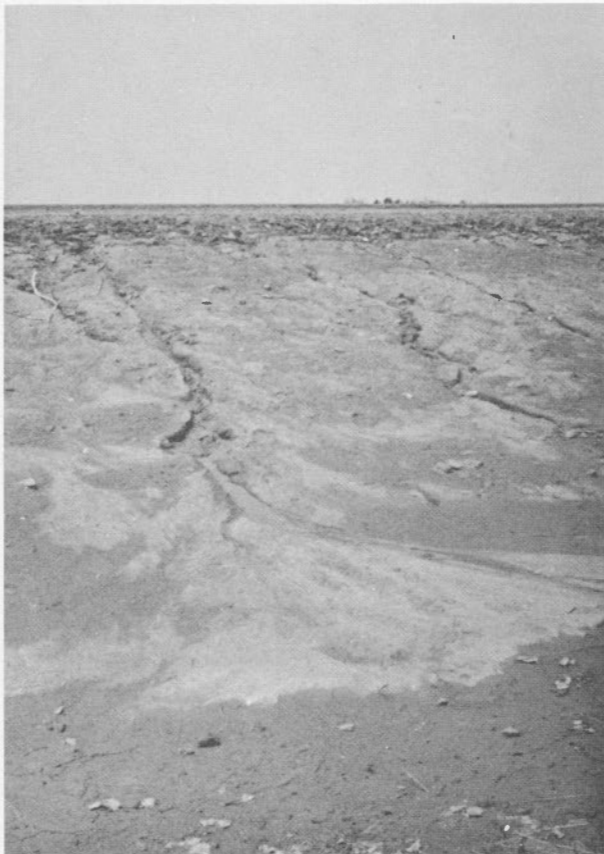
FIGURE 2. Western Road, western Prince County, near Elmsdale. Rill erosion (Class 2) on the sideslope. Note fan-shaped deposit.

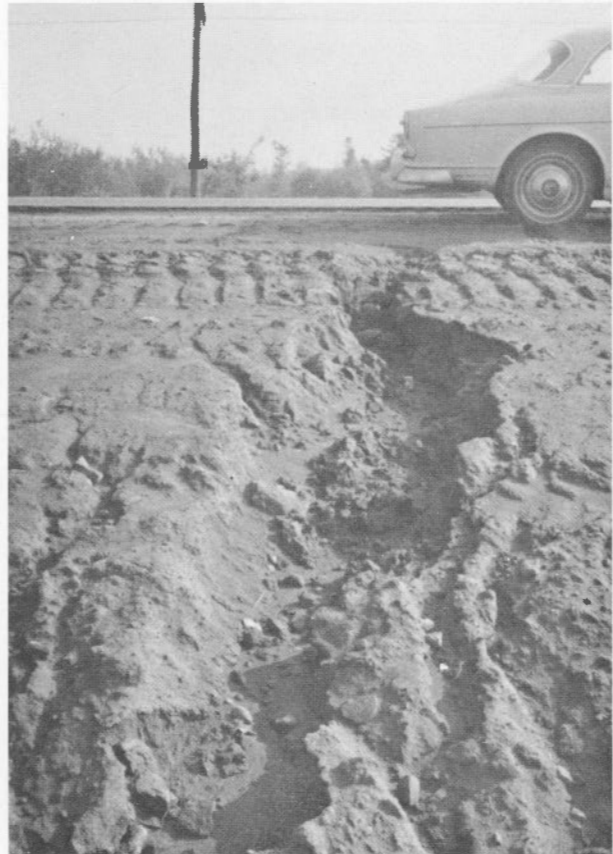
FIGURE 3. Western Road, western Prince County. Initial gully erosion (Class 3) on sideslope. Gully 10" deep and 1'6"-2' across.

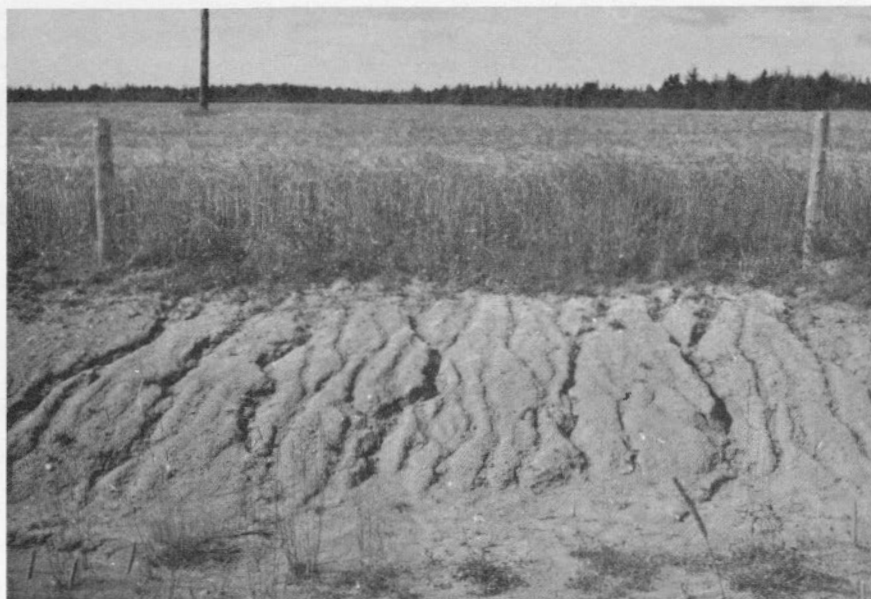
FIGURE 4. Western Road, western Prince County, near Carleton. Rill erosion (Class 2) on the backslope.

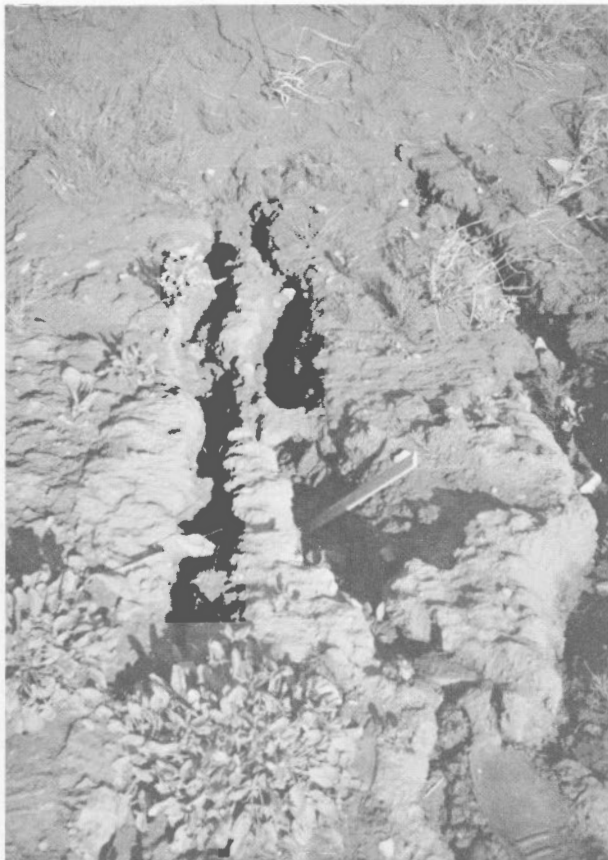
FIGURE 6. Northam Road, western Prince County. Initial gully erosion (Class 3) on sideslope. Small gullies 9" in depth beginning to coalesce.

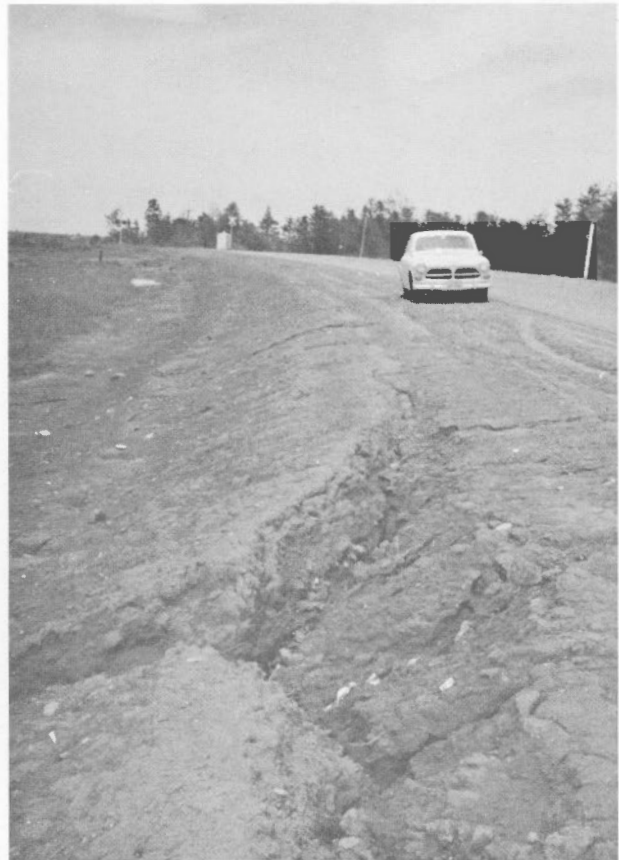
FIGURE 7. Western Prince County. Sideslope gully 3' in depth beginning to eat into the shoulder of the road.

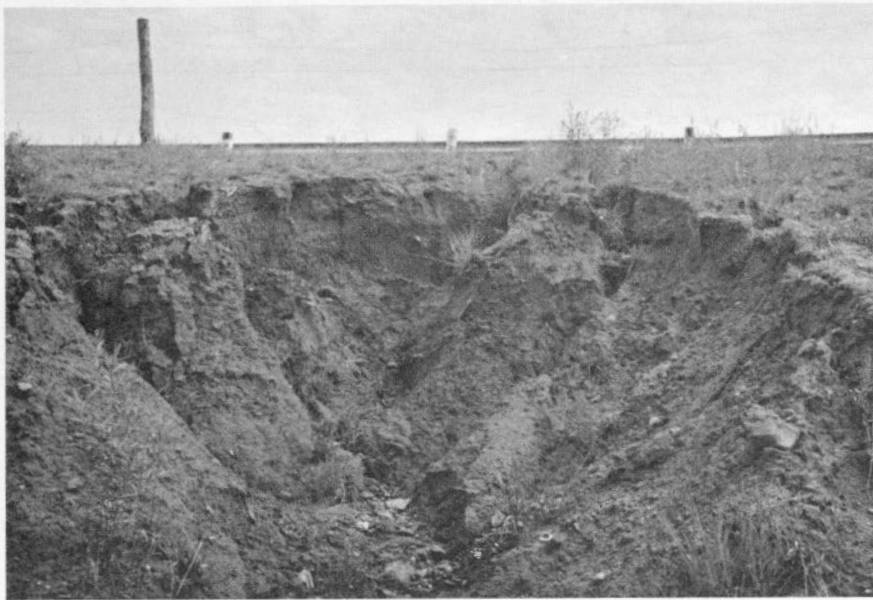
FIGURE 8. St. Anthony-Mill Road, western Prince County. Severe erosion (Class 5) on a long side-slope at a stream crossing. Note road guard rail above.

\*The gully shown in Figure 8 is an exceptionally large one; most gullies present at this particular site averaged less than 4 ft. in depth and 7 ft. in width.

Repairing large gullies and washouts is expensive, averaging \$2.50 per cu. yd. for fill and for compacting and finishing the surface (14). Thus, a massive gully approximately 200 cu. yds. in area, similar to but larger than that shown in Figure 8\*, engenders a repair bill of about \$500.00.

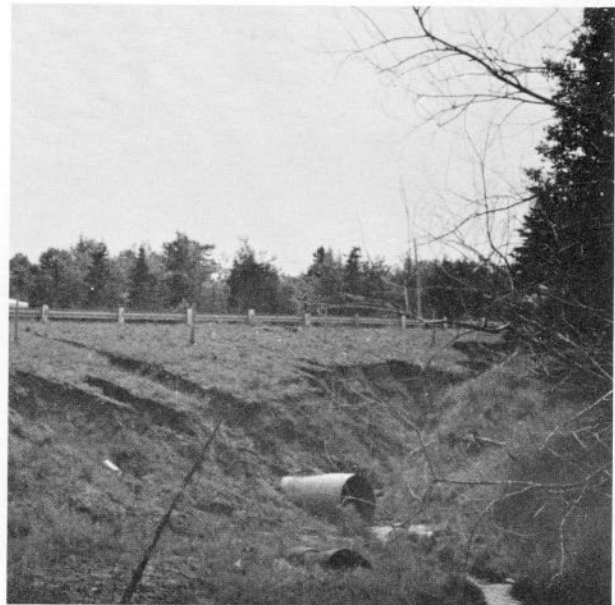
FIGURE 10. St. Anthony-Mill Road, western Prince County. Advanced erosion (Class 5) at stream crossing. Note stream at bottom right-hand corner.

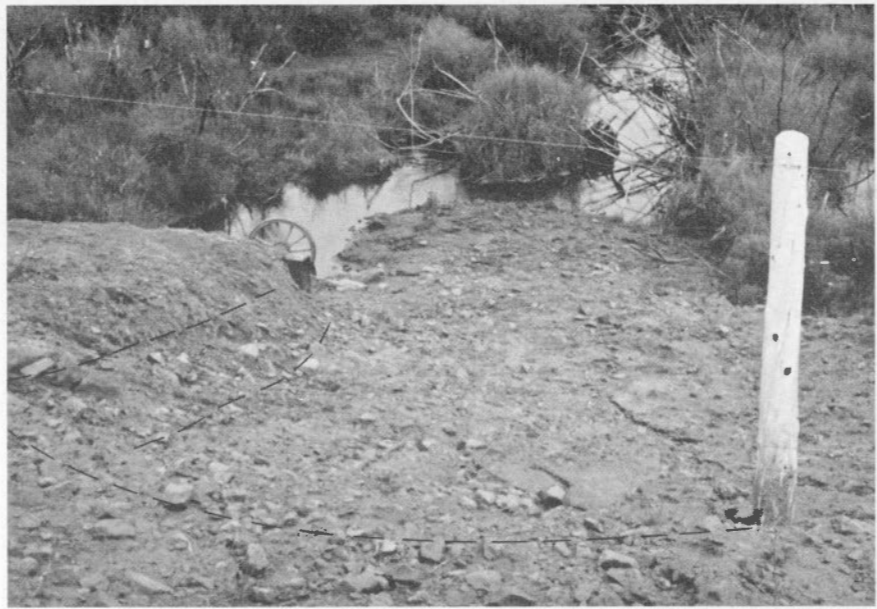
FIGURE 11. Montague Road, at junction of Routes 23 and 206, eastern P.E.I. Advanced erosion (Class 5) at a stream crossing. Depression measures 3' in depth and 19' across. Note deposition in stream.

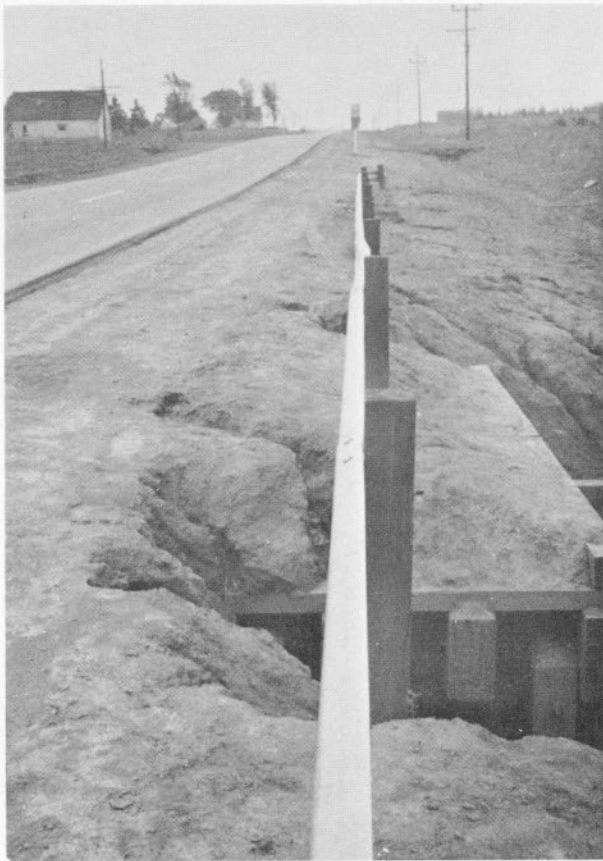
FIGURE 16. Western Road, western Prince County, near Richmond. Advanced erosion (Class 5) encountered at bridge structure. Note the extension of gullies inside the guard rail. One gully measures 3'6" in depth and 5' in width.

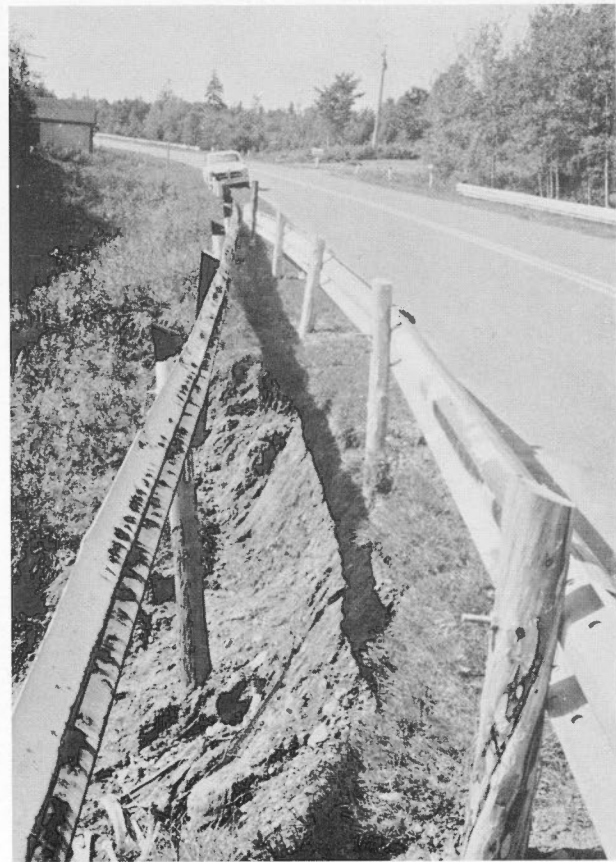
FIGURE 17. East Point Road, Route 16, eastern P.E.I. An example of very severe erosion on a steep roadside slope. Note the old guard rail on the left and the new rail on the right, demonstrating the extent to which the embankment has been eroded. Note also that the new guard rail is beginning to be affected.

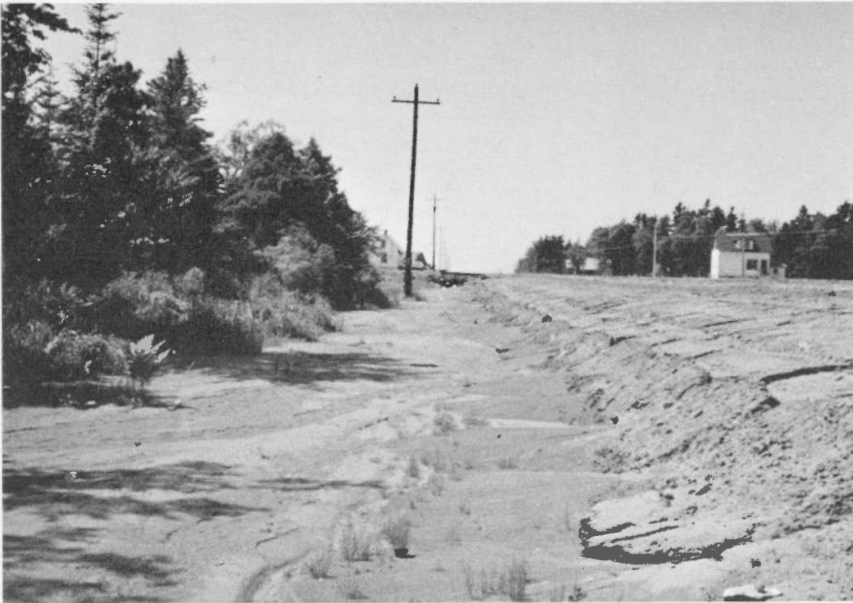
FIGURE 18. Western Road, western Prince County, near Portage. Rill erosion (Class 2) is found on the road side-slope at right. Note the absence of vegetation. An outstanding example of extensive deposition in ditches. The deposit present at this site measured 3'2" in depth and 15'-20' in surface width across the ditch.

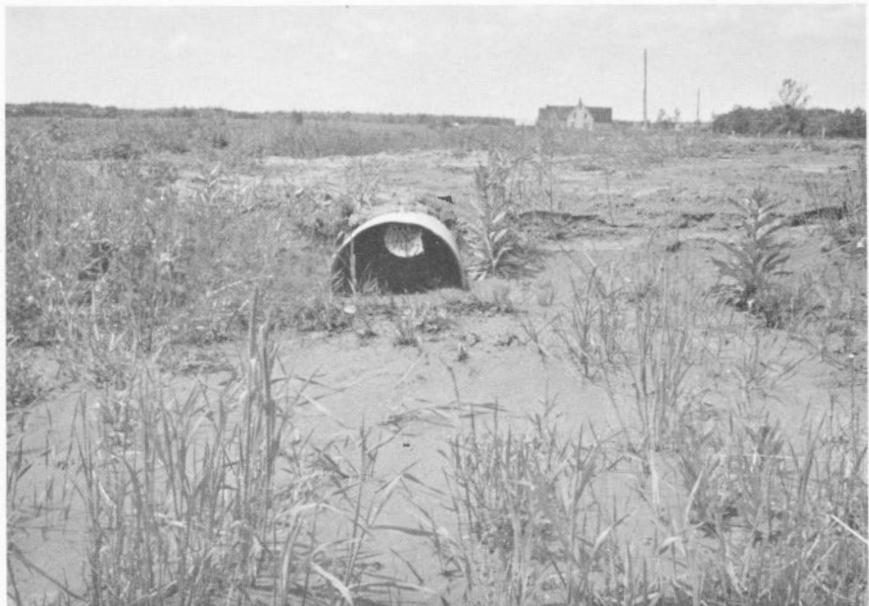
FIGURE 19. Duvar Road, western Prince County. An example of sediment, accumulated in a ditch, which is beginning to block a culvert.

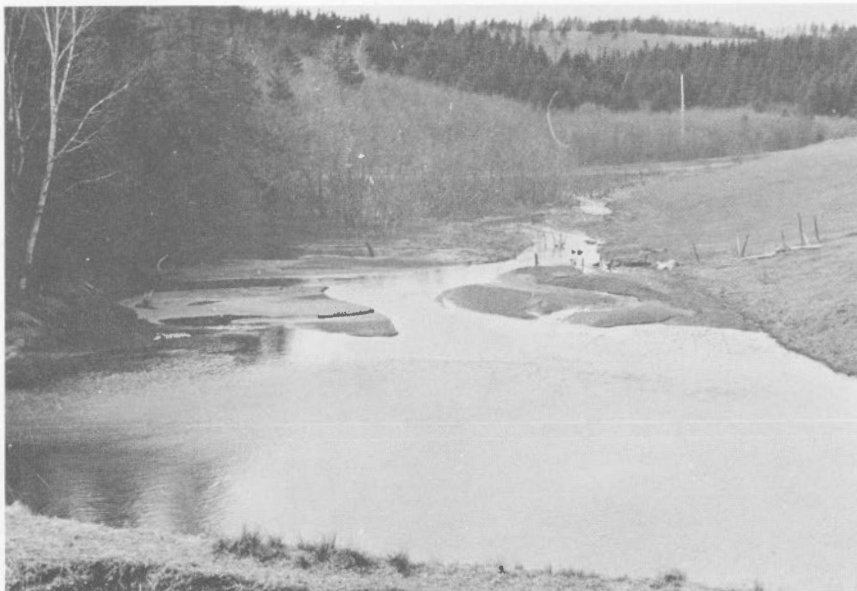
FIGURE 20. Kellys Cross, central P.E.I. A typical example of a small pond silting up with eroded material. Note the recent bar deposits in the pond.

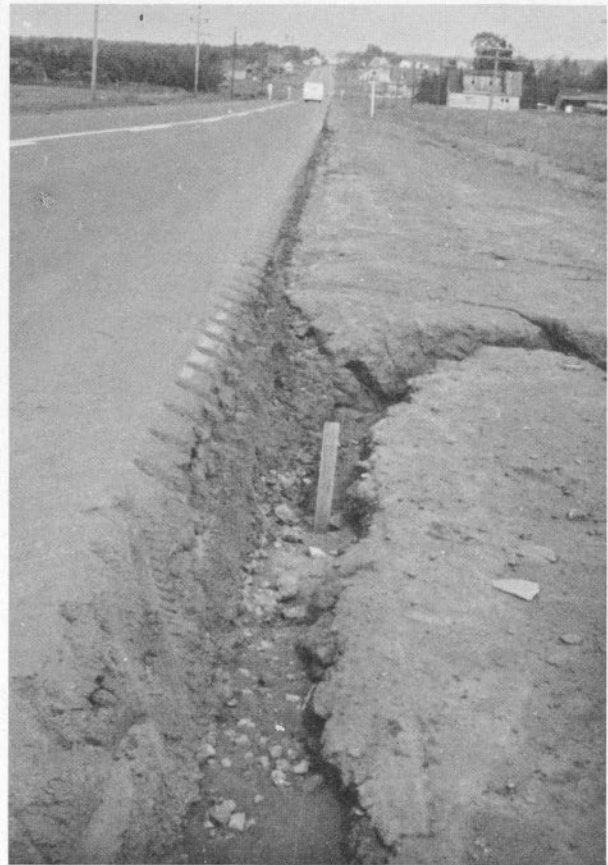
FIGURE 22. Western Road, western Prince County, near Richmond. The development of unsafe motoring conditions due to gully-ing parallel to the edge of the pavement.

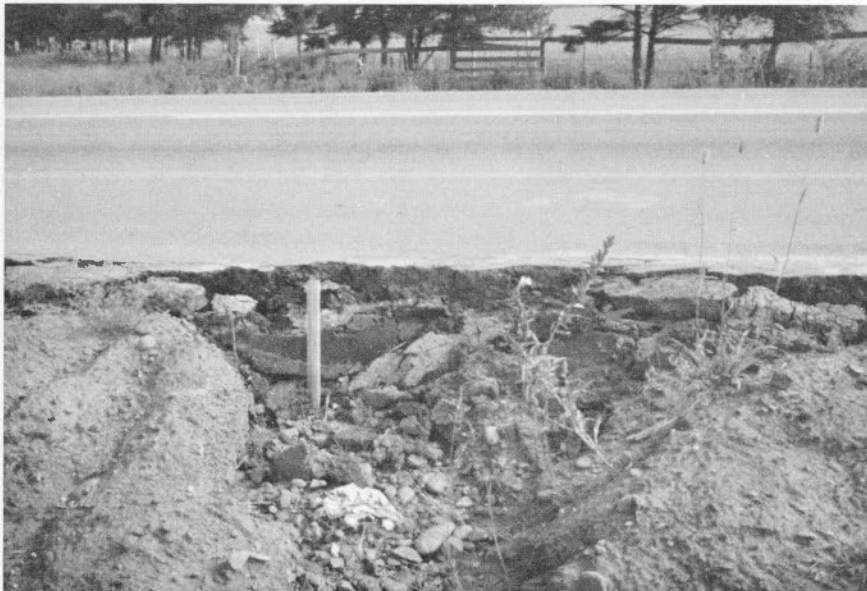
FIGURE 23. Trans-Canada Highway, near Vernon, eastern P.E.I. Notable deterioration of the paved highway shoulder and the roadside area. This gully is 11" deep and 3' wide.

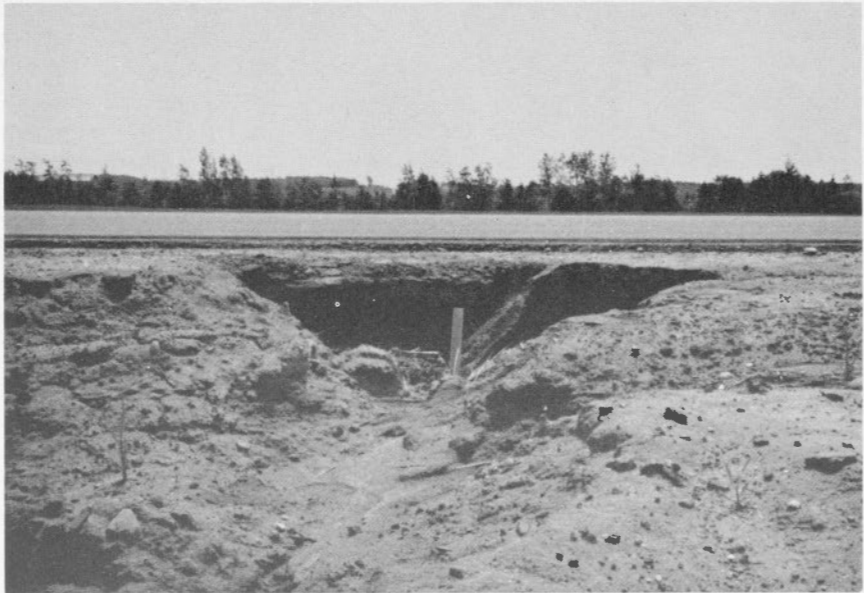
FIGURE 24. Duvar Road, western Prince County. The exposure and undermining of the road base as a result of roadside erosion. Note the absence of vegetation along the roadside. The gully is 1'6" deep.

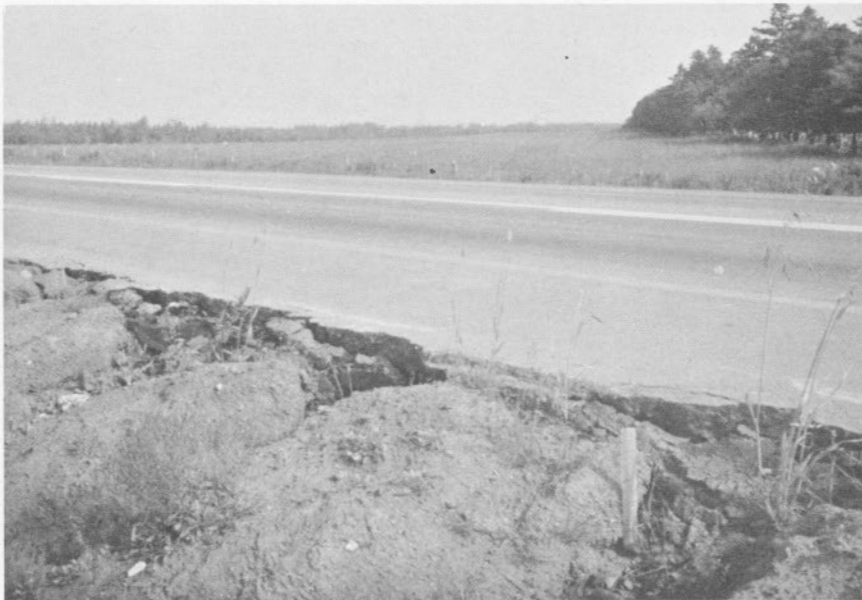
FIGURE 25. Trans-Canada Highway, near Vernon, eastern P.E.I. Numerous sections of pavement, over a very short distance, are deteriorating as a result of roadside erosion. These conditions are also safety hazards. The closely-spaced gullies average 10"-11" in depth.

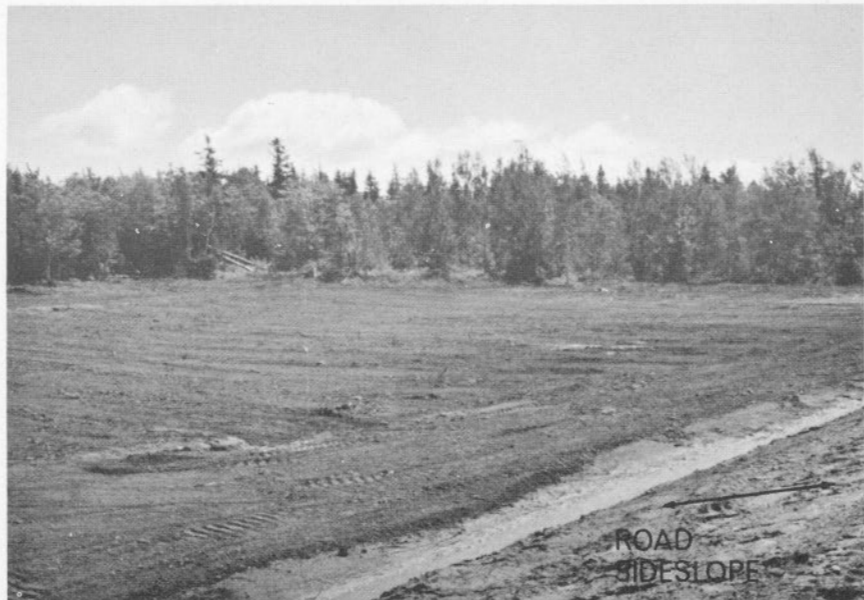
FIGURE 26. Western Road, western Prince County. A typical example of a borrow pit located close to the highway. These are normally abandoned without any attempt to seed the surface.
