**GEOLOGICAL SURVEY OF CANADA  
OPEN FILE 8707**

**Report on 2018 field activities and collection of  
ground-thermal and active-layer data in the  
Mackenzie corridor, Northwest Territories**

**C. Duchesne, J. Chartrand, and S.L. Smith**

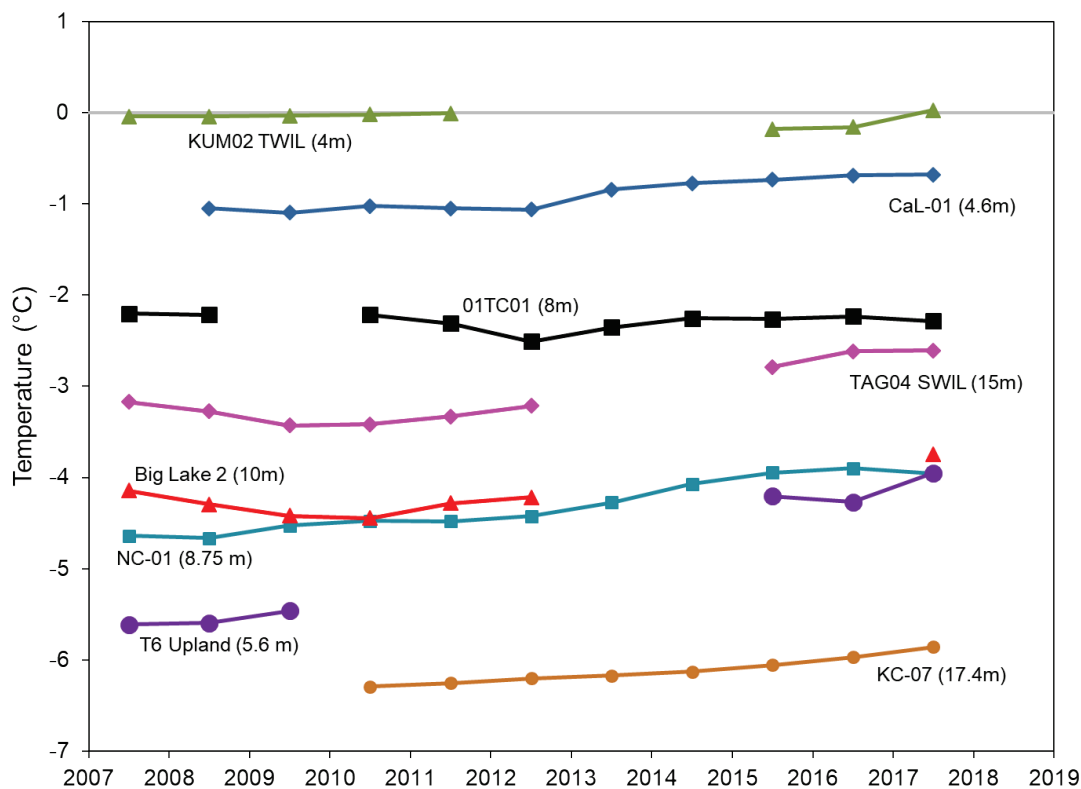
Figure 4. Annual mean ground temperature (AMGT) at measurement depth at or closest to depth of zero annual amplitude (ZAA) for selected sites in the continuous permafrost zone. Borehole name and depth of AMGT indicated.

Analysis of data collected in the continuous permafrost zone indicates that at most sites permafrost has been warming at rates greater than  $0.05\text{ }^{\circ}\text{C}\text{y}^{-1}$  (Figure 4). However, at some of the warmer permafrost sites (e.g. KUM02 TWIL, 01TC01), little warming or even slight cooling ( $0.005\text{ }^{\circ}\text{C}\text{y}^{-1}$ ) has occurred. An increase in the rate of warming at some sites since about 2011 may be associated with a period of higher air temperature since 2010 (Figure 6). At NC-01 and T6 Upland, greater increases in ground temperature ( $0.08$  and  $0.17\text{ }^{\circ}\text{C}\text{y}^{-1}$ , respectively) was observed over the same period. However, the measurement depths for these sites are shallower than that for many of the more northerly sites, and also above the ZAA depth, where temperatures exhibit more short-term fluctuation in response to air temperature changes.

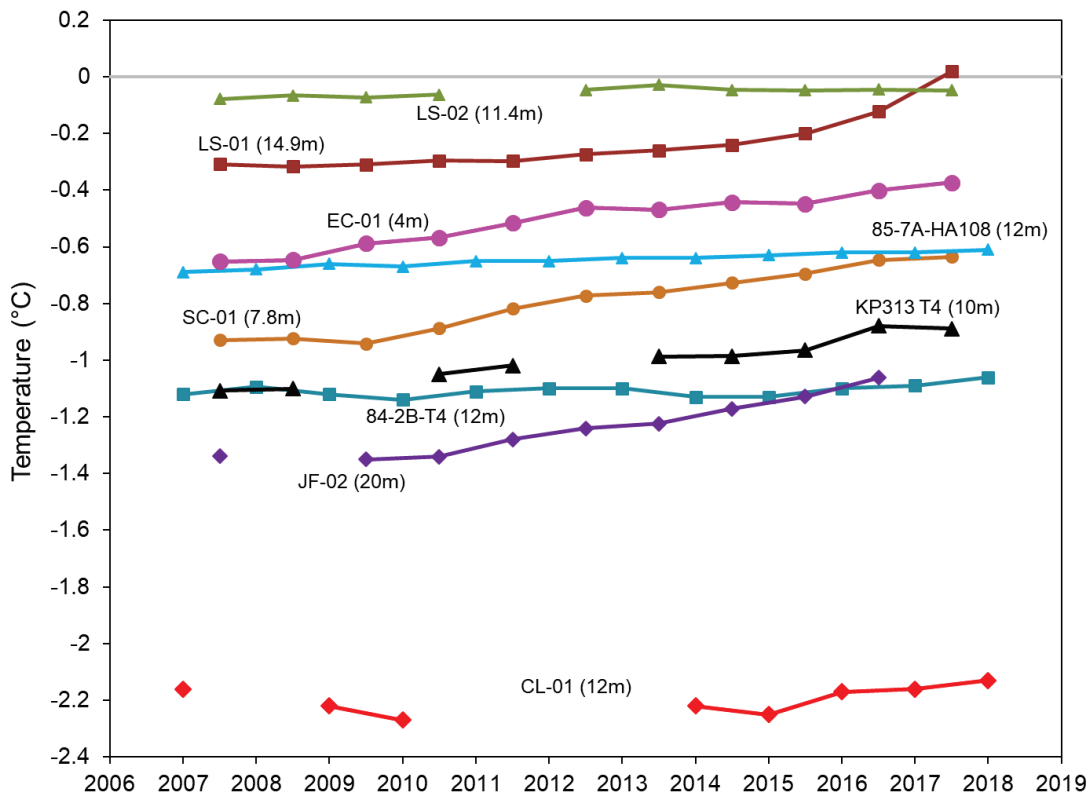
Figure 5. Annual mean ground temperature (AMGT) at the measurement depth at or closest to depth of zero annual amplitude (ZAA) for selected permafrost sites in the discontinuous permafrost zone. Borehole name and depth of AMGT indicated. Some sites are represented with a manual measurement.

The rate of change in AMGT in warmer permafrost of the discontinuous zone has generally been less than that for the colder permafrost sites. Over the last decade, the AMGT has increased by up to  $0.03\text{ }^{\circ}\text{C}\text{y}^{-1}$  at sites between Norman Wells and Fort Good Hope and by  $0.02\text{ }^{\circ}\text{C}\text{y}^{-1}$  or less at sites south of Norman Wells (Figure 3 and 5). These changes in AMGT are in agreement with those acquired from longer records for the central Mackenzie Valley (see Smith et al., 2019; Romanovsky et al., 2019) which indicate permafrost has been warming since the mid 1980s. Similarly to sites in continuous permafrost, the increase in AMGT since 2010 at some sites (Figure 5) may be the result of higher air temperatures in the last 9 years compared to those between 2007 and 2009 (Figure 6).

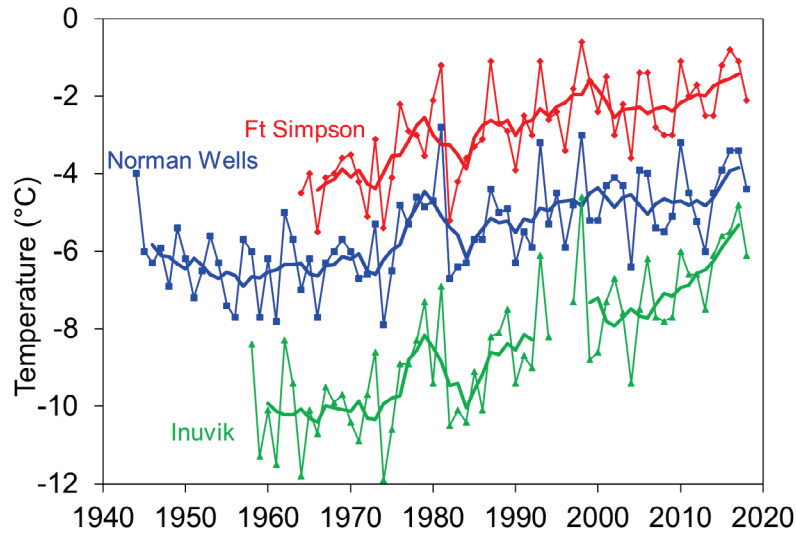
Figure 6. Mean annual air temperature (MAAT) for weather stations in the Mackenzie Valley (data from Environment Canada <http://climate.weather.gc.ca/>). The thick line represents the 5-year running mean.

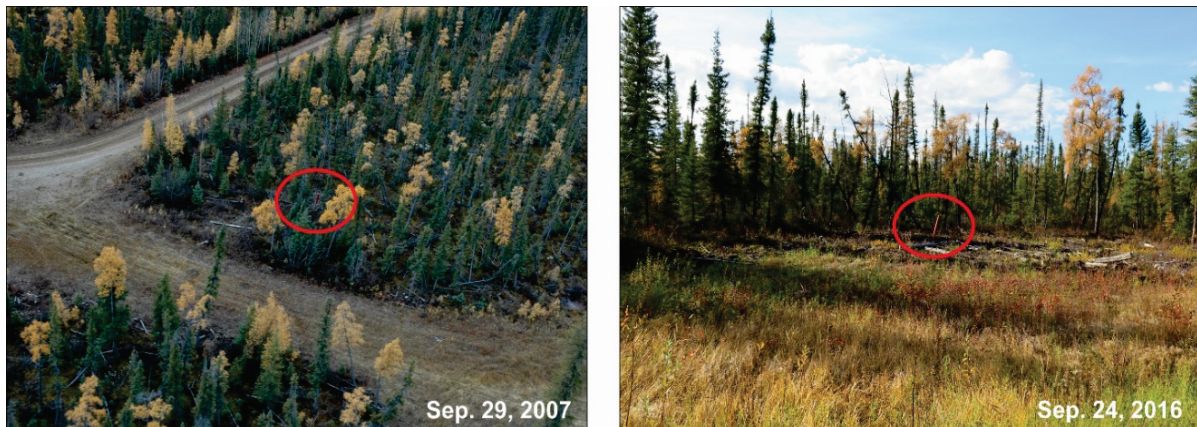
Figure 7. Vegetation cover at site LS-01 following cable installation in 2007 (NRCan Photo 2019-759), and after tree clearing between 2015 and 2016 (NRCan Photo 2019-758).

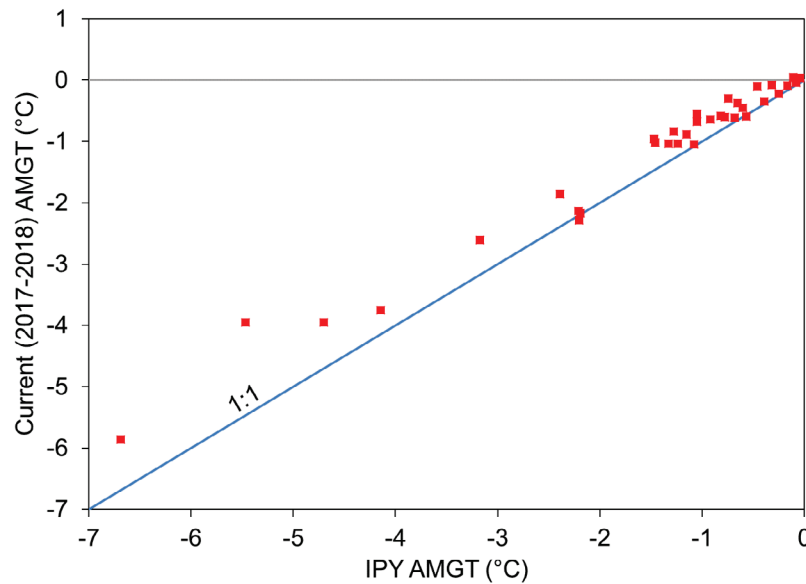
Figure 8. Comparison of current (2017–2018) annual mean ground temperature (AMGT) with international polar year (IPY) (2007–2009) baseline for sites visited in 2018. A 1:1 line is shown for comparison.

AMGTs for 2017–2018 for 34 sites have been compared to the baseline established during the International Polar Year (IPY, 2007–2009) (Smith et al., 2010b). Overall AMGTs are currently higher than the IPY baseline (Figure 8) with the difference generally being greater for colder permafrost sites. Similar results are found for other northern Canadian sites (Smith et al., 2019). At some of the colder permafrost sites, the current AMGT is about 1 °C higher than the IPY baseline. For warmer permafrost sites, especially where AMGT is close to 0 °C and soils are ice rich, latent heat effects associated with phase change result in very little change in ground temperature over the last decade (e.g. Bonnaventure et al., 2015; Smith et al., 2010b). At some very warm permafrost sites, permafrost has thawed at the measurement depth used for AMGT (Figure 8).

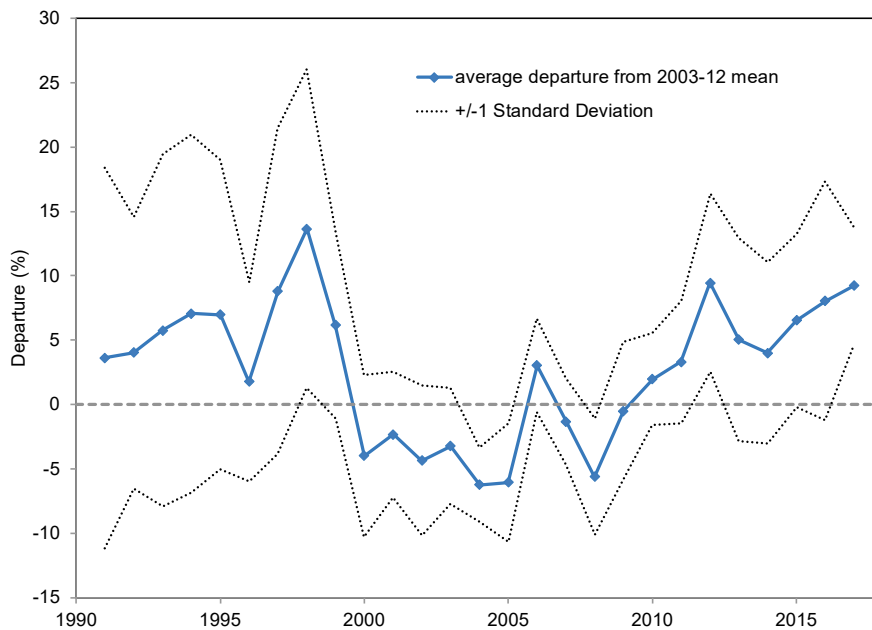
Figure 9. Mean active-layer thickness (ALT) departures (%) from 2003–2012 mean for 25 sites.

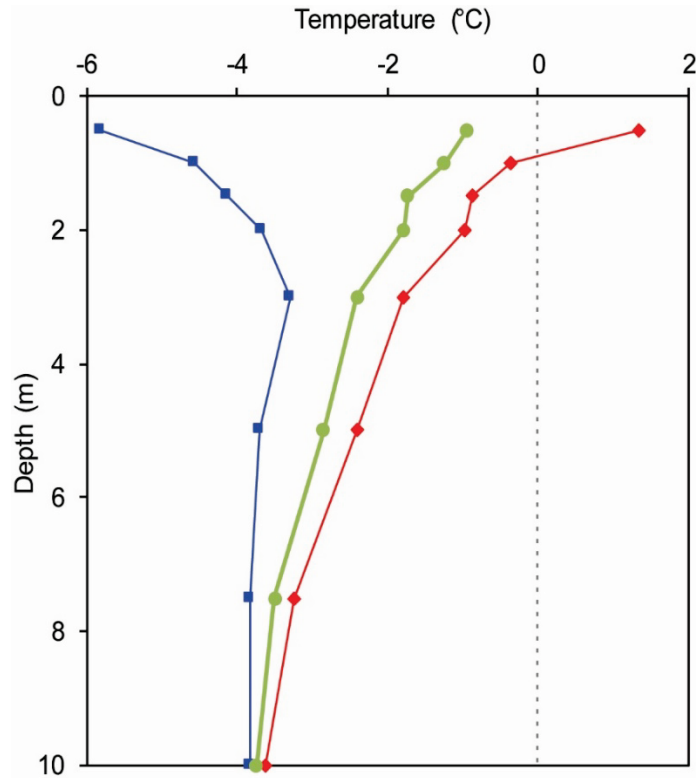
Aug 2017 – Jul 2018			
Depth (m)	Max (°C)	Min (°C)	Mean (°C)
0.5	1.34	-5.82	-0.95
1	-0.36	-4.57	-1.26
1.5	-0.88	-4.12	-1.73
2	-0.98	-3.68	-1.78
3	-1.79	-3.29	-2.41
5	-2.39	-3.70	-2.85
7.5	-3.24	-3.82	-3.50
10	-3.62	-3.83	-3.75

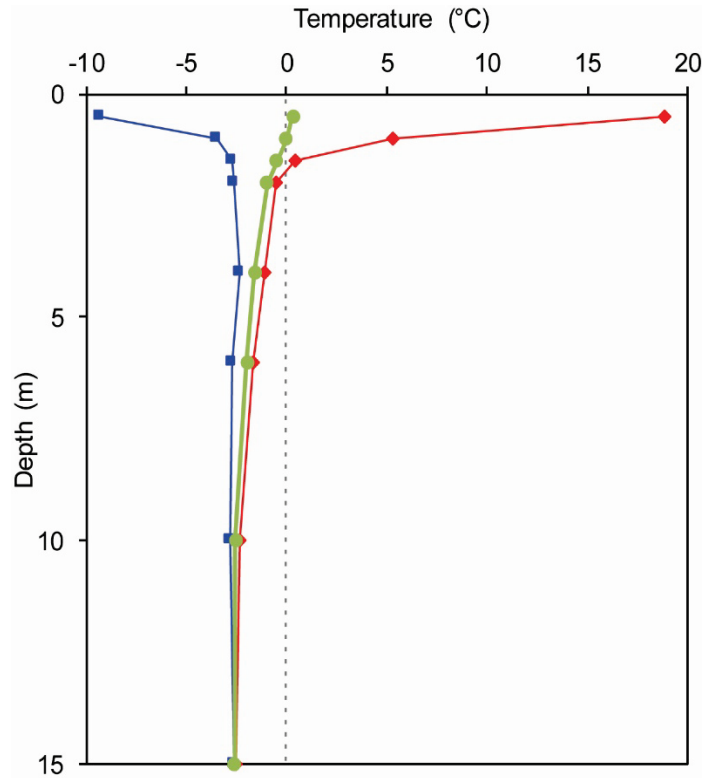
Aug 2017 – Jul 2018			
Depth (m)	Max (°C)	Min (°C)	Mean (°C)
0.5	18.87	-9.27	0.32
1	5.28	-3.45	0.01
1.5	0.46	-2.70	-0.50
2	-0.48	-2.64	-0.95
4	-1.11	-2.37	-1.59
6	-1.62	-2.71	-1.99
10	-2.34	-2.77	-2.53
15	-2.54	-2.65	-2.61

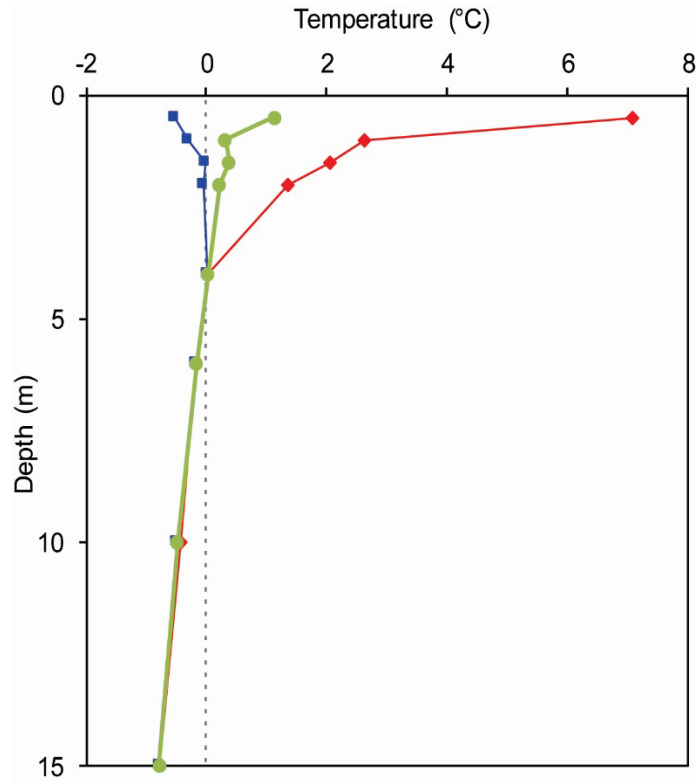
Aug 2017 – Jul 2018			
Depth (m)	Max (°C)	Min (°C)	Mean (°C)
0.5	7.08	-0.51	1.12
1	2.62	-0.30	0.31
1.5	2.04	0.00	0.38
2	1.35	-0.04	0.22
4	0.03	0.03	0.03
6	-0.16	-0.17	-0.16
10	-0.43	-0.48	-0.48
15	-0.78	-0.79	-0.78

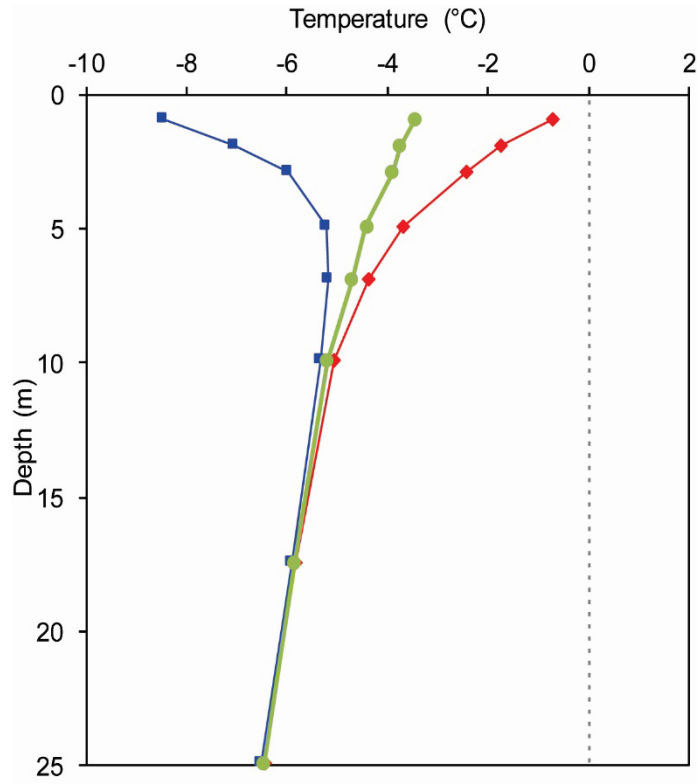
Aug 2017 – Jul 2018			
Depth (m)	Max (°C)	Min (°C)	Mean (°C)
0.9	-0.70	-8.46	-3.45
1.9	-1.75	-7.03	-3.75
2.9	-2.45	-5.99	-3.91
4.9	-3.70	-5.22	-4.43
6.9	-4.36	-5.17	-4.71
9.9	-5.05	-5.35	-5.20
17.4	-5.82	-5.90	-5.86
24.9	-6.44	-6.49	-6.47

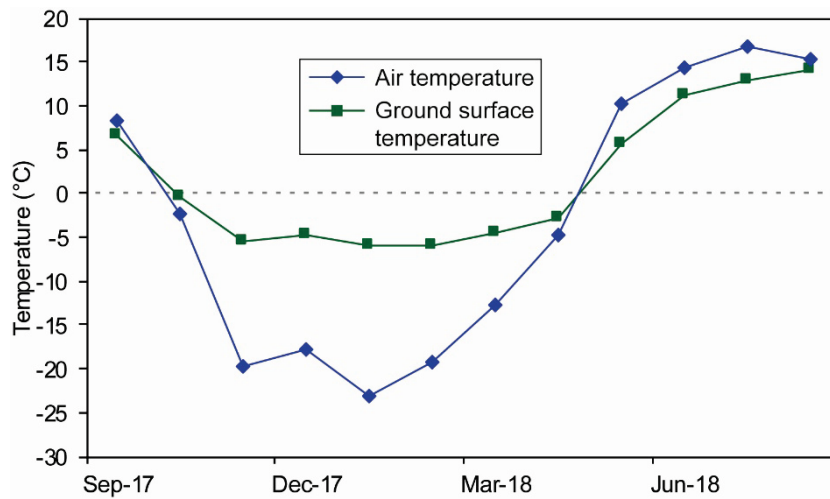
Month / Year	Temperature (°C)	
	Air	Surface
Sep-17	8.18	6.57
Oct-17	-2.41	-0.45
Nov-17	-19.74	-5.56
Dec-17	-17.75	-4.87
Jan-18	-23.23	-5.85
Feb-18	-19.23	-5.97
Mar-18	-12.73	-4.46
Apr-18	-4.82	-2.75
May-18	10.12	5.54
Jun-18	14.36	11.30
Jul-18	16.68	12.93
Aug-18	15.28	14.16
