ORE DRESSING AND METALLURGICAL LABORATORIES.

Investigation No. 886.

Report on Bren Gun Tripod Welded Sections received from the Department of National Defence, Ottawa, Ontario, on August 9th, 1940.

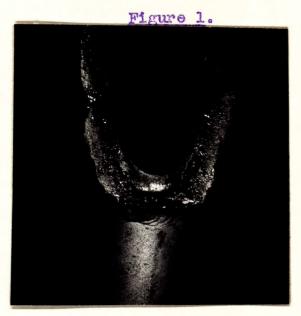
Figure 2.

Figures 1 and 2 show the steel welded pieces as received:

Weld on tube.

Weld on plate.

The leg tube was welded to a flat plate at an angle of 25 degrees (approximately). This angle is too acute to allow the weld metal to "fill in". The weld metal parted from the plate under stress.

When complete fusion between weld metal and welded object is obtained, this type of weld is satisfactory. In this case a continuous fused joint was not produced. Either the welding temperature was too low, or the fluxing action was not sufficient to remove the oxides and slag from the welded surface.

For this application (welding together tubes and plates of low-carbon steel about 1/16 inch thick), brazing or brass welding with Muntz metal should be more satisfactory than welding with low-carbon steel rod. Brazing can be done at a much lower temperature than welding with low-carbon steel rod. The low temperature means

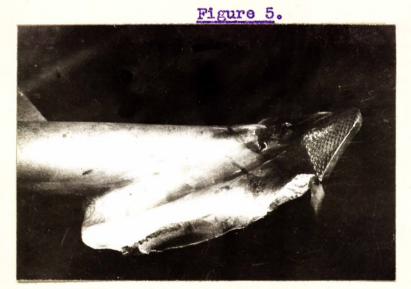
The third leg, as received, is shown in Figure 5.

(NOTE: The tube was welded to a flat plate. The plate was hammered to a 90-degree angle and the weld was still intact.)

This weld was definitely much stronger than either tube or plate.

This material is commonly used for welding and brazing. A very good adhesion was obtained in most areas of the welds examined. The weld was stronger than the metal sections it joined together.

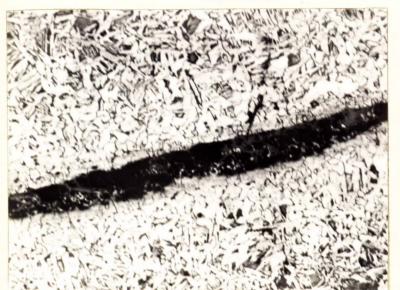
Figure 6.

Figure 6 shows the average condition at the weld joint. A layer of oxide and slag has been entrapped. This weakens the joint. Figure 7 shows a perfect fusion of metals which existed only at the outer edge of the joint.

100X. (Nital) Weld seam, showing slag inclusions. Figure 7.

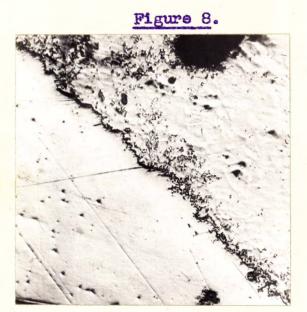
Figure 9.

In both of the brass welded legs there was a very close adherence between the brass and the steel. Figure 8 shows Leg No. 2 and Figure 9 shows Leg No. 3.

100X. (Leg No. 2) Weld seam, unetched. 100X. (Leg No. 3) Weld seam, unetched.
