O T T A W A September 25th, 1940.

ORE DRESSING AND METALLURGICAL LABORATORIES.

Investigation No. 898.

Examination of Six Defective Aluminium
Alloy Forgings.

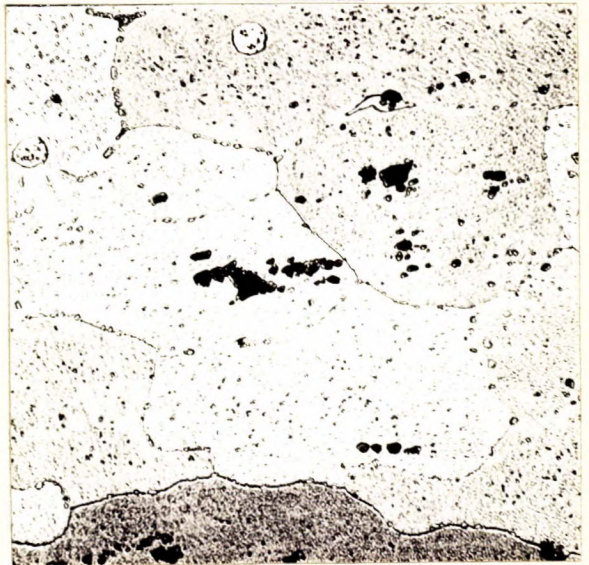
Figure 2.

X500.

Forging 1, etched in Keller's reagent.

All specimens were then etched in Keller's reagent (1 part hydrofluoric acid, 1.5 parts hydrochloric acid, 2.5 parts nitric acid, and 95 parts water) and re-examined. The white etching rosettes in Forging 1, the white etching CuAl_2 compounds in Forgings 1 and 2, and the dark etching copper-iron-manganese-aluminium particles in all forgings were again evident. The etching revealed that all forgings with the possible exception of Forging 6 were fairly large-grained and that Forging 2 was mixed-grained, there being some very coarse-grained areas in the vicinity of the flash on this forging. These facts are demonstrated by Figures 2 to 8, which are all photomicrographs at X500 magnification.

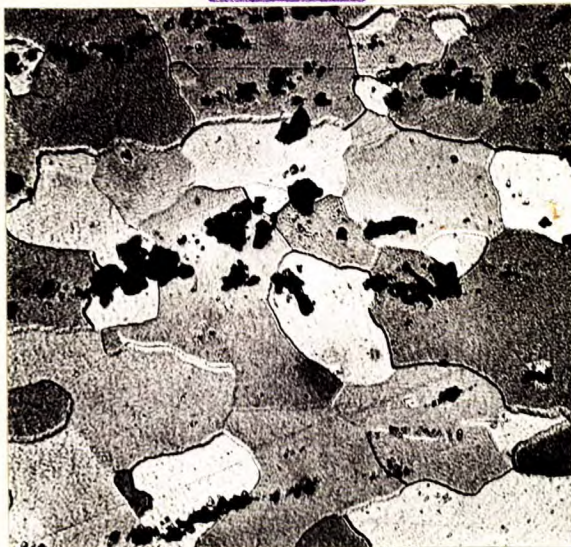
Figure 6.

X500.

Forging 4, etched in
Keller's reagent.

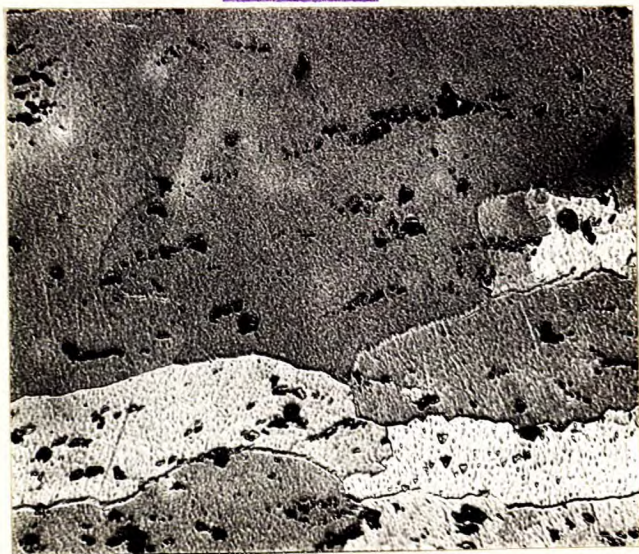
Figure 7.

X500.

Forging 5, etched in
Keller's reagent.

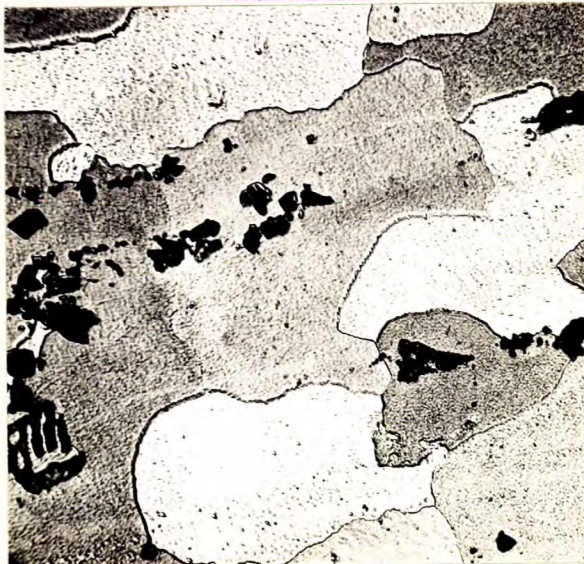
Figure 8.

X500.

Forging 6, etched in
Keller's reagent.

The fairly large-grained samples must have been forged at a fairly high temperature, as the grain size becomes smaller as the temperature at which the forging was finished is lowered. Forging 6 was probably formed at the proper temperature. The mixed grain size in Forging 2 indicates that this forging was cold worked in trimming, for the large grains are associated with the flash line, and grain growth will not occur in the absence of cold work.
