July 11th, 1941.

ORE DRESSING AND METALLURGICAL LABORATORIES.

Investigation No. 1048.

Report on Aircraft Engine Adaptor.

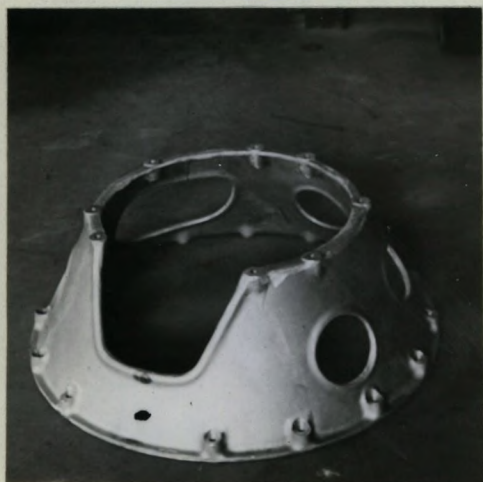
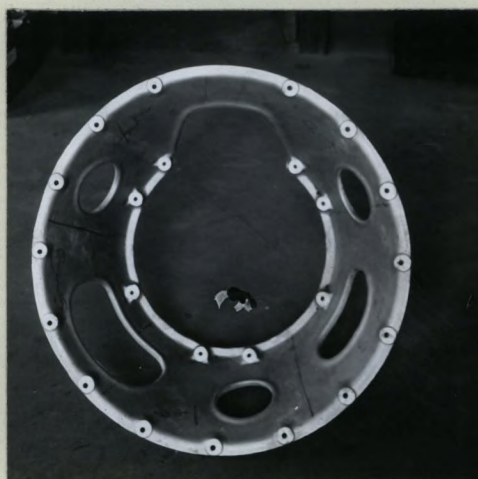
Figures 1 and 2 show the casting as received. Original aircraft design included a motor of English manufacture, which required 15 bolts to mount on the aircraft. It became necessary to alter the design to use another motor mounted with 8 bolts.

Casting as Received.

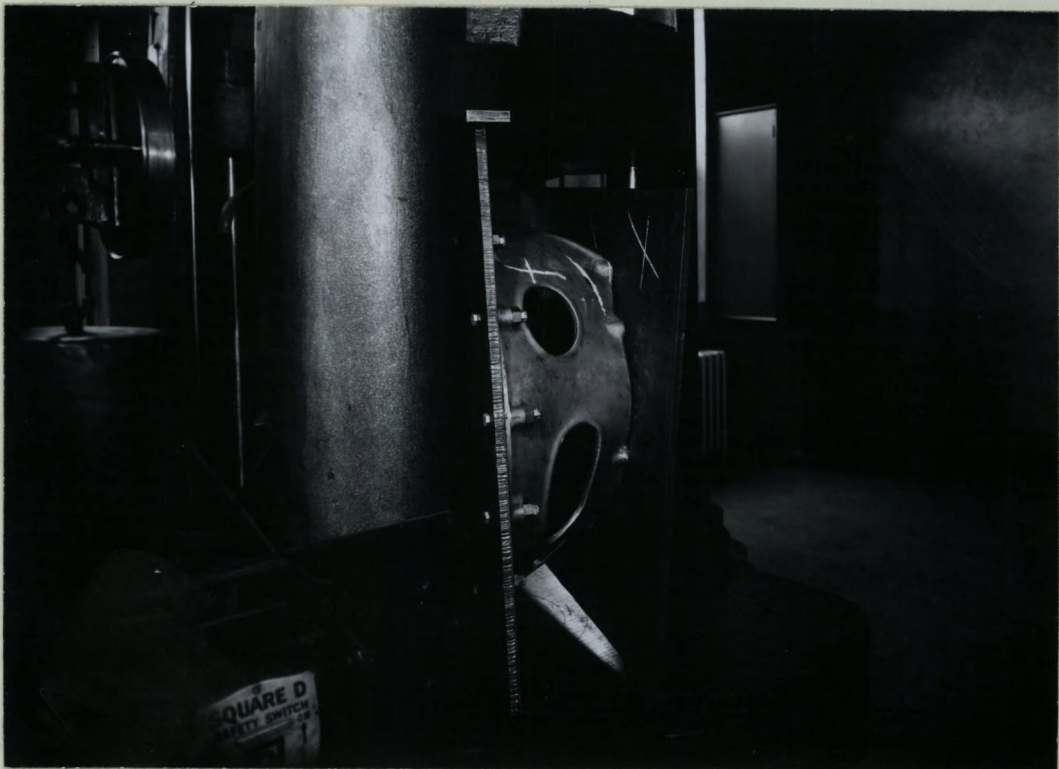
Figures 3 and 4 show the method of testing in torsion. Two square steel plates of identical size were bolted to the casting in such a way that when the assembly was compressed in a press, the clockwise torsion exerted by one plate was balanced by counterclockwise torsion in the other plate.

TESTING IN TORSION.  
(Continued on next page)

When a load of 42,000 pounds was reached, the casting cracked. Measurement of the points of load application showed that the breaking force was equal to a 21,000-pound load on a 12-inch lever.

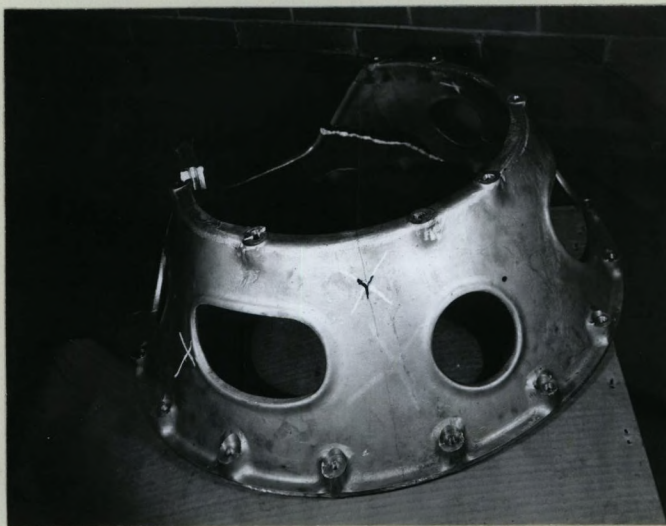
An examination carried out by L. W. Ball (on loan from the National Research Council, Ottawa) showed about twelve small shrinkage cavities. The location of these cavities are shown in Figures 5, 6 and 7 by mark "X" on the casting.

The results of the torsion test are shown in Figures 5, 6 and 7.

CASTING AFTER FRACTURE.

The section shown in Figures 8 and 9 was obtained from the casting as shown in Figure 7 and marked by "Y".

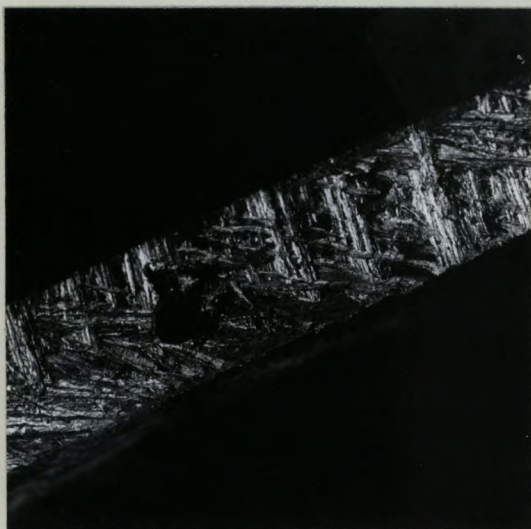
Figure 8.

The character of the cavities as located by the X-ray are shown in Figures 8 and 9.

X2, rough, unetched.

The x-ray photographs show minor casting defects and a slight mottling that is characteristic of aluminium alloy castings. For engineering purposes, the casting has a satisfactory soundness.

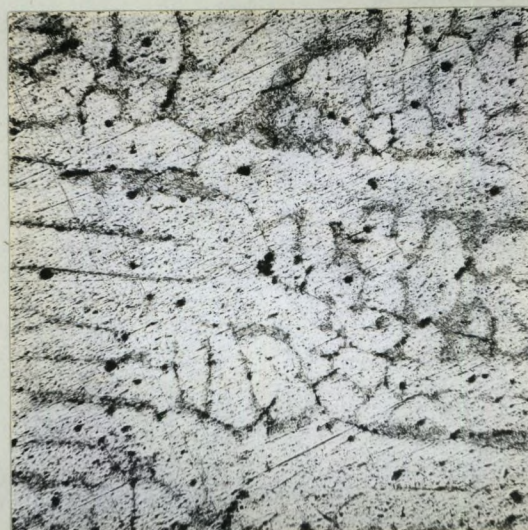
Figure 11.

X200, etched with Keller's reagent.†

† HF, 1 per cent; HCl, 1.5 per cent; HNO<sub>3</sub>, 2.5 per cent and H<sub>2</sub>O, 95 per cent.

The microphotographs show a normal structure for this type of alloy cast in sand moulds.
