Investigation No. 1153.

Examination of Extruded Aluminium Alloy  
Shapes.

R E P O R T  
of the  
ORE DRESSING AND METALLURGICAL LABORATORIES.

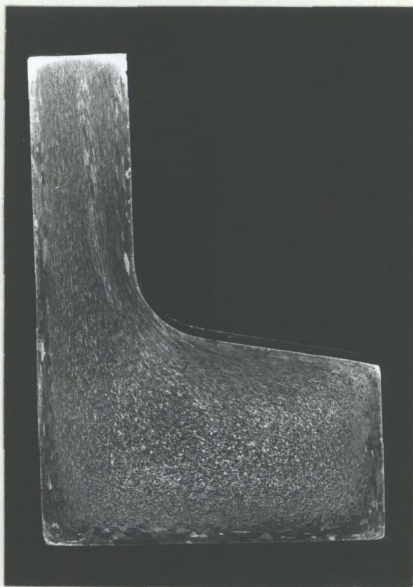
Figure 2.

Figure 2 shows the appearance of a part of the etched surface in the heat-treated sample (No. 2). On the outside of the shape a coarse-grain area may be observed.

Macro-structure of a part  
of Sample No. 2 (heat-treated).

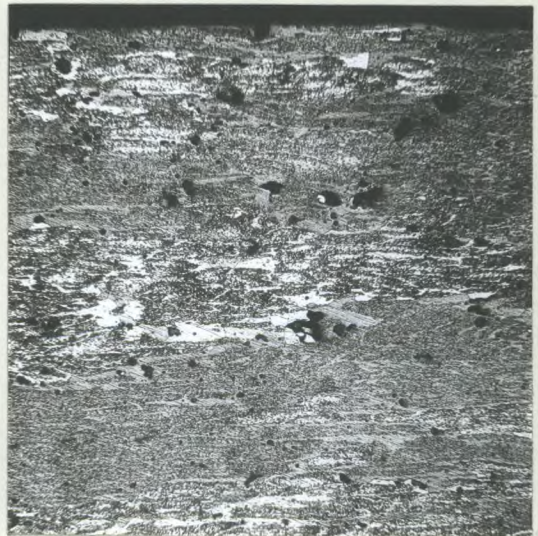
Figure 6.

Although Figures 6 and 8 were obtained from the outer coarse-grained area there is no apparent evidence of this coarseness of grain in the photomicrographs. This is because the structure was so coarse that it is difficult to show it in a 100-magnification photomicrograph. Actually, the fine-grained area in the centre of this photomicrograph is from one grain, while the other areas are from other

X100, etched.\*  
Location, "d" in Figure 1.

Figures 5 and 6 show a full heat-treated structure.

Micro-examination shows this material to be satisfactory. The coarse-grain area shown in Figures 3, 6 and 8 is caused by recrystallization which occurs during the solution heat-treatment due to the material being critically cold-worked in the outer areas in the extruding process.
