R E P O R T
of the
ORE DRESSING AND METALLURGICAL LABORATORIES.

Investigation No. 1170.

Examination of English Valentine
Tank Track Pin.

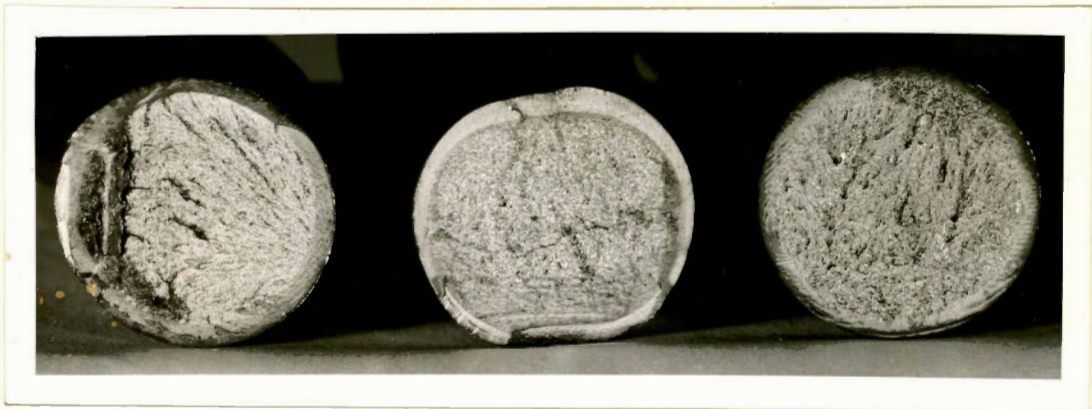
Figure 2.

Examination of the fracture revealed the presence of a crystalline core. A fresh fractured surface was obtained by striking a part of the pin with a heavy hammer until it broke. Figure 2 shows the crystalline appearance of this fresh fracture as compared to the silky fractures obtained by bending a pack-carburized (C.P.R.) and a Tocco pin to destruction.

C.P.R.
Pack-Carburized
Pin.

English
Pin.

Tocco-
Hardened
Pin.

A crystalline pin structure is undesirable, as it indicates pin brittleness. Crystalline structure can be removed by proper heat treatment.

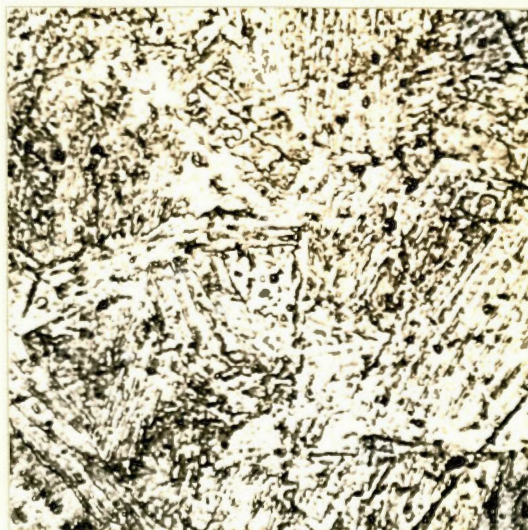
Figure 5.

Figure 5 shows the more uniform and tough core structure that it is possible to obtain by heating the pin to 1650° F. for $\frac{1}{2}$ hour, quenching in water, and drawing to the desired hardness.

X1000, nital etch.

AFTER HEAT TREATMENT.

Note more uniform structure.

Elimination of ferrite is desirable if the best combination of strength and toughness is to be obtained. This investigation shows that a quench from 1650° F. and a subsequent draw to the required case hardness gives satisfactory results.
