March 19th, 1942.

ORE DRESSING AND METALLURGICAL LABORATORIES.

Investigation No. 1186.

Examination of Bracket Castings for Tanks.

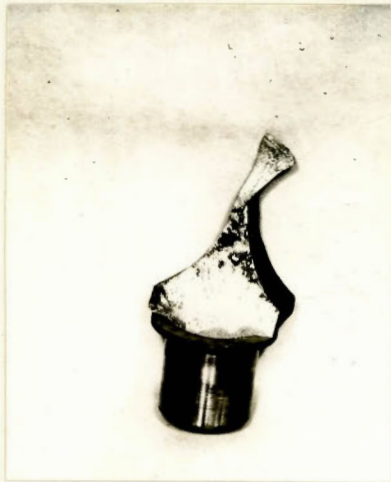
Figure 1.

- Casting No. 1. - (Figure 1) Spring bottom seat
(C-66429).
Manufacturer: M.L.W.
Broken during field test.
- Casting No. 2. - (Figure 2) Schenectady suspension.
Broken at Camp Borden.
Vehicle: Ram I, M3 41-1-3601.
Centre assembly suspension
(Left side).
Mileage: 1128.
Date: 19-1-42.
- Casting No. 3. - (Figure 3) M.L.W. suspension bracket
(D-37893).
Piece of suspension bracket
broken during field test,
Jan. 30th, 1942.

BROKEN SPRING BOTTOM SEAT.
(1/6 actual size).

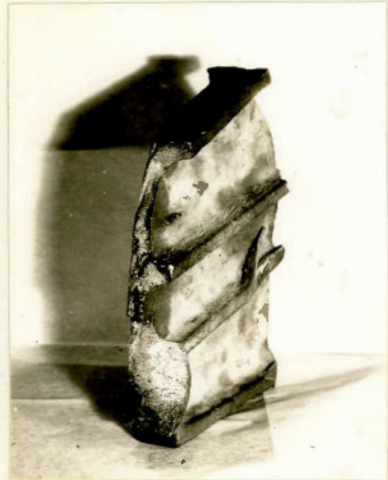
Figure 2.

BROKEN SCHENECTADY
SUSPENSION BRACKET.
(1/10 actual size).

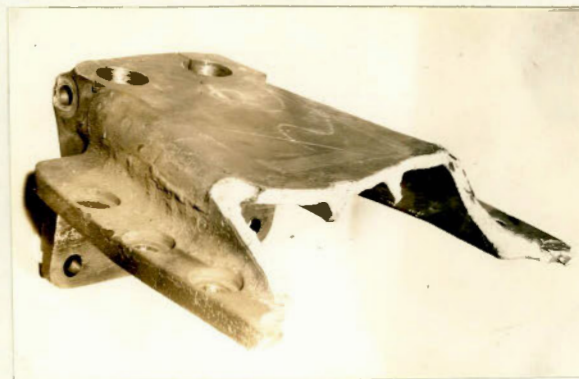
Figure 3.

Casting No. 3 was submitted to X-ray examination at the National Research Council, Ottawa. It was found to be quite sound, indicating good foundry practice. On subsequent cutting-up of all castings for physical test purposes, no evidence of poor foundry practice could be found.

BROKEN M.L.W. SUSPENSION BRACKET
(Drawing D-37893). (1/10 actual size).

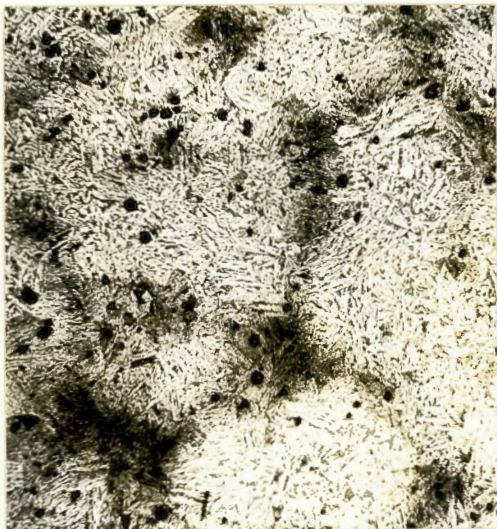
Figure 4.

X100, picral etch.

PHOTOMICROGRAPH SHOWING
"AS RECEIVED" STRUCTURE OF
STEEL IN CASTING NO. 1.

A comparison of the microstructures of all three alloys before and after heat treatment would indicate that the low impact properties were due to a relatively coarse microstructure. In the heat treatment tests conducted these

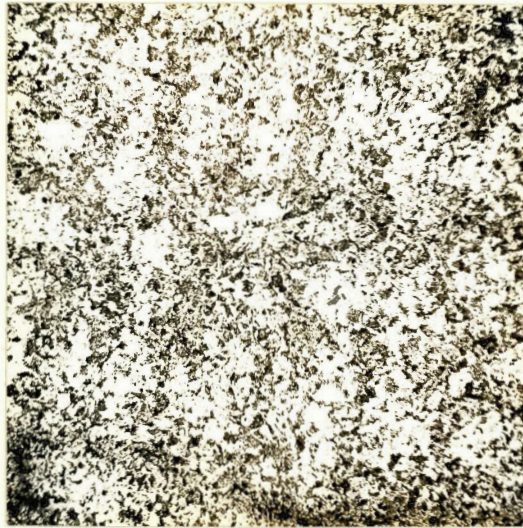
Figure 8.

X100, picral etch.

PHOTOMICROGRAPH SHOWING
"AS RECEIVED" STRUCTURE OF
METAL IN CASTING NO. 3.

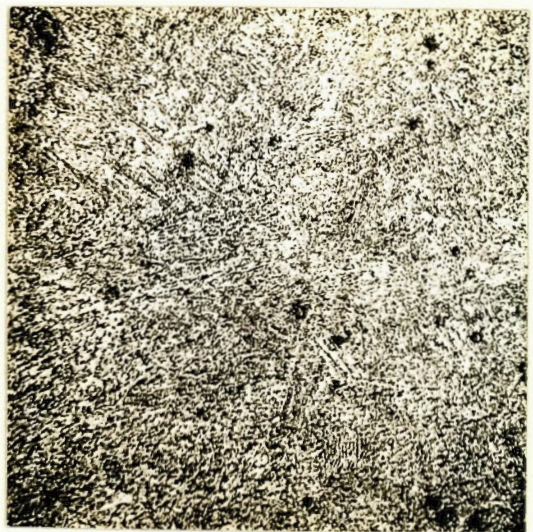
Figure 10.

: Casting : No. 1.	: Casting : No. 2.	: Casting : No. 3.
Final heat treatment:	:	:	:
Normalize -	: 1850° F.	1525° F.	1850° F.
" -	: 1550° F.	1425° F.	1525° F.
Draw -	: 1300° F.	1200° F.	1250° F.
Tensile strength, p.s.i.	: 114,000	105,000	123,000
Yield strength, p.s.i.	: 83,600	75,000	105,000
Elongation, per cent	: 21	27	25
Reduction in area, per cent:	27.4	55	55
Izod impact, ft.lb.	: 53.5	56	40
Brinell hardness	: 254	227	282
Microstructures	:Fig.9, X100 :Fig.10,X500	Fig.11, X100 Fig.12, X500	Fig.13, X100 Fig.14, X500

X500, picral etch.

PHOTOMICROGRAPH SHOWING
MICROSTRUCTURE OF METAL IN
CASTING NO. 1 AFTER HEAT
TREATMENT.
