March 21st, 1942.

ORE DRESSING AND METALLURGICAL LABORATORIES.

Investigation No. 1188.

Examination of 8-Inch Howitzer Recuperator Pintle.

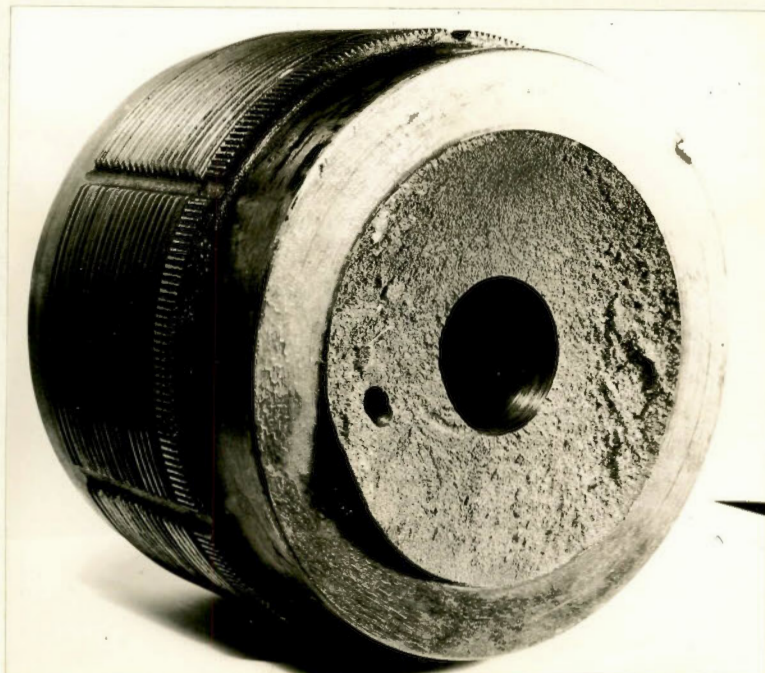
Figure 1.

Figure 1 is a photograph of the pintle as received by the Bureau of Mines.

PHOTOGRAPH OF FRACTURED 8-INCH
HOWITZER GUN PINTLE.

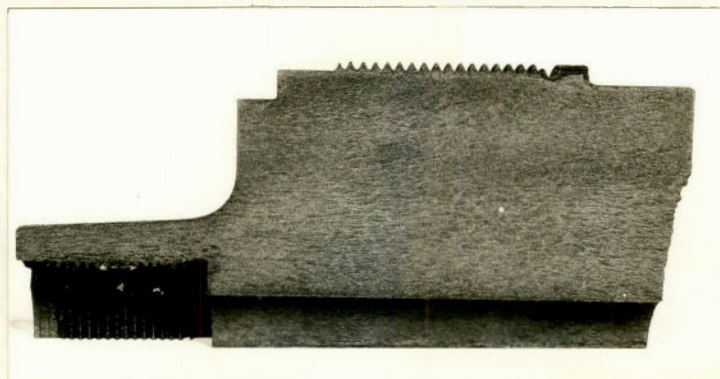
Figure 2.

Figure 2 is a cross-section of the pintle macro-etched in a hot aqueous solution of 38 per cent HCl, 12 per cent H₂SO₄.

PHOTOGRAPH OF MACRO-ETCHED SECTION
OF 8-INCH HOWITZER GUN PINTLE.

The macrograph would give the impression that this part is cut out of a forged billet. This would also be indicated by the photomicrographs.

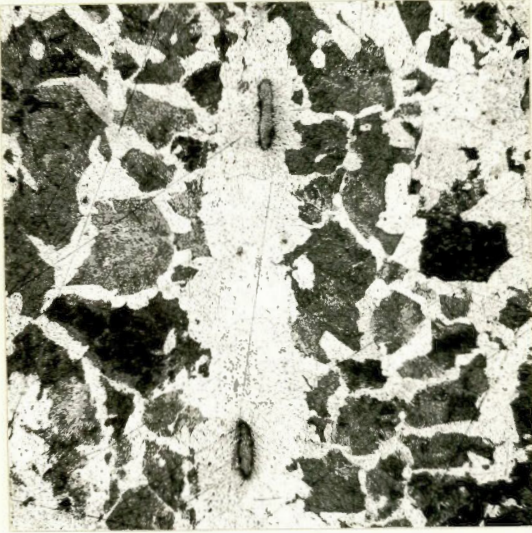
Figure 3.

Figure 3 is a photomicrograph of the longitudinal structure taken at a magnification of 100 diameters. Note that the direction of the forging lines is indicated by the elongation of the sulphide particles. There is also evidence of some banding.

X100, picral etch.
PHOTOMICROGRAPH OF
LONGITUDINAL SECTION.

The fact that the metal failed in service is probably best explained by its low izod impact value. The reason for this could be the rather coarse structure as revealed by Figures 3 and 4.

Coupling the information obtained from Figures 3 and 4, at 100 diameters, and Figure 5, at 1,000 diameters, it is possible that the most recent thermal history of this steel has been a slow cool from a temperature well above

1. The 8-inch howitzer pintle submitted failed due to the low impact strength of the material. This low impact strength can be attributed to the coarse structure of the metal.

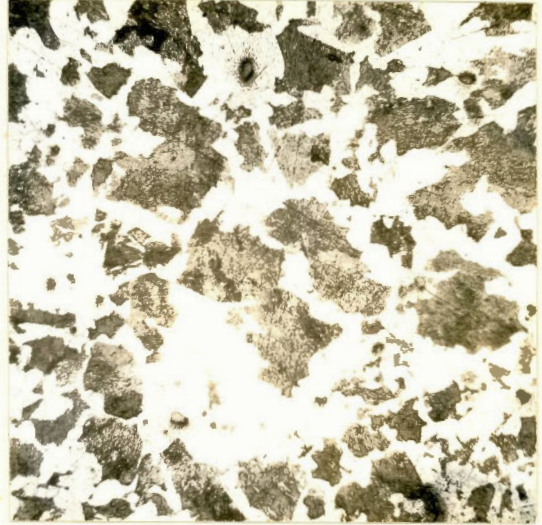
Figure 4.

Figure 4 is a photomicrograph of the transverse structure taken at a magnification of 100 diameters.

X100, picral etch.
PHOTOMICROGRAPH OF
TRANSVERSE SECTION.

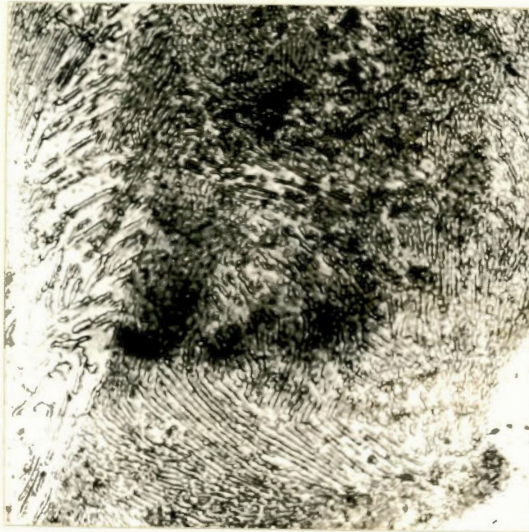
Figure 5.

Figure 5 is a photomicrograph taken at a magnification of 1,000 diameters to show the structure of the pearlite.

X1000, picral etch.
PEARLITIC STRUCTURE.

The structure of the pearlite, as revealed in Figure 5, is characteristic of steel that has been cooled slowly through the critical range.

2. This microstructure is characteristic of metal that has been slowly cooled from a temperature well above the upper critical point through the critical range.
