March 26th, 1942.

ORE DRESSING AND METALLURGICAL LABORATORIES.

Investigation No. 1192.

Investigation of Atomic
Hydrogen Welding Test Specimens.

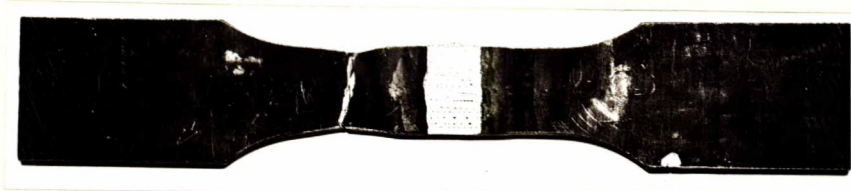
Figure 1.

WELD TEST SPECIMEN.

Weld machined down flush. Note fracture in parent metal.

(1/3 actual size).

The two types of test pieces submitted are shown in Figures 1 and 2. Three had the welds machined off to the thickness of the plate, as in Figure 1, and the other three remained as welded. It was stated that the specimens were welded from one side only.

Test Specimens Nos. 1, 2 and 3 broke in the parent metal (see Figure 1).

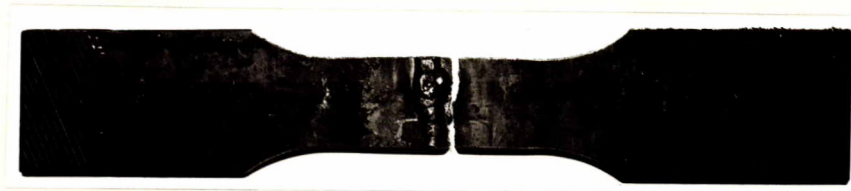
Figure 2.

WELD TEST SPECIMEN.

Weld not machined. Note fracture at weld.

(1/3 actual size).

Test Specimens Nos. 4, 5 and 6 broke in the weld metal (see Figure 2).

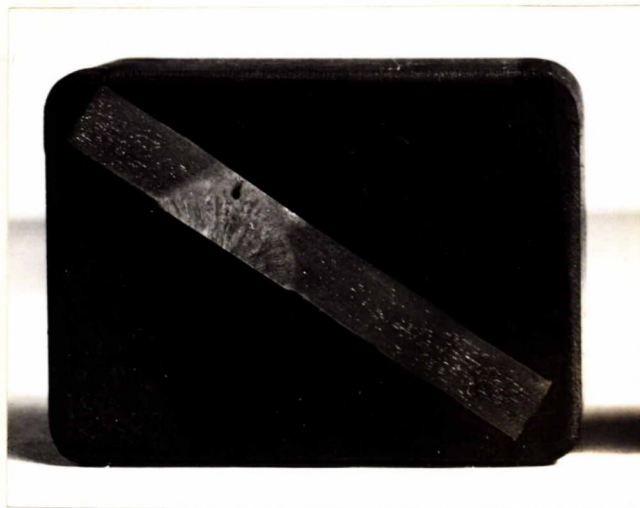
Figure 3.

Macrostructure characteristic of
Bars 1, 2, and 3.

Apparently welded from only
one side.

(Approximately $1\frac{1}{2}$ times actual size).

Figure 3 is a photograph, enlarged to twice actual size, of the macrostructure of the weld in Specimens Nos. 1, 2, and 3.

From a study of the macrostructure of the weld metal in both groups of bars it is apparent that, while the welds in Bars 1, 2, and 3 were undoubtedly made from one side only, Bars 4, 5, and 6 were very probably welded from both sides.

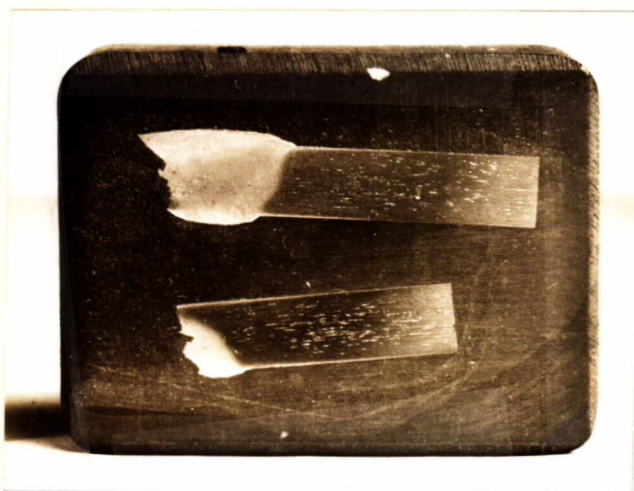
Figure 4.

Macrostructure characteristic
of Bars 4, 5, and 6.

Apparently welded from both sides.

(Approximately $1\frac{1}{2}$ times actual size).

Figure 4 is a photograph, enlarged to twice actual size, of the macrostructure of the weld in Specimens Nos. 4, 5, and 6.
