ORE DRESSING AND METALLURGICAL LABORATORIES.

Investigation No. 1245.

Investigation of Drop Forged Naval Gun Cam.

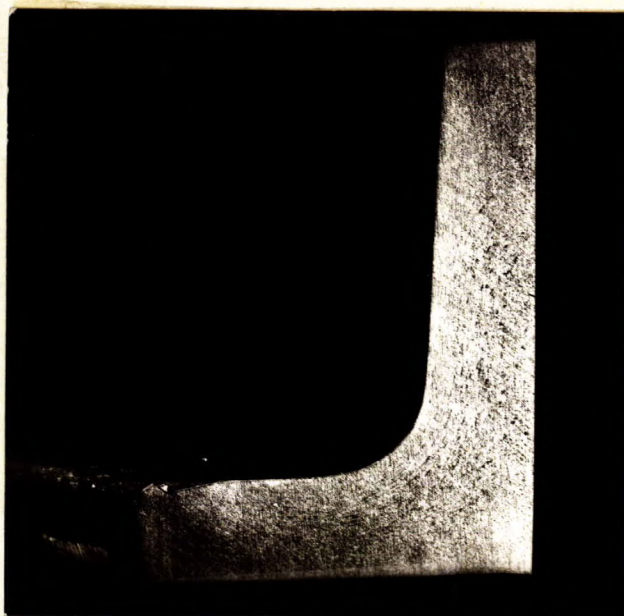
Figure 2.

The macro-etching shows that the lines of forging are in the proper direction to develop the best properties in the forging.

Macro-etched
cross-section,
about $\frac{1}{3}$ size.

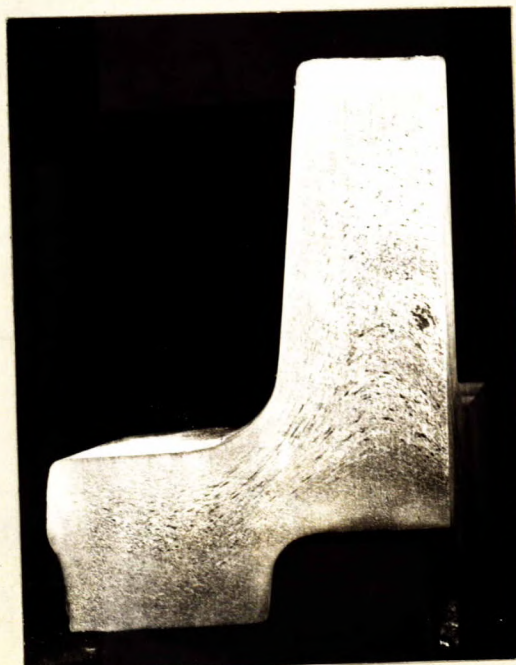
Figure 3.

Macro-etched
cross-section,
about $\frac{1}{3}$ size.

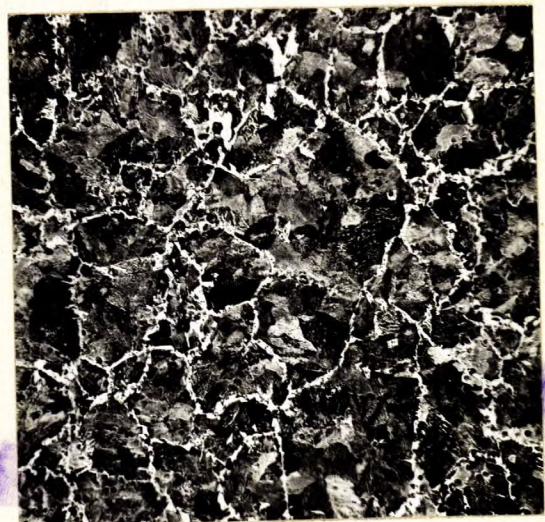
Sections for the microscopic examination were obtained from under the hub and also from out in the plate. Figure 6 is a photomicrograph of the structure under the hub at 100 diameters. Figure 7 is a photomicrograph of the structure in the plate at 100 diameters.

The low reduction in area and low impact strength point to faulty heat treatment. This is verified by the photomicrographs. The structure is characteristic of that resulting from forging with no subsequent heat treatment. As illustrated in Figure 8, normalizing will do much to refine this structure and develop higher physical properties, while, as reported in our P.M. Lab. Report No. 5007 (Feb. 19th, 1942), an oil quench and draw will develop maximum toughness.

Photomicrographs, X100, picral etch,
showing structure existing in forging as received.
Figure 6 - beneath hub. Figure 7 - in plate.

1. The forging practice is good.
2. The forging received no subsequent heat treatment.
