ORE DRESSING AND METALLURGICAL LABORATORIES.

Investigation No. 1268.

Examination of Two Failed Austenitic
Manganese Steel Castings.

CANADA
DEPARTMENT
OF
MINES AND RESOURCES
MINES AND GEOLOGY BRANCH

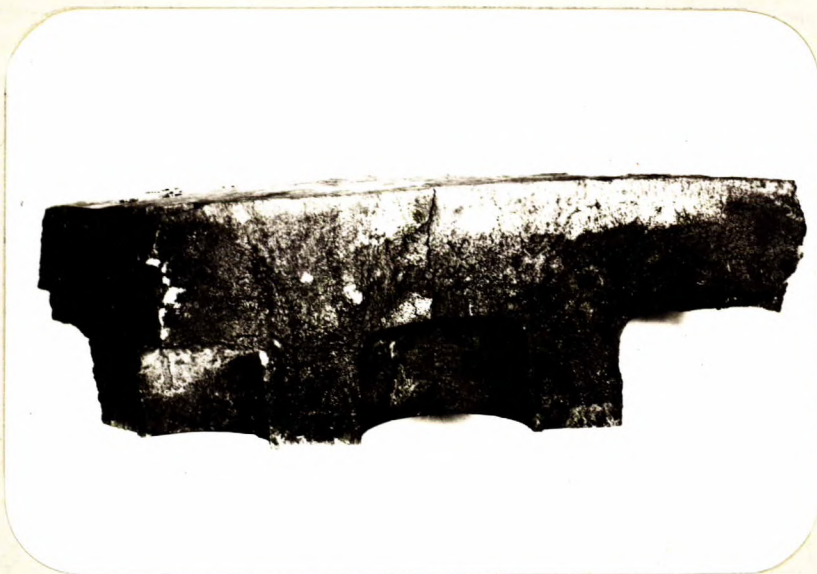
Figure 1.

Figures 1 and 2 show the fractures of the two castings.

JAW PLATE
FRACTURE.
(Approx.
1/3 size).

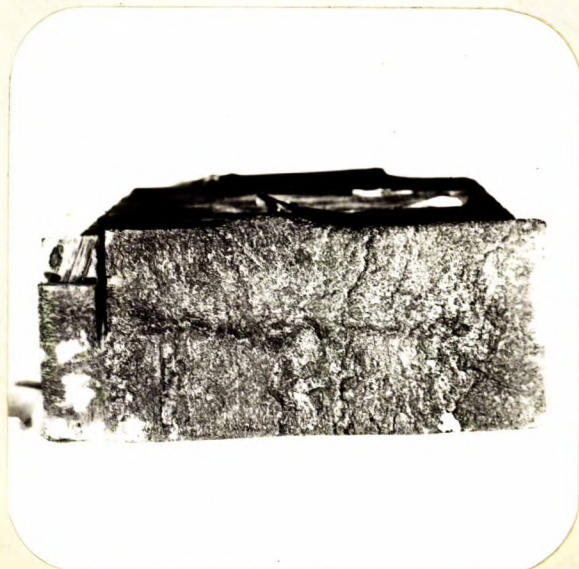
Figure 2.

DIPPER TOOTH
FRACTURE.
(Approx.
1/3 size).

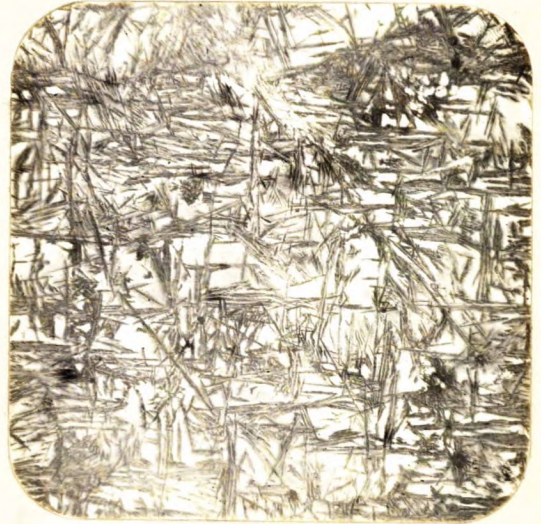
Figure 4.

Both steels were found to be fairly clean. Figures 3 and 4 are photomicrographs at X100 magnification of Steels Nos. 1 and 2 respectively, after an etch in a solution of 4 per cent picric acid in alcohol. Figures 5 and 6 are photomicrographs of the same steels at X1000 magnification, also etched in picral. Figure 7 shows, at X100 magnification, the structure of Steel No. 1. Both steels contain massive free carbides (the white etching constituent) along the grain boundaries and also within the grains.

X100, picral etch.
STEEL NO. 2.

The failure of the castings can be attributed to the embrittling effect of the free carbides at the grain boundaries.

The presence of these carbides in the steel was due to a faulty heat treatment.
