ORE DRESSING AND METALLURGICAL LABORATORIES.

Investigation No. 1270.

Ram Tank Volute Springs.

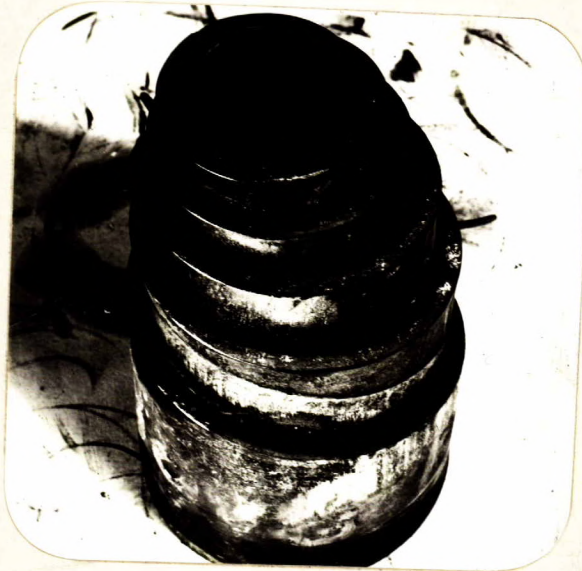
Figure 1.

VOLUTE SPRING.

Approximate physical dimensions:

Weight	-	50 pounds
Diameter at base	-	7 inches
Diameter at pointed end	-	3 "
Number of coils	-	6
Height	-	12 $\frac{1}{8}$ inches.

A decision must be made whether course (a) or (b) is to be adopted. Prevention of the decarburized rough surface will involve extra equipment for grinding, atmosphere controlled furnaces for heat treating. Some protective coating may also be necessary. Copper, electro-zinc, or lead might be used to prevent corrosion. (See Figure 1). One way of eliminating decarburization is to gas carburize and thus produce a surface

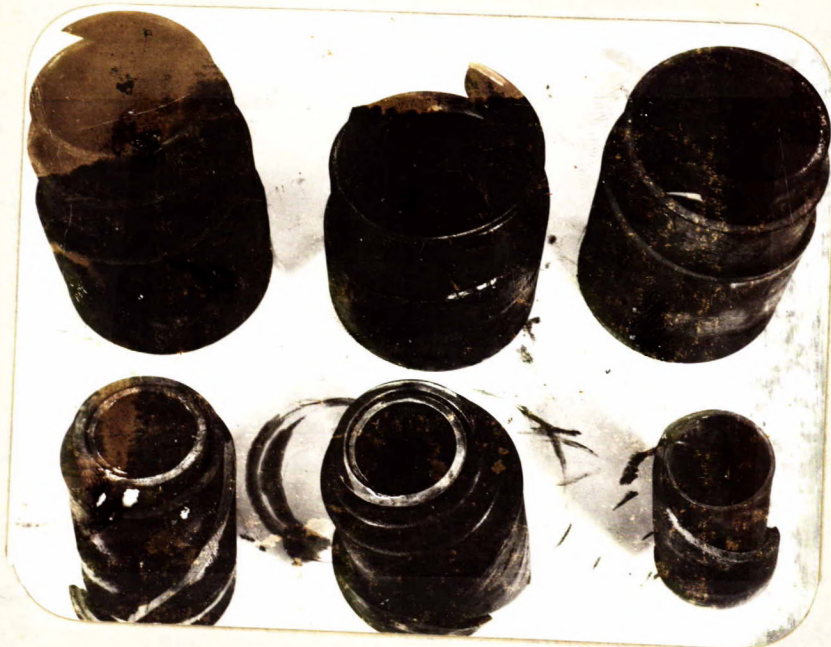
Figure 2.

"D", "E", and "F", AS RECEIVED.

Note spiral course of fracture. Compare with Figure 21. Failures occurred within the first three coils from the centre.

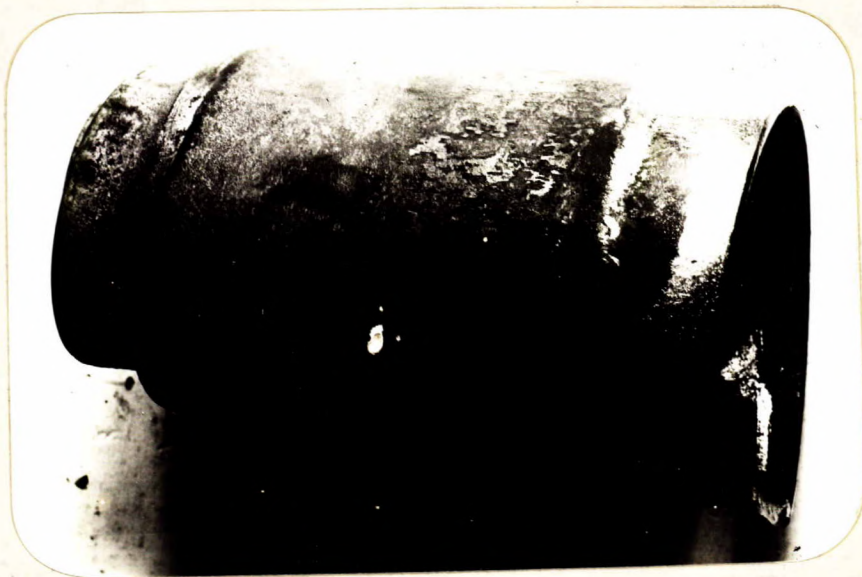
Figure 3.

Typical rough surface
on all specimens.

From an examination of several springs, it is concluded that fatigue strength of the spring could be almost doubled if decarburization, rough surface, abrasion, and corrosion were eliminated.

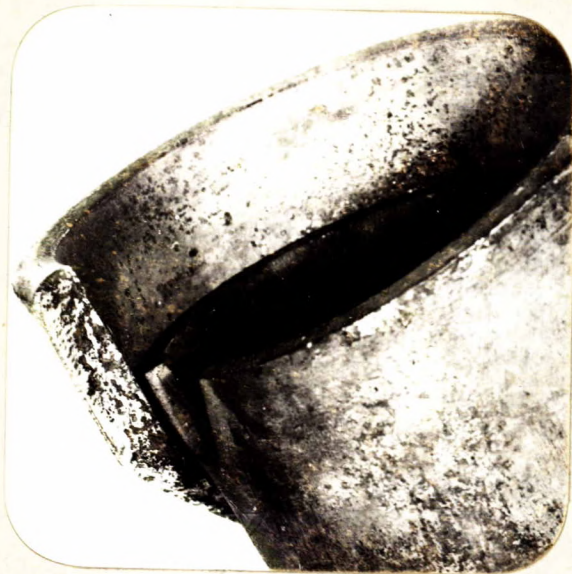
Figure 4.

Fracture of Spring "D".

Figures 4, 5, and 6 attempt to show the nature of the fractured surfaces, which are characterized by smooth areas, indicating the gradual growth of a crack and rough areas which were caused by rupture after the fatigue crack reduced the section below its load-carrying capacity.

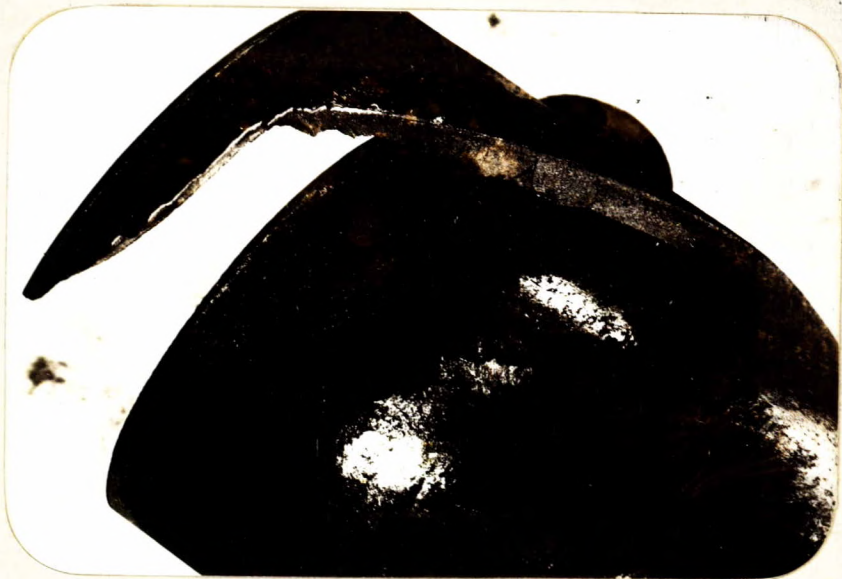
Fracture of Spring "E".

Note the similarity between this and Figure 5.

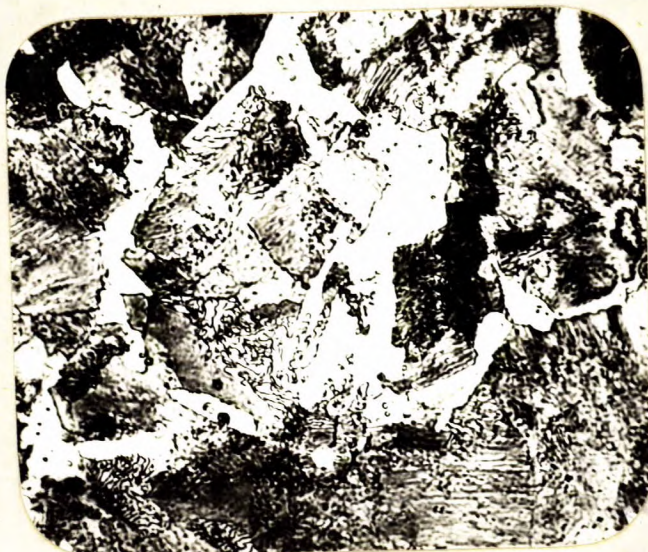
Figure 7.

"C" X1000 nital etch.
V.H.N. 285.
Showing pearlite and ferrite.

Samples "A", "B", and "C" all show that part of the spring had been properly quenched, and other parts had been improperly quenched. The ferrite network shown in Figures 7, 10 and 12 is associated with low hardness and hence low fatigue strength.

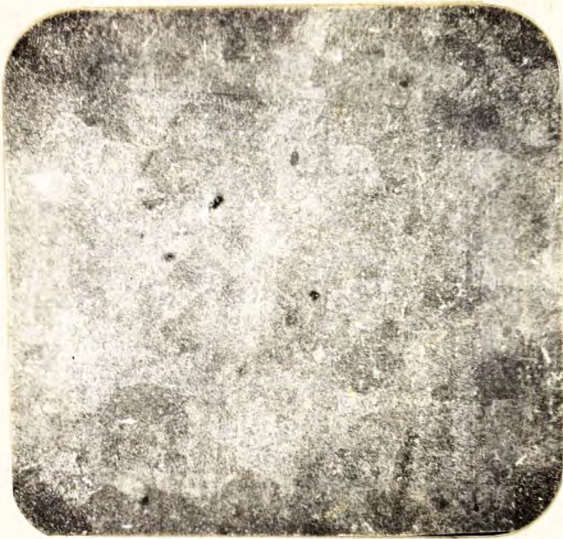
Figure 9.

X100, nital etch.
Sample "C"
Sorbite.

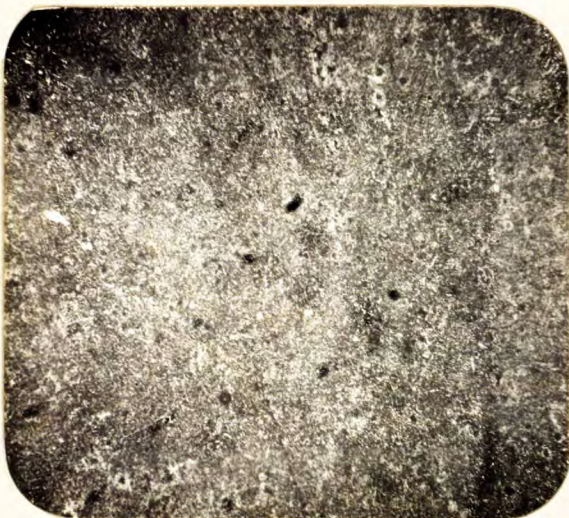
Figure 11.

X100, nital etch.
Sample "A"
Sorbite.

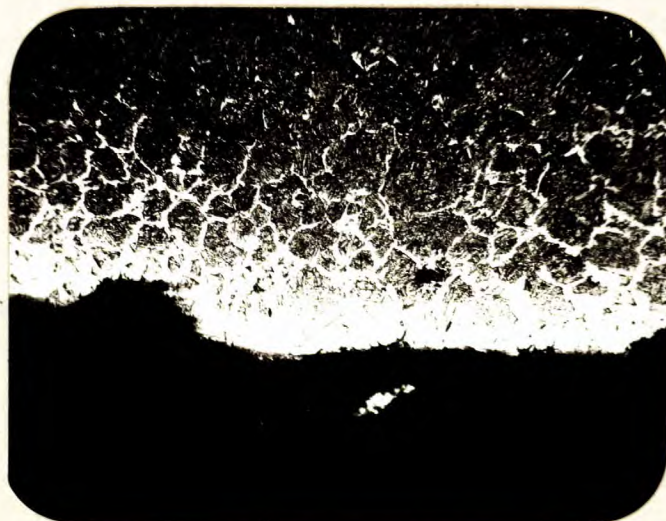
Figure 13.

X100, nital etch.
Sample "A"
Above decarburized edge is typical of all springs examined.

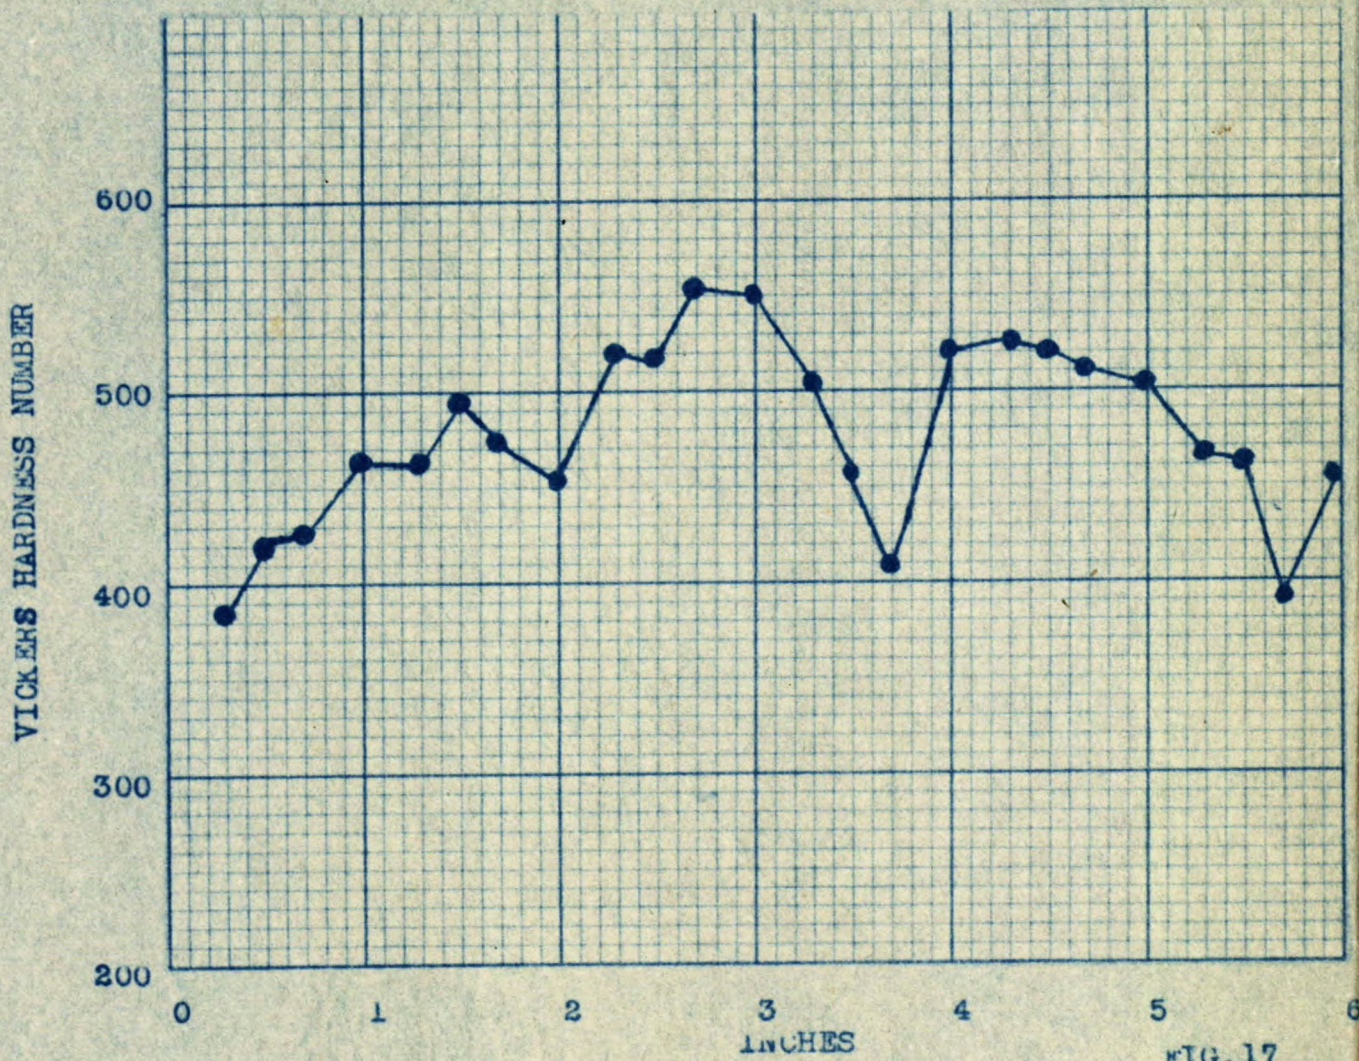
FIG. 17
SAMPLE "C"

RAM TANK SPRING
HARDNESS ON TRANSVERSE CROSS-SECTION
