R E P O R T
OF the
ORE DRESSING AND METALLURGICAL LABORATORIES.

Investigation No. 1272.

A Metallographic Study of
Three Spot Welds.

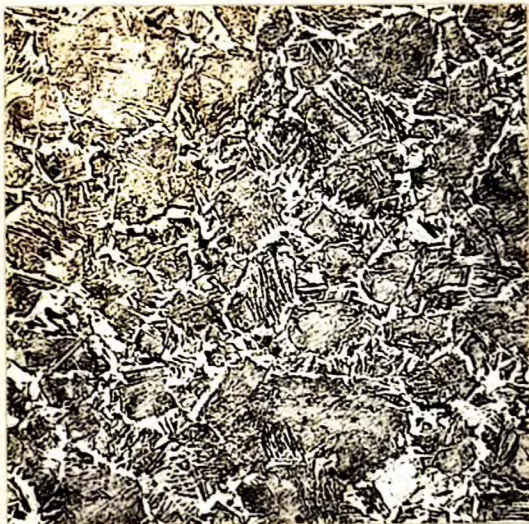
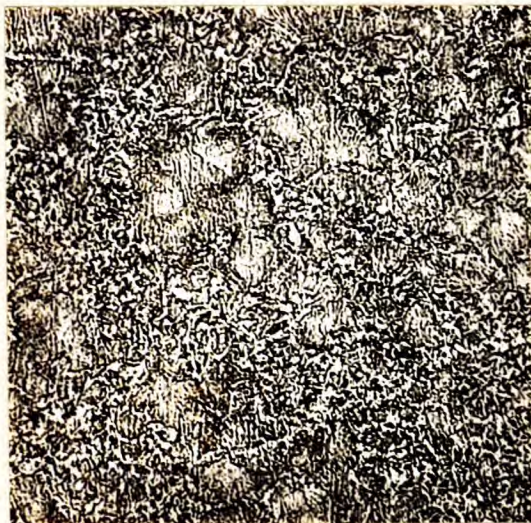
The three samples were polished and etched in a 4 per cent solution of picric acid in alcohol. Photomicrographs, at 250 diameters, were taken of every distinctive phase from the parent metal to the weld interior. These pictures are numbered progressively beginning with the parent metal and proceeding to the centre of the weld.

X250, picral etch.
UNTREATED WELD.

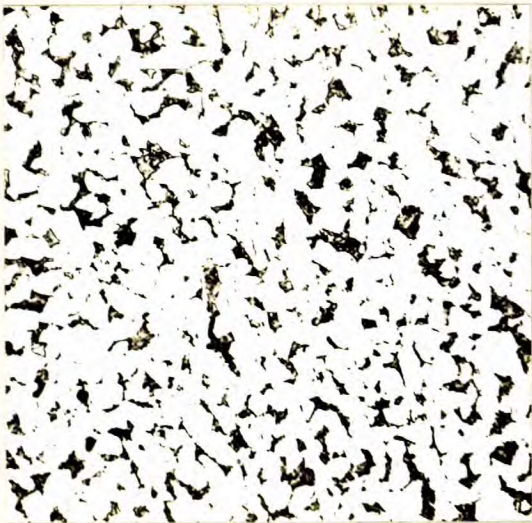
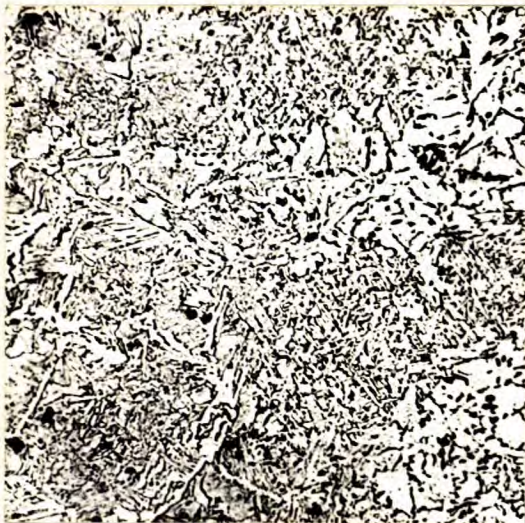
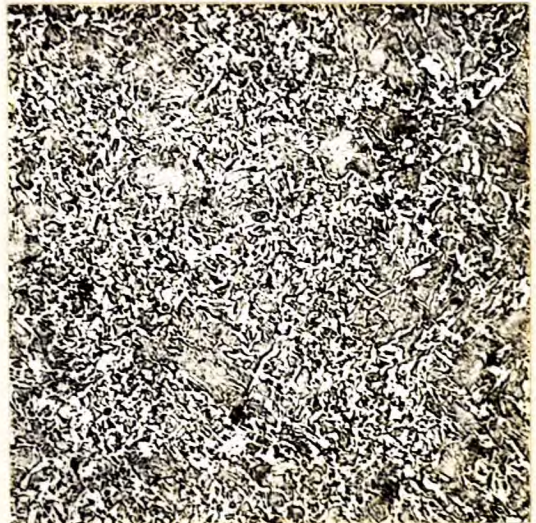
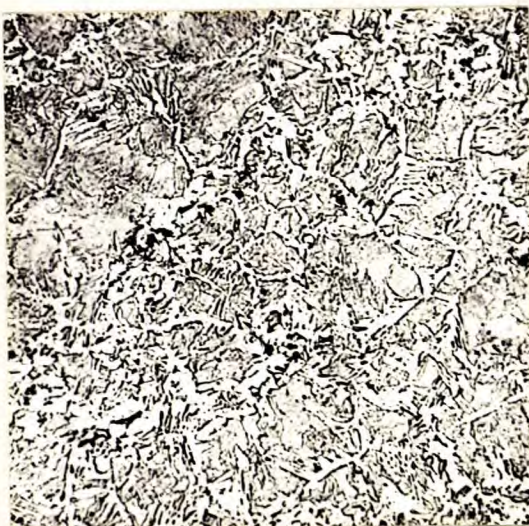
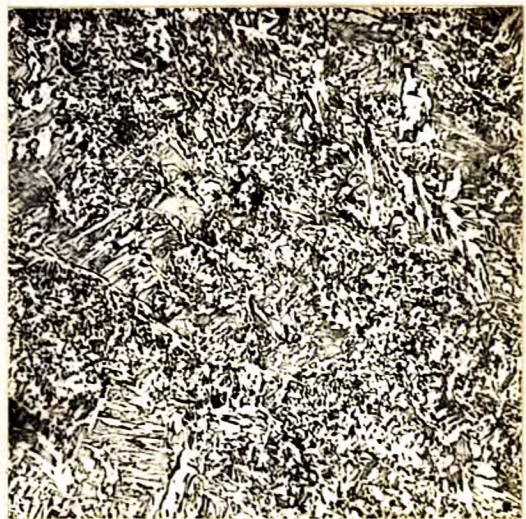
ONE HEAT TREATMENT WELD.

TWO HEAT TREATMENT WELD.

The one heat treatment received by sample number two broke up the weld structure to some extent but the centre was still coarse. The two heat treatments given sample number three completed the transformation. The refinement of the structure apparent in samples two and three is caused by the temperature to which they were reheated. Obviously, mere repetition of the welding cycle would not result in this refinement. Hardness tests confirm the fact that heat treatment improved the welds and that maximum improvement was obtained by the double heat treatment.
