Investigation No. 1279.

Examination of a "Broken Crusher Lug"  
Manganese Steel Casting.

R E P O R T  
of the  
ORE DRESSING AND METALLURGICAL LABORATORIES.

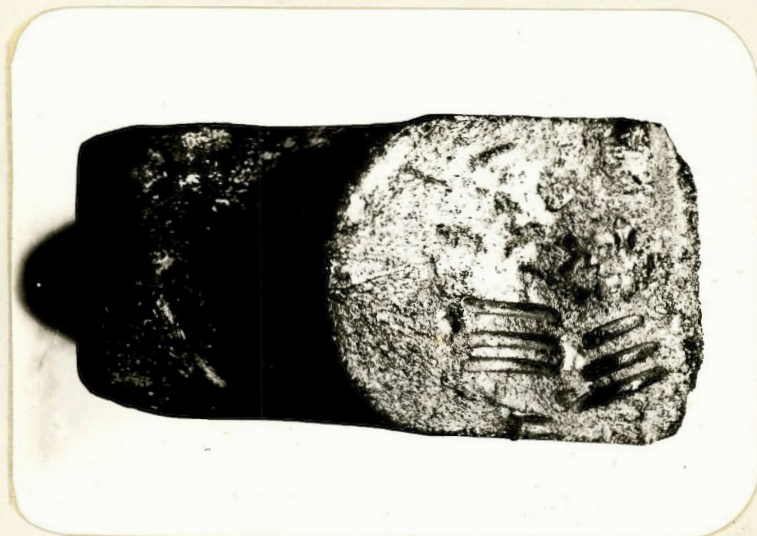
Figure 1.

"Broken Crusher Lug"  
Showing spring steel internal  
chill in fracture.

(Approx. 1/3 size).

Figure 1 is a photograph of the lug. The imprint of a wire chill can be seen on the surface of the fracture and also some of the wire at the edge of the fracture. Apart from this defect, the casting appeared to be free from any surface imperfections.

From the results obtained on the examination of this broken austenitic manganese steel lug, it is concluded that failure was due to the presence of a steel wire chill.

If internal chills are being used to prevent shrinkage of the metal in the lug, it is recommended that some other method be used to obtain a sound casting.

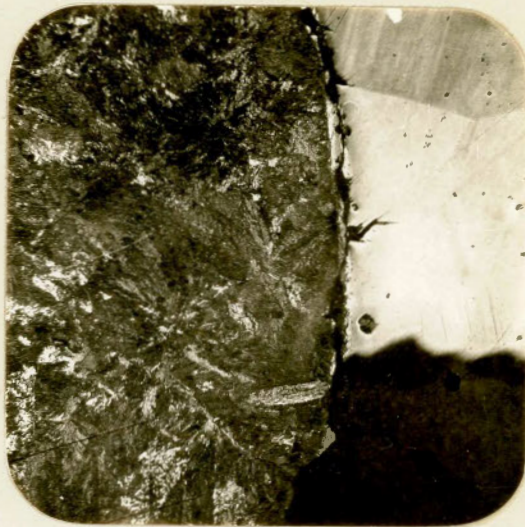
Figure 3.

Figure 2 shows, at X100 magnification, the steel in the unetched condition. The crack shown in this photomicrograph lies between the steel wire chill and the manganese steel. The etched structure of steel wire and the manganese is shown in Figures 3 and 4, photomicrographs taken at X100

X100, 2 per cent  
nital etched.

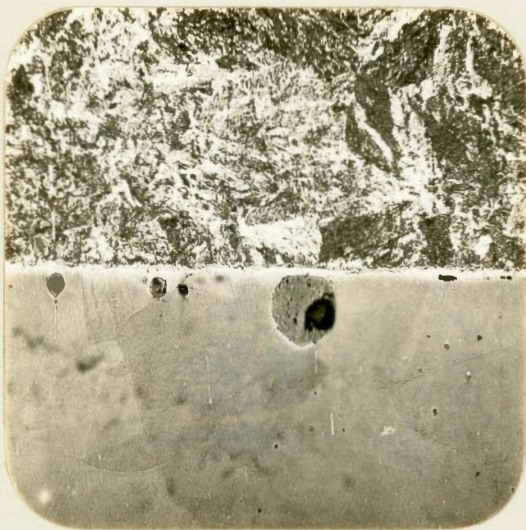
Figure 4.

X100, 2 per cent  
nital etched.

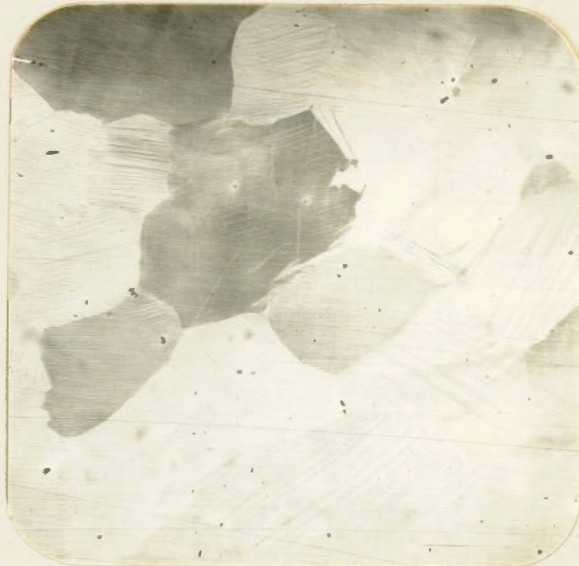
Figure 5.

magnification. Figure 5 shows, at X100 magnification, the etched structure of the manganese steel. The grains are medium sized and are free from carbides within the grains and also along the grain boundaries.

X100, 2 per cent  
nital etched.

The size of the austenitic grains indicates that the steel was not poured from too high a temperature. The presence of the unmelted chill in the lug would lower the impact properties of the steel.

The absence of free carbides indicates that the steel was properly heat treated.
