ORE DRESSING AND METALLURGICAL LABORATORIES.

Investigation No. 1303.

Examination of Two Ram Tank Volute Springs.

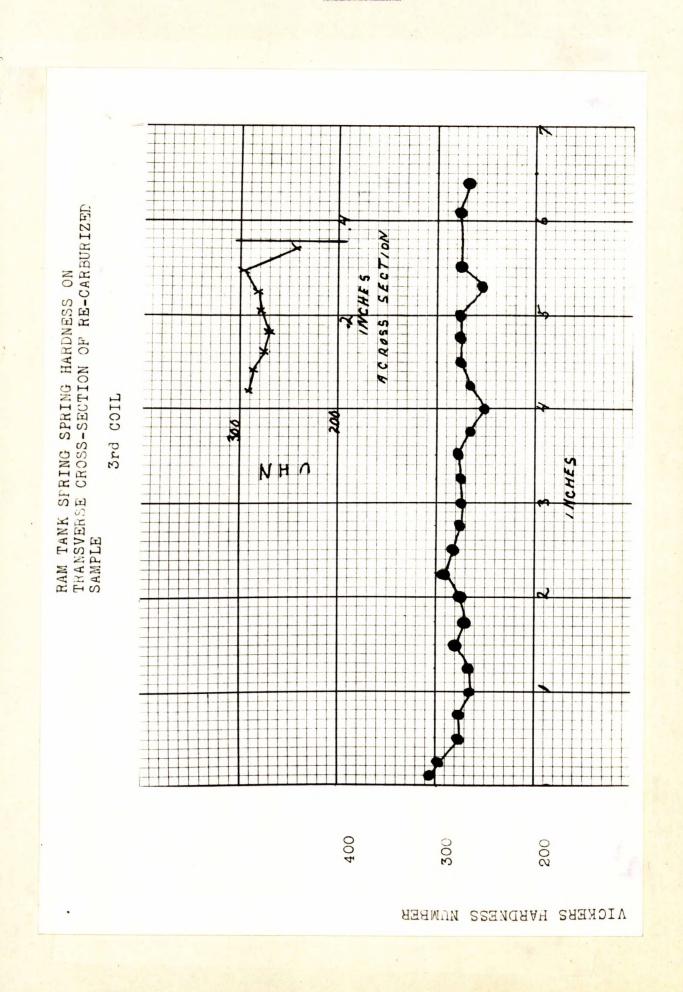
Figure 1.

A transverse section of the third coil (counting from the inside) of each spring was removed and polished. Figures 1 and 2 illustrate graphically the hardness along and across these two segments.

The "as received" spring, besides being too soft, has all the evils inherent in a decarburized surface. The recarburizing treatment given the other spring was effective, but the quenching medium lacked the agitation necessary to harden the inner coils successfully.

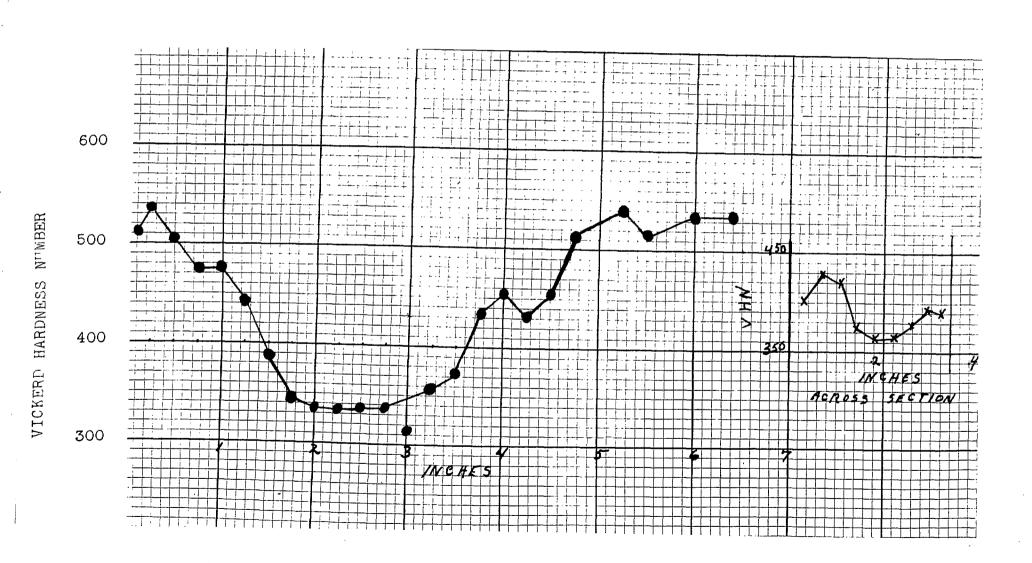
RAM TANK SPRING HARDNESS ON TRANSVERSE CROSS-SECTION OF SAMPLE AS RECEIVED 3rd COIL

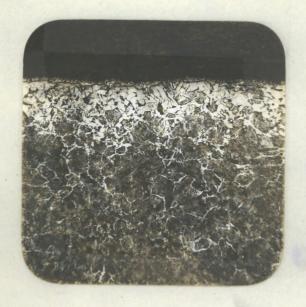
Figure 3.

The polished specimens were etched in a 4 per cent solution of picric acid in alcohol. Figure 3 shows the "as received" spring to be severely decarburized. The recarburized case on the re-heat-treated spring is illustrated in Figure 4.

X100, picral etch.

DECARBURIZED
SURFACE.

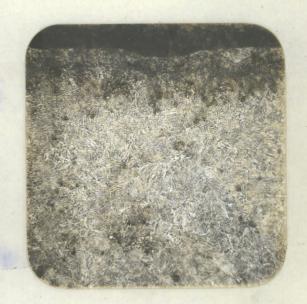
Figure 4.

X100, picral etch.

RECARBURIZED
SURFACE.
