September 30th, 1942.

ORE DRESSING AND METALLURGICAL LABORATORIES.

Investigation No. 1310.

Examination of a Failed Exhaust Ring
from a Lysander IIIA Aircraft.

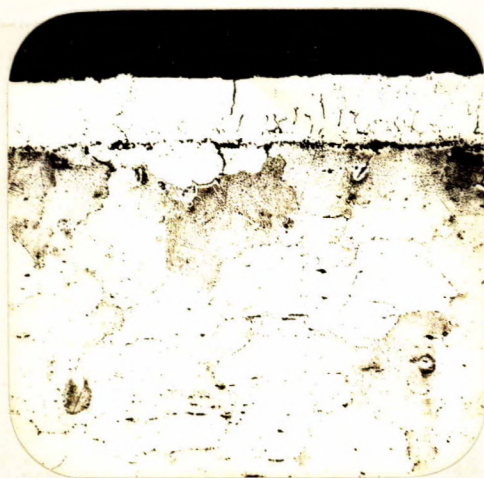
Figure 3.

X100, etched with Keller's reagent.

ALUMINIUM COATING ON SHEET STEEL.

The aluminium coating shown in Figure 3 was found on only one side of the sample submitted.

3. One side of the specimen was found to be aluminium-coated. It is probable that the other side had also been coated but the corrosive-erosive action of exhaust gases had removed this coating.
