ORE DRESSING AND METALLURGICAL LABORATORIES.

Investigation No. 1322.

Examination of a Cheetah IX Cylinder Barrel  
Chromium-Plated by the Van der Horst Process.

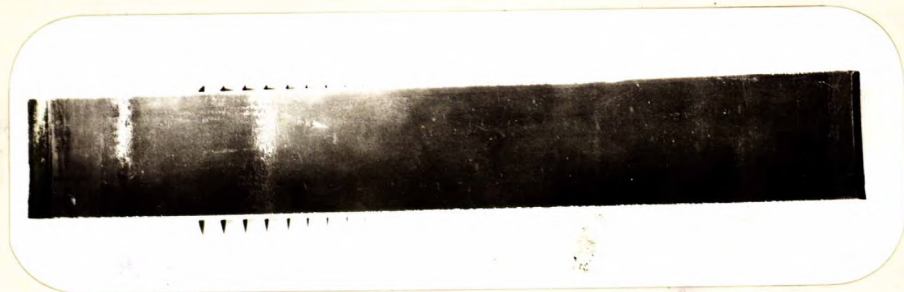
A longitudinal section was cut out. This is shown in Figure 1. Note the bright area on the surface.

INTERNAL SURFACE OF LONGITUDINAL STRIP CUT  
FROM THE CYLINDER  
BARREL.  
(Approximately  $\frac{1}{2}$  actual size).

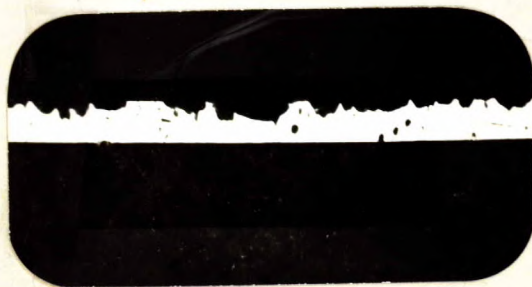
Figure 6.

Figure 6 is a view of the cross-section through the plate, showing the irregularities of the surface.

Magnification, X40.  
CROSS-SECTION OF CHROMIUM PLATE, SHOWING  
SURFACE IRREGULARITIES.
