REPORT
of the
ORE DRESSING AND METALLURGICAL LABORATORIES.

Investigation No. 1330.

Examination of Universal Carrier Track Pins
from Field Tests C-6, 13-W, 16-W,
Windsor, Ontario.

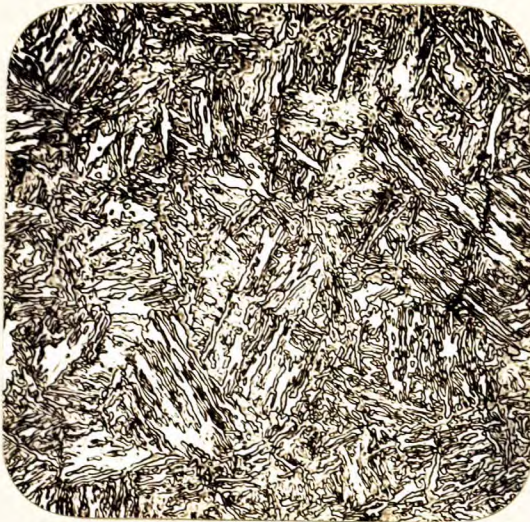
Figure 3.

X500.

CORE OF NE 8124
SOFT-CENTRE PIN.

(Note: White constituent - ferrite;
dark - lamellar carbide.)

The photomicrographs of the cores of the NE 8124 and SAE X1020 pins indicate that the manufacturer quenched all of the pins from approximately the same temperature, as all pins contain about the same small amount of ferrite. It follows, then, that the soft-core pins were obtained by a slower quench. Figure 7, showing the case structure of a soft-cored SAE X1020 pin, indicates the presence of troostite. This is also the result of a slow quench. A more drastic quench would eliminate this troostite, which has an embrittling effect on the case.

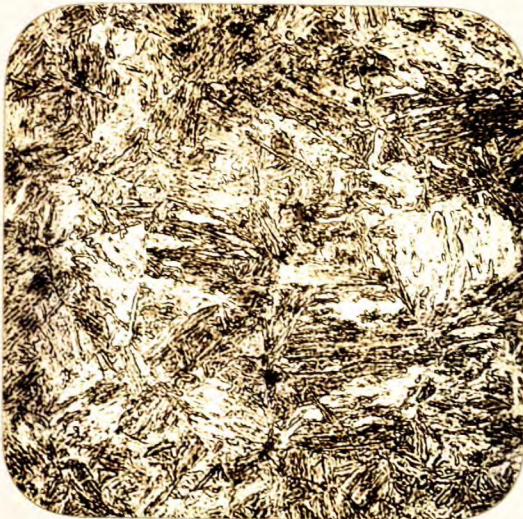
Figure 5.

X500.

CORE OF NE 8124
HARD-CENTRE PIN.

Structure is tempered martensite
with elongated nodules.

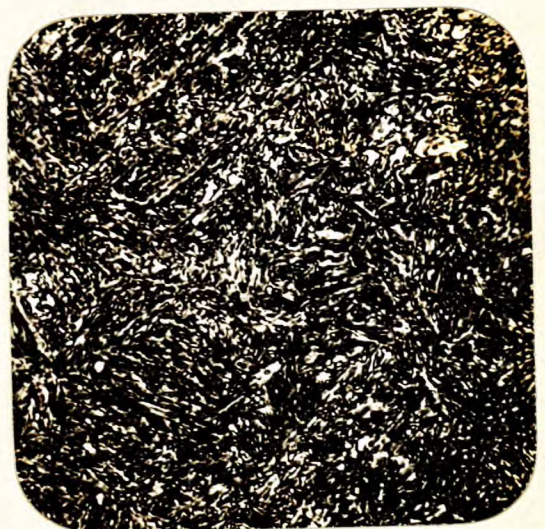
Figure 6.

X1000.

CASE OF NE 8124
HARD-CENTRE PIN.

Tempered martensite.

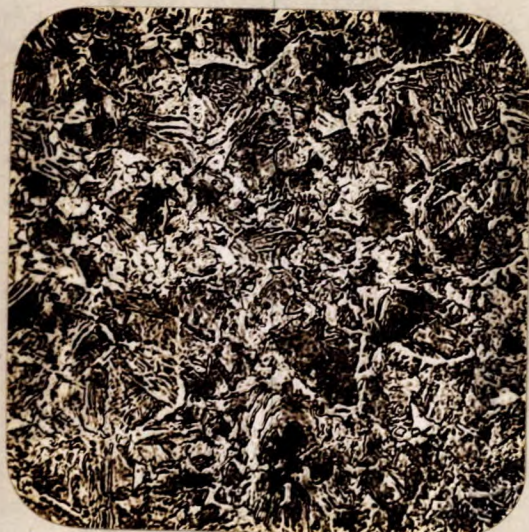
Figure 7.

X500.

CORE OF SAE X1020
SOFT-CENTRE PIN.

(Note: White constituent -
ferrite; black areas -
sorbite; also nodules
of carbide present.)

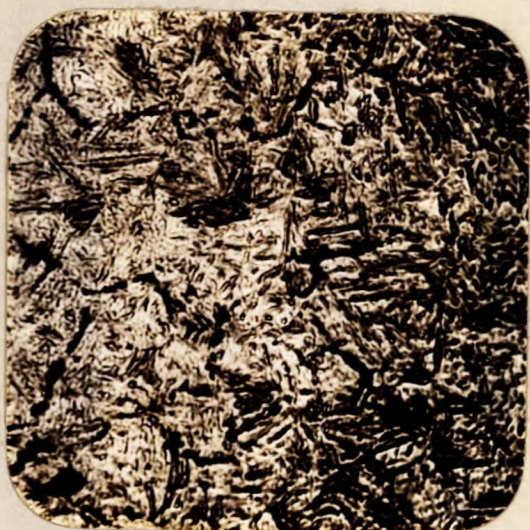
Figure 8.

CASE OF SAE X1020
SOFT-CENTRE PIN.

Note presence of troostite
(black constituent) around
grain boundaries.

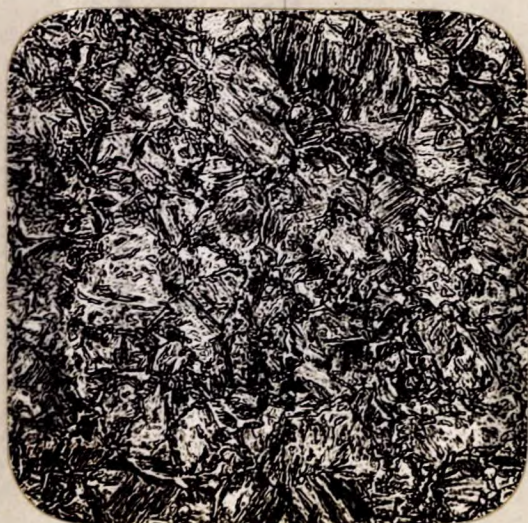
Figure 9.

X500.

CORE OF SAE X1020
HARD-CENTRE PIN.

Note presence of ferrite
(white constituent),
nodules of carbide, and
amount of sorbite.

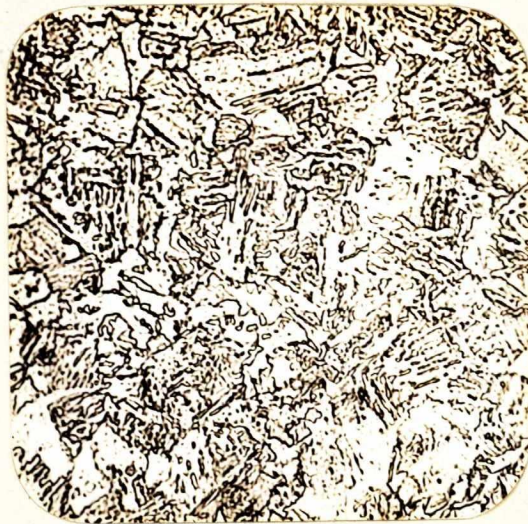
Figure 12.

X500, nital etch.

CORE OF SAE 3115 PIN.

Note ferrite (white constituent)
and nodular carbides.
