ORE DRESSING AND METALLURGICAL LABORATORIES.

Investigation No. 1331.

Investigation to Identify Inclusions
in Fractured Transverse Tensile Test Pieces
from a Gun Barrel.

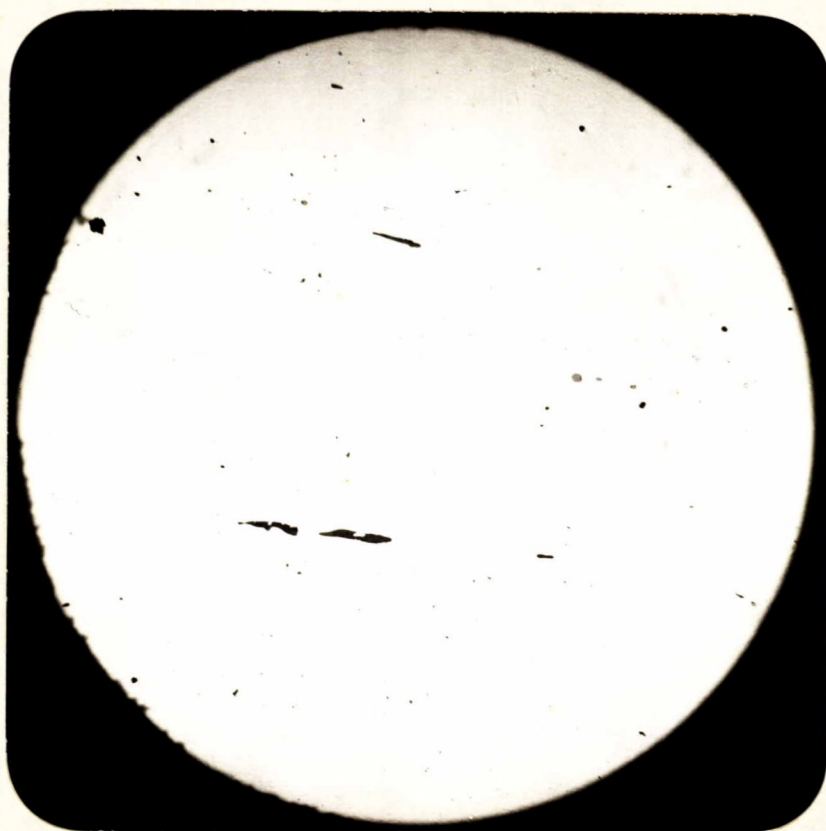
Figure 1.

X100, unetched.

GENERAL VIEW OF INCLUSIONS.

Note appearance.

A specimen for microscopic examination was prepared from Test Bar B. Upon examination before etching, two principal types of inclusions were observed. A very few normal elongated sulphide inclusions were found. One of these is shown in Figure 5 at 1000 diameters. At 100 diameters, the majority of them appeared to be a very dark grey (see Figure 1). Figure 1 also shows three small sulphide inclusions. One of the dark-grey elongated inclusions in Figure 1 was photographed at 1000 diameters and is shown in Figure 2. Compare this with Figure 5.

The first step is a 10-second etch in 10 per cent nital. The results on the two types of inclusions are shown in Figures 3 and 6. This is followed by an etch in 10 per cent chromic acid in water for 5 minutes and the results of this treatment are shown in Figures 4 and 7. Note that the inclusion shown in Figure 2 has not been affected, while that shown in Figure 5 has been strongly attacked. This means that the dark-grey elongated inclusions shown in Figure 1 and enlarged in Figure 2 are not sulphides.

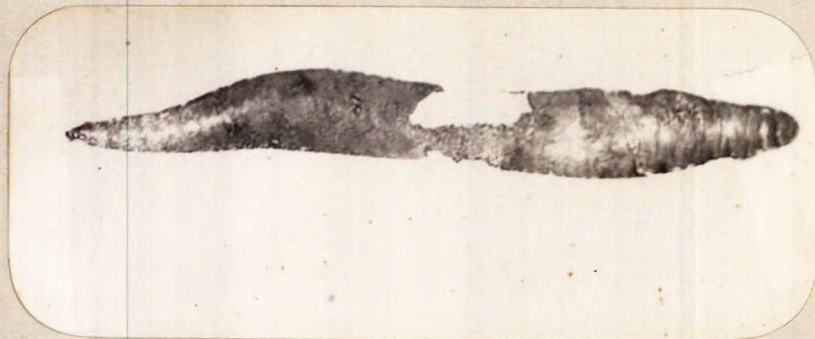
Figure 2.

X1000, unetched.

Same as one of the dark elongated inclusions in Figure 1.

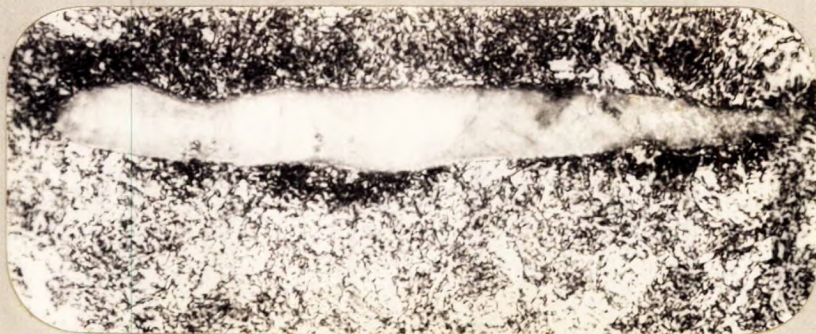
Figure 3.

X1000, etched for 10 seconds
in 10 per cent nital.

Same type of inclusion as
shown in Figure 2.

Note absence of attack.

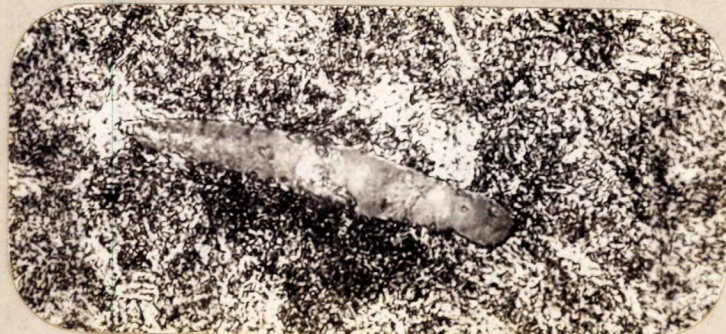
Figure 4.

X1000, etched in 10 per cent chromic
acid in water for 5 minutes.

Same type of inclusion as
shown in Figure 2.

Note absence of attack.

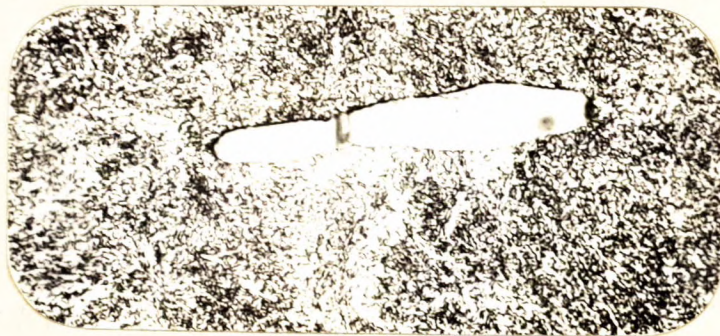
Figure 6.

X1000, etched for 10 seconds
in 10 per cent nital.

Same as Figure 5.

Note absence of attack.

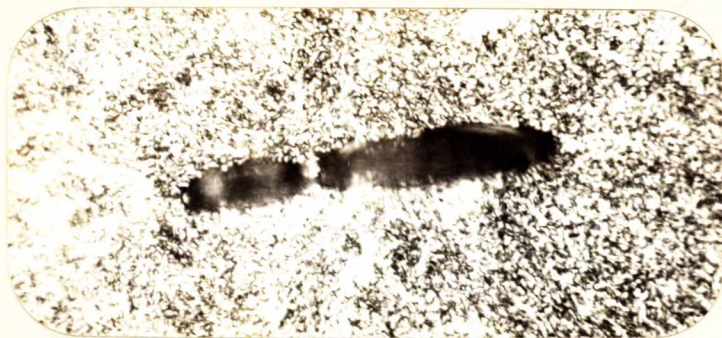
Figure 7.

X1000, etched in 10 per cent chromic
acid in water for 5 minutes.

Same inclusion as Figure 5.
This is a sulphide inclusion.

Note severe attack.

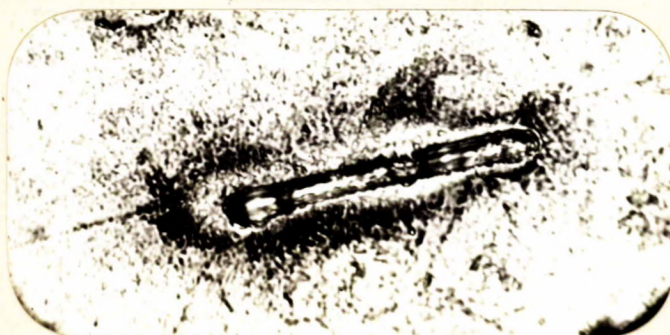
Figure 9.

X1000, etched in 20 per cent
aqueous HF for 10 minutes.

Same type of inclusion as shown
in Figure 2. This is a silicate.

Note attack.

The next treatment was to etch for 10 minutes in 20 per cent hydrofluoric acid in water. Figure 8 shows the results at 100 diameters and Figure 9 at 1000 diameters.

This etchant has severely attacked these inclusions, identifying them as silicate inclusions.
