ORE DRESSING AND METALLURGICAL LABORATORIES.

Investigation No. 1342.

Examination of Track Link and Track Pin
from a German P.Z.K.W. Mk II Tank.

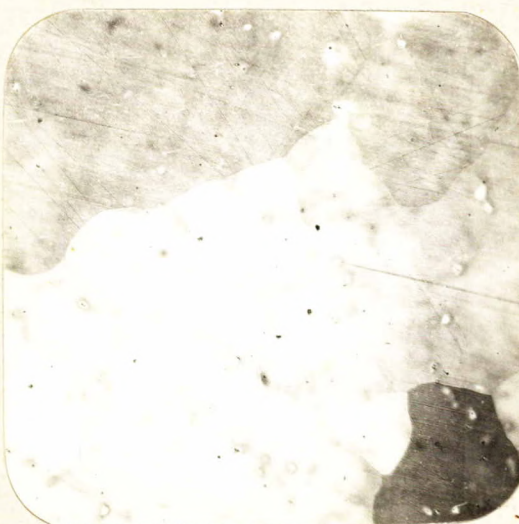
Figure 5.

Specimens were cut from the link and examined under the microscope. The unetched specimens showed that the steel was quite clean. The nital-etched specimen showed the structure illustrated in Figure 5 (taken at X100 magnification).

X100, nital etch.
STRUCTURE OF LINK.

The microstructure shows a normal austenitic grain size, which indicates that the pouring temperature was satisfactory. The link also received the proper heat treatment for a high-manganese steel, i.e., water-quenched rapidly after holding at 1850-1940° F.

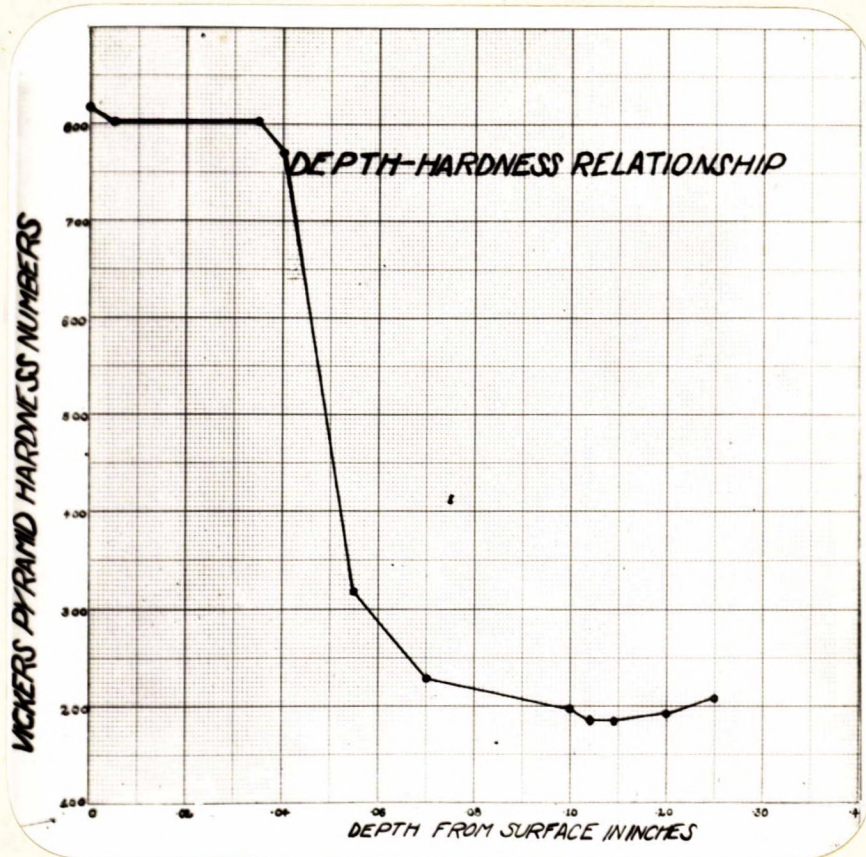
Figure 6.

A transverse section of the pin was cut and hardness readings were taken across the face of the section, using the Vickers hardness machine and a 10-kilogram load.

Figure 6 is a depth-hardness chart plotted from the hardness results obtained. It can be seen that the surface hardness is 518 V.P.N. and the core hardness 195 V.P.N.

The case depth, 0.047 inch, is considered to be too thick. A large number of pins having approximately this depth and hardness (800 V.P.N.) failed in a field test carried out on the Valentine tank at the start of production in Canada.

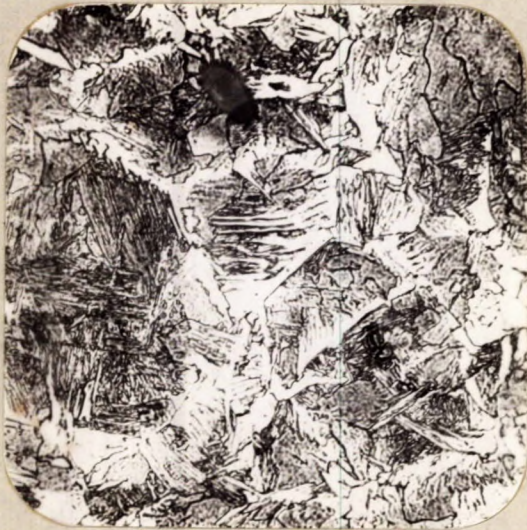
Figure 7.

A transverse section was cut from the pin and then polished. The unetched specimen indicated that the bar stock used was quite clean. Figures 7 and 8 are taken from the nital-etched specimen, at X500 and X1000, of the core and case respectively.

X500, nital etch.

CORE OF PIN.

Note the presence of ferrite - white constituent.

The bend test caused the case of the pin to crack at a low load, signifying that it was in a brittle condition. The coarsely acicular martensitic structure shown by the photomicrograph corroborates this fact. This structure, and also that of the core (coarse grain size and ferrite) indicates that the pin was pack-carburized at a relatively high temperature, 1700-1750° F. It was then cooled in the box to a point below the upper critical of the core and then quenched.
