ORE DRESSING AND METALLURGICAL LABORATORIES.

Investigation No. 1362.

An Investigation of the Ballistic  
Properties of High Test Cast Iron.

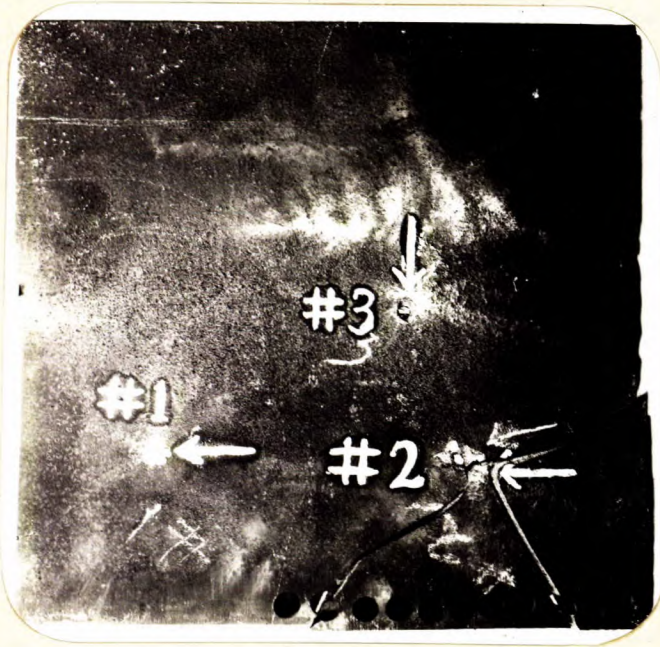
Figure 1.

Front of Plate.

Photographs of Plate No. 1 after firing trials.  
Note pieces broken out of corner and spalling  
on the back of the plate.

The ballistically tested plates were photographed. These photographs are presented in Figures 1 to 8 inclusive. It should be noted that in Plate No. 1, Shot No. 1 broke the corner out and in Plate No. 2, Shots Nos. 1 and 4 cracked the plate badly. Plates Nos. 3 and 4 were not cracked.

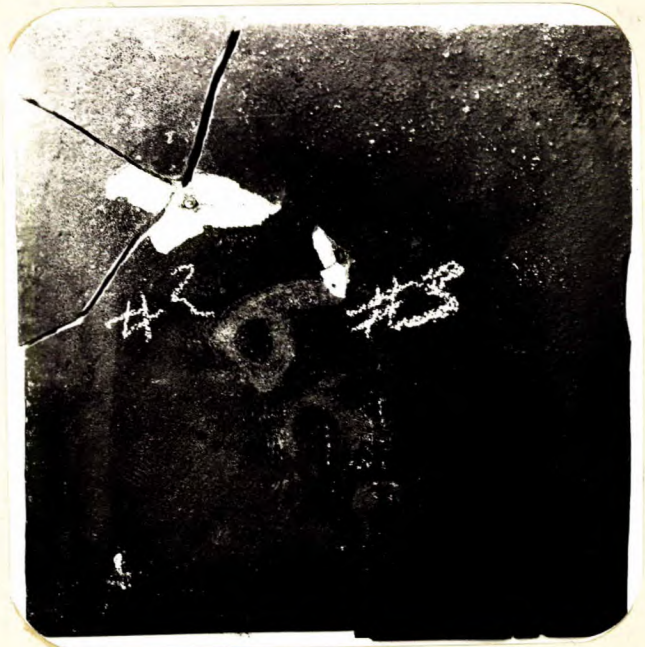
Figure 2.

Back of Plate.

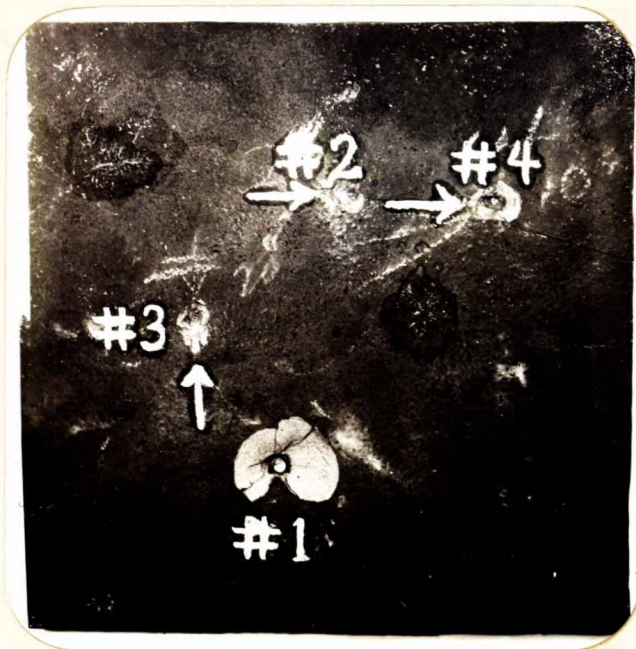
Figure 3.

Back of Plate, Shot No. 1.  
Front of Plate, Shots 2, 3 and 4.

Photographs of Plate No. 2 after firing trials.  
Note cracks in plate around Shots Nos. 1 and 4.  
Also note spalling at back of Shots Nos. 1 and 4.

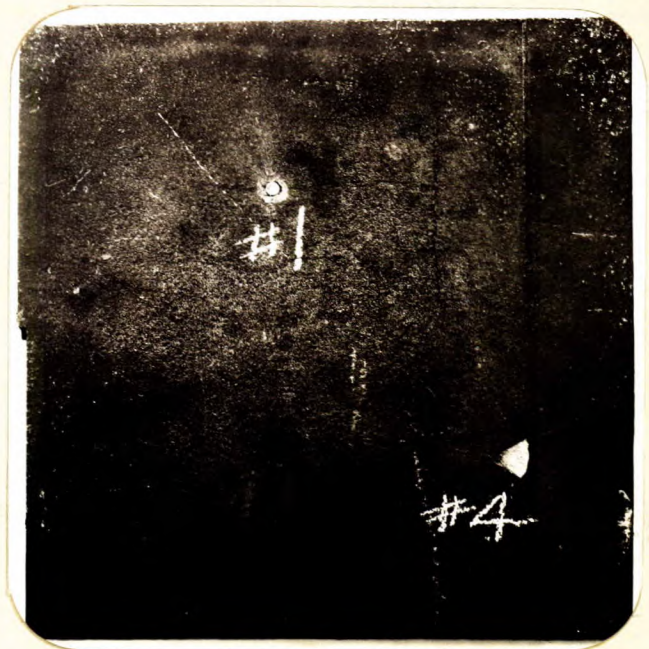
Figure 4.

Front of Plate, Shot No. 1.  
Back of Plate, Shots Nos. 2, 3 and 4.

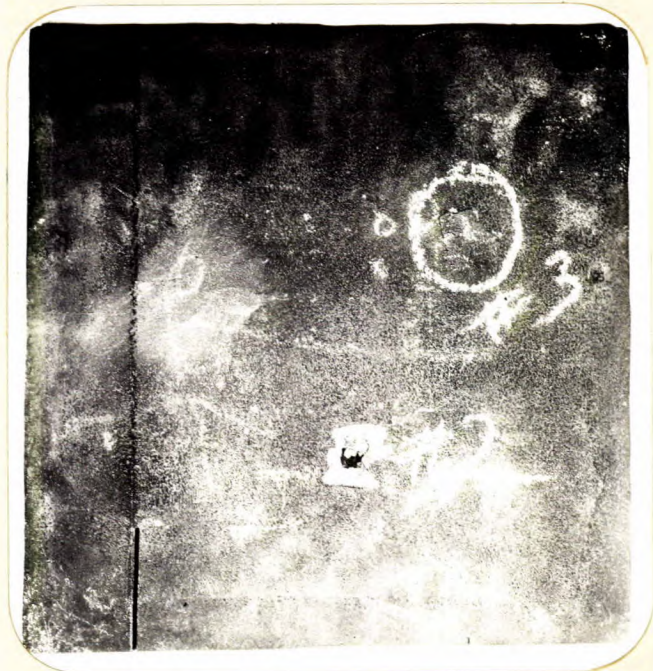
Figure 6.

Back of Plate.

Photographs of Plate No. 3 after firing trials.  
Note spalling at back of Shot No. 1 and commencement  
of spalling at back of Shot No. 3.

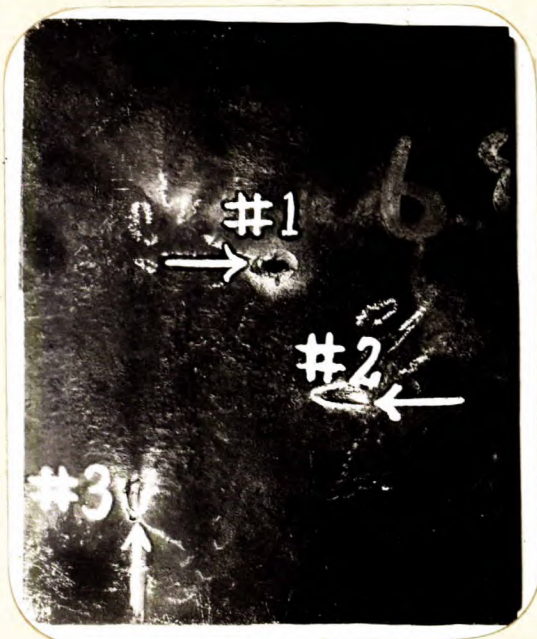
Figure 7.

Front of Plate.

Photographs of Plate No. 4 after firing trials.  
Note small amount of spalling at back of Shot No. 1.

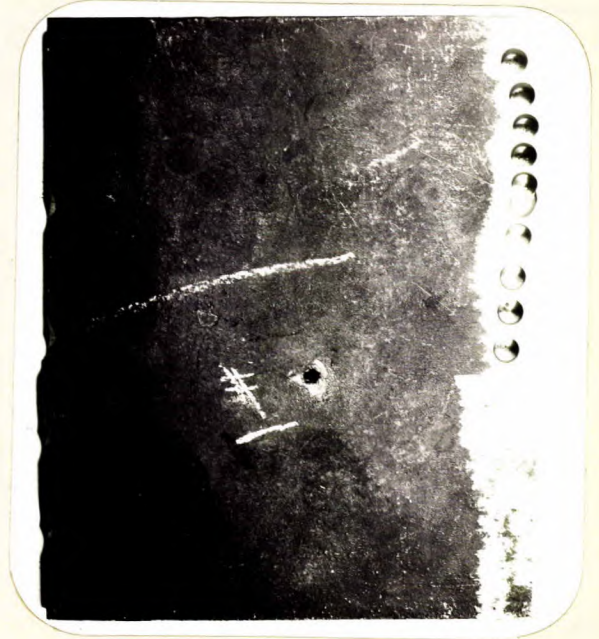
Figure 8.

Back of Plate.
